Machmell River Restoration

Ivan Stefanov, SRM-Levelton

Western Forest Products Limited

Machmell and Sheemahant Rivers

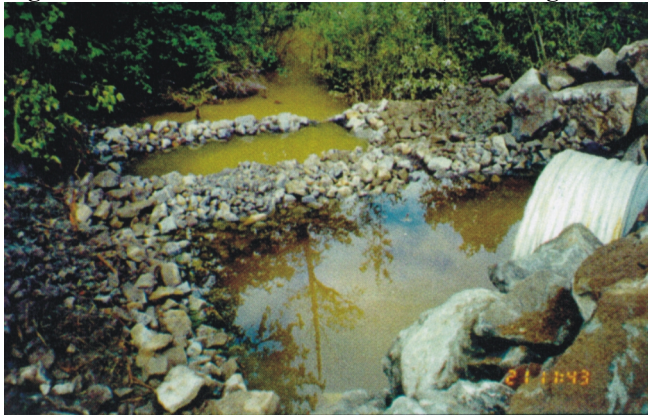
Figure 1: Site MM 07 – view of culvert, retaining weirs and the resulting pools.

Site MM07, replacement of a culvert structure and construction of two rock weirs to maintain adequate water depth in the culvert and the pool upstream of the road crossing. An existing upstream pool was complexed with LWD and enlarged. A sediment control structure was built at the outfall of the road ditch. Bank disturbance from implementation was addressed with seeding.

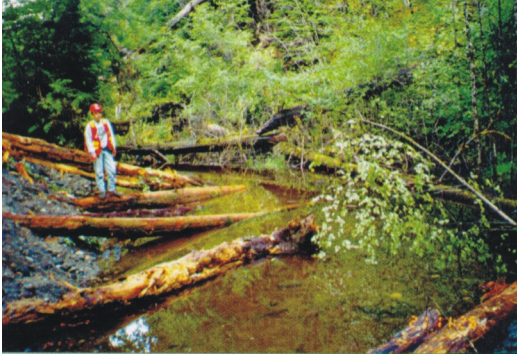
Figure 2: Site MM07 – view of excavated pool with LWD positioned at approximately 40° angle.
