# **Rebman Creek**

## **Evaluation of In-Stream Rehabilitation Structures**

### **Draft Report**

***December 2000***

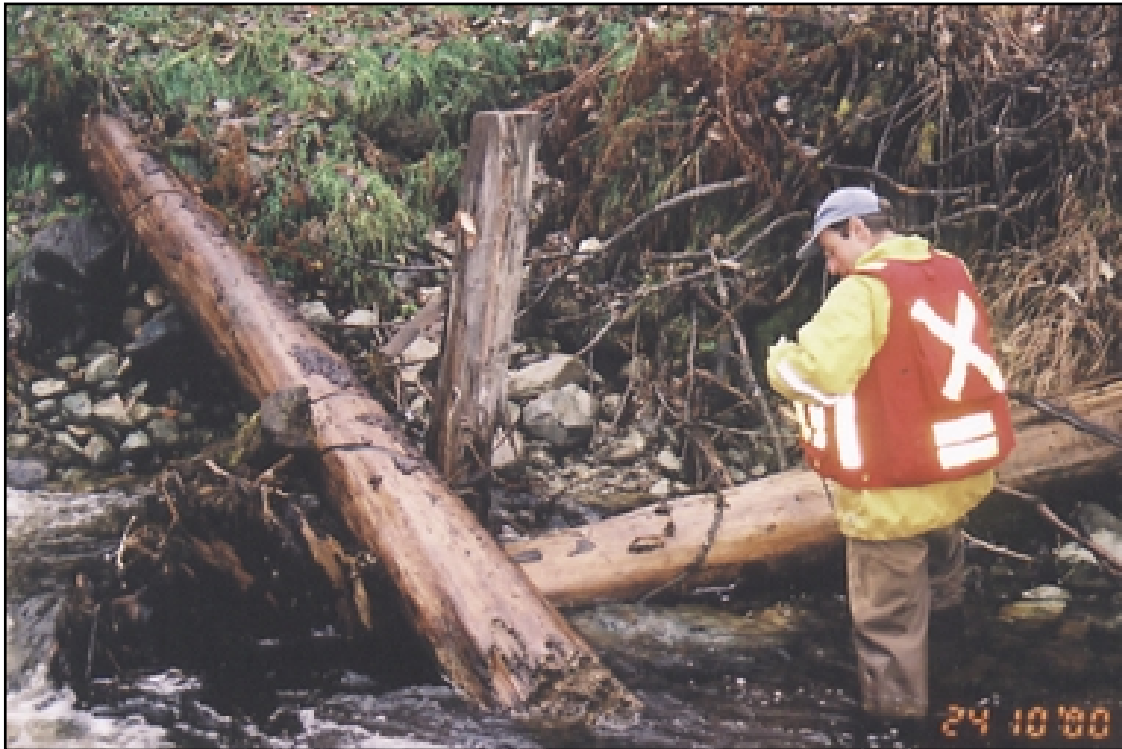
**Photo 1:** Rebman Creek Site 1: left bank LWD structure, Reach 2 at ~1,440 m.

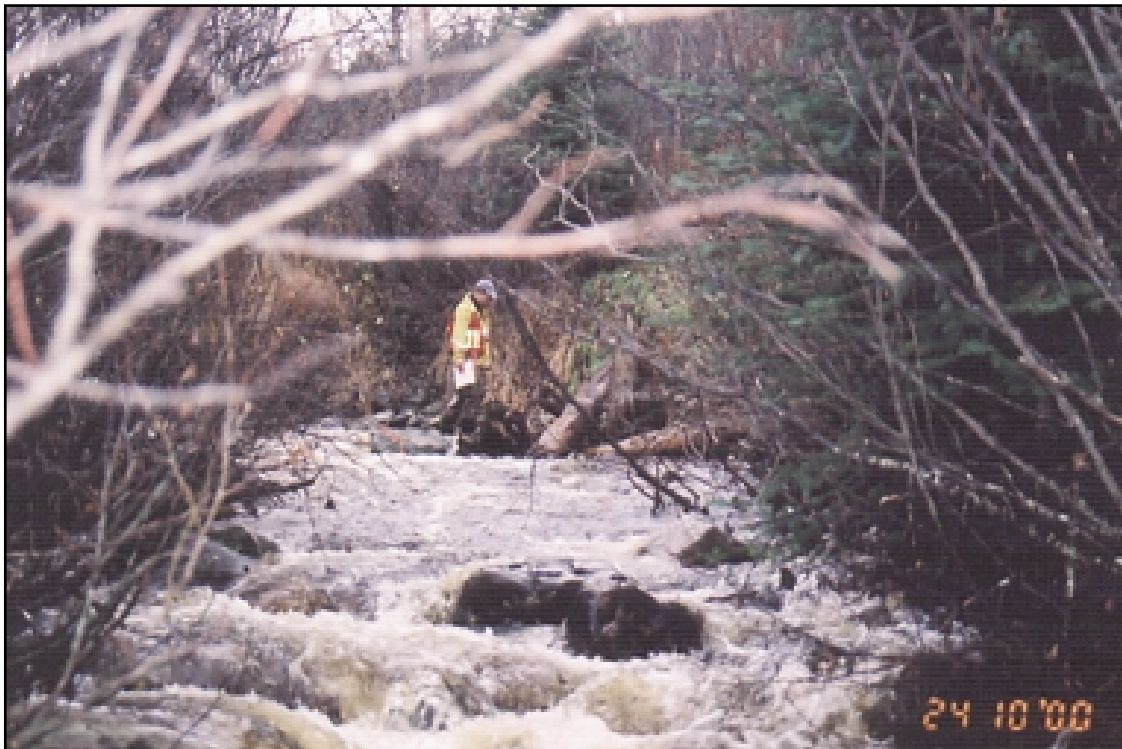
**Photo 2:** Rebman Creek Site 1: view upstream toward constructed riffle, Reach 2 at ~1,432 m.

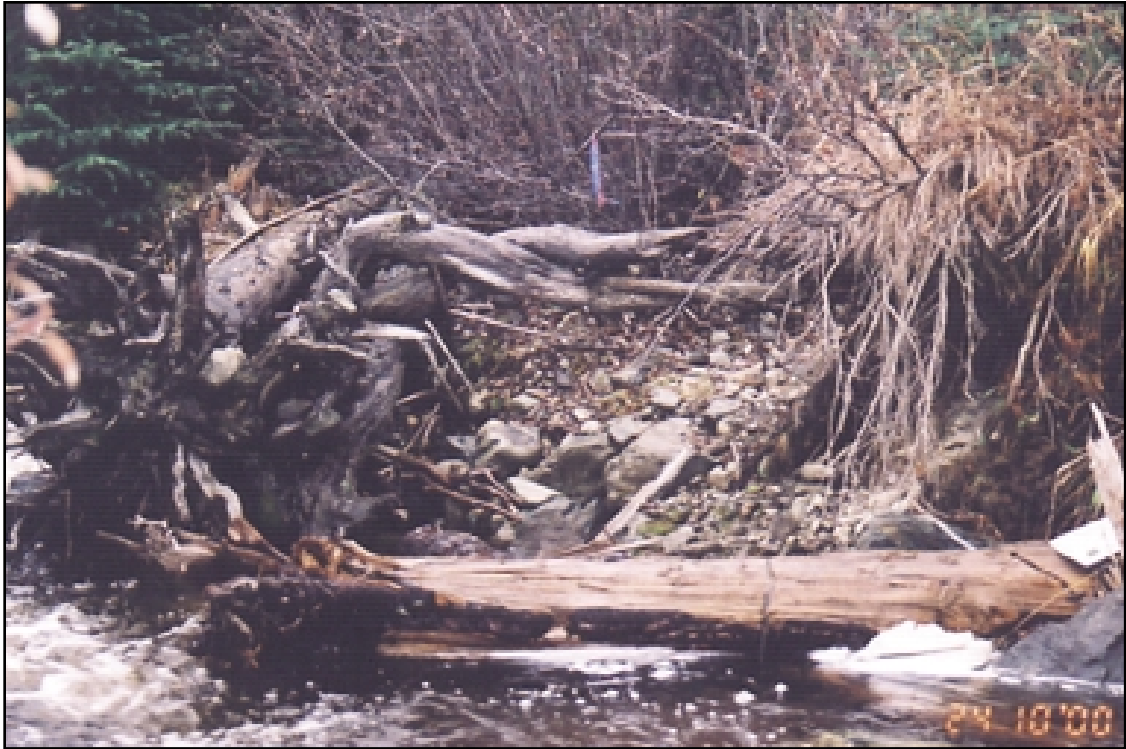
**Photo 3:** Rebman Creek Site 2: left bank LWD structure, Reach 2 at ~1,505 m.

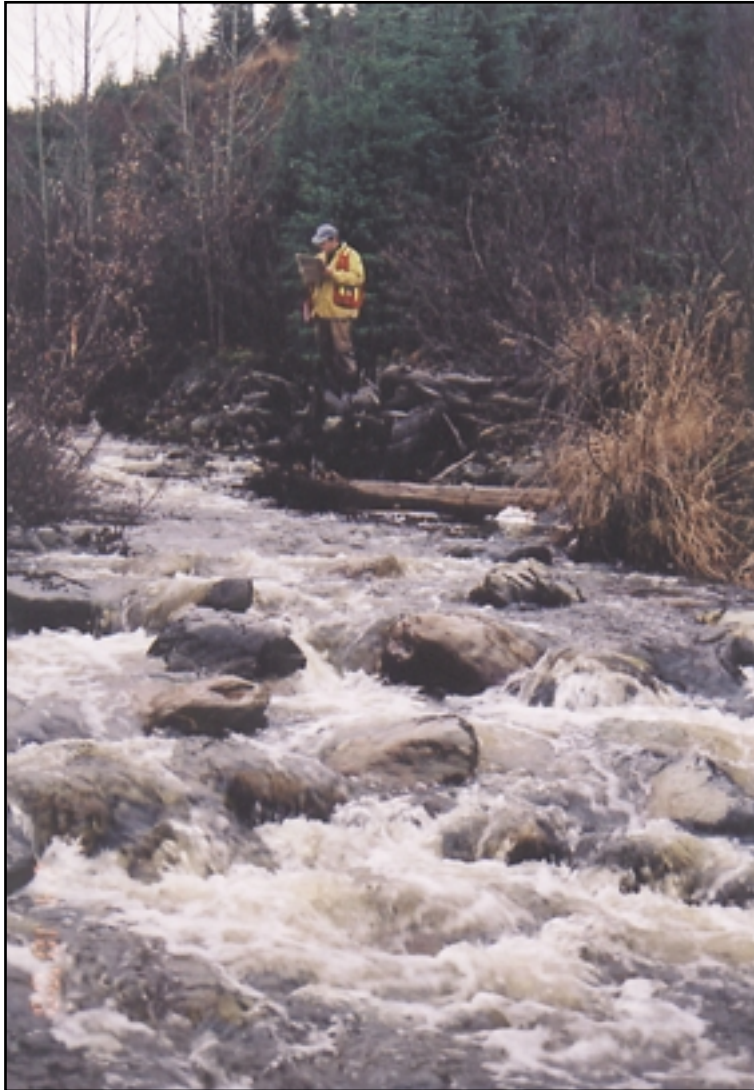
**Photo 4:** Rebman Creek Site 2: view upstream toward constructed riffle, Reach 2 at ~1,499 m.

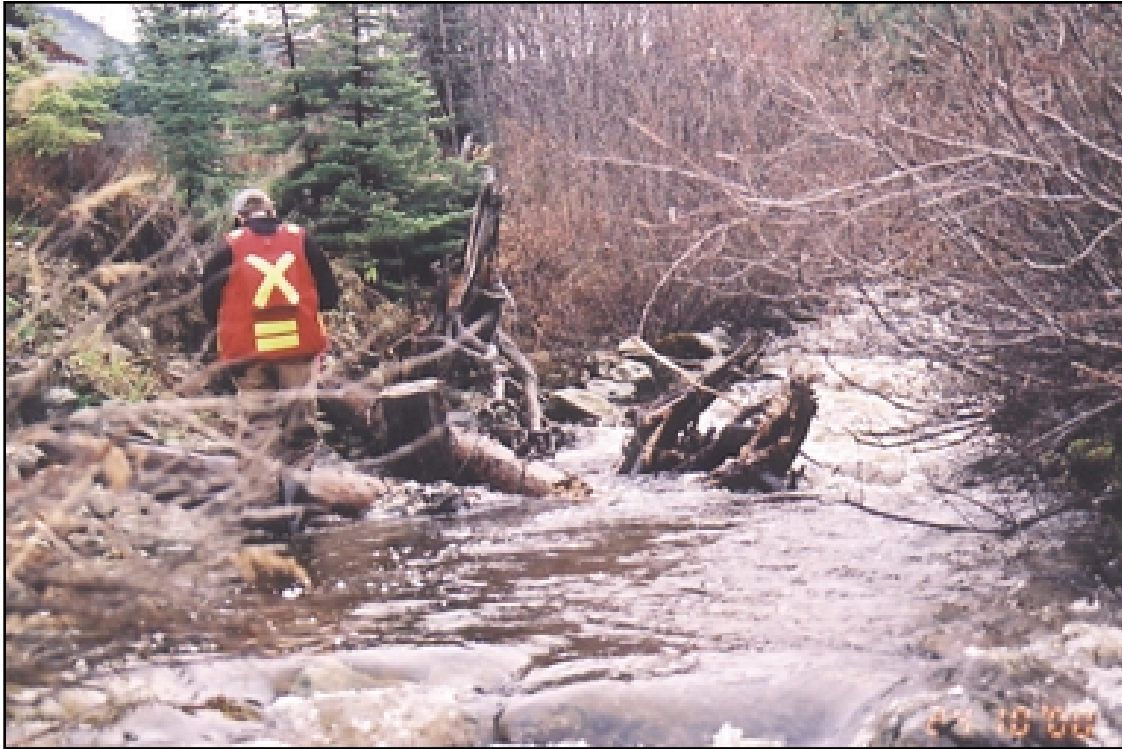
**Photo 5:** Rebman Creek Site 3: view upstream toward LWD structure, Reach 2 at ~1,525 m.

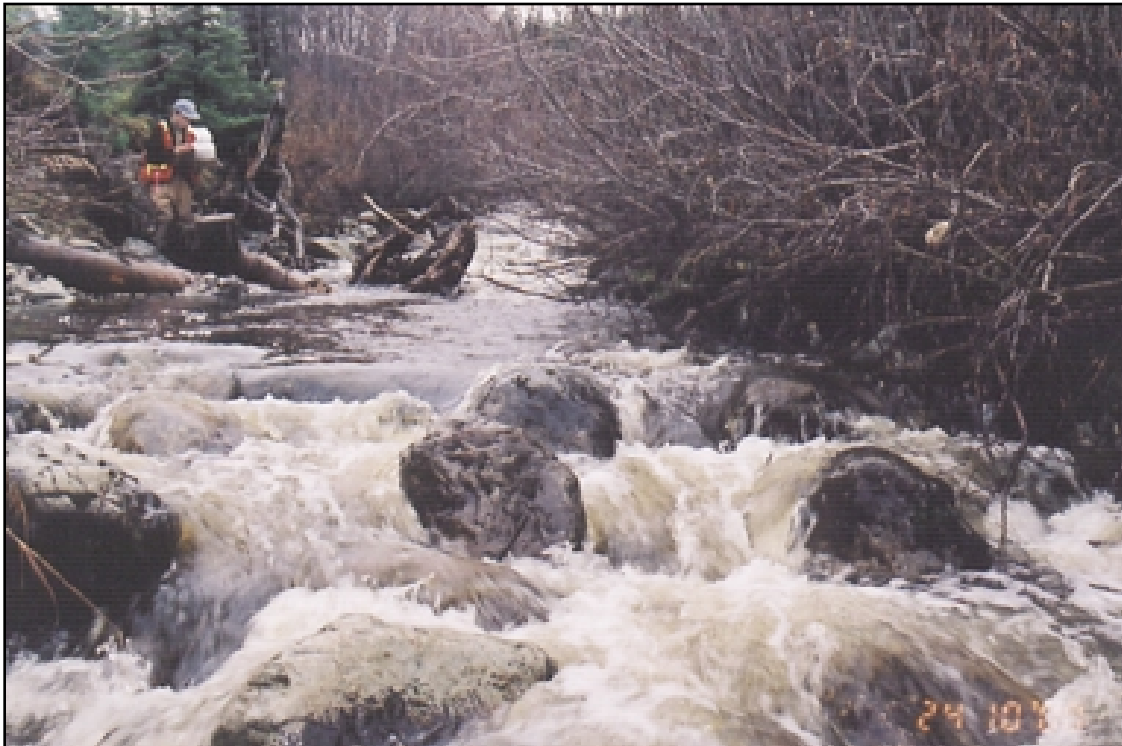
**Photo 6:** Rebman Creek Site 3: view upstream toward constructed riffle, Reach 2 at ~1,520 m.

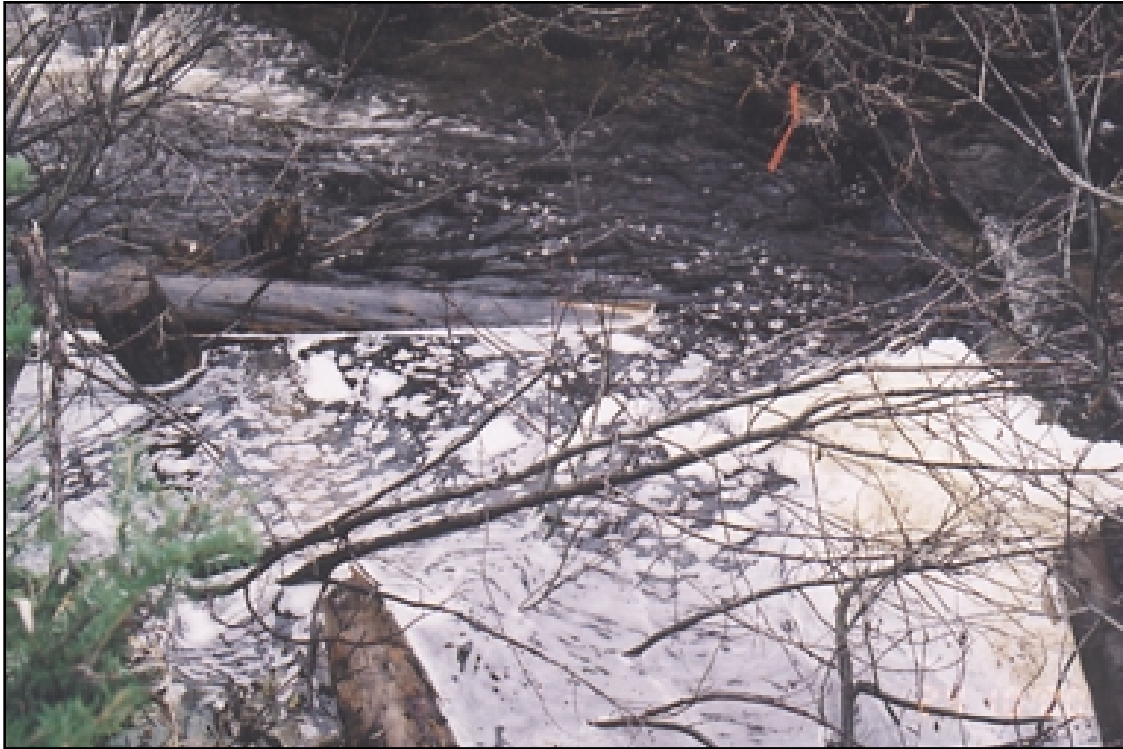
**Photo 7:** Rebman Creek Site 4: view toward left bank LWD structure, Reach 2 at ~1,590 m.

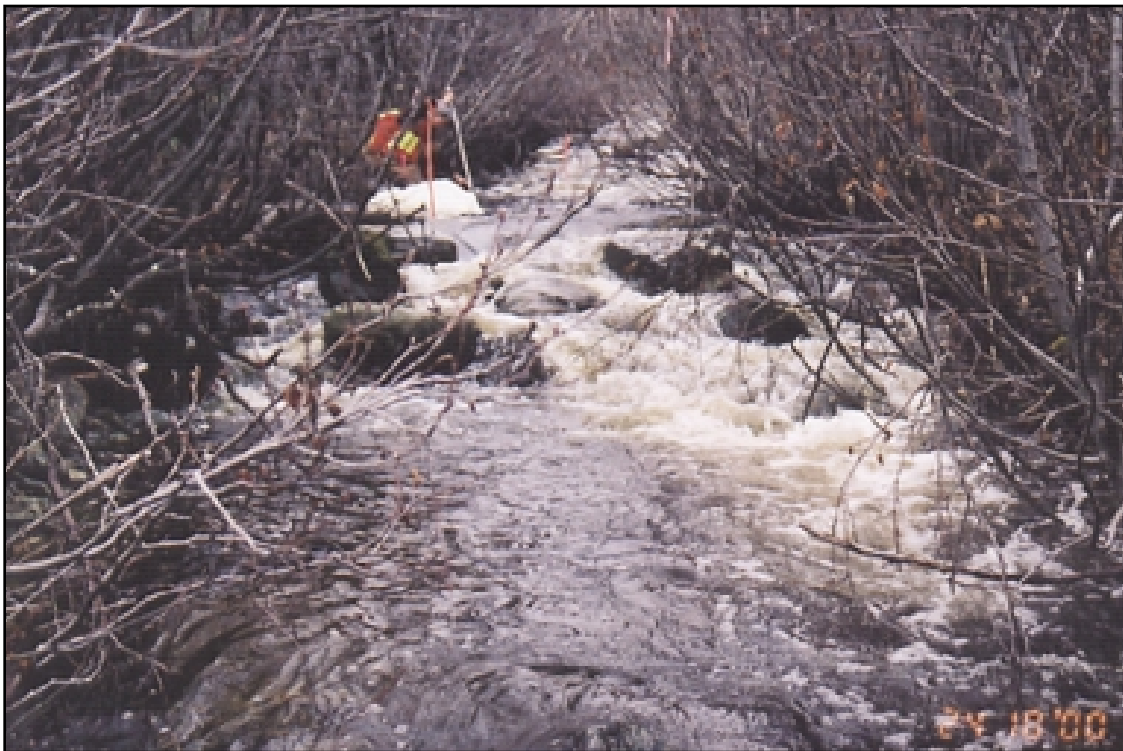
**Photo 8:** Rebman Creek Site 4: view upstream toward constructed riffle, Reach 2 at 1590 m.

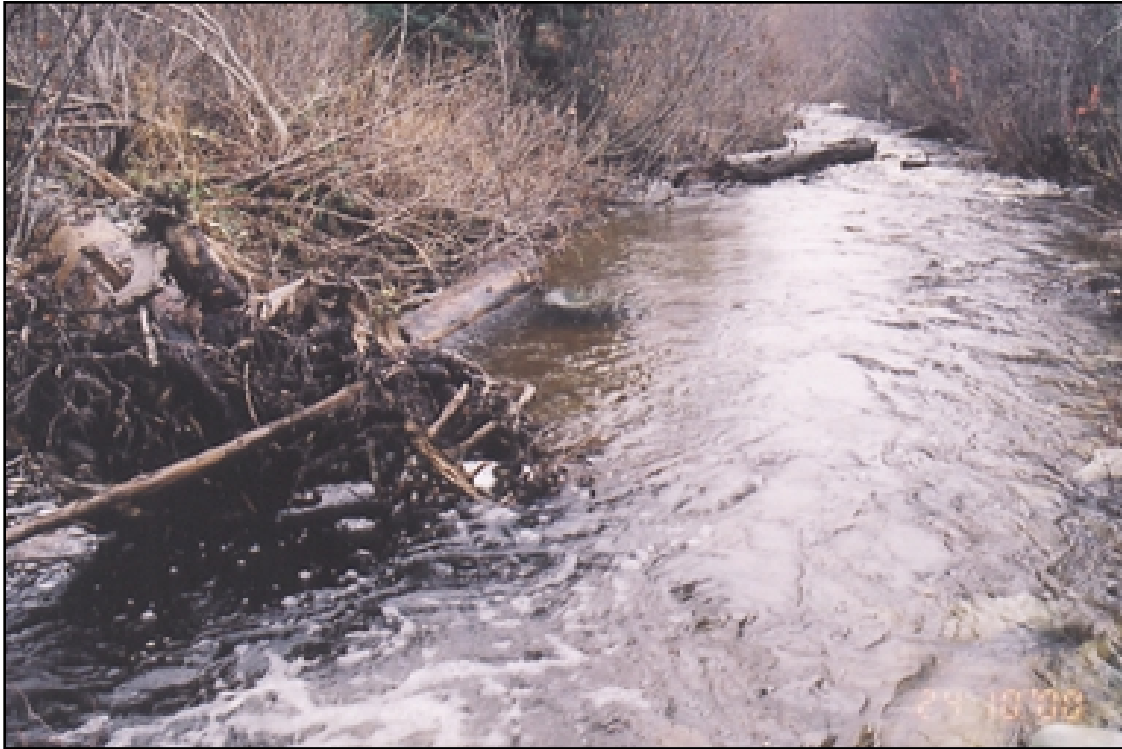
**Photo 9:** Rebman Creek Site 5: view downstream toward LWD structure, Reach 2 at ~1,640 m.

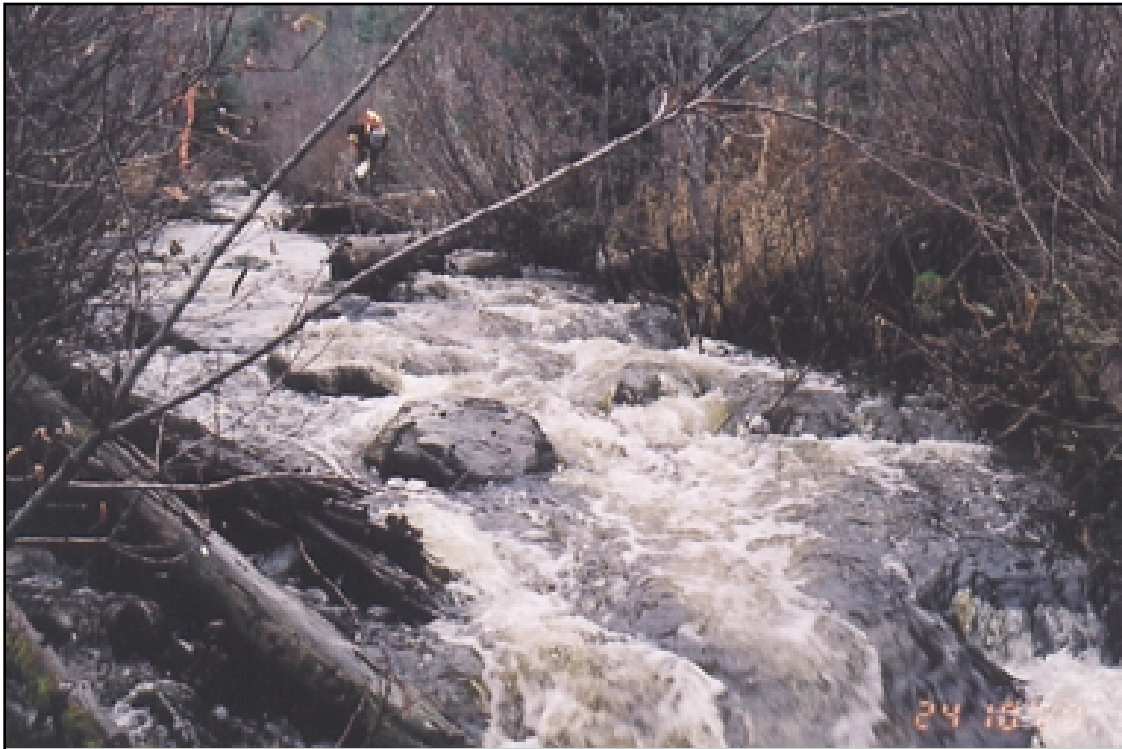
**Photo 10:** Rebman Creek Site 5: view upstream toward constructed riffle, Reach 2 at ~1,625 m.

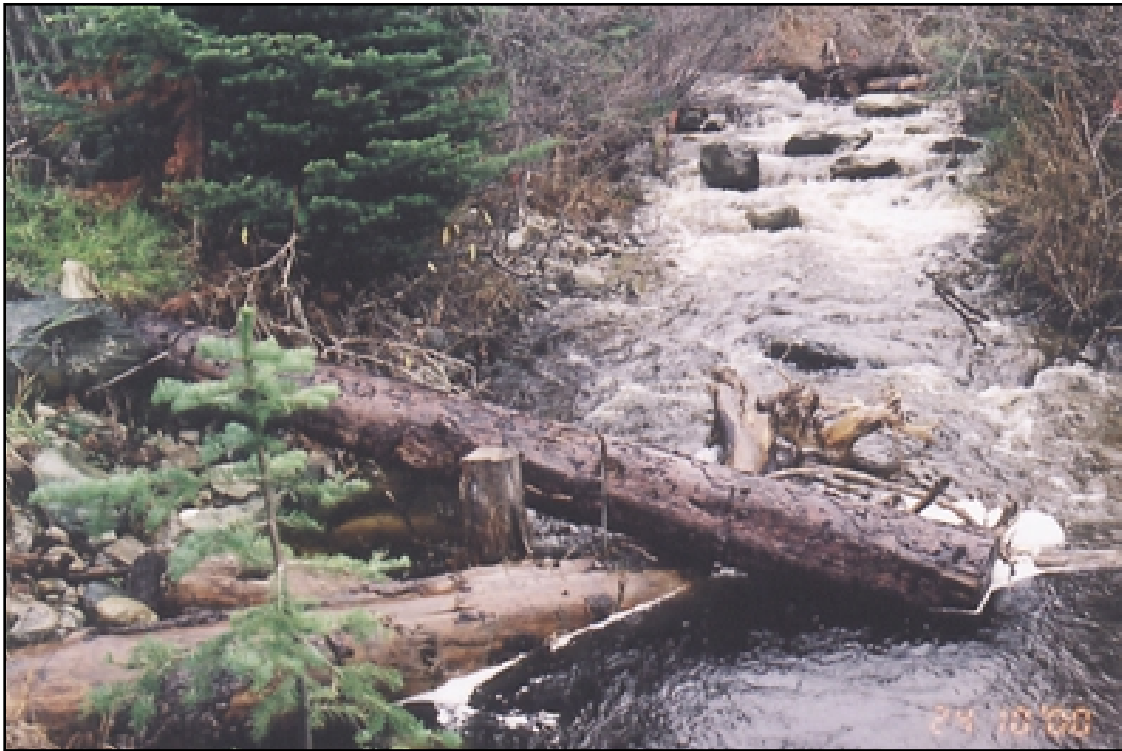
**Photo 11:** Rebman Creek Site 6: view upstream toward LWD structure, Reach 2 at ~1,660 m.

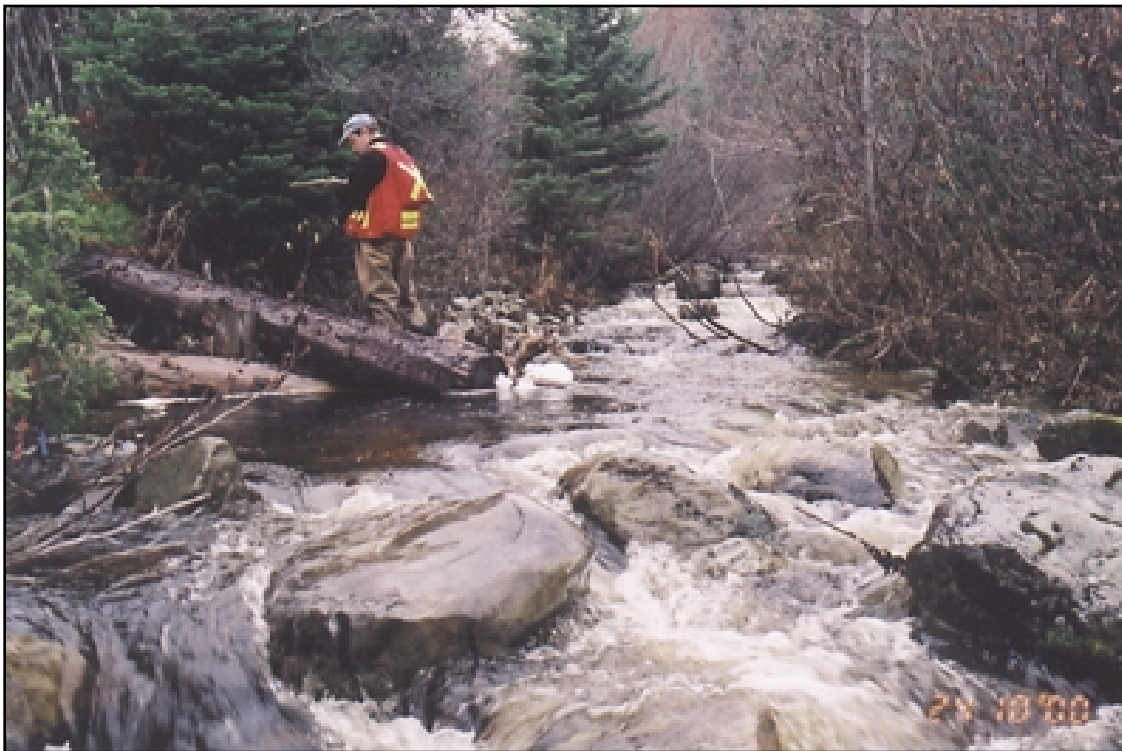
**Photo 12:** Rebman Creek Site 6: view upstream toward constructed riffle and LWD structure, Reach 2 at ~1,655 m.

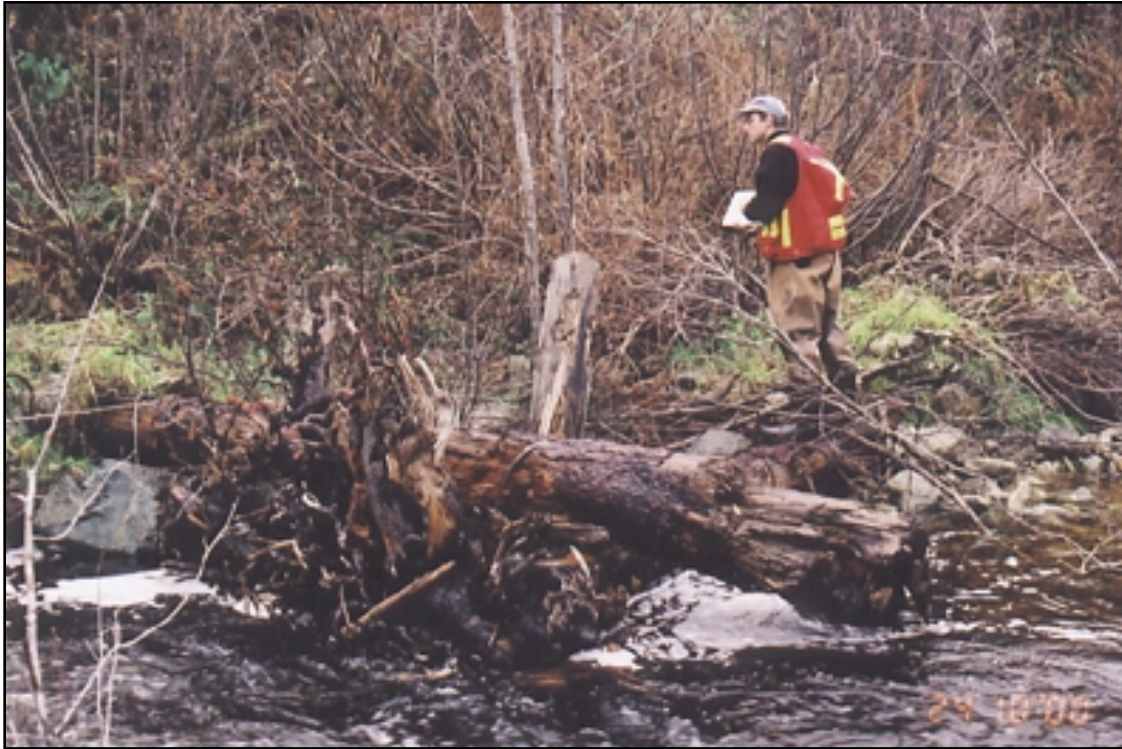
**Photo 13:** Rebman Creek Site 7: left bank LWD structure, Reach 2 at ~1,680 m.

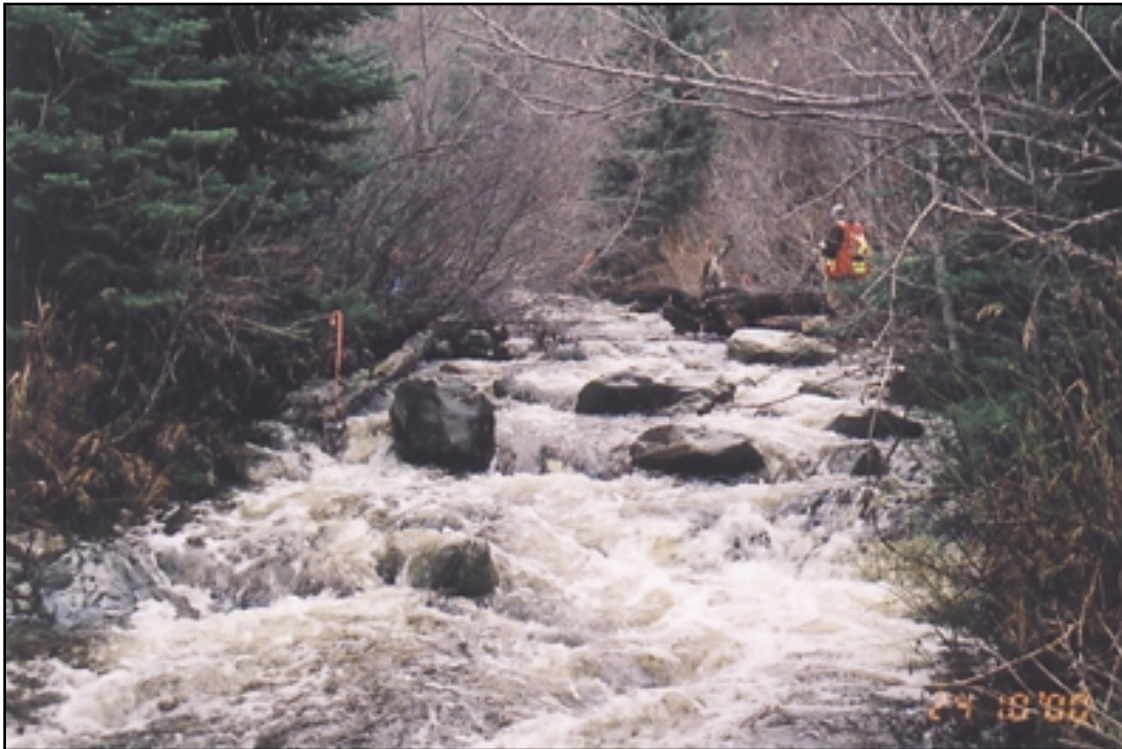
**Photo 14:** Rebman Creek Site 7: view upstream toward constructed riffle, Reach 2 at ~1,675 m.

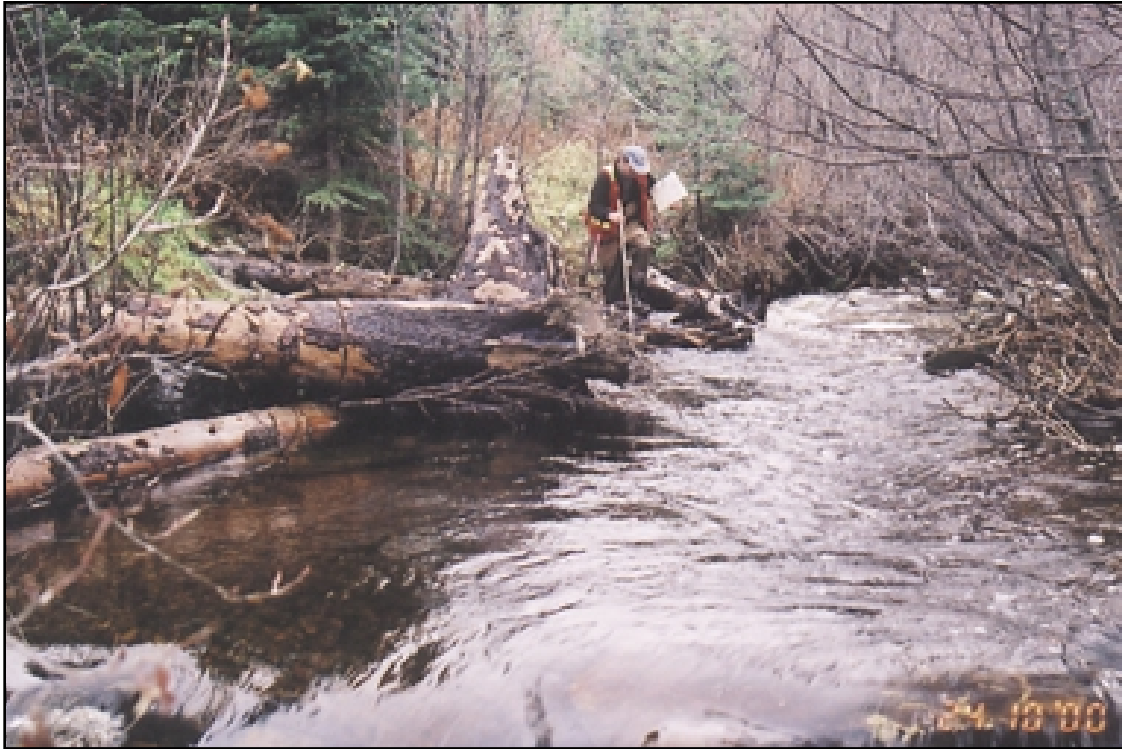
**Photo 15:** Rebman Creek Site 8: view upstream toward LWD structure, Reach 2 at ~1,756 m.

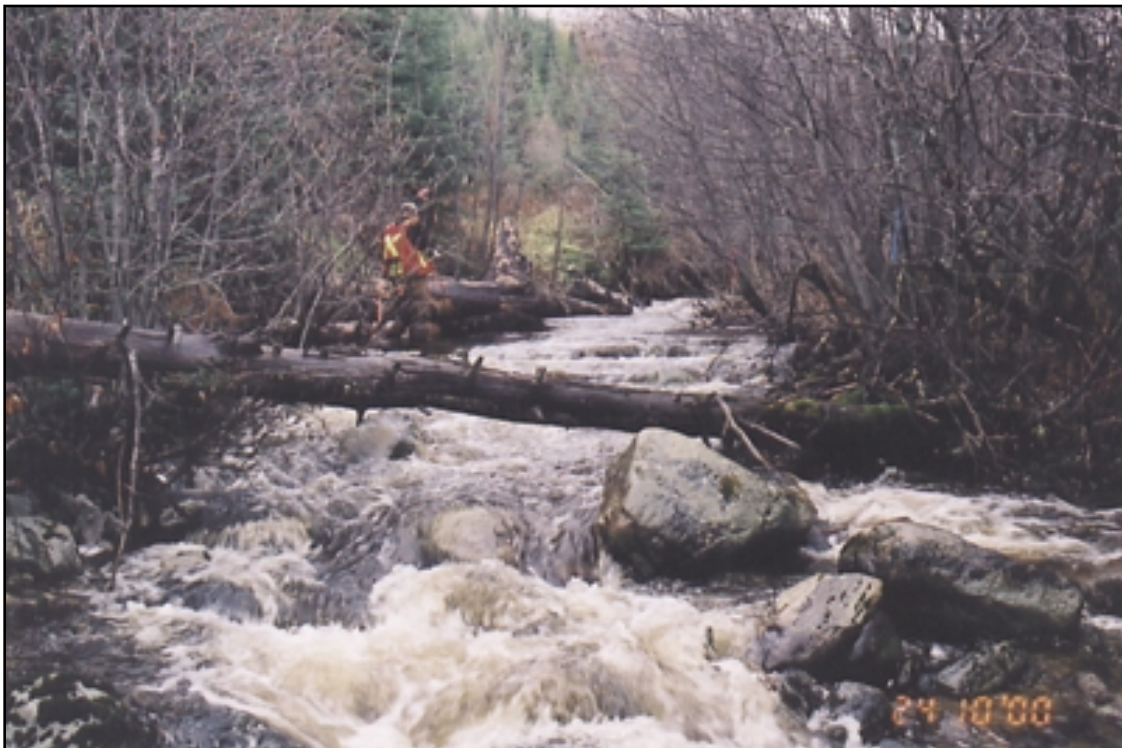
**Photo 16:** Rebman Creek Site 8: view upstream toward constructed riffle, Reach 2 at ~1,749 m.

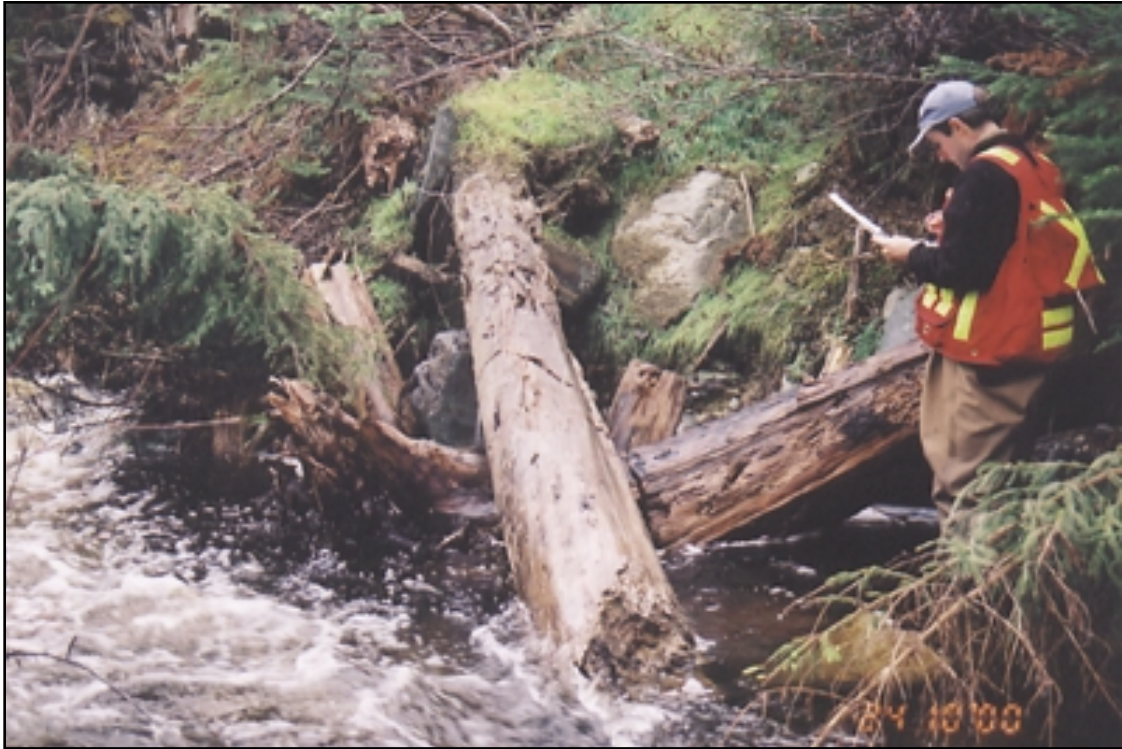
**Photo 17:** Rebman Creek Site 9: view upstream toward LWD structure, Reach 2 at ~1,930 m.

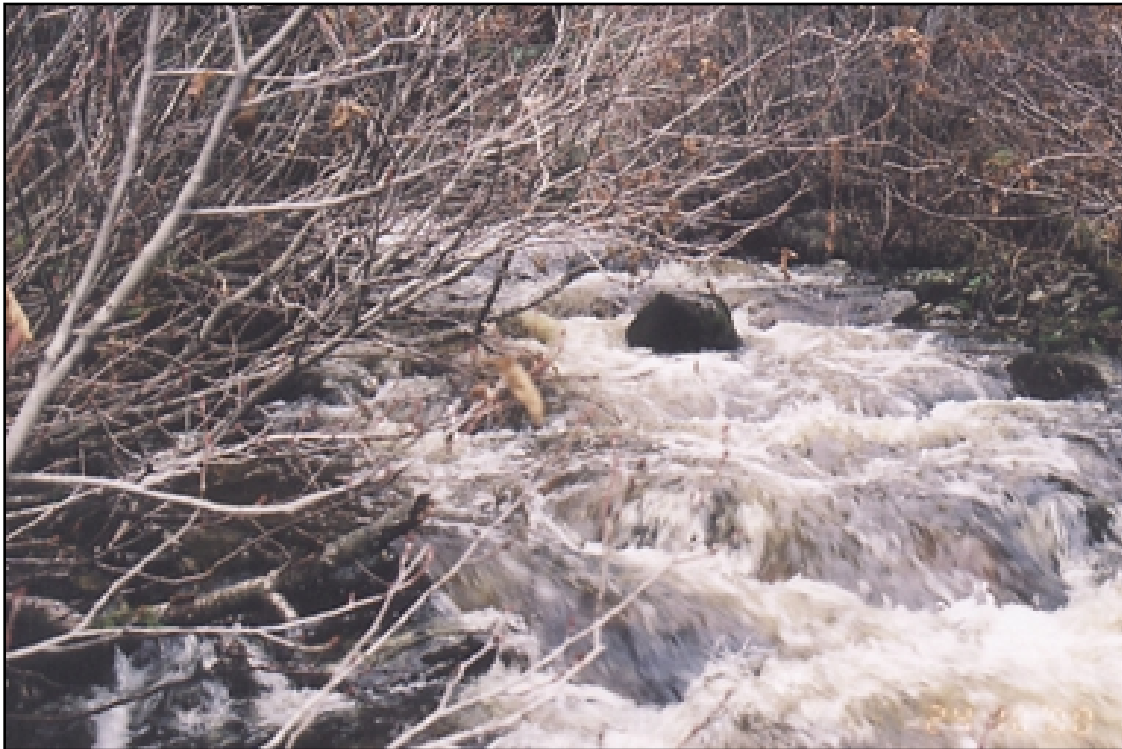
**Photo 18:** Rebman Creek Site 9: view upstream toward constructed riffle, Reach 2 at ~1,920 m.

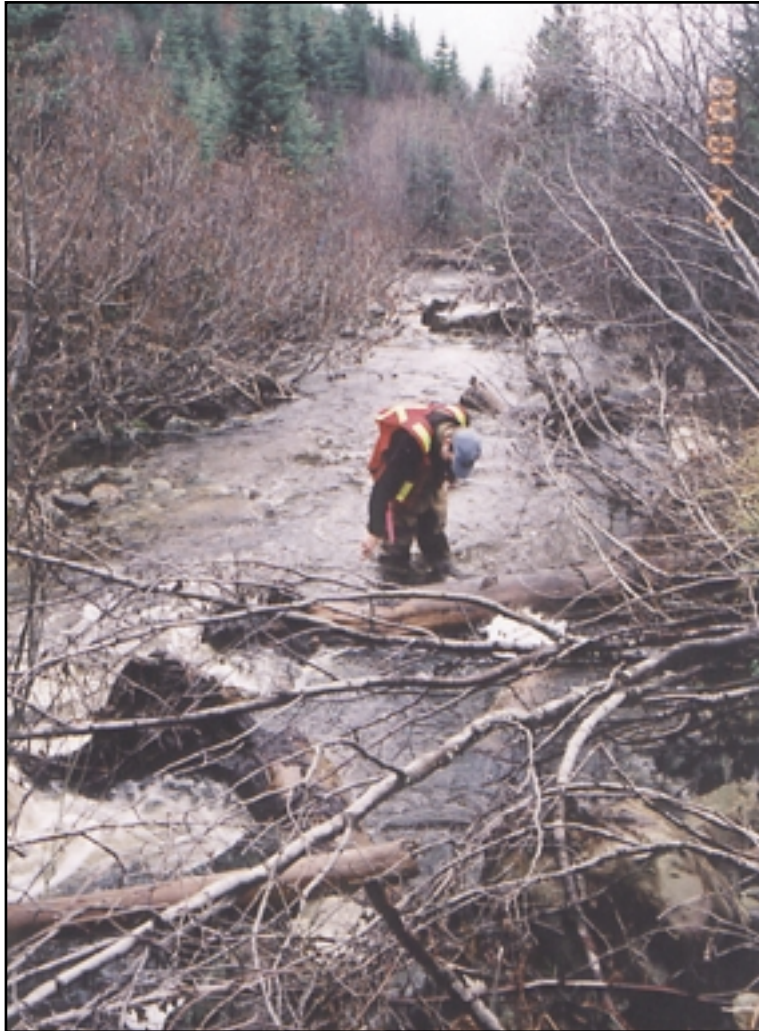
**Photo 19:** Rebman Creek Site 10: view downstream toward LWD structure, Reach 2 at ~1,980 m.

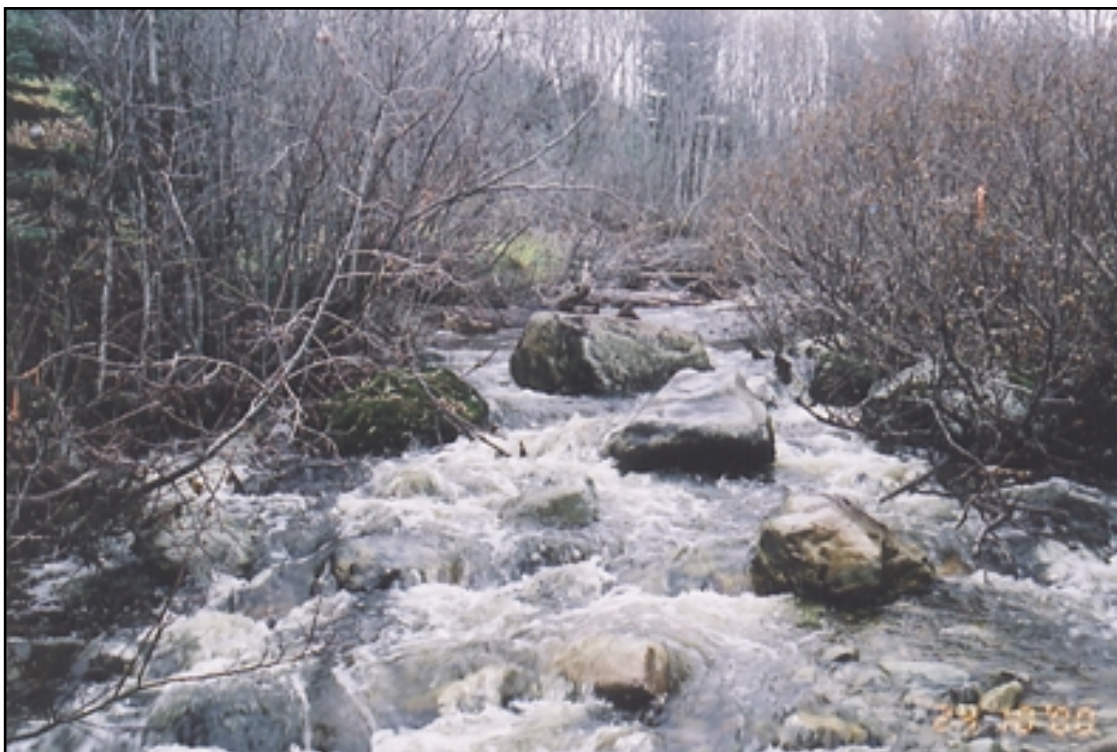
**Photo 20:** Rebman Creek Site 10: view upstream toward constructed riffle, Reach 2 at ~1,975 m.

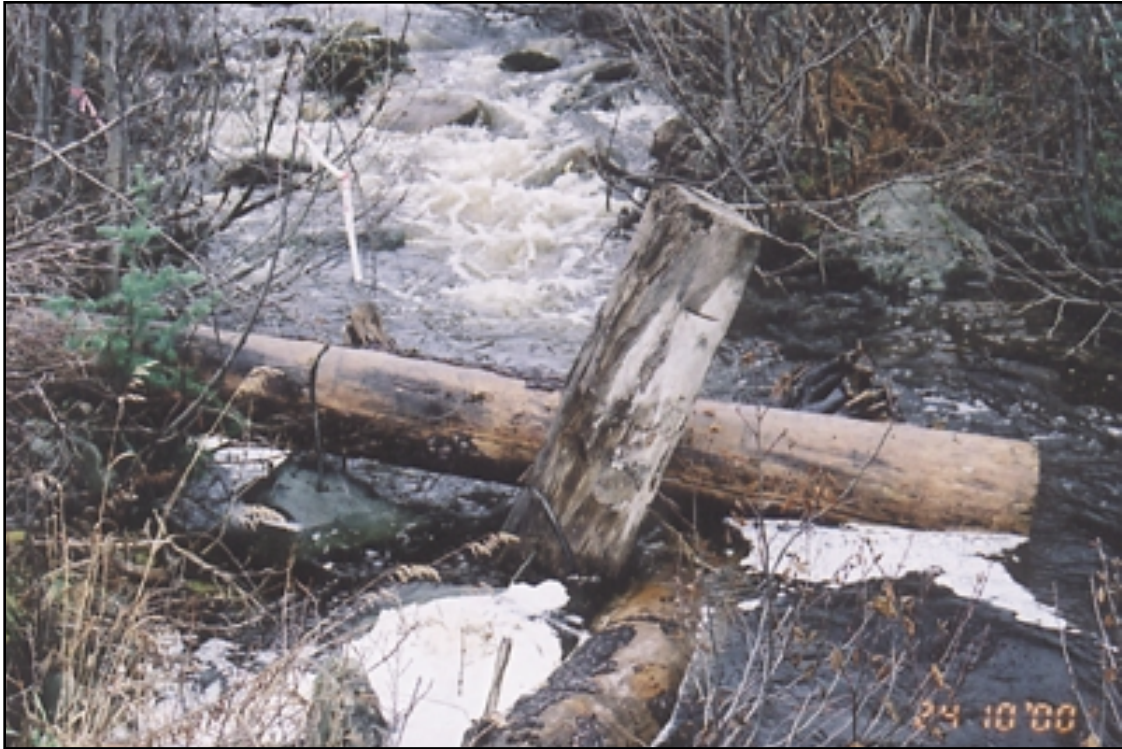
**Photo 21:** Rebman Creek Site 11: view upstream toward LWD structure, Reach 2 at ~2,070 m.

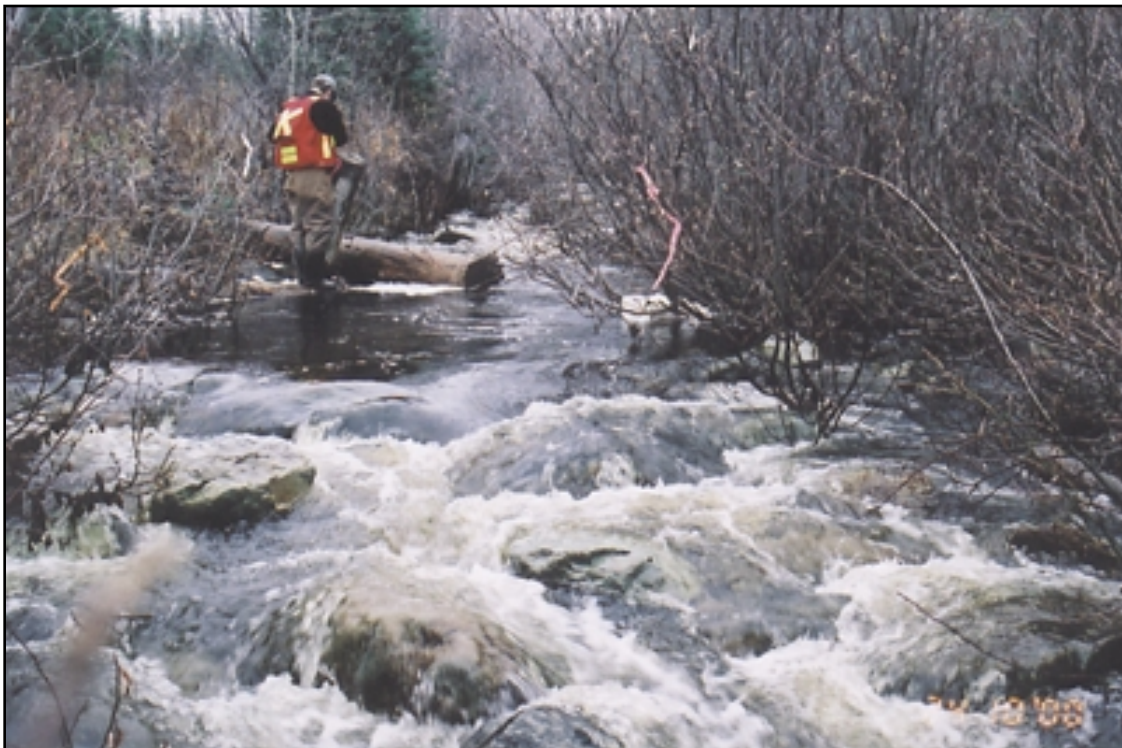
**Photo 22:** Rebman Creek Site 11: view upstream toward constructed riffle, Reach 2 at ~2,065 m.

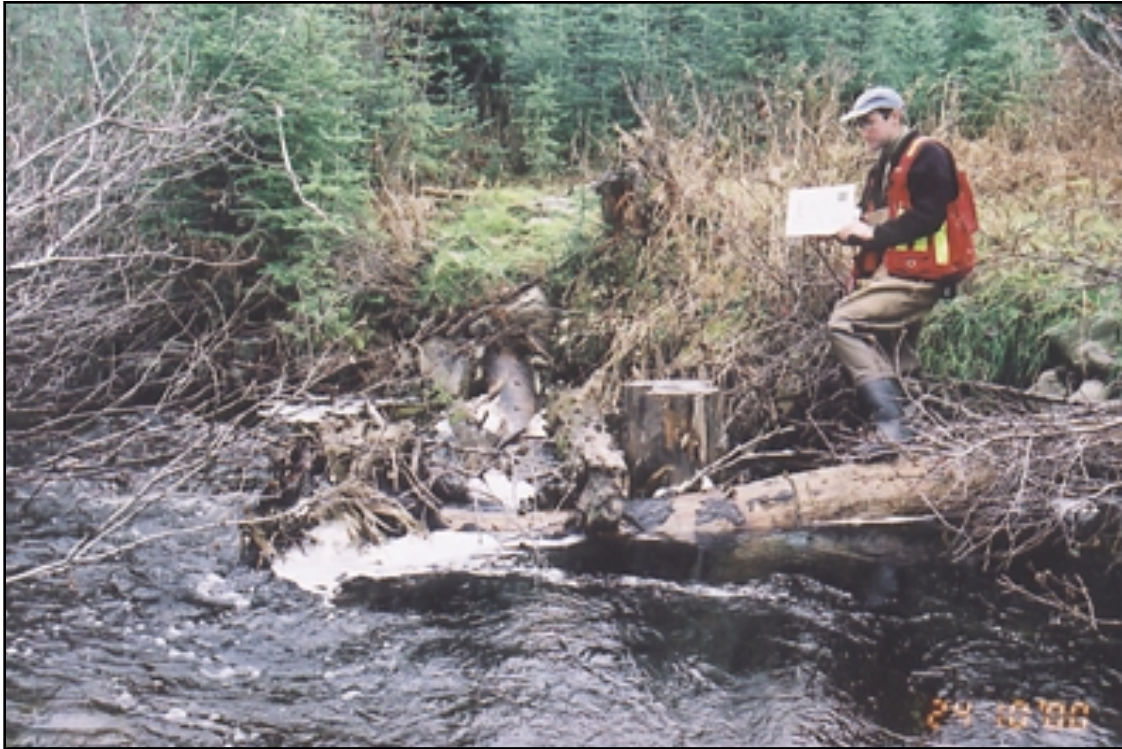
**Photo 23:** Rebman Creek Site 12: left bank LWD structure, Reach 2 at ~2,096 m.

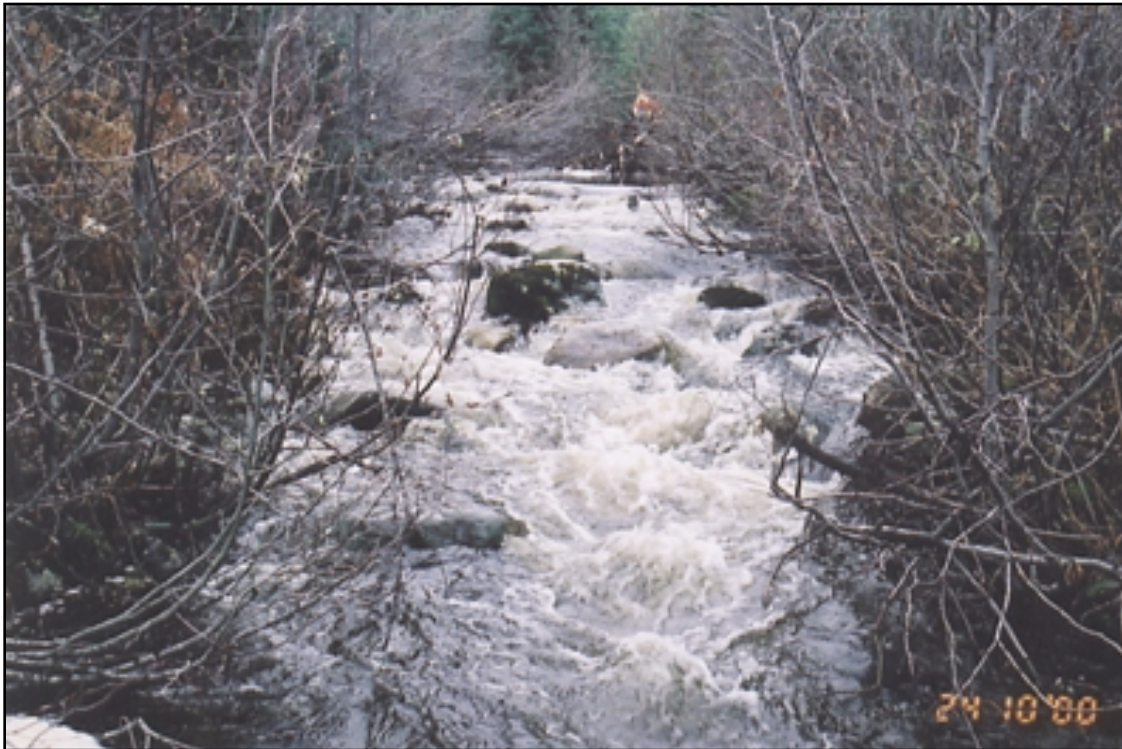
**Photo 24:** Rebman Creek Site 12: view upstream toward constructed riffle, Reach 2 at ~2,091 m.

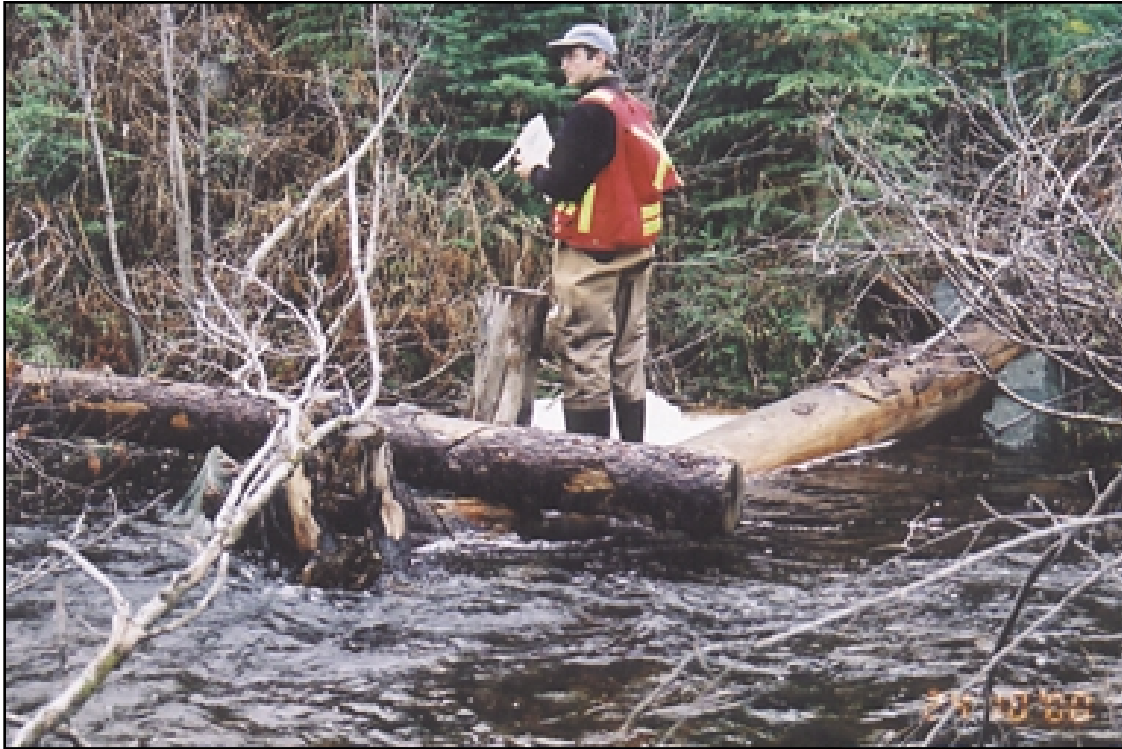
**Photo 25:** Rebman Creek Site 13: left bank LWD structure, Reach 2 at ~2,160 m.

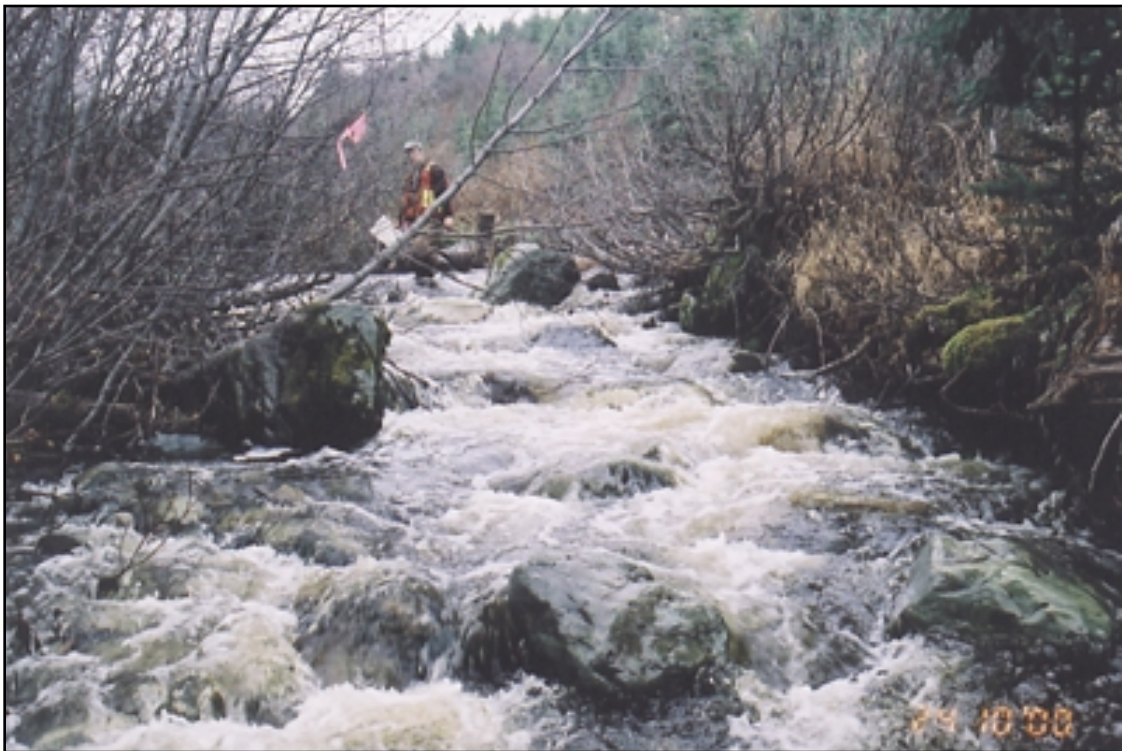
Riffles investigated appeared functional in high flow, as each was stable and passable by adult fish. Bank erosion was not evident. Only the riffle downstream of Site 13 was not well keyed into the right bank and a portion of flow went around the top of the riffle. It is recommended that this site be further monitored and boulders be added should erosion continue.

**Photo 26:** Rebman Creek Site 13: view upstream toward constructed riffle, Reach 2 at ~2,156 m.
