# **Rebman Creek**

## **Evaluation of In-Stream Rehabilitation Structures**

### **Draft Report**

***December 2000***

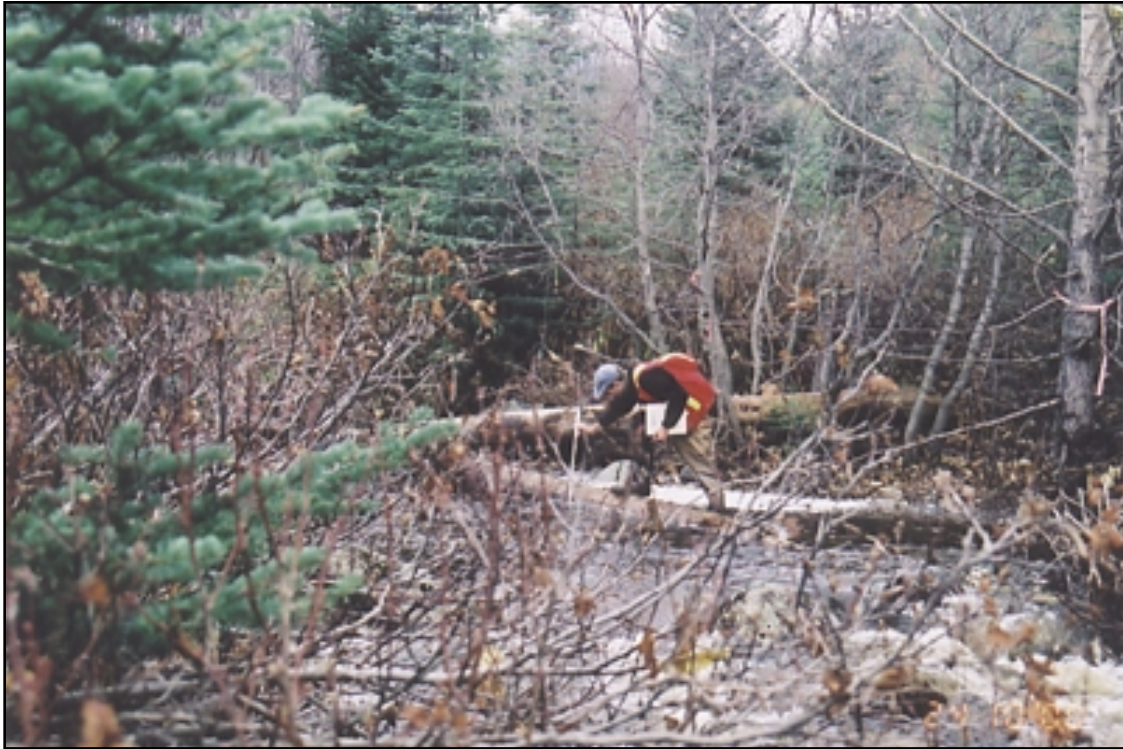
**Photo 27:** Rebman Creek Site 14: view upstream toward LWD structure, Reach 2 at ~2,250 m.

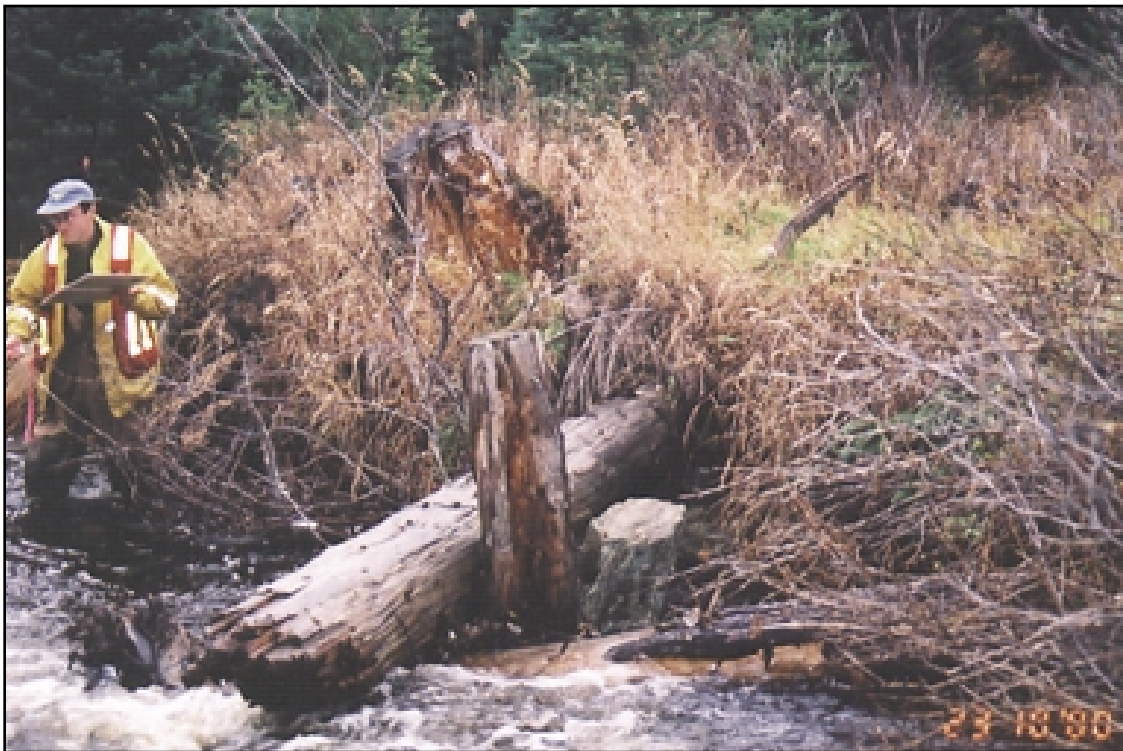
**Photo 28:** Rebman Creek Site 15: view downstream toward LWD structure, Reach 4 at ~370 m.

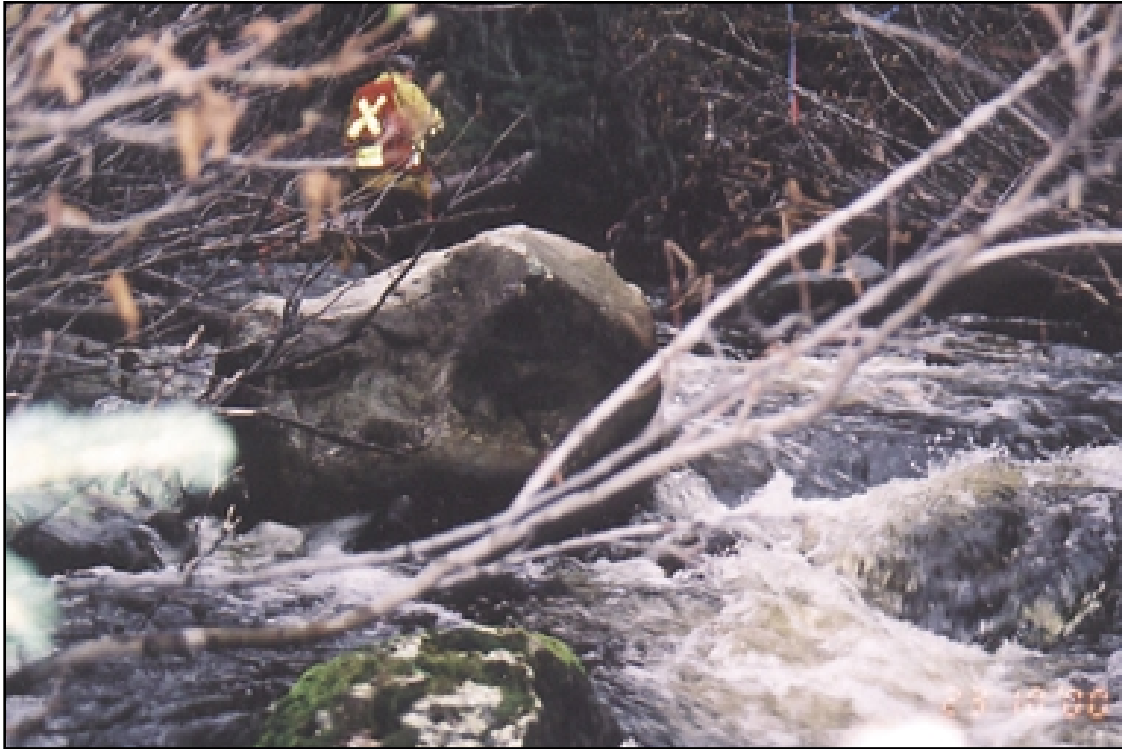
**Photo 29:** Rebman Creek Site 16 (downstream part): view upstream toward constructed riffle, Reach 4 at ~430 m.

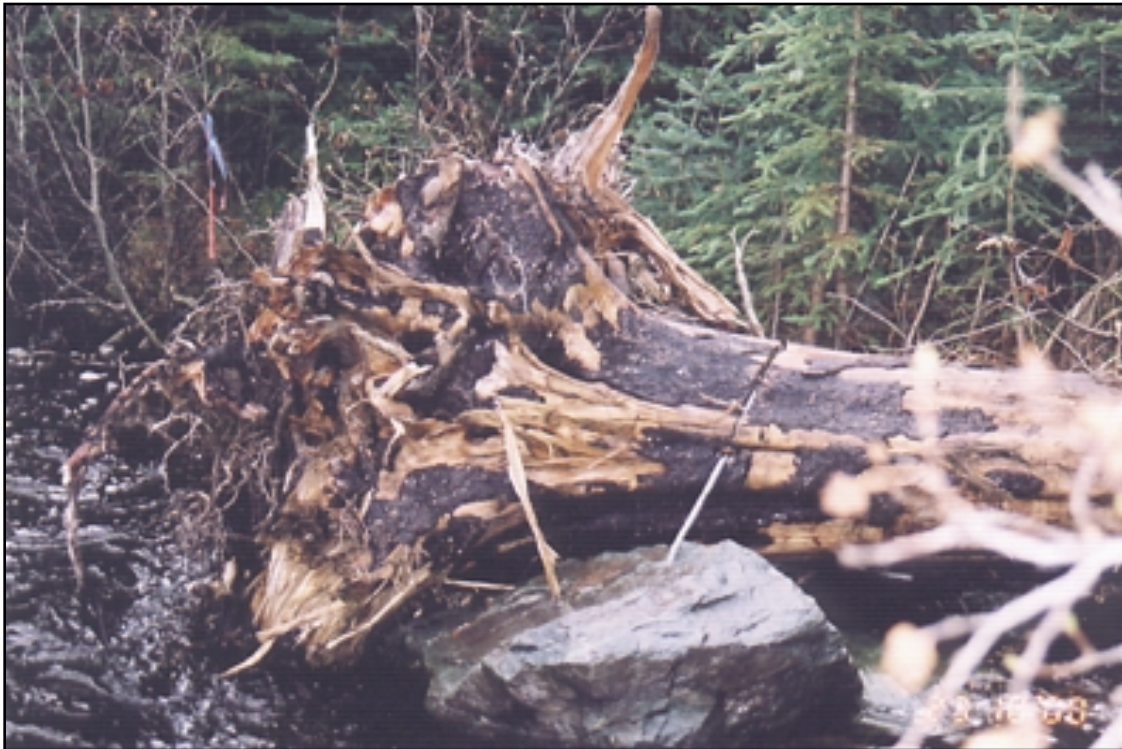
**Photo 30:** Rebman Creek Site 16 (downstream part): view upstream toward LWD structure, Reach 4 at ~440 m.

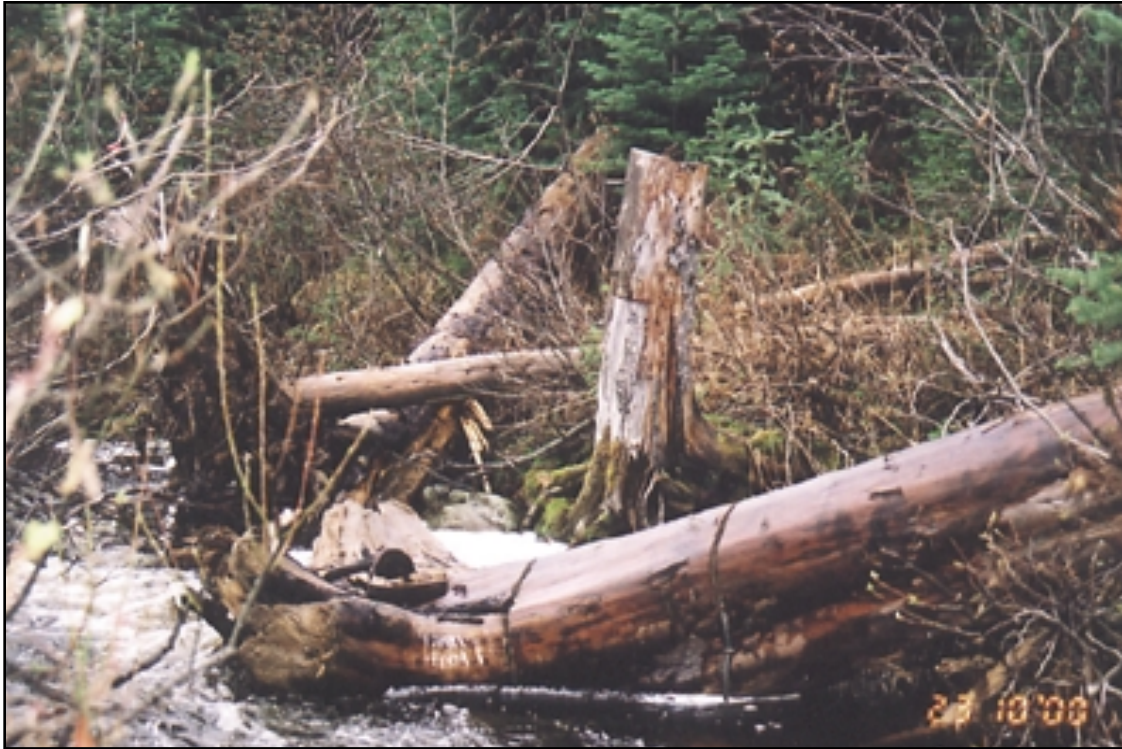
**Photo 31:** Rebman Creek Site 16 (upstream part): view upstream toward LWD structure, Reach 4 at ~445 m.

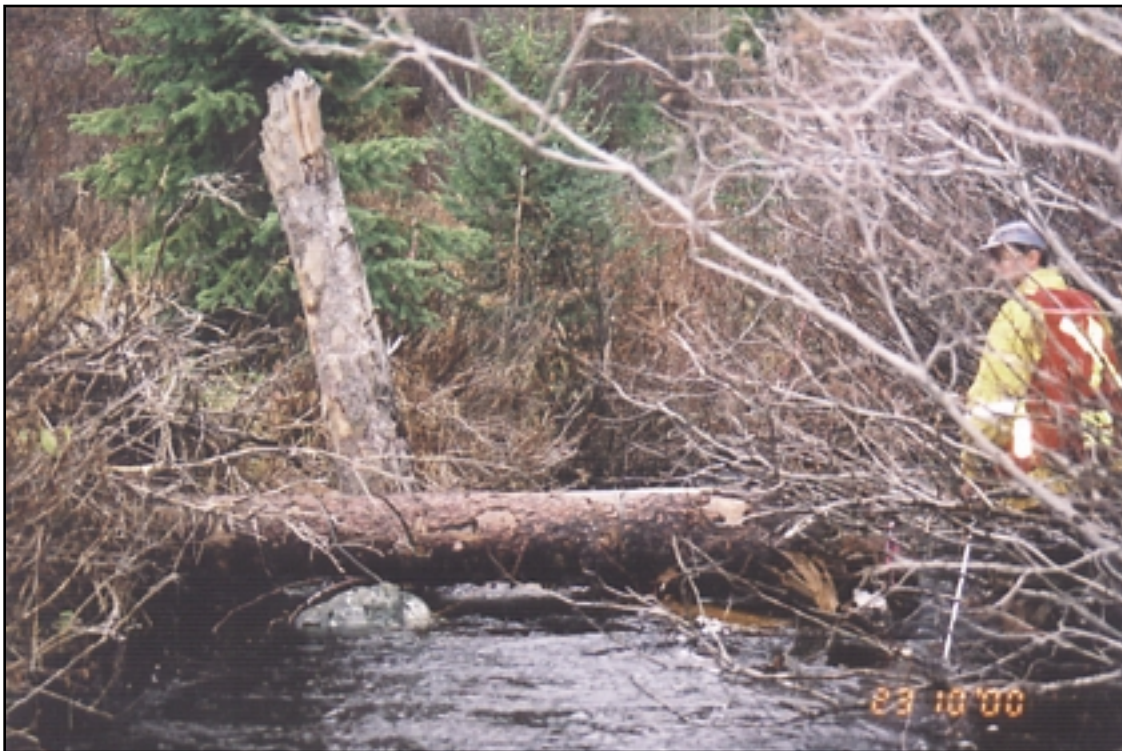
**Photo 32:** Rebman Creek Site 17: view upstream toward LWD structure, Reach 4 at ~466 m.

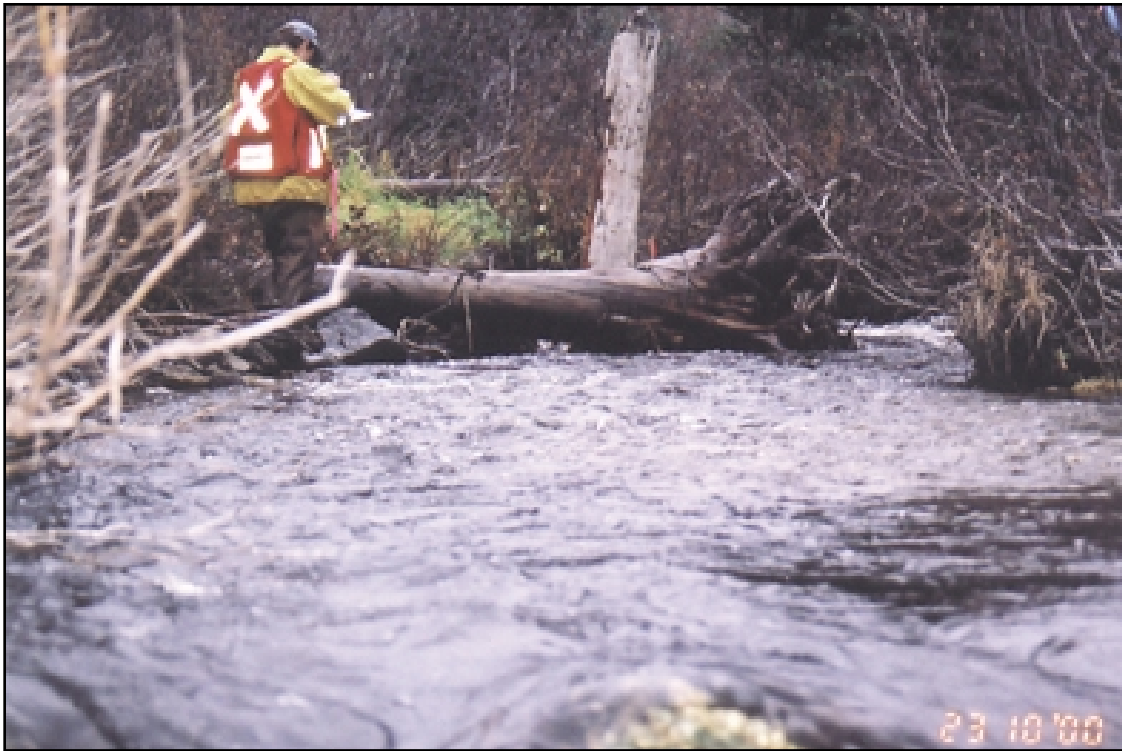
**Photo 33:** Rebman Creek Site 18: view upstream toward LWD structure, Reach 4 at ~508 m.

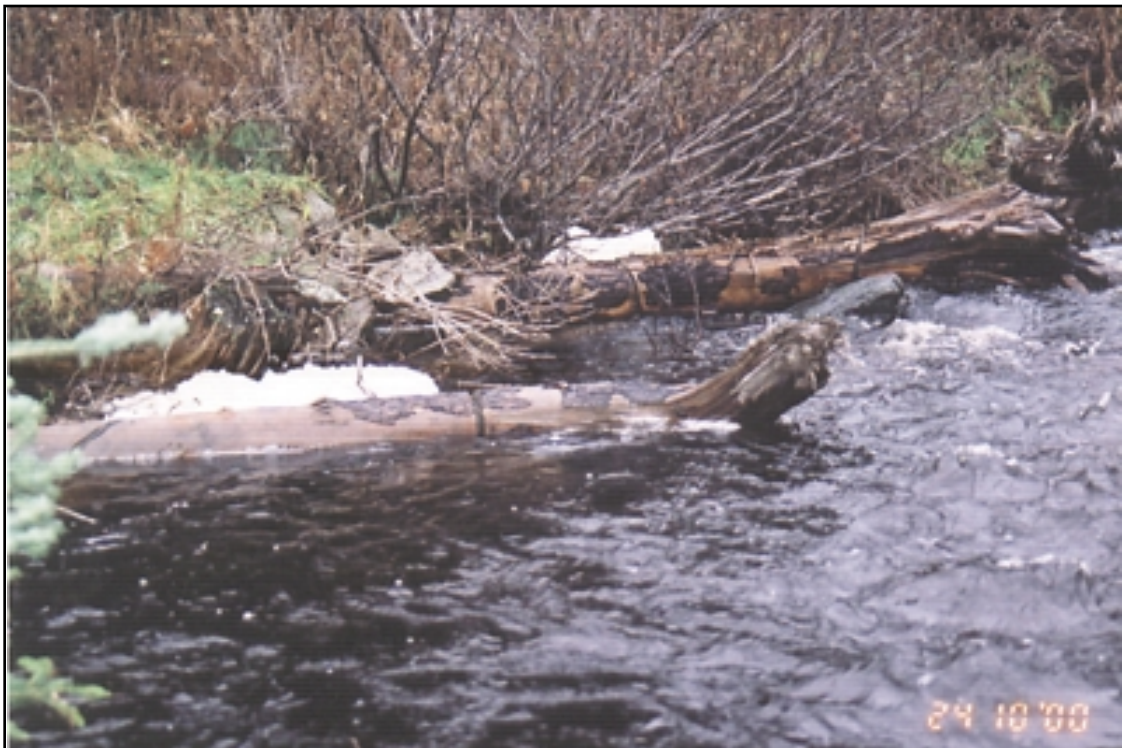
3	16	13	E (LB)	H	MDW	Y	12	Y	6	6	I	PP/C	S	IN	L	P (H)	P	0.5	
	3	17	13	E (RB)	H	AWD	Y	~ 3	Y	3	3	I	PP/C	S	IN	L	P (H)	P	0.7	
	3	18	13	E (RB)	H	AWD	Y	4	Y	3	3	I	PP/C	S	IN	L	P (H)	P	0.6	
	3	19	13	E (RB)	H	MWD	Y	~ 8	Y	5	5	I	PP/C	S	IN	L	P (H)	P	0.6	structure totally submerged, BO hard to see!, UTM 10.568408.5913996

**Photo 34:** Rebman Creek Site 19: view upstream toward LWD structure, Reach 4 at ~542 m.
