Homathko River & Mosley Creek Watersheds

Level 2 Fish Habitat & Riparian Assessment Procedure & Restoration Prescriptions

Final Report

October 1999

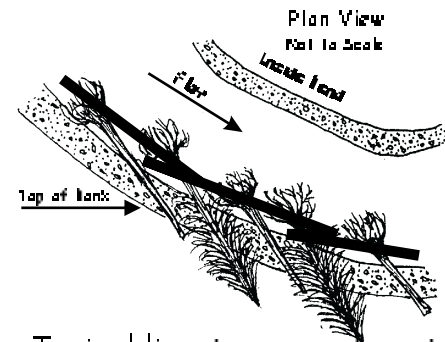
Typical live-tree revetment using coniferous tree species

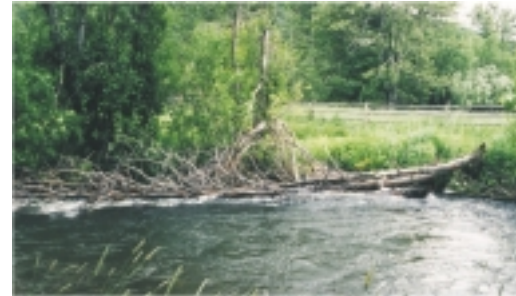
Natural template of live-tree revetment occurring on outside of river bend

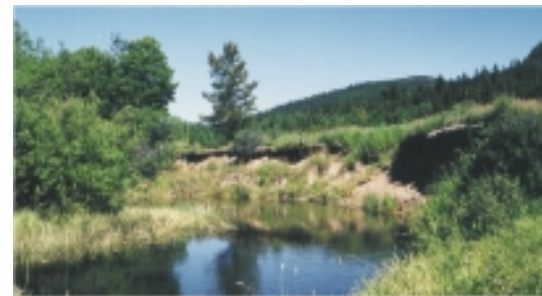
Typical candidate area for live-tree revetment prescription

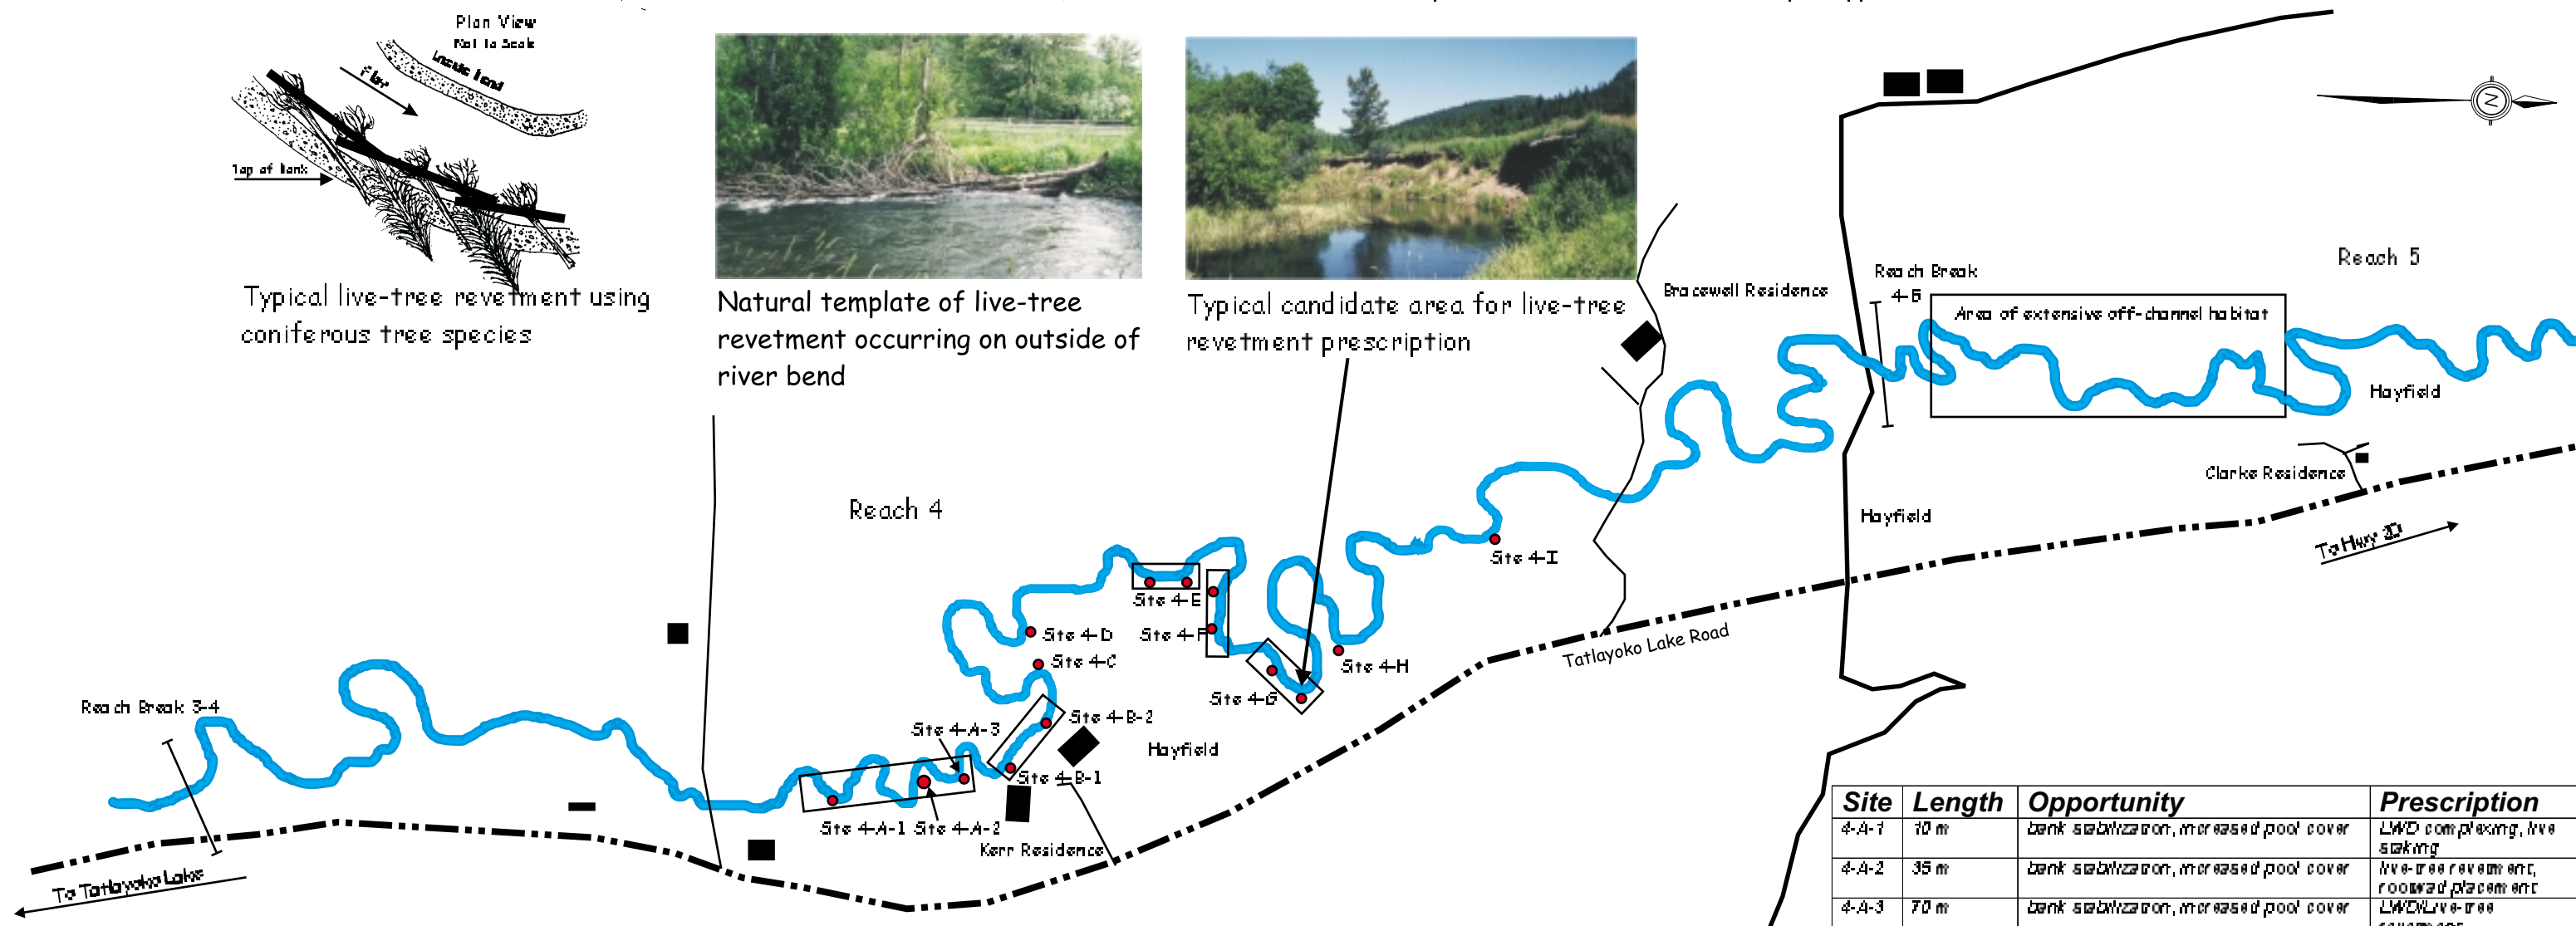
Reach 4: Bank Stabilization & Fish Habitat Restoration Prescriptions

Technical Notes: Well developed pools observed throughout surveyed section. Riparian vegetation limited in some areas of agricultural development. Opportunity to stabilize stream banks on several outside stream bends. Property boundaries not depicted.

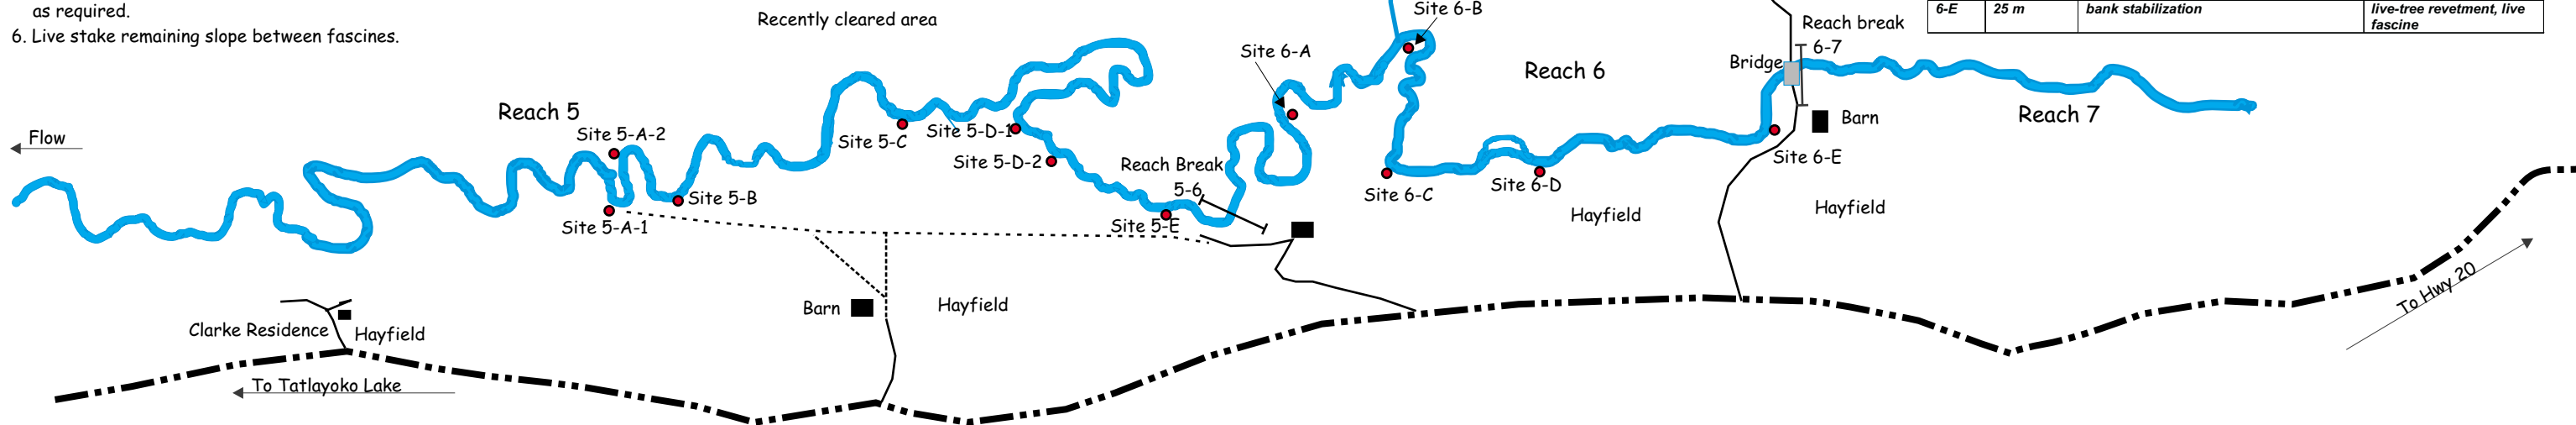
REACHES 5 & 6 : Bank Stabilization & Fish Habitat Restoration Prescriptions

Technical Notes: Well developed pools observed throughout surveyed section. Riparian vegetation limited in some areas of agricultural development. Opportunity to stabilize stream banks on several outside stream bends. Property boundaries not depicted.

Site	Length	Opportunity	Prescription
5-A-1	35 m	bank stabilization, increased pool cover	live-tree revetment, live staking
5-A-2	45 m	bank stabilization, increased pool cover	live-tree revetment, live staking
5-B	35 m	bank stabilization, increased pool cover	live-tree revetment, live fascine and staking
5-C	25 m	bank stabilization, increased pool cover	LWD/Live-tree revetment, rootwad
5-D-1	35 m	bank stabilization	LWD/Live-tree revetment, live staking, riparian planting
5-D-2	10 m	bank stabilization	LWD/Live-tree revetment, live staking, riparian planting
5-E	30 m	bank stabilization,	live-tree revetment, live staking, live fascine
6-A	55 m	bank stabilization, increased pool cover	live-tree revetment, live fascine, rootwad placement
6-B	35 m	bank stabilization)	live staking, live fascine, increased riparian planting
6-C	30 m	bank stabilization, increased fish habitat cover (pool and glide)	live-tree revetment, rootwad placement, live staking

6-D	35 m	bank stabilization, increased pool/glide cover	LWD revetment rootwad placement
6-E	25 m	bank stabilization	live-tree revetment, live fascine

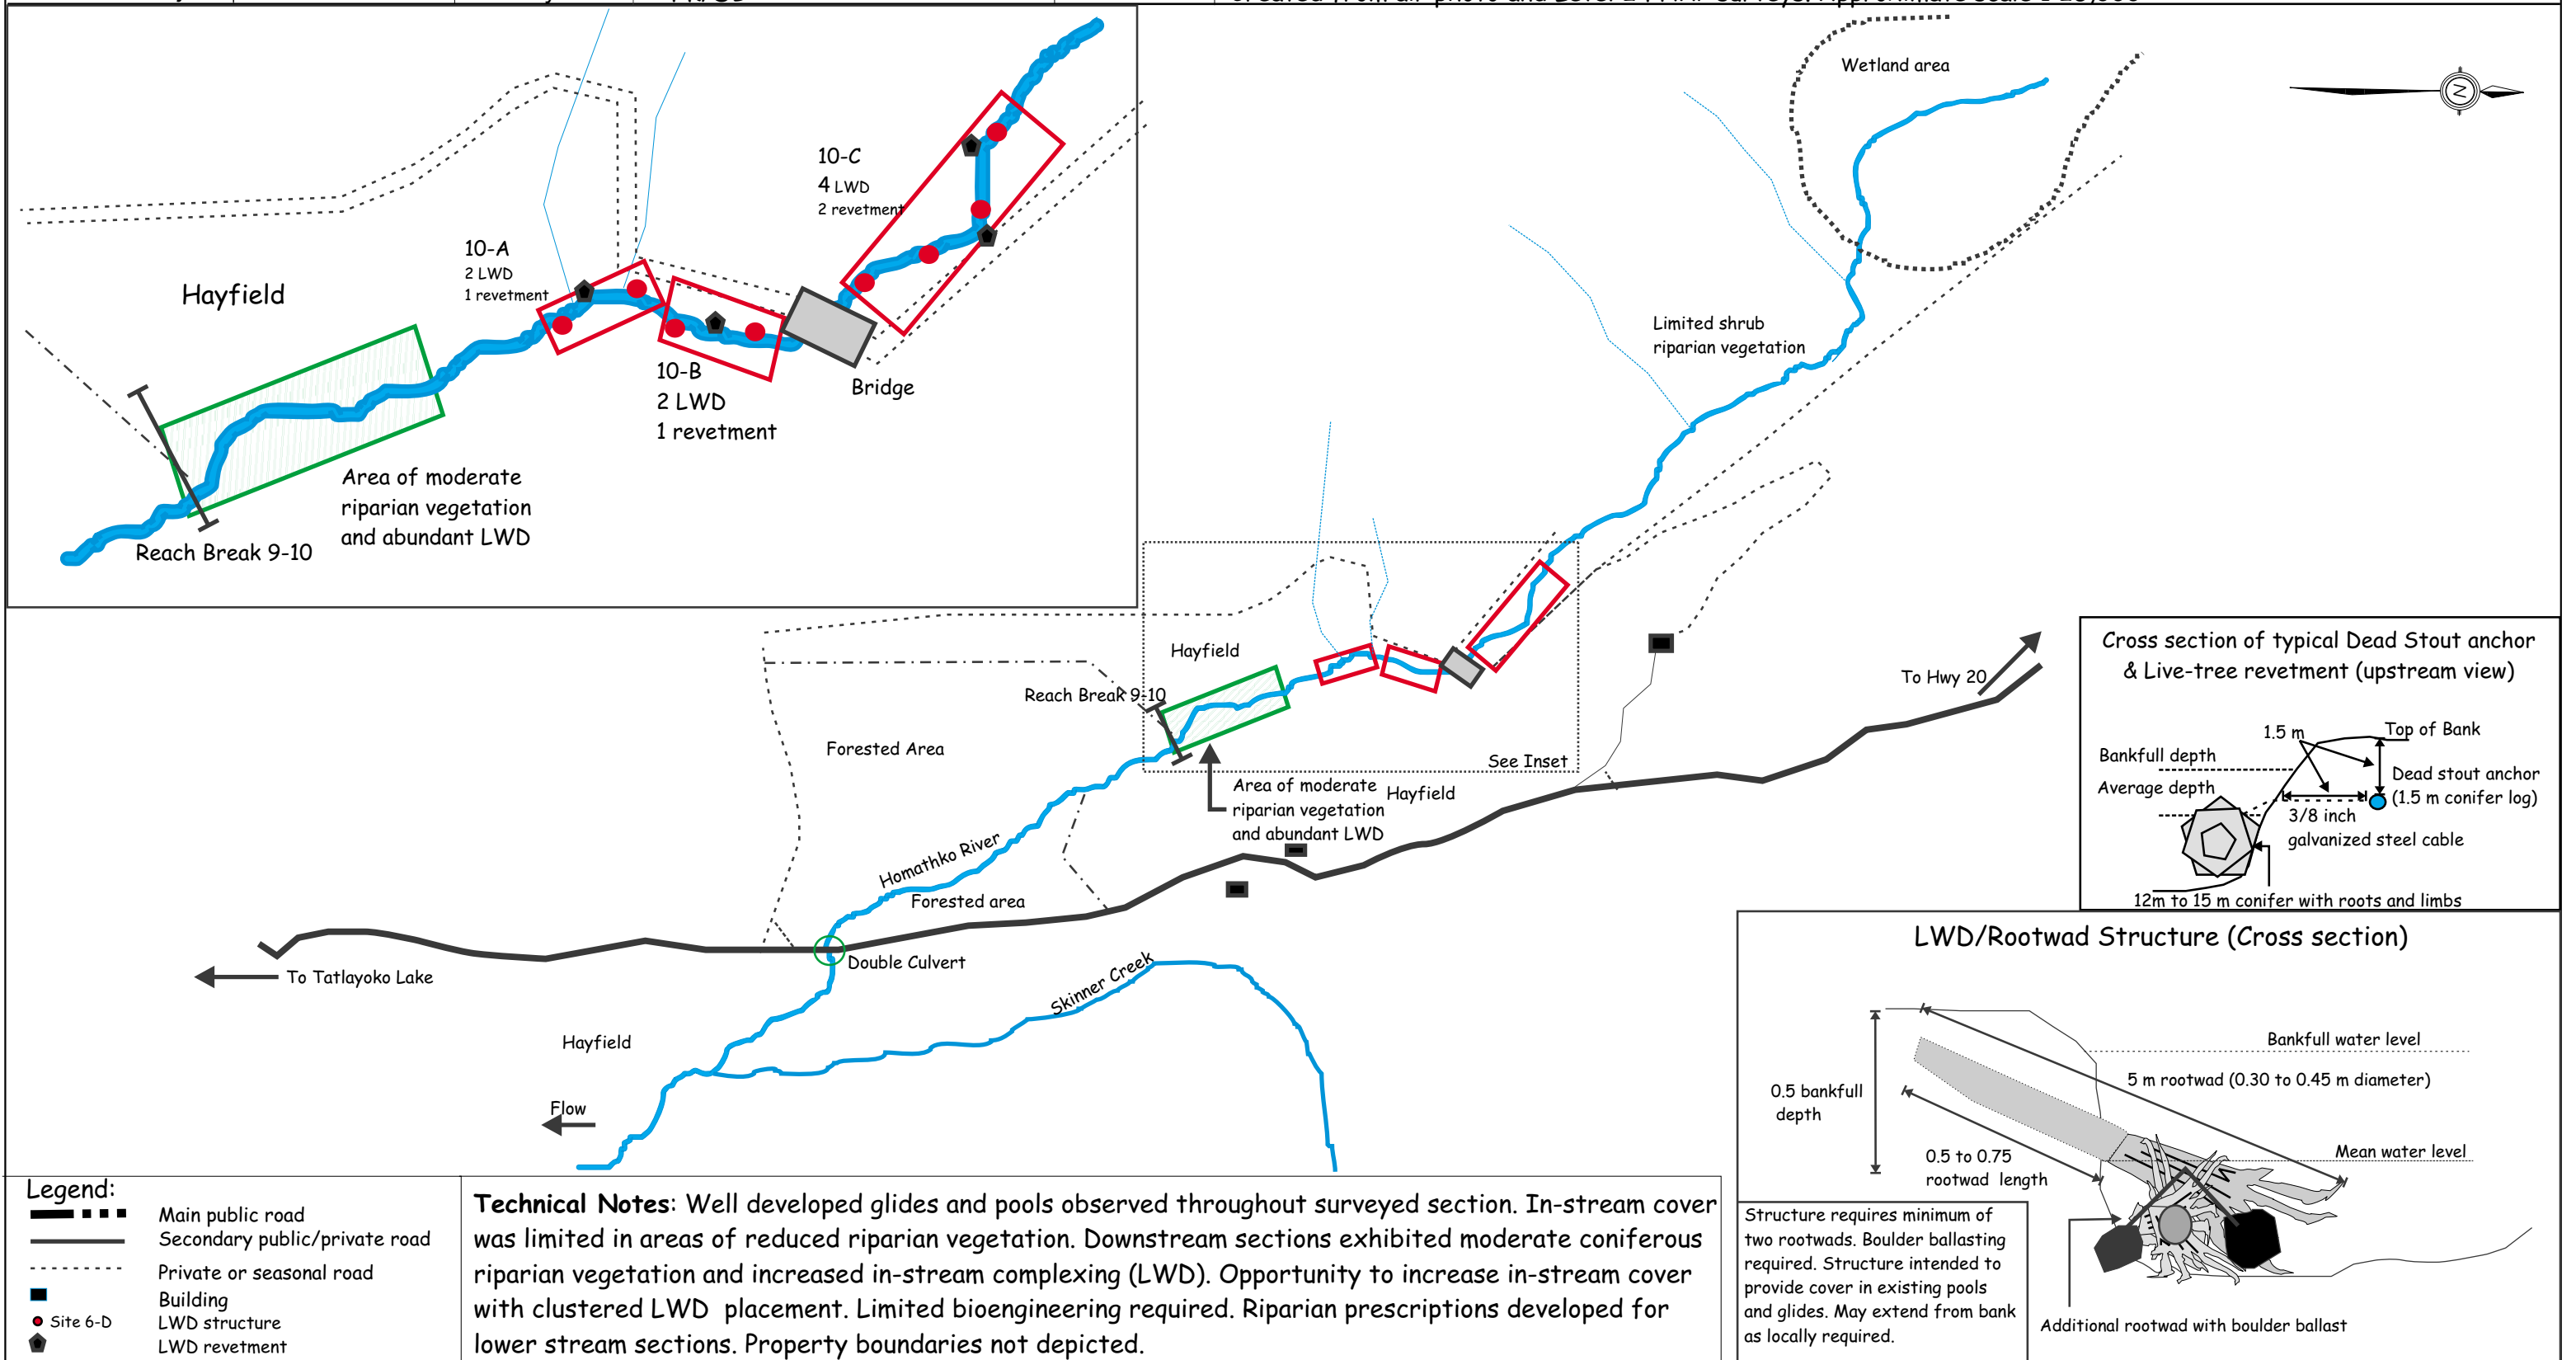
Reach 10: Fish Habitat Restoration Prescription

Technical Notes: Well developed glides and pools observed throughout surveyed section. In-stream cover was limited in areas of reduced riparian vegetation. Downstream sections exhibited moderate coniferous riparian vegetation and increased in-stream complexing (LWD). Opportunity to increase in-stream cover with clustered LWD placement. Limited bioengineering required. Riparian prescriptions developed for lower stream sections. Property boundaries not depicted.

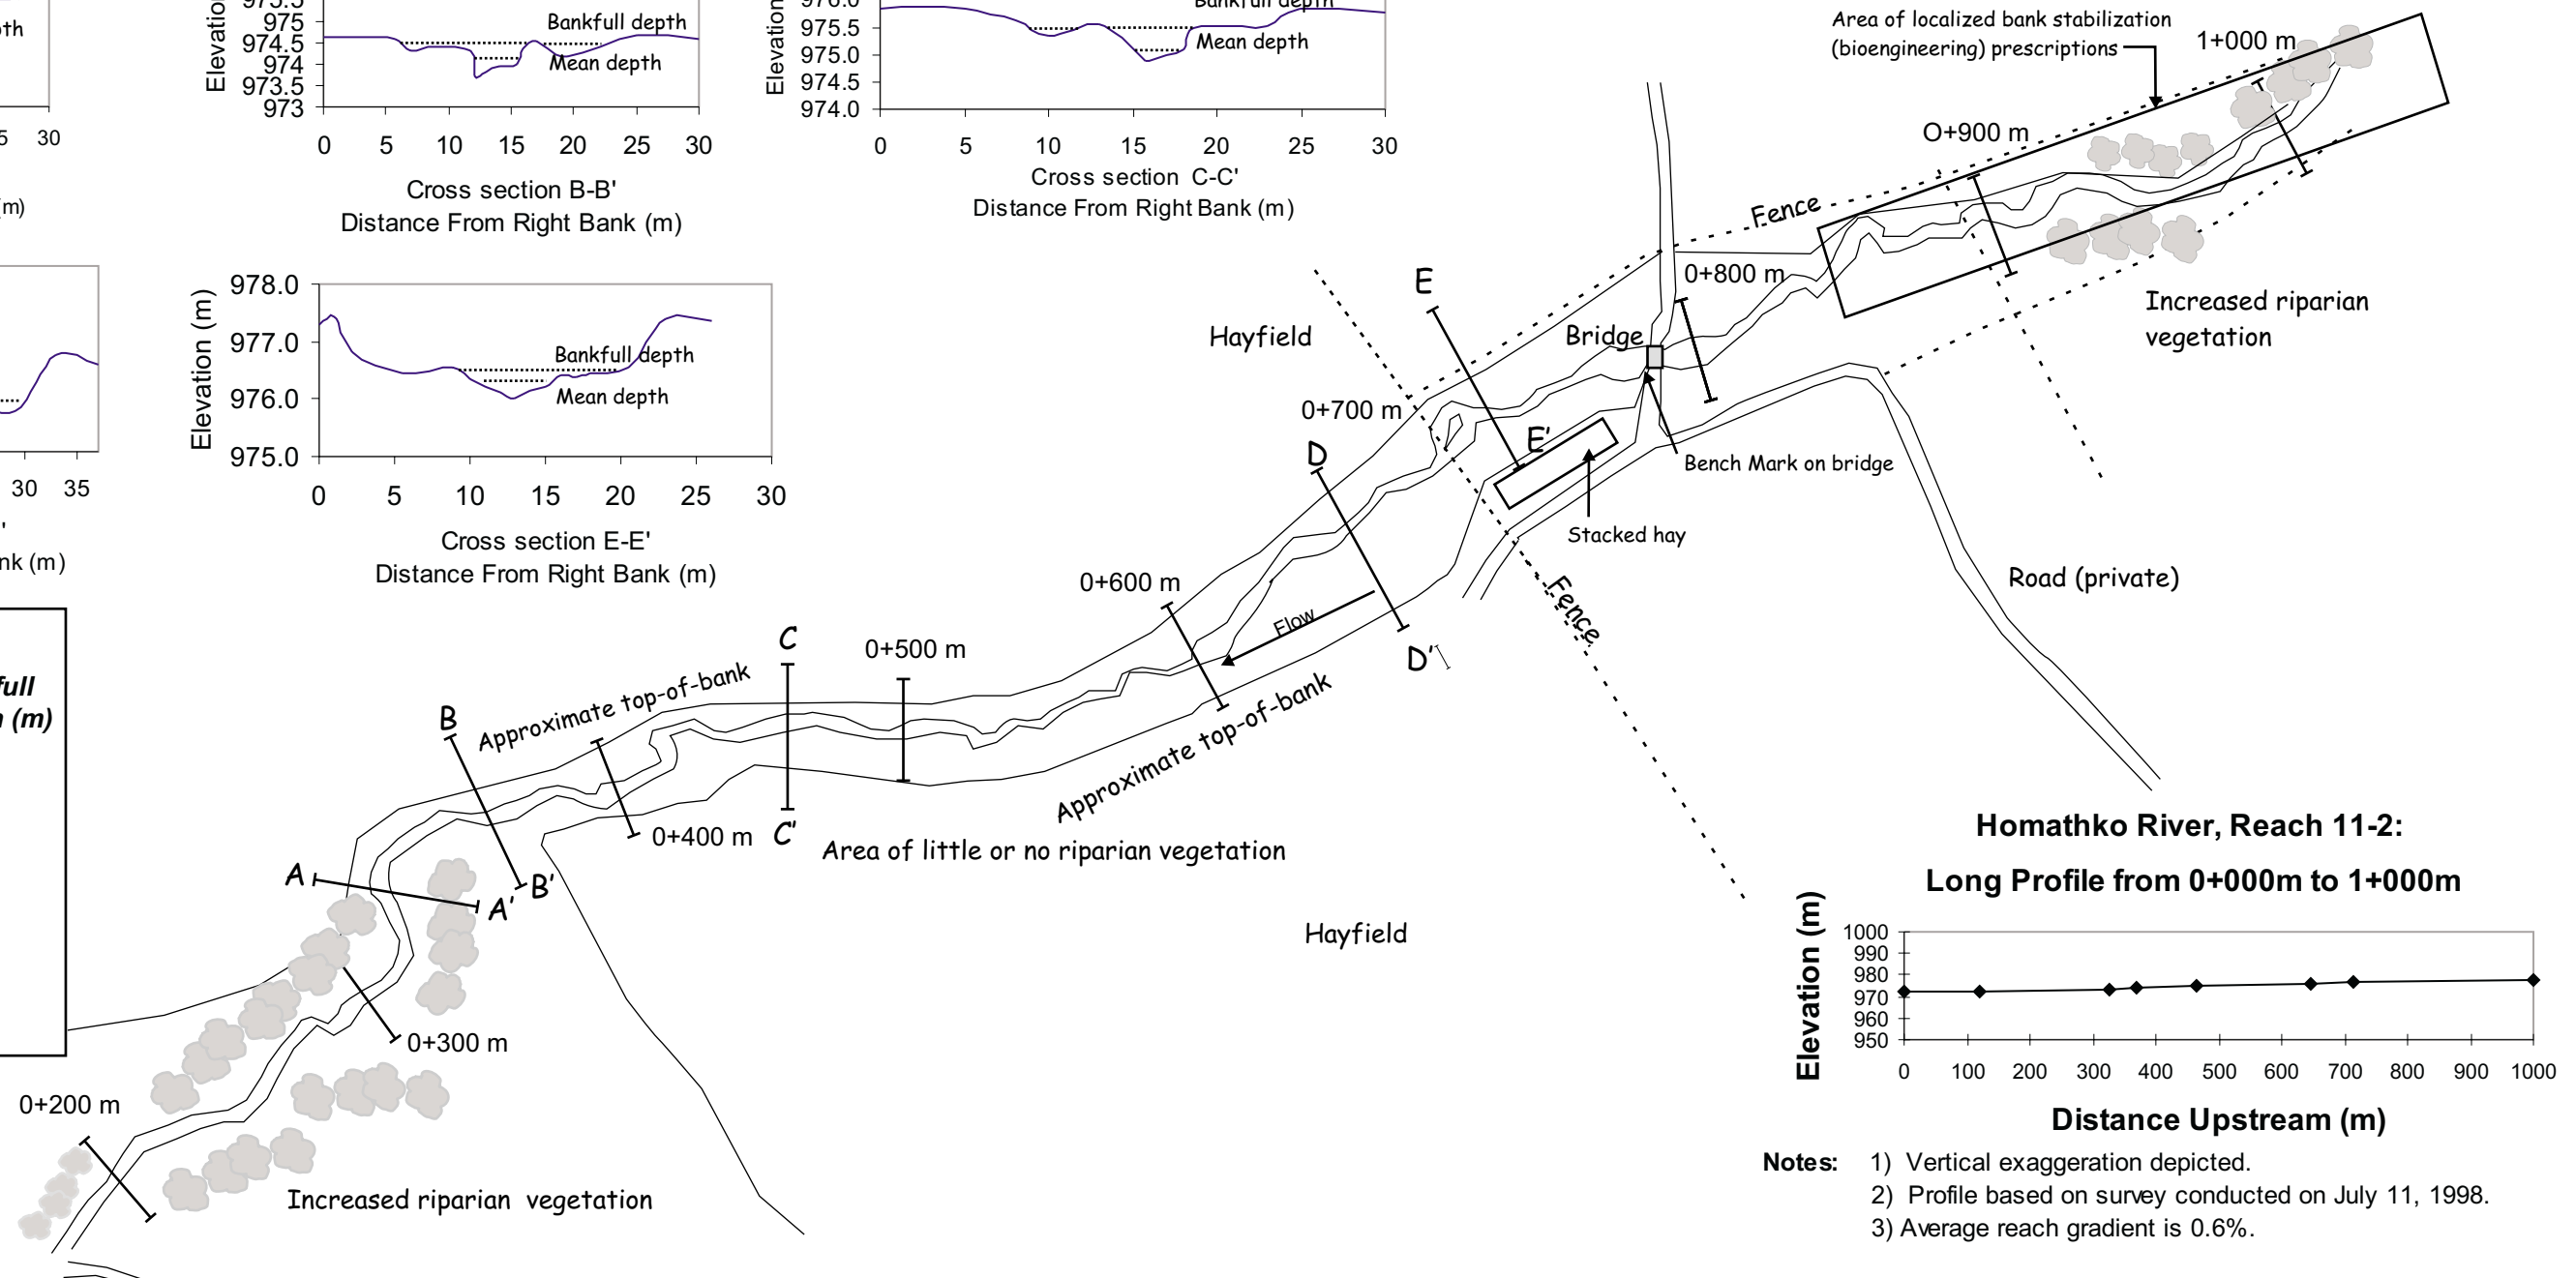
Reach 11, Fish Habitat Restoration Prescription

Technical Notes: Well developed pools observed throughout surveyed section. Riparian vegetation limited from 0+360 m to 0+800 m. Recommended to increase riparian vegetation and in-stream cover throughout Reach 11-2. LWD, rootwads and in-stream reefs are recommended to provide cover in pools..
