**WATERSHED RESTORATION PROGRAM**

**STREAM REHABILITATION  
2001 AS-BUILT REPORT FOR  
GRILSE CREEK**

**Renewal Investment Corporation  
Suite 3, 730-13th Ave.  
Campbell River, BC  
V9W 4H1**

**December 2001**

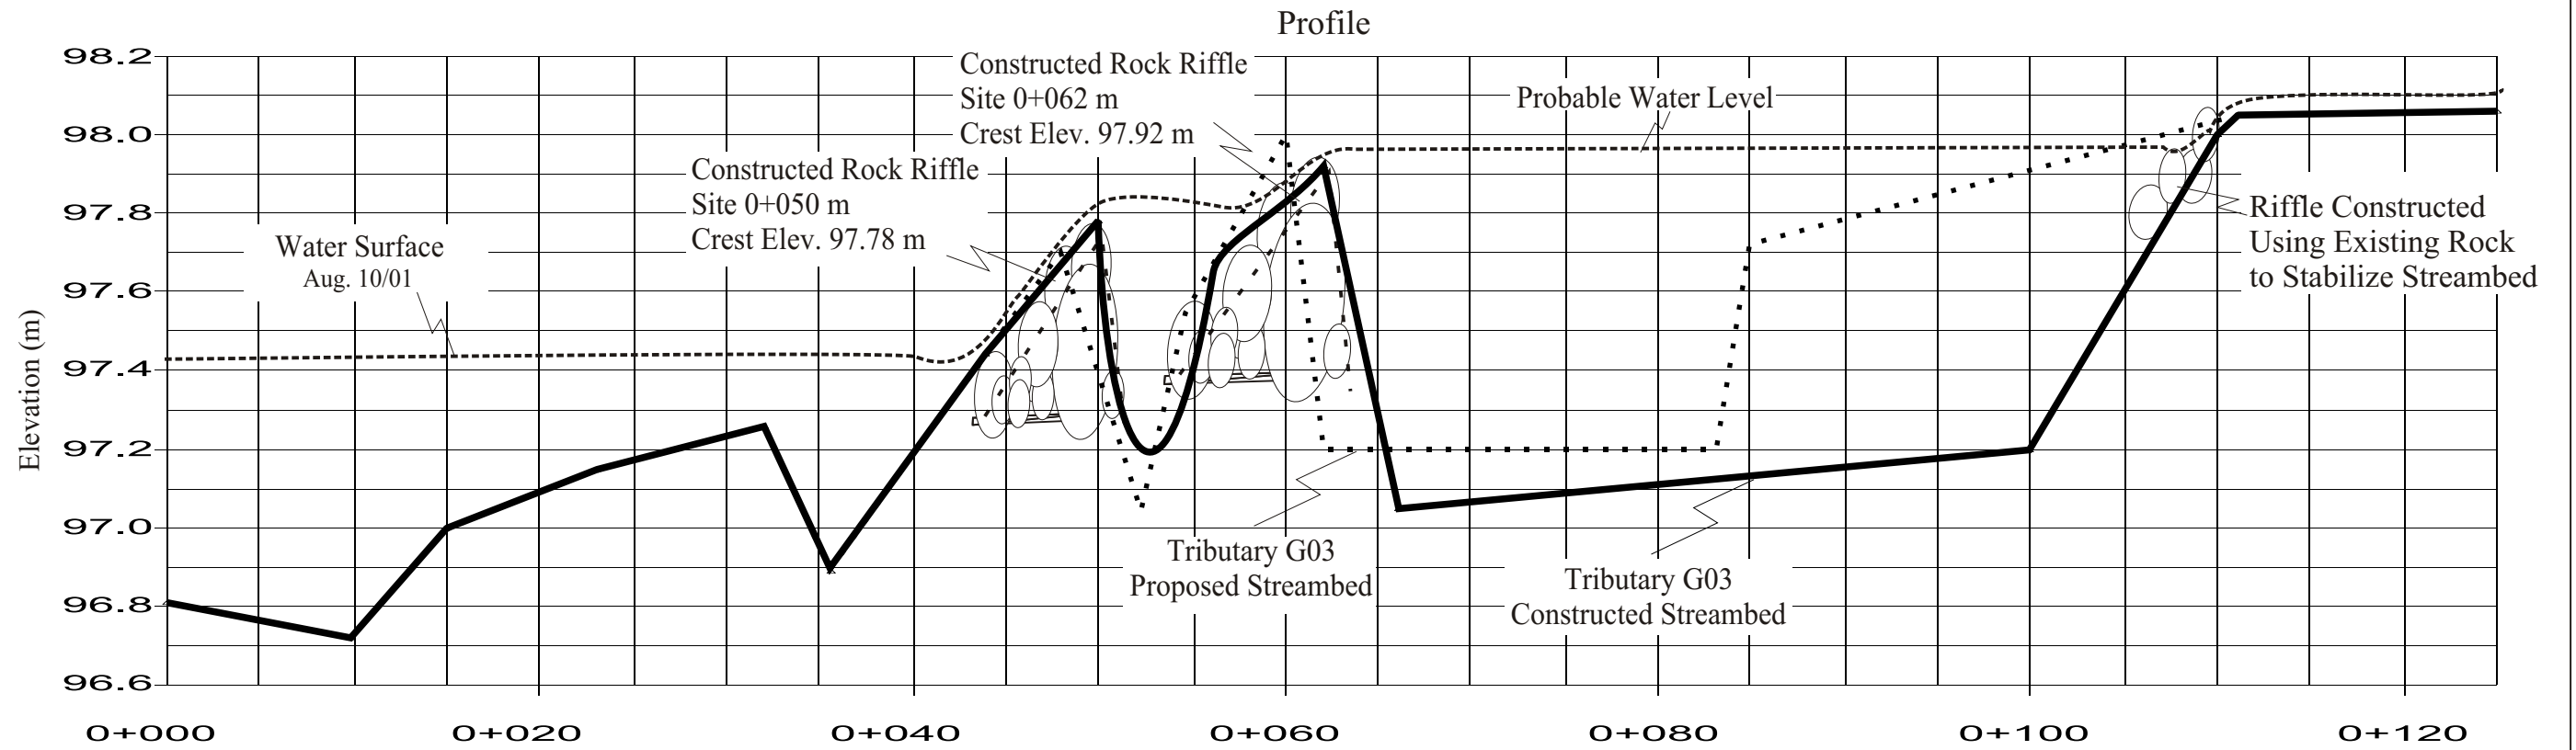
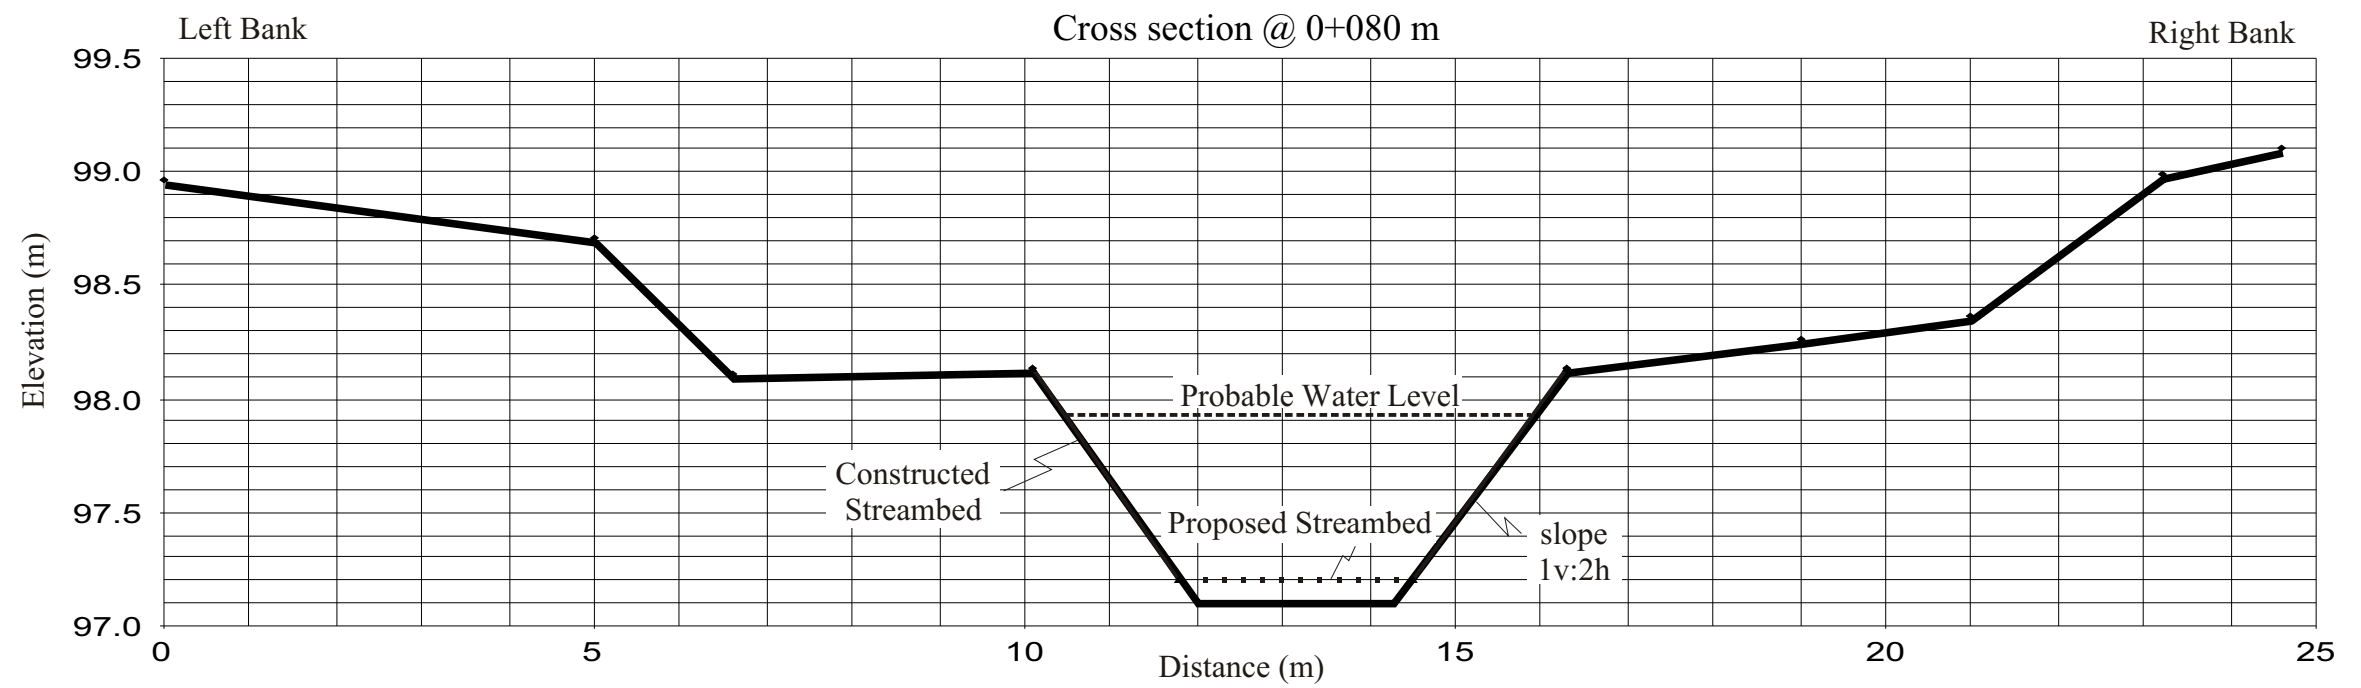
Figure 4. As-built profile and cross section in Tributary G03.

Figure 4 shows the longitudinal profile, cross section and elevations of the riffles constructed in Tributary G03 (Photo 17). Riffle construction generally followed the prescription report (Gaboury 2001). Riffle crest elevations and locations were modified slightly from the prescription plan due to site conditions. The pool located upstream of the rock riffles was extended 25 m further upstream (Figure 4). A riffle was constructed using parent materials at the upstream end of the pool (chainage 0+115 m) to stabilize the streambed and reduce head-cutting (Photo 20).

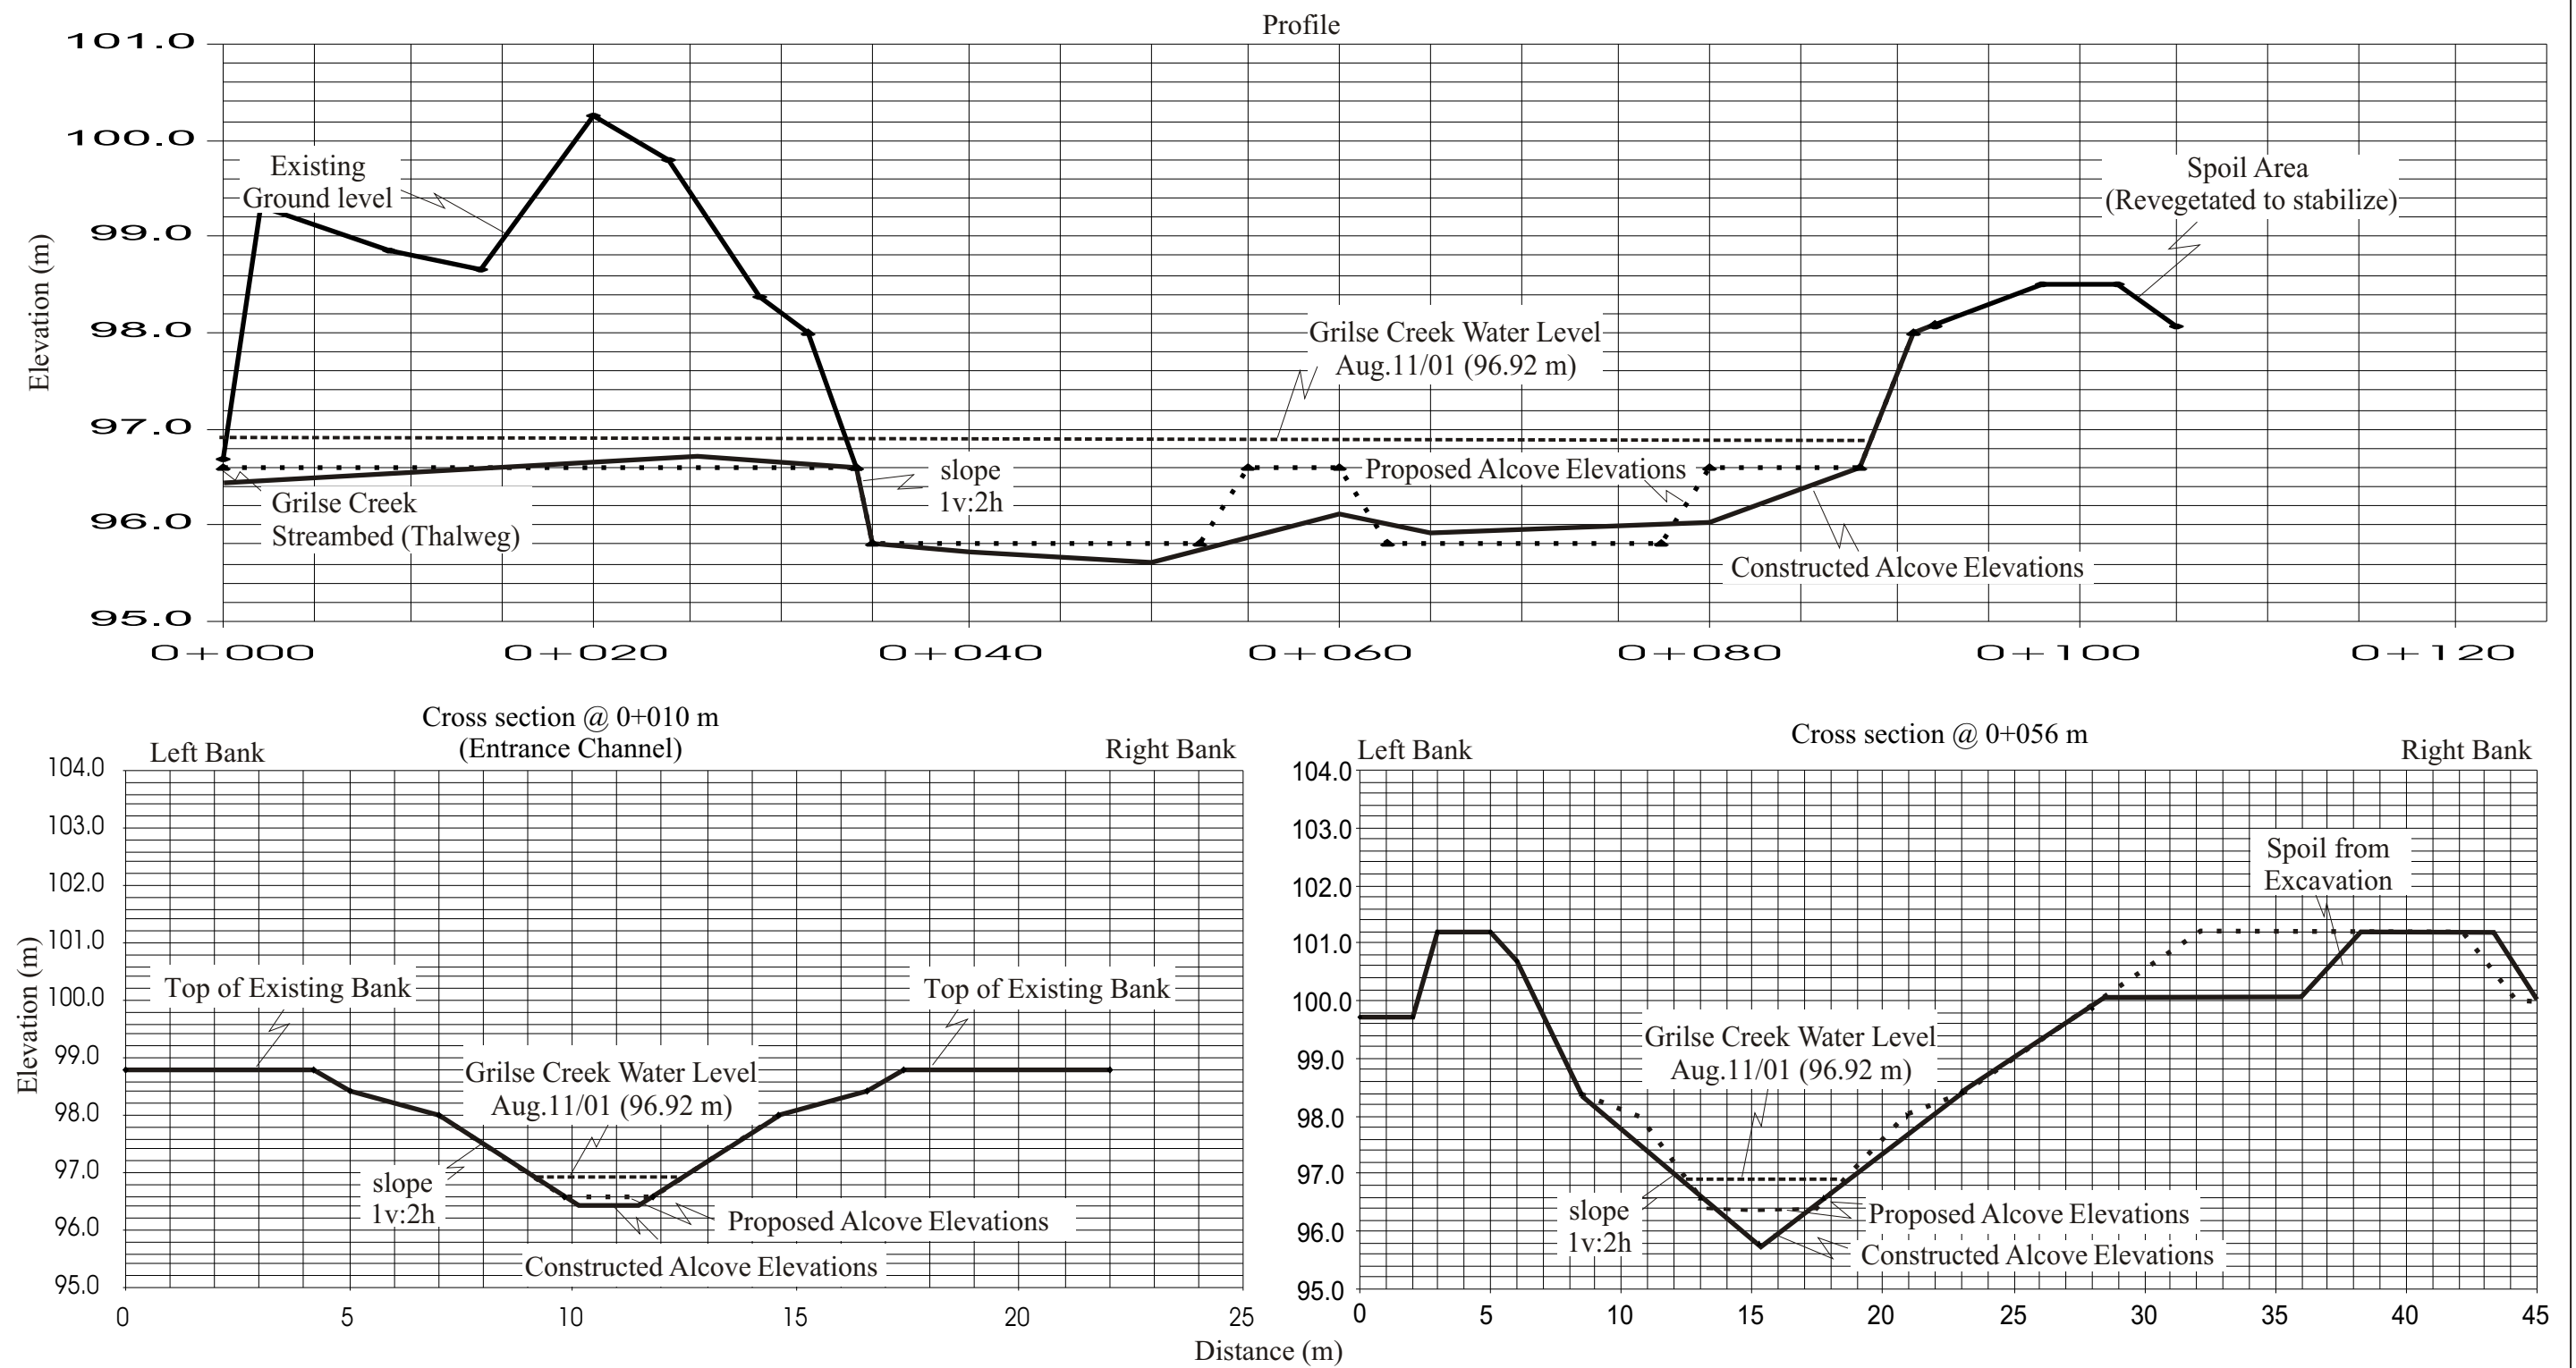
Figure 5. As-built profile and cross sections of the alcove adjacent to Grilse Creek.

The alcove was constructed with a width of between 14 and 18 m, and a length of 75 m (Figures 3 and 5). Photos 29 and 30 show the constructed backwater alcove with LWD that had been added to provide cover. The maximum depth of excavation below the existing ground level was about 2.7 m. Most of the excavated material was loaded on a truck and dumped along the deactivated spur road on the South side of the alcove. Also, spoil was placed around the perimeter of the alcove. Residual pool depths in the alcove were between 1.0 and 1.3 m. The alcove pool was complexed with about 56 pieces of large and small woody debris. Some of the woody debris was obtained during the clearing for the alcove. Three logs were crossed and anchored at the outlet of the alcove pool to prevent the woody debris from floating out of the channel during high water levels (Photos 31 and 32). The height of the spoil around the perimeter of the alcove averaged about 1.5 m above the existing ground surface. At the completion of the backwater alcove project, the berm area was seeded to grass.

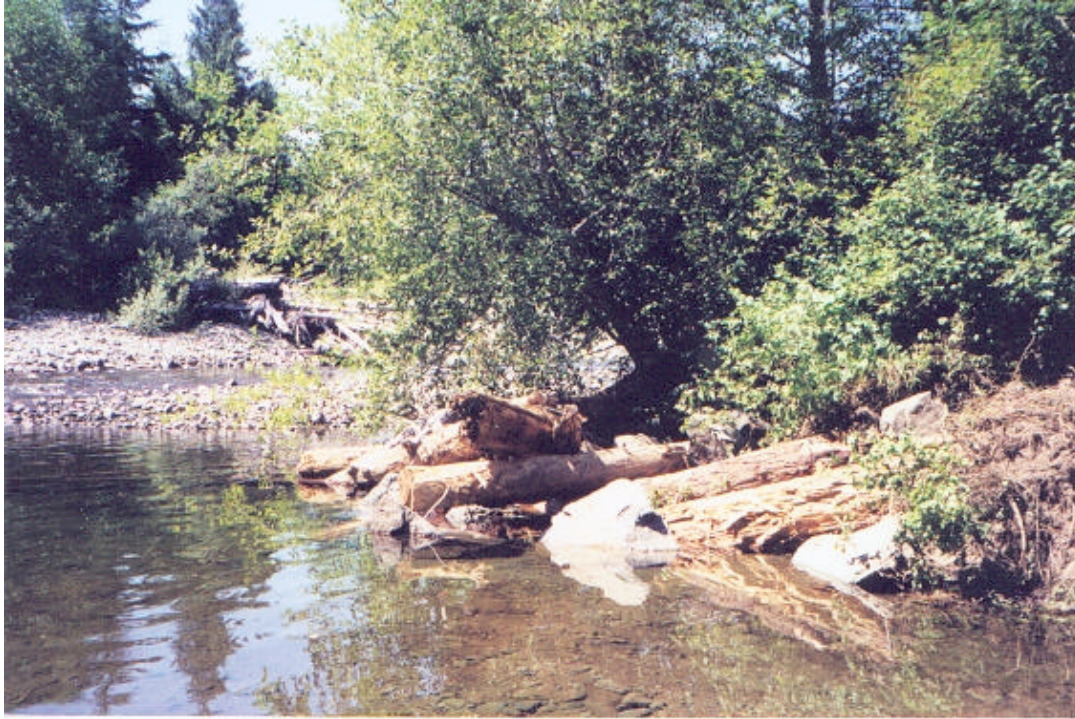
Photo 1. Looking downstream at LWD structure located at 0+000 m in Tributary G02.

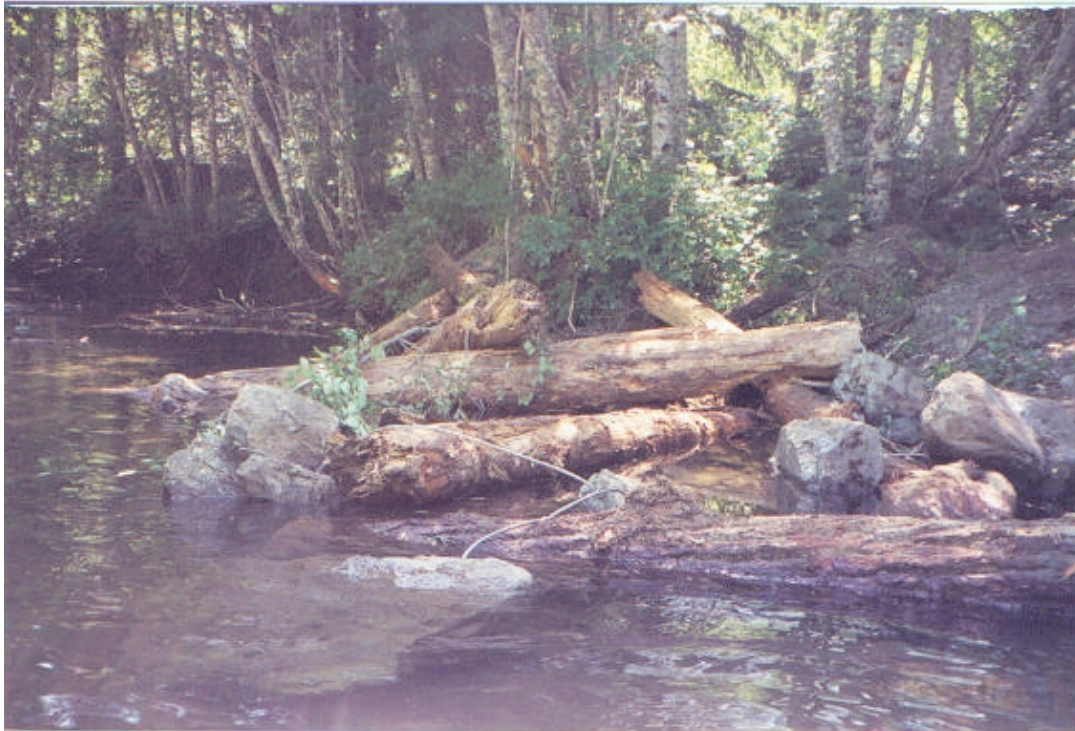
Photo 2. Looking downstream at LWD structure located at 0+038 m in Tributary G02.

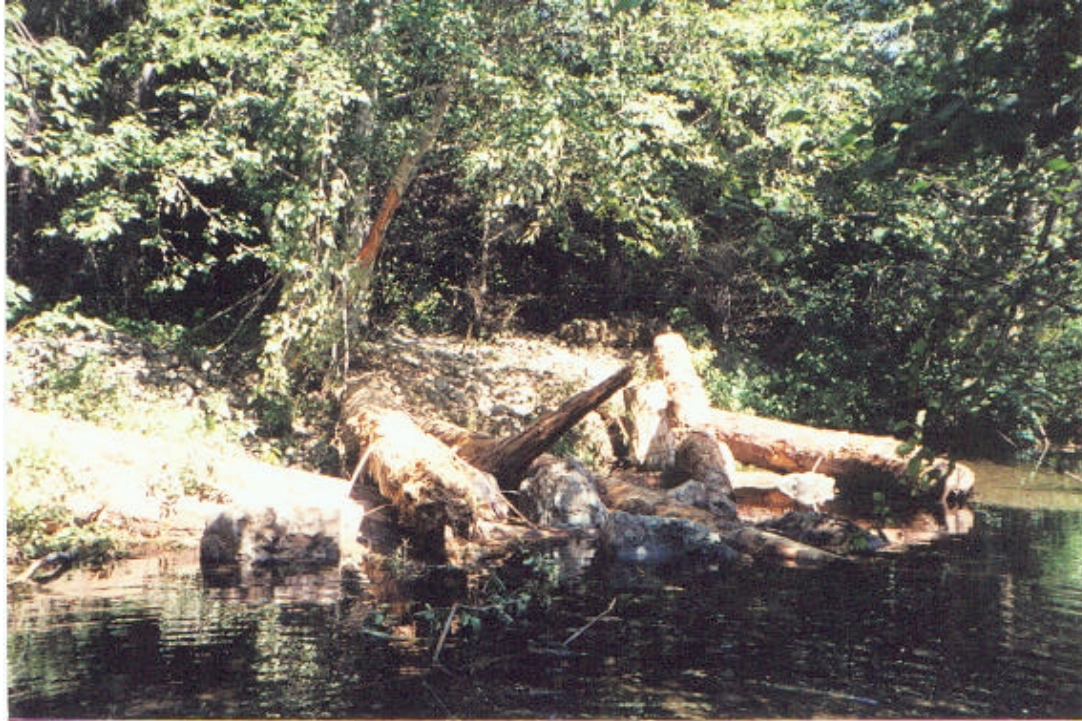
Photo 3. Looking downstream at LWD structure located at 0+076 m in Tributary G02.

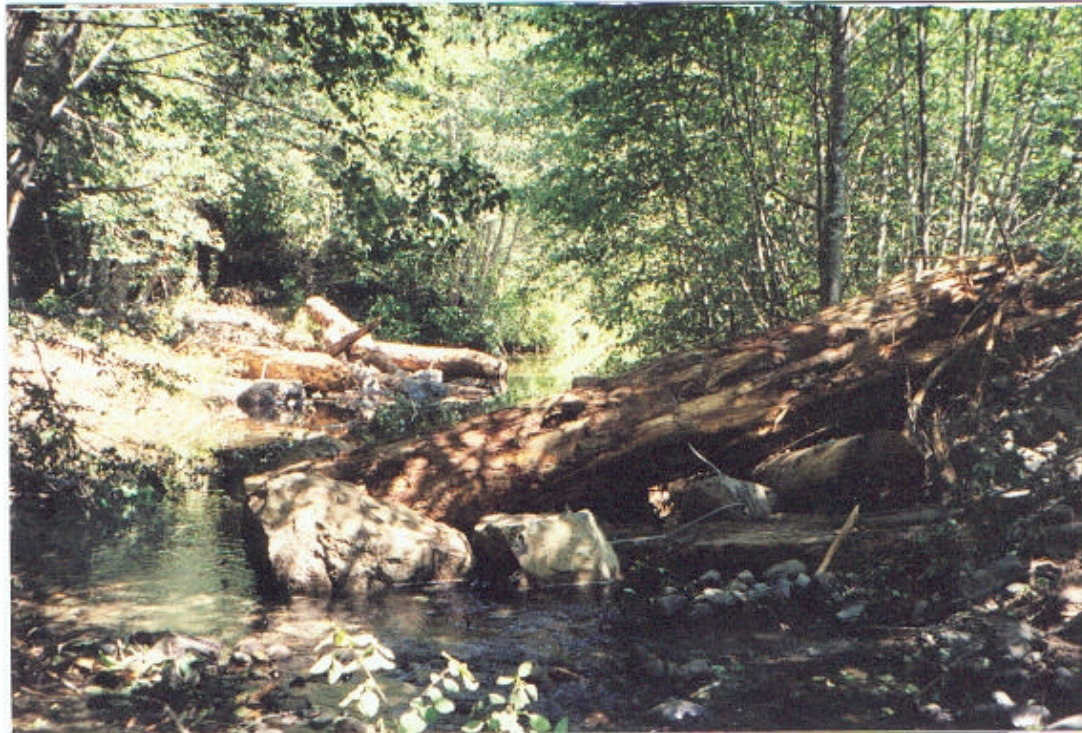
Photo 4. Looking downstream at LWD structure located at 0+101 m in Tributary G02.

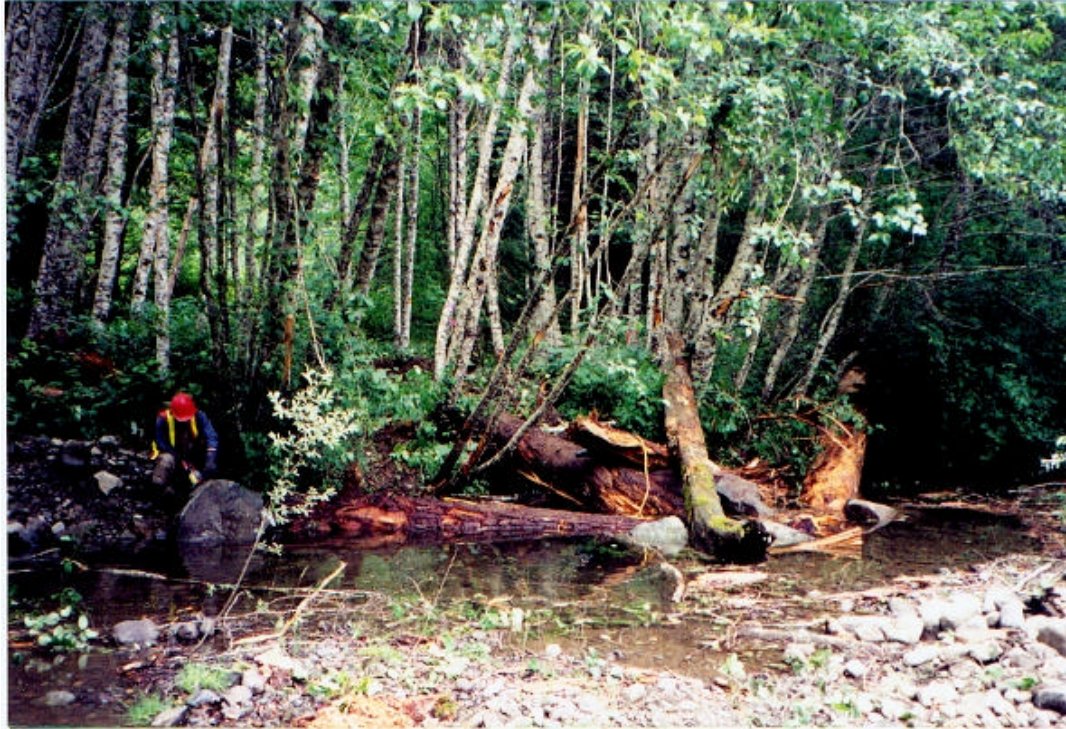
Photo 5. Looking downstream at LWD structure located at 0+136 m in Tributary G02.

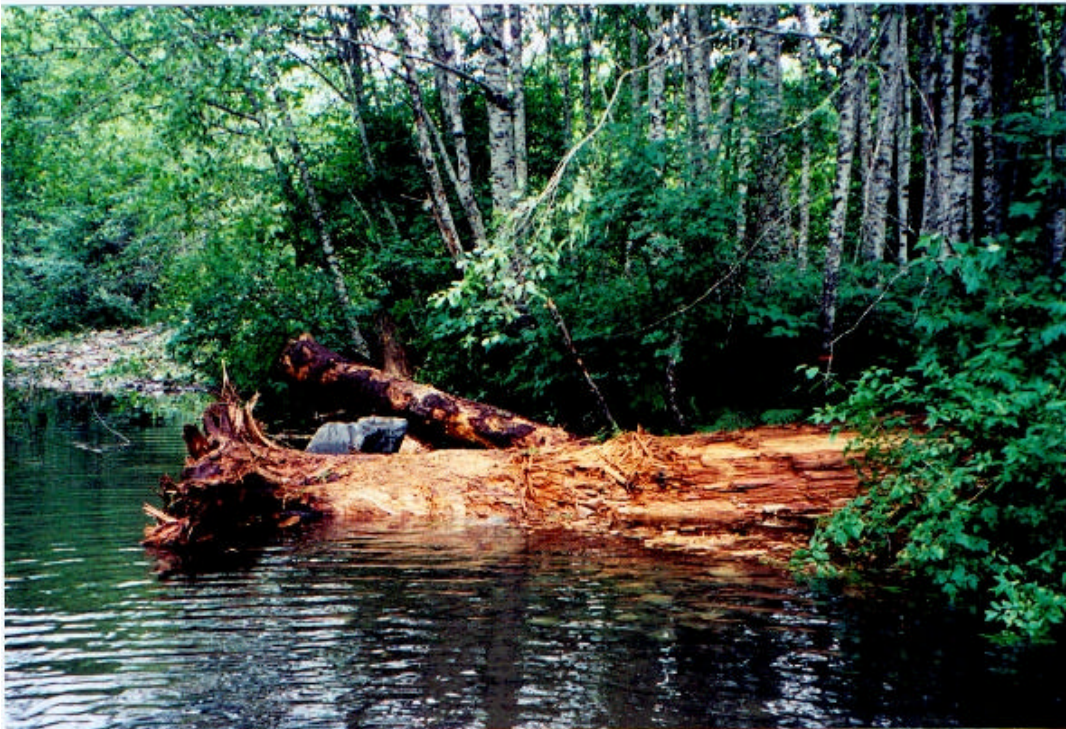
Photo 6. Looking downstream at LWD structure located at 0+160 m in Tributary G02.

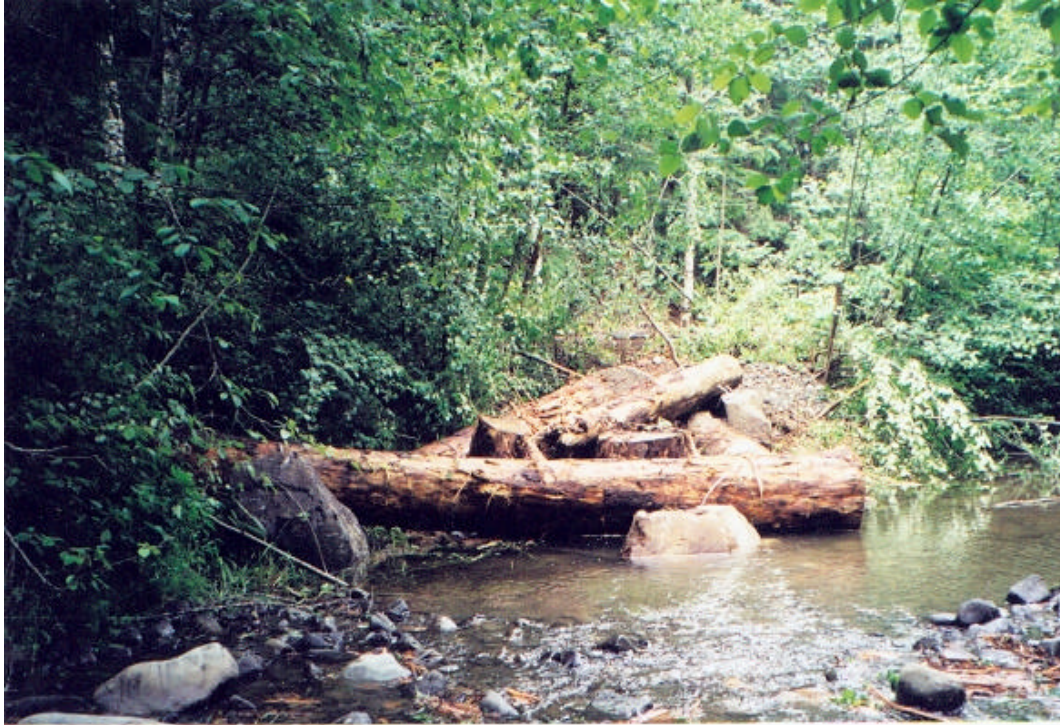
Photo 7. Looking downstream at LWD structure located at 0+191 m in Tributary G02.

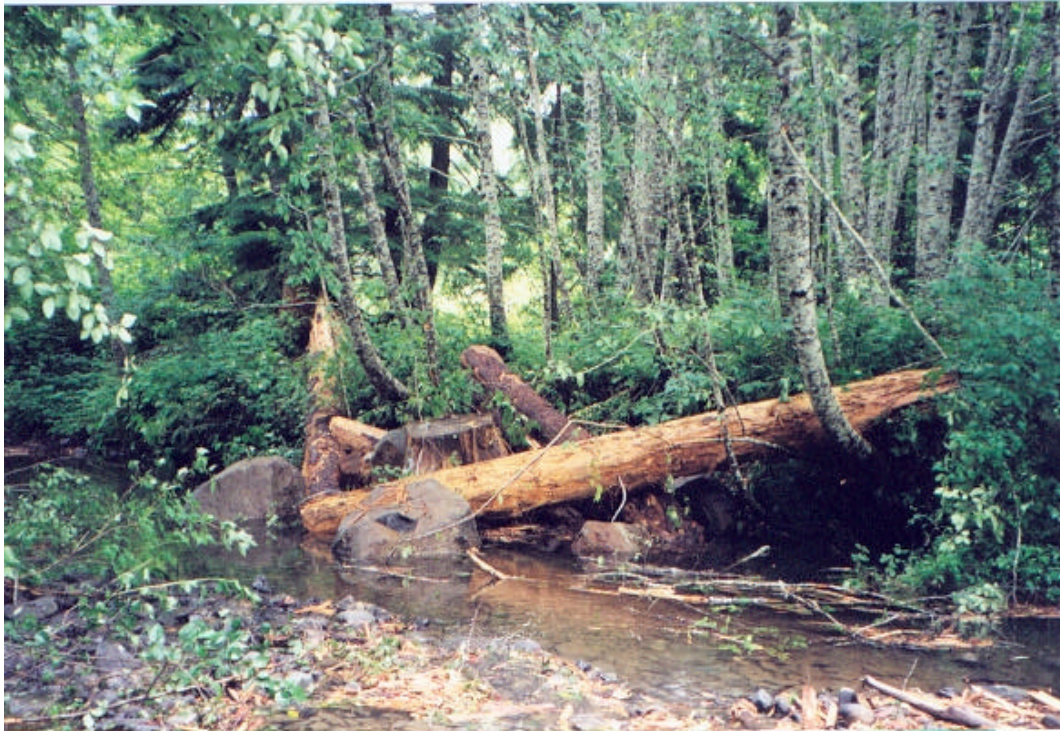
Photo 8. Looking downstream at LWD structure located at 0+217 m in Tributary G02.
