Title: RICHMOND DYKES-REMEDIAL TREATMENT

Location: CORPORATION OF THE TOWNSHIP OF
RICHMOND, BRITISH COLUMBIA

Client: FRASER RIVER JOINT
PROGRAM COMMITTEE
THE PROVINCE OF BRITISH COLUMBIA
MINISTER OF LANDS, FORESTS &
WATER RESOURCES

Our File: VA1346 OCTOBER 17, 1969

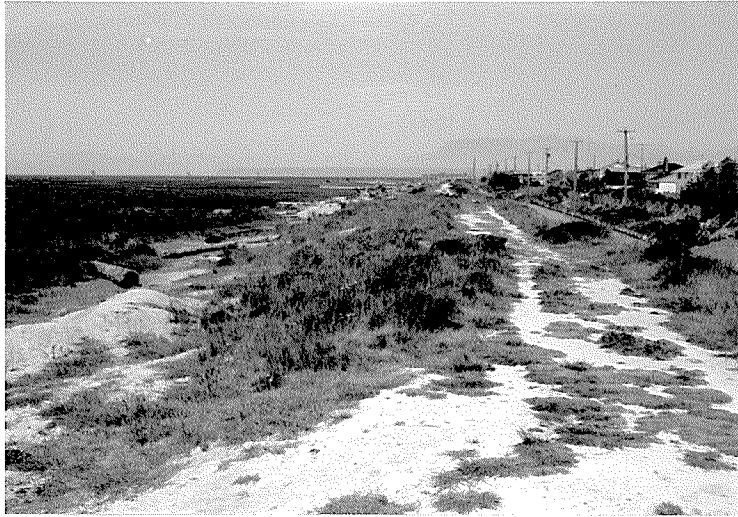
LULU ISLAND WEST
AT SECTION 1002

DYKE AND
STURGEON BANK
WEST END OF
FRANCIS ROAD
LOOKING NORTH

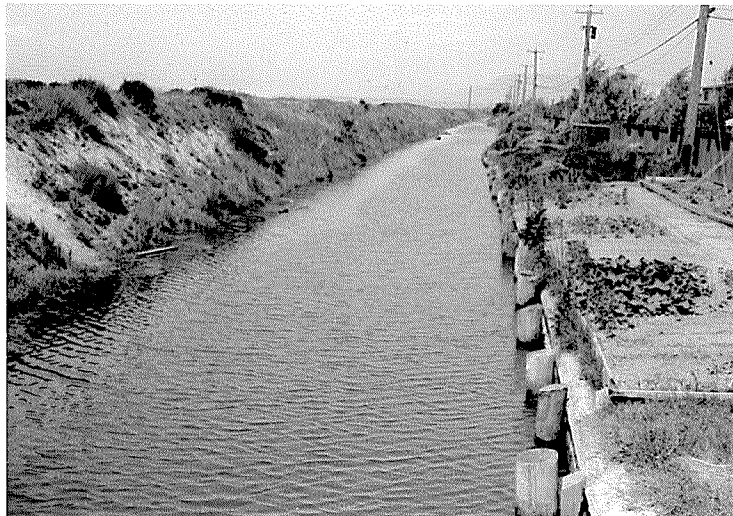
DITCH AND
LANDSIDE OF DYKE
LOOKING NORTH

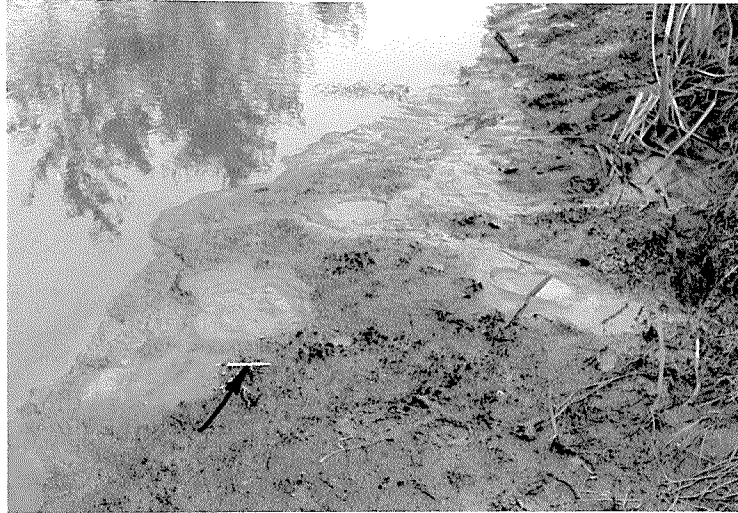
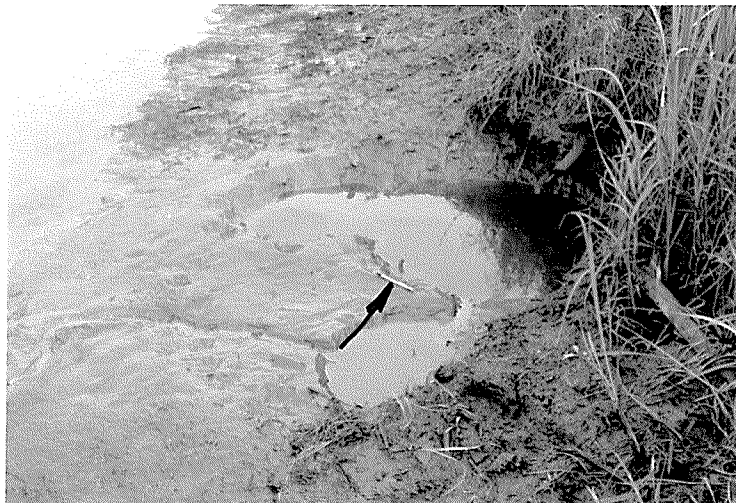
2. Pervious Foundations - The deep sand layer was encountered under most of the sections investigated. This layer is relatively pervious and readings from piezometers installed at a typical section demonstrated that pore pressures in the sand layer follow the hydraulic head variations quite closely and with relatively little time lag. Thus, in areas where the overlying silt layer is thin or non-existent, and there is little or no silt layer on the riverside to hinder access by water to the sand strata, a potential exists for strong underseepage, boils and piping. Appendix B contains a description of the piezometer tests.

LULU ISLAND - SOUTH ARM
BOILS IN DITCH AT SECTION 1018
PENCIL 6" LONG FOR SCALE

With silt layers of thickness less than the design hydraulic head as defined above, the potential for development of boils and piping exists, particularly where erosion or dredging has removed the silt layer riverward of the dyke. It is recommended that such areas be the subject of a further investigation, details of which are outlined in Section IV, Discussion.
