# **CLISBAKO RIVER HABITAT RESTORATION EFFECTIVENESS MONITORING**

# **CLISBAKO RIVER FISH HABITAT RESTORATION PROJECT**

## **EFFECTIVENESS MONITORING SUMMARY**

October 2000

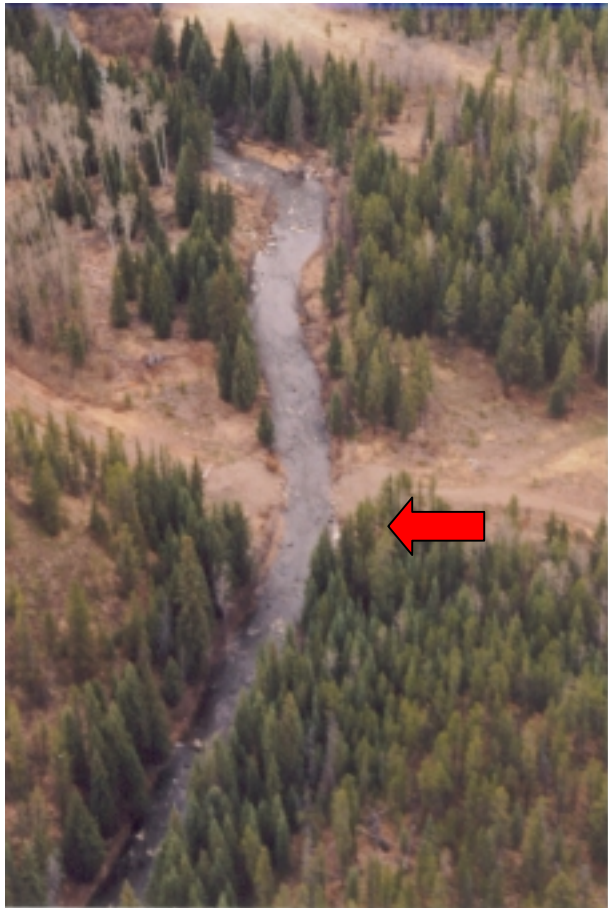
## SITE 1

Aerial view of site 1 and old bridge crossing. (May 4, 2000)

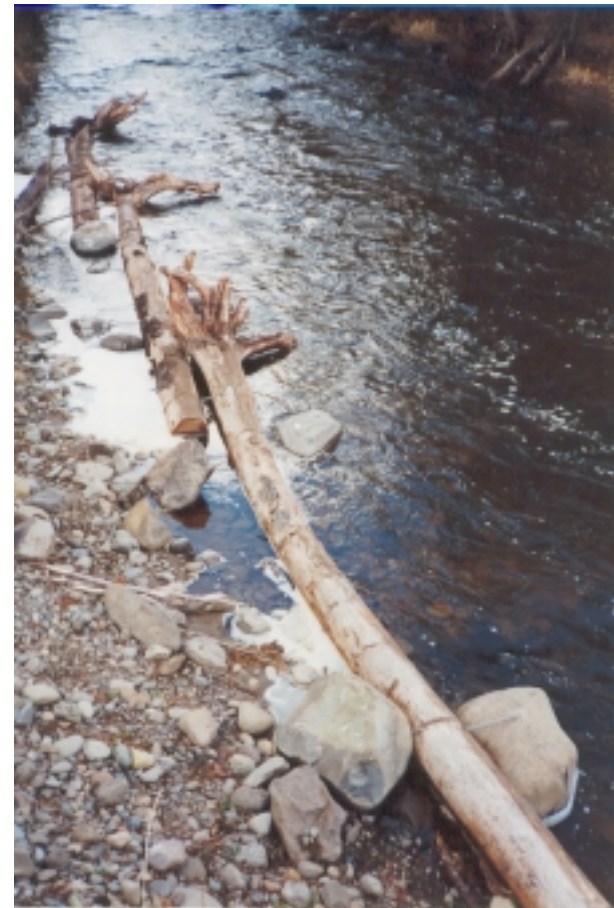
Close-up view of site 1 – May 5, 2000

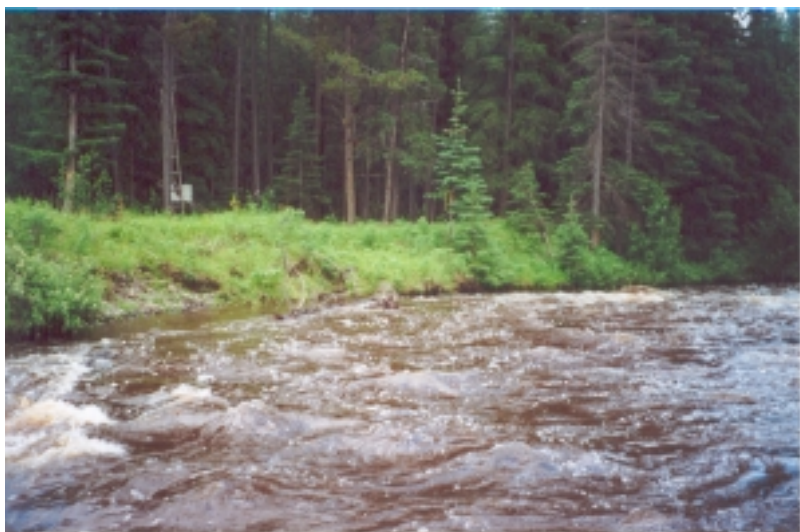
## SITE 1

Site 1 – July 11, 2000

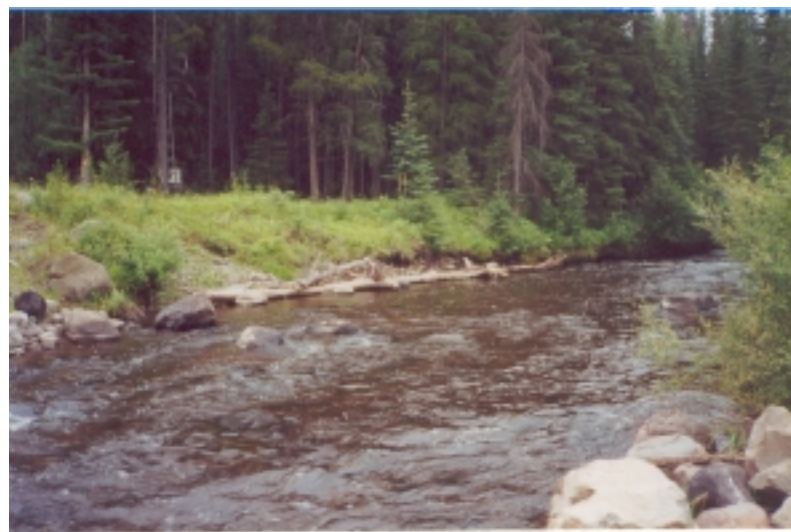
Site 1 – August 3, 2000

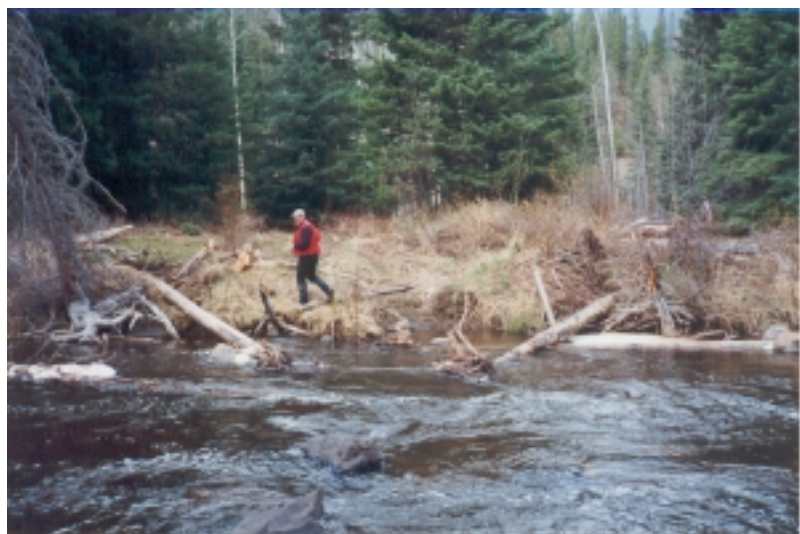
## SITE 2

Site 2 – May 5, 2000

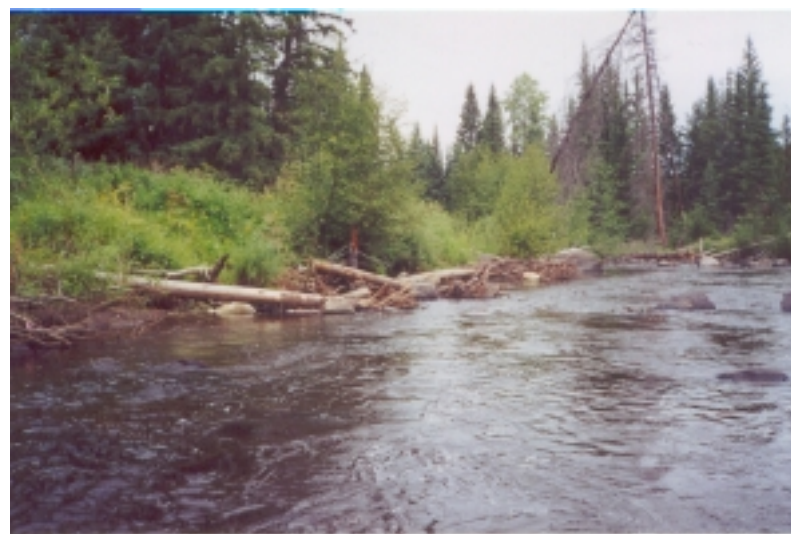
Site 2 – August 3, 2000

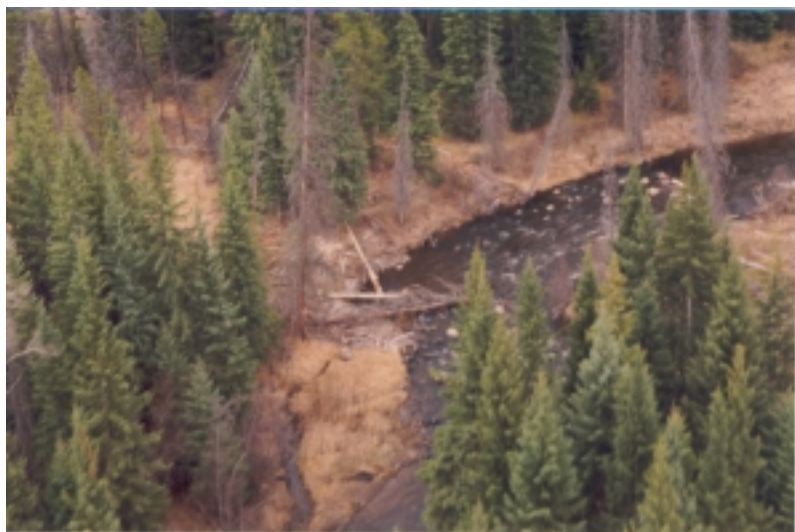
### SITE 3

Site 3 – May 4, 2000

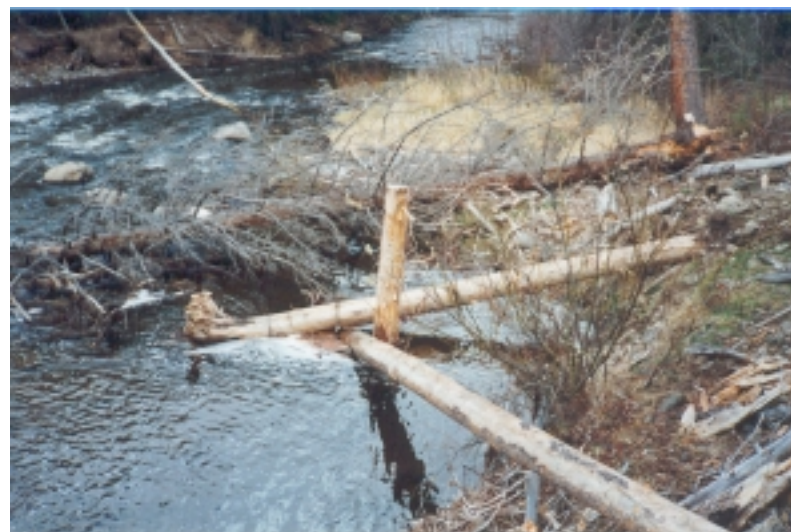
Site 3 – August 3, 2000

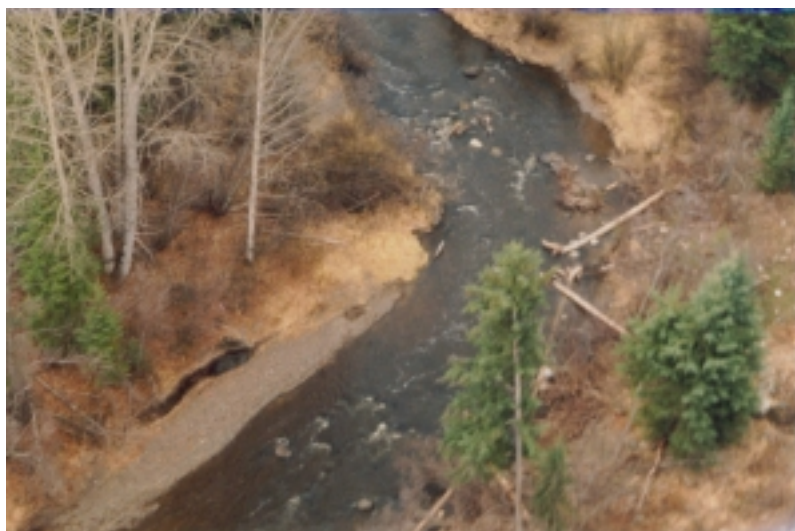
### SITE 8

Site 8 – May 4, 2000

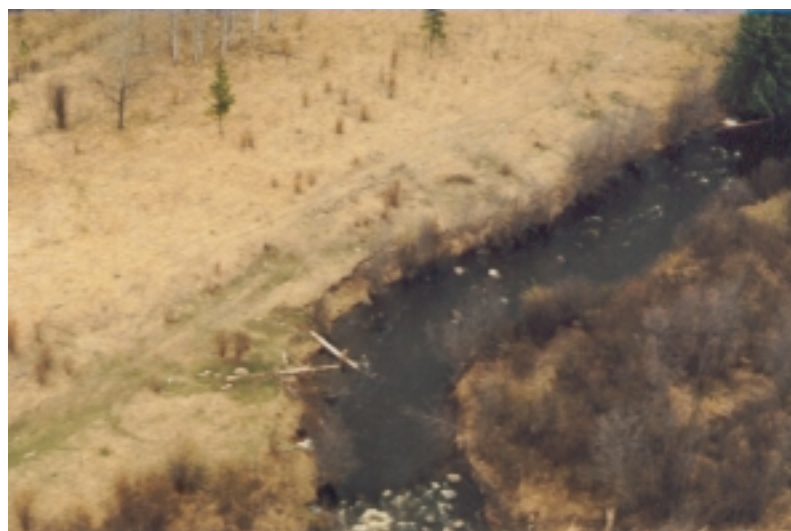
### SITES 13B & 14

Sites 13B & 14 – May 4, 2000
