# **CLISBAKO RIVER FISH HABITAT RESTORATION PROJECT**

## **EFFECTIVENESS MONITORING**

### **Site Based Evaluation**

October 2000

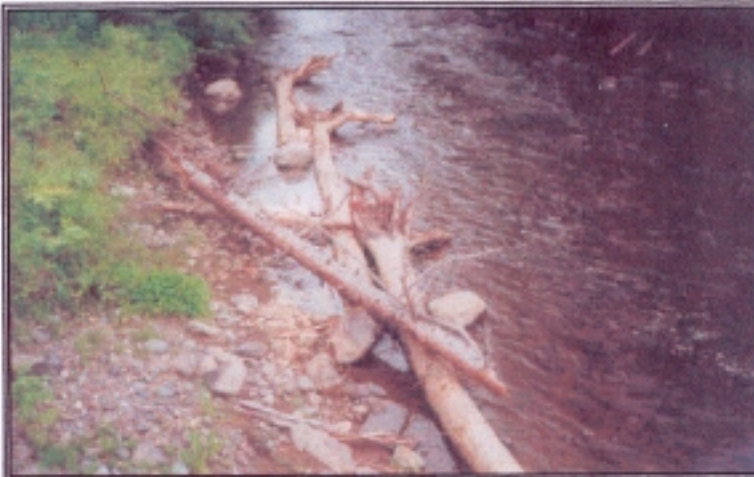
- upstream most log has rolled away from bank, resulting in some slack in the cable
- small pool habitat has formed in between logs and the bank, would provide refuge at high flows
- moderate amounts of small woody debris have accumulated among the roots of the log structure

View upstream from left bank.

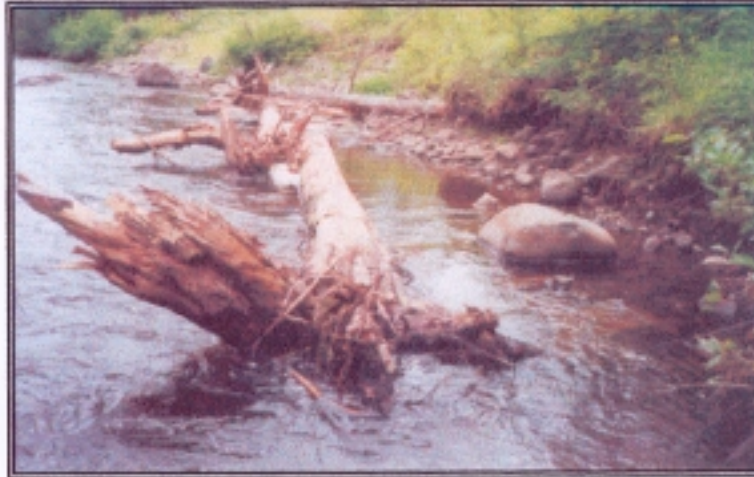
Downstream view.  
Note that log has shifted  
slightly away from the bank.

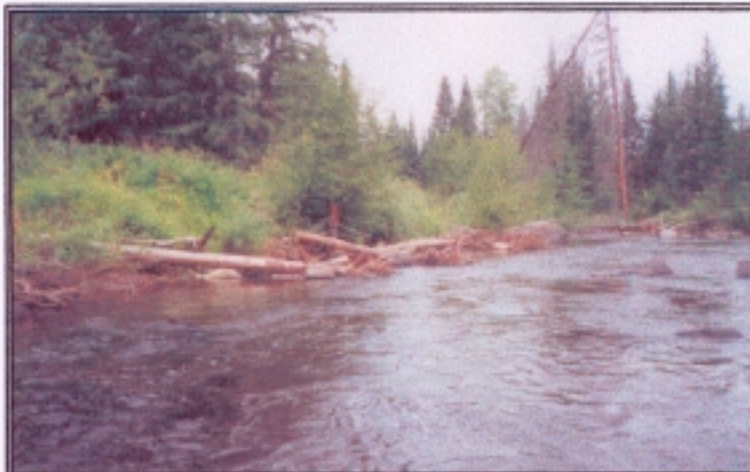
- large amounts of small woody debris accumulated, especially on downstream LWD
- good pool/glide habitat created, downstream of structure
- high numbers of juvenile salmonids observed here (feeding)

Downstream view.

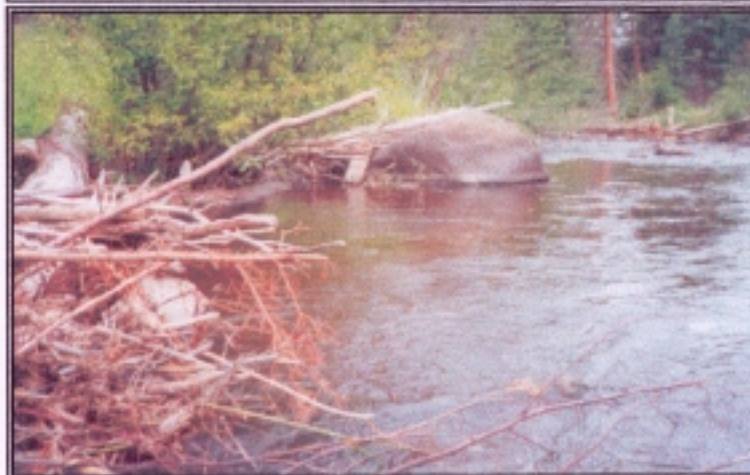
Downstream from last log of site 2. Good accumulation of woody debris. Many juvenile salmonids observed here.

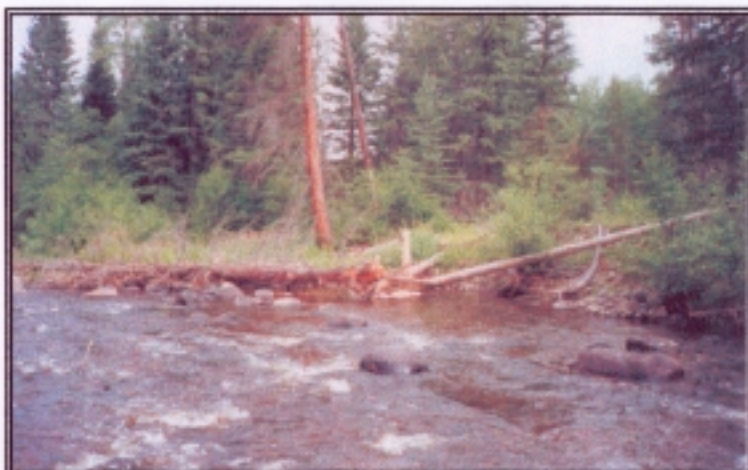
- 4th piece of LWD from a fallen tree which has landed more or less on this structure
- remainder of beaver dam at this site may serve as refuge at high water
- large amount of fines observed around site, next high water will likely clean it out

Downstream view to site 3.  
Note addition of blow down

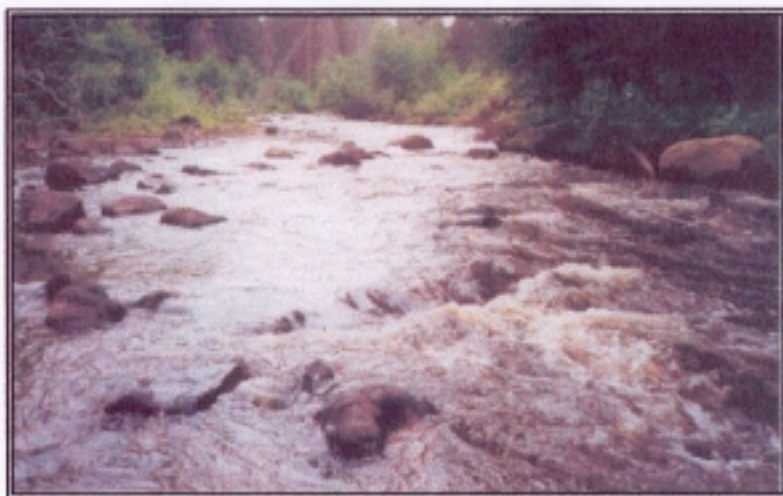
Upstream view of site 5B.

- prominent hydraulic head at the upstream face of the riffle
- good hydraulic complexity, upstream movement will likely be facilitated

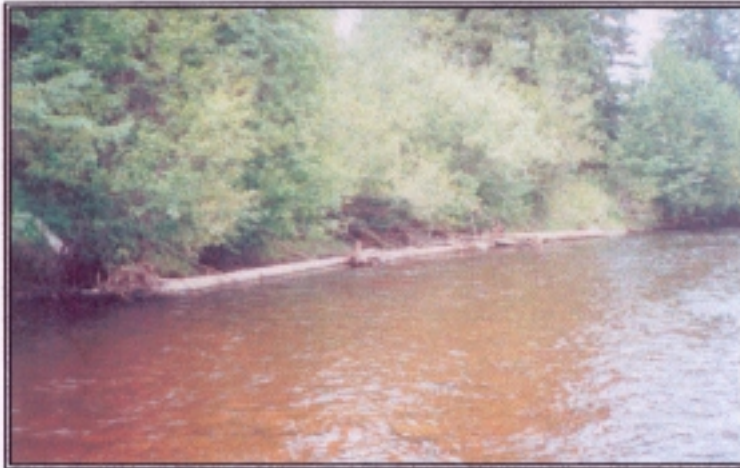
Downstream view of site 6B.

- good glide habitat along LWD
- small pool contained between LWD and bank

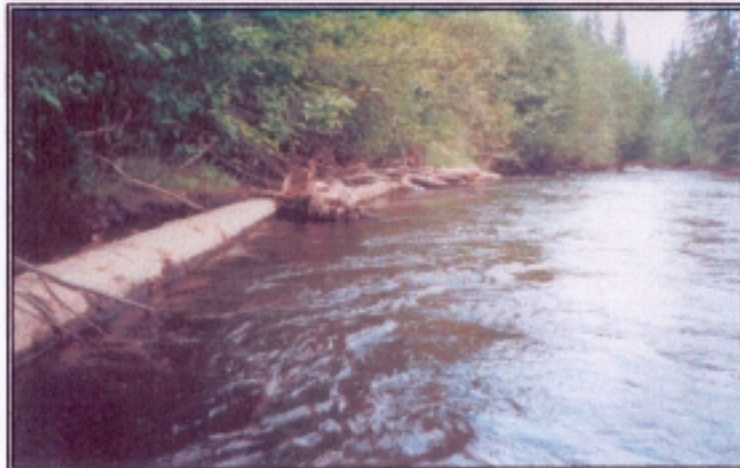
Note glide habitat along edge of structure.

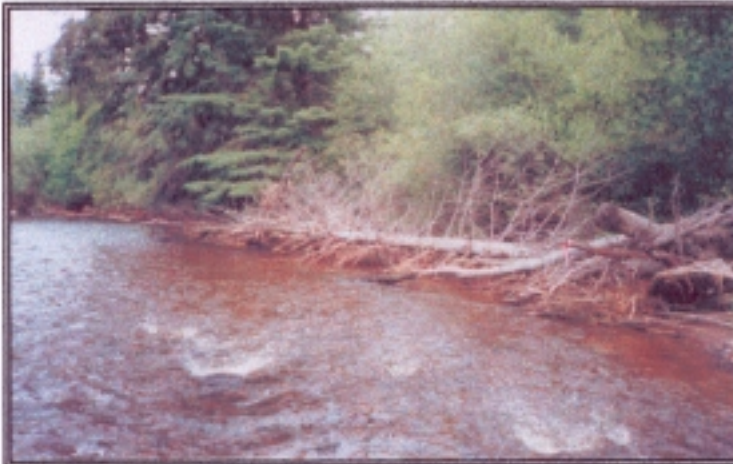
- small, tertiary pools in behind LWD
- small woody debris captured in rootwads
- has been effectively lengthened, by 2 additional LWD captured after installation

Downstream view of site 6.  
Additional LWD (natural) had  
accumulated at the upstream  
end of the structure.

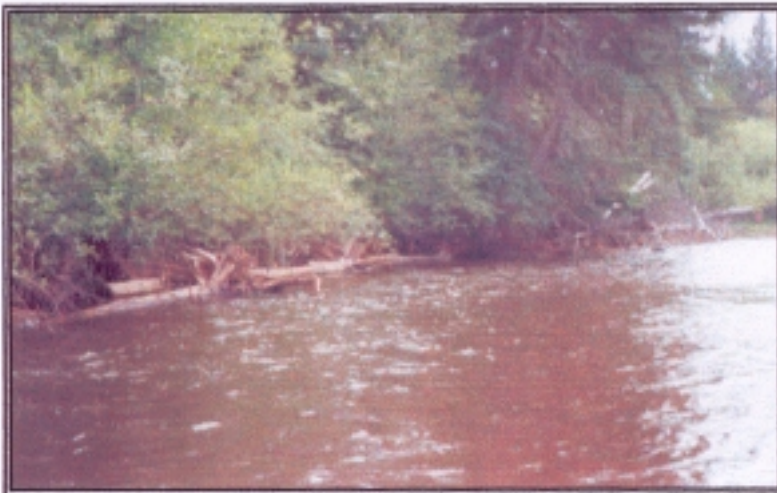
Downstream view of site 7.

- many fish observed utilizing this structure - appear to dart out and capture prey, then return to cover
- good accumulation of small woody debris

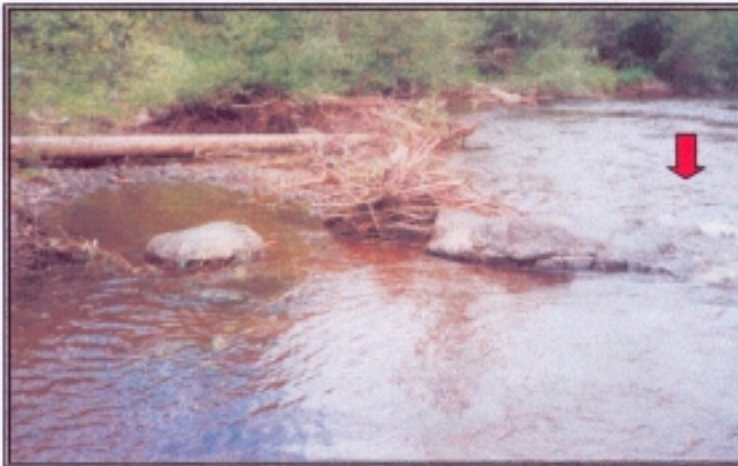
- good accumulation of small woody debris - this structure is "naturalizing" well
- good deepwater habitat at this site - the slight bend in the river here, combined with the structure location, has resulted in a very hydraulically complex site
- one salmon observed up this far, rainbow trout up to 20 cm observed here

Downstream view of site 8. Good pool habitat identified by arrow.

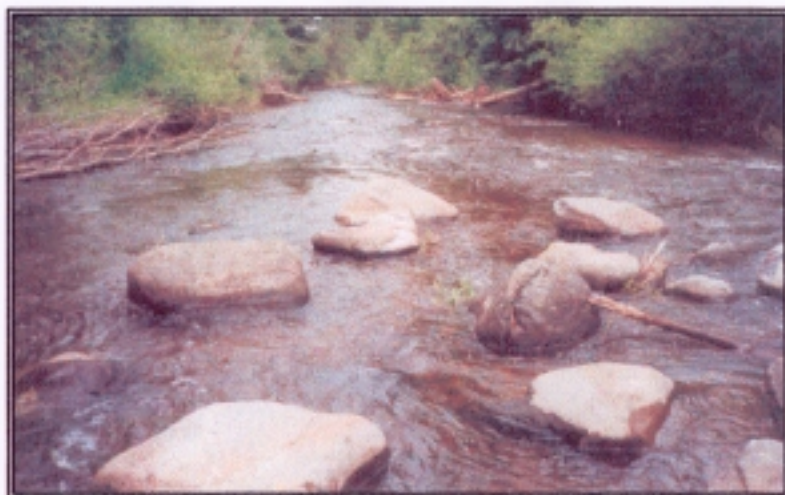
Downstream view of site 9.

- good holding habitat, offers refuge from high velocity flows
- many of the boulders have scoured into place, and are currently very stable

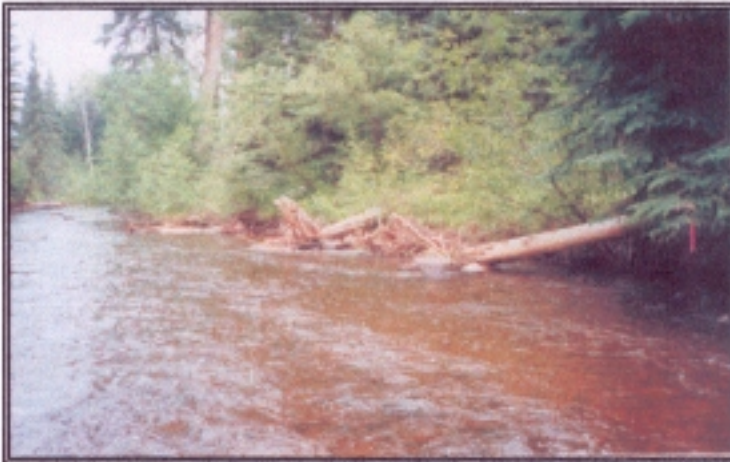
Downstream view.

- large amounts of small woody debris accumulated
- many small tertiary pools created in between LWD and bank, may offer seasonal habitat.

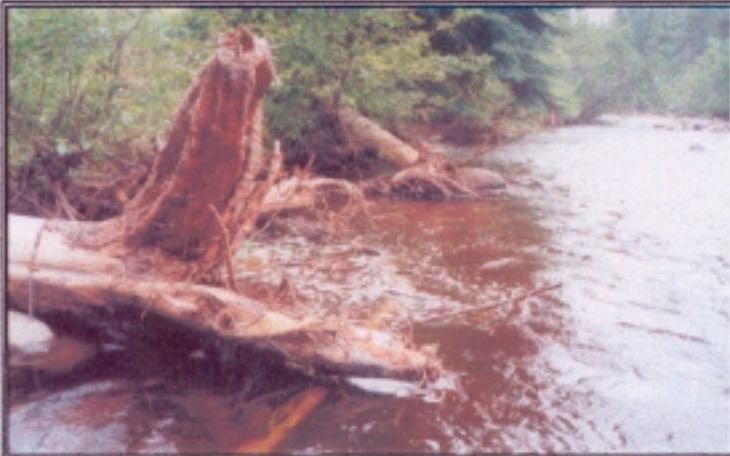
Upstream view showing small refuge habitats in between root wads.

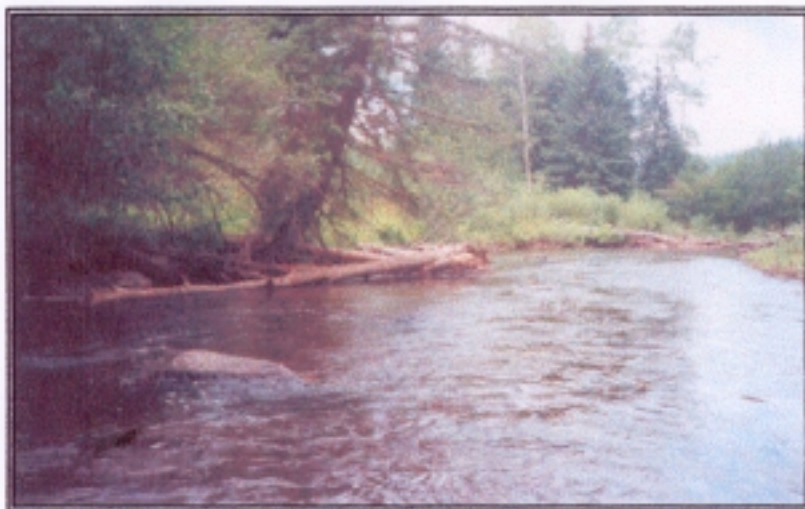
Downstream view

-likely that a pool will eventually scour here, but currently full of fines. Next high water event may clean the fines out.

-the thalweg appears to be located some distance from this structure, so it likely functions better at high flows. At low flow, the structure may not have adequate levels of water to fully function.

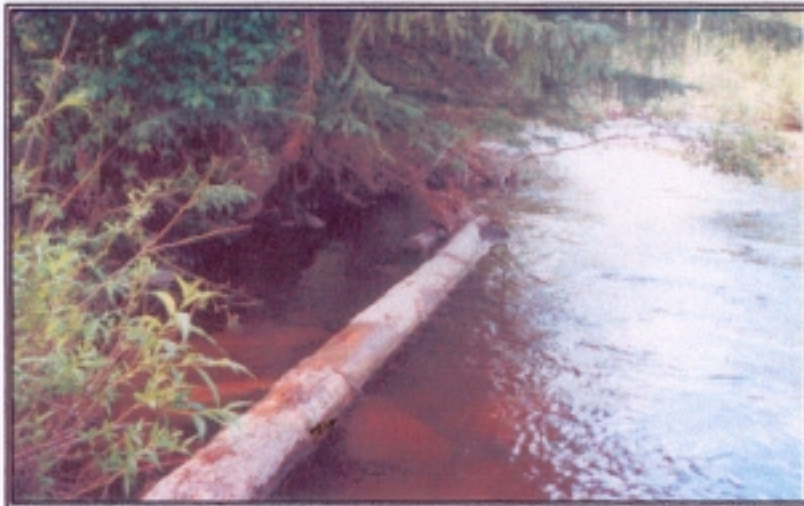
Downstream view.

- good glide habitat along edge of LWD
- still water habitat available between the structure and the bank (small pools)

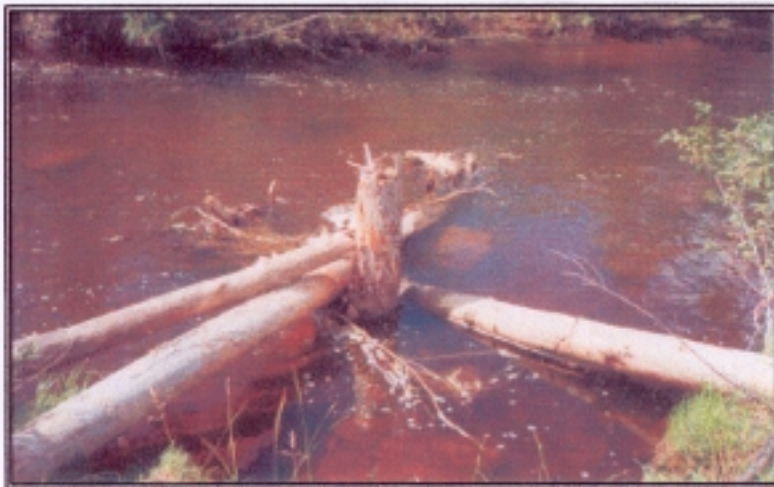
View from right bank.

- forms upstream end of a good pool- between this site and site 14 (riffle)
- good scour downstream of structure

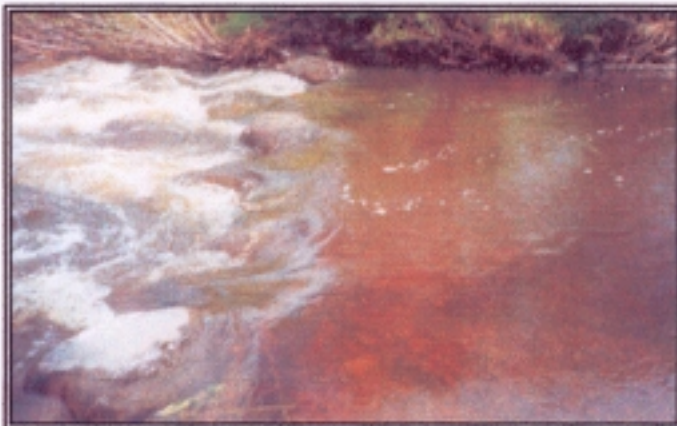
- good hydraulic head at upstream end of riffle - @ 0.50 m deep
- excellent scour at tailout of riffle - likely that large pool will develop downstream
- many routes available for upstream movement of fish

Good pool created  
upstream of the head of the riffle

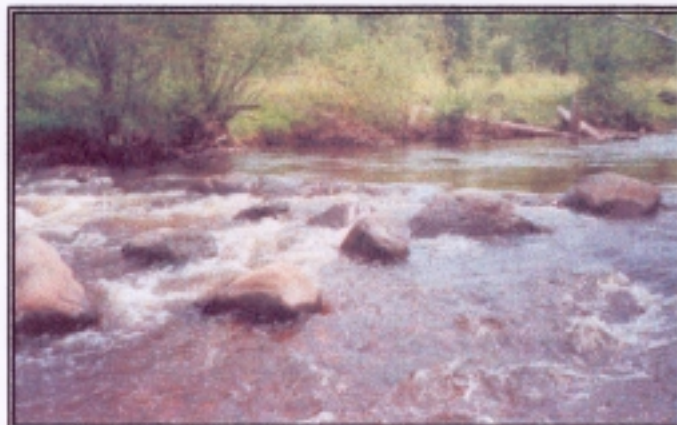
Upstream view  
(Site 13 visible at the top of  
the photo)

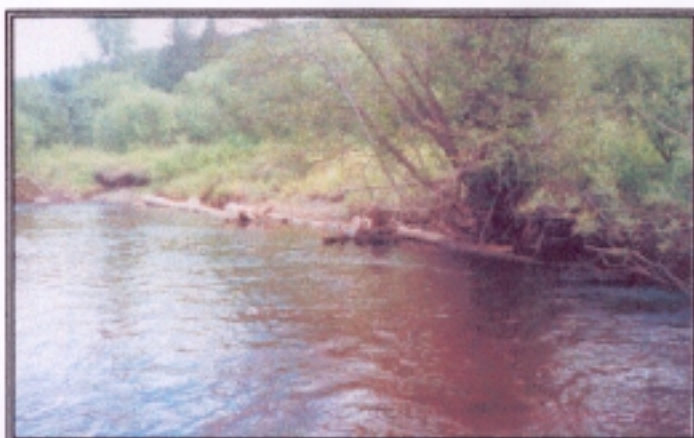
Downstream view.

- appears to direct water towards the bank at high flow. Bank is scoured and undercut downstream from the last piece of LWD
- good glide and tertiary pool habitat

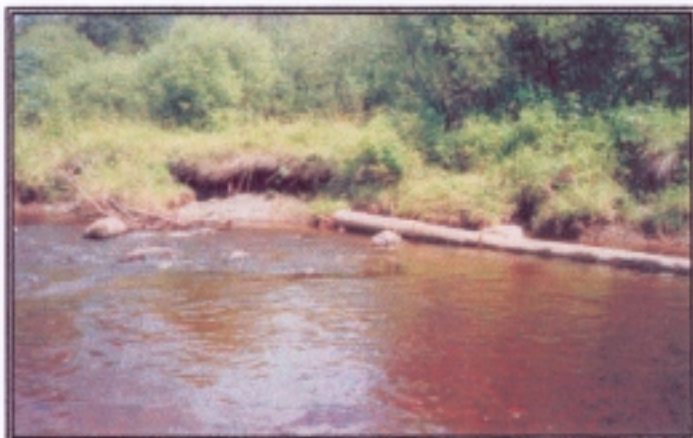
Downstream view.  
Note scour at downstream  
end of structure.

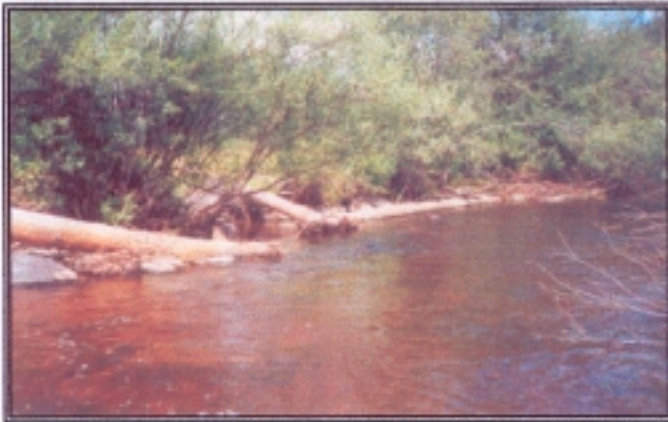
Downstream view.

- good maintenance of pool depth - active scour promoted by structure
- good juvenile habitat available between the structure and the bank (tertiary pools)
- large accumulation of small woody debris on the rootwads of the structure

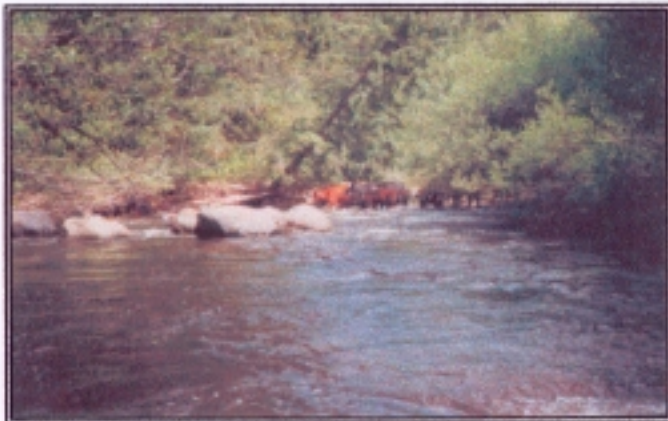
Downstream of the site, well-used cattle crossing (right at the downstream end of the riffle).
