**WATERSHED RESTORATION PROGRAM  
INSTREAM ROUTINE EFFECTIVENESS EVALUATION 2001  
KOBES AND COLT WATERSHEDS**

**Forest Renewal BC  
Watershed Restoration Program  
Ministry of Water, Land and Air Protection  
400-10003 110<sup>th</sup> Ave.,  
Fort St. John, BC V1J 6M7**

**February 2002**

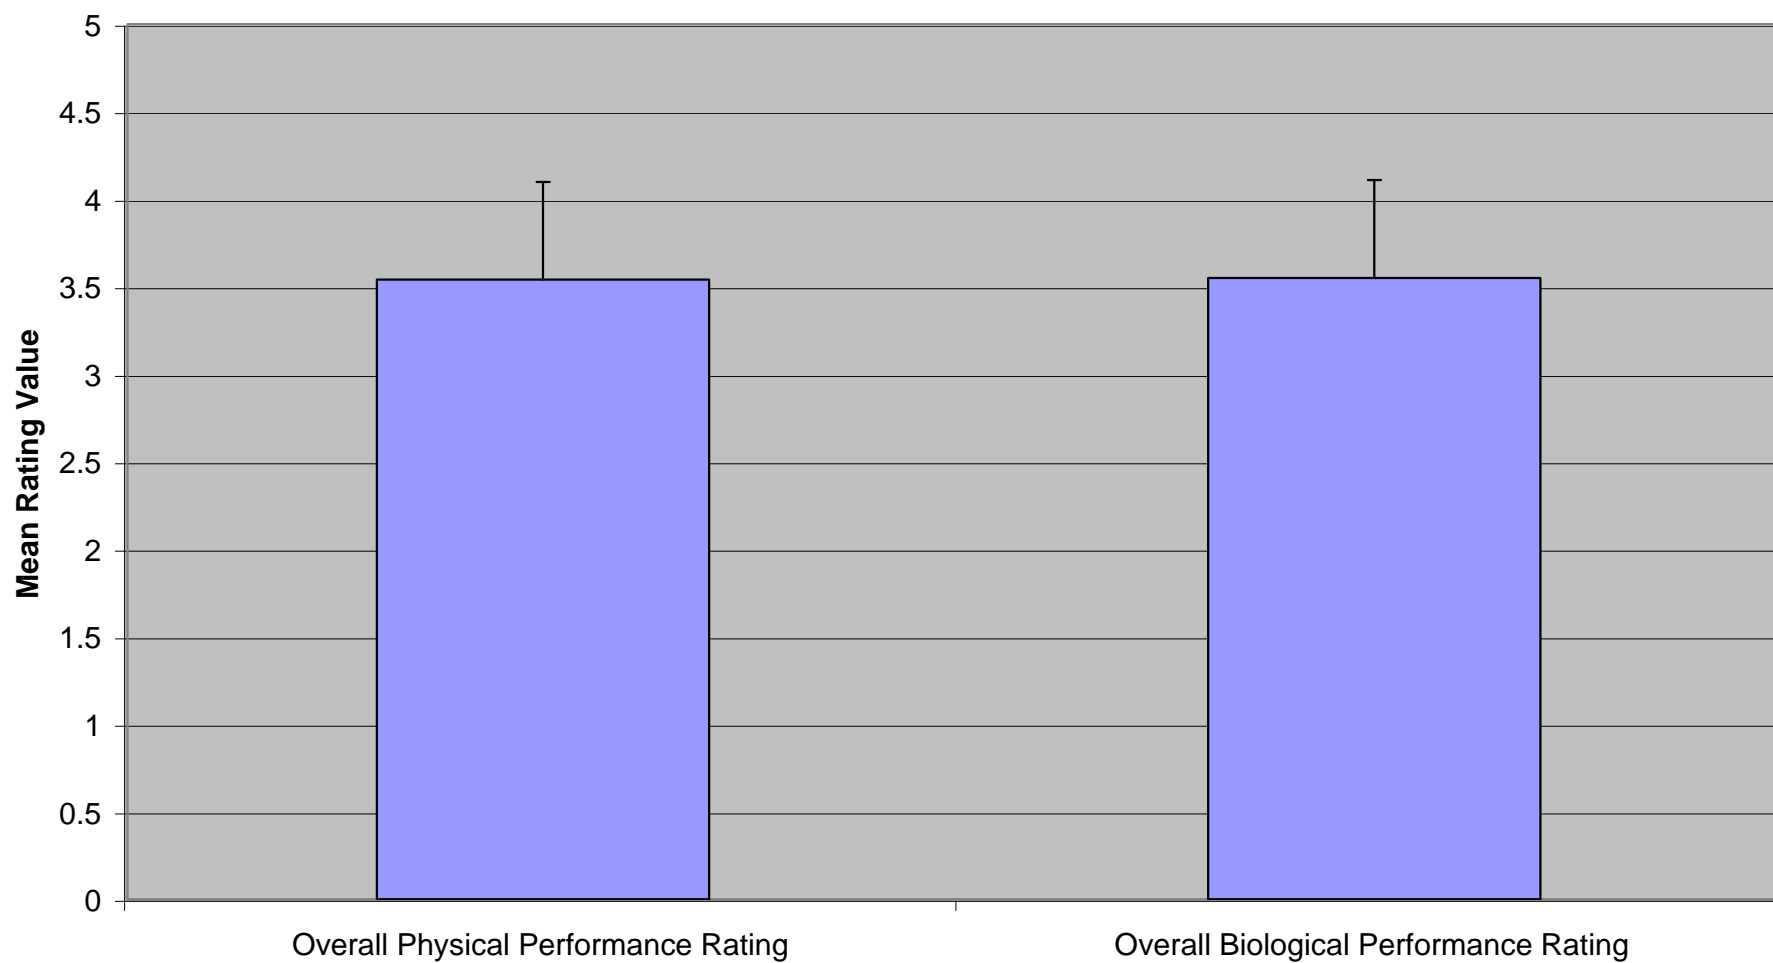
**Figure 3. Summary of performance ratings across all structure types ( $\pm$  one standard deviation).**

A total of 59 structures (i.e., 30 in West Kobes Creek and 29 in Colt Creek) were evaluated for physical and biological performance (Tables 1 and 2, respectively). Across all structures, the pooled mean physical performance objective was  $3.54 \pm 0.559$ , whereas the mean biological performance objective was  $3.55 \pm 0.563$  (Figure 3).

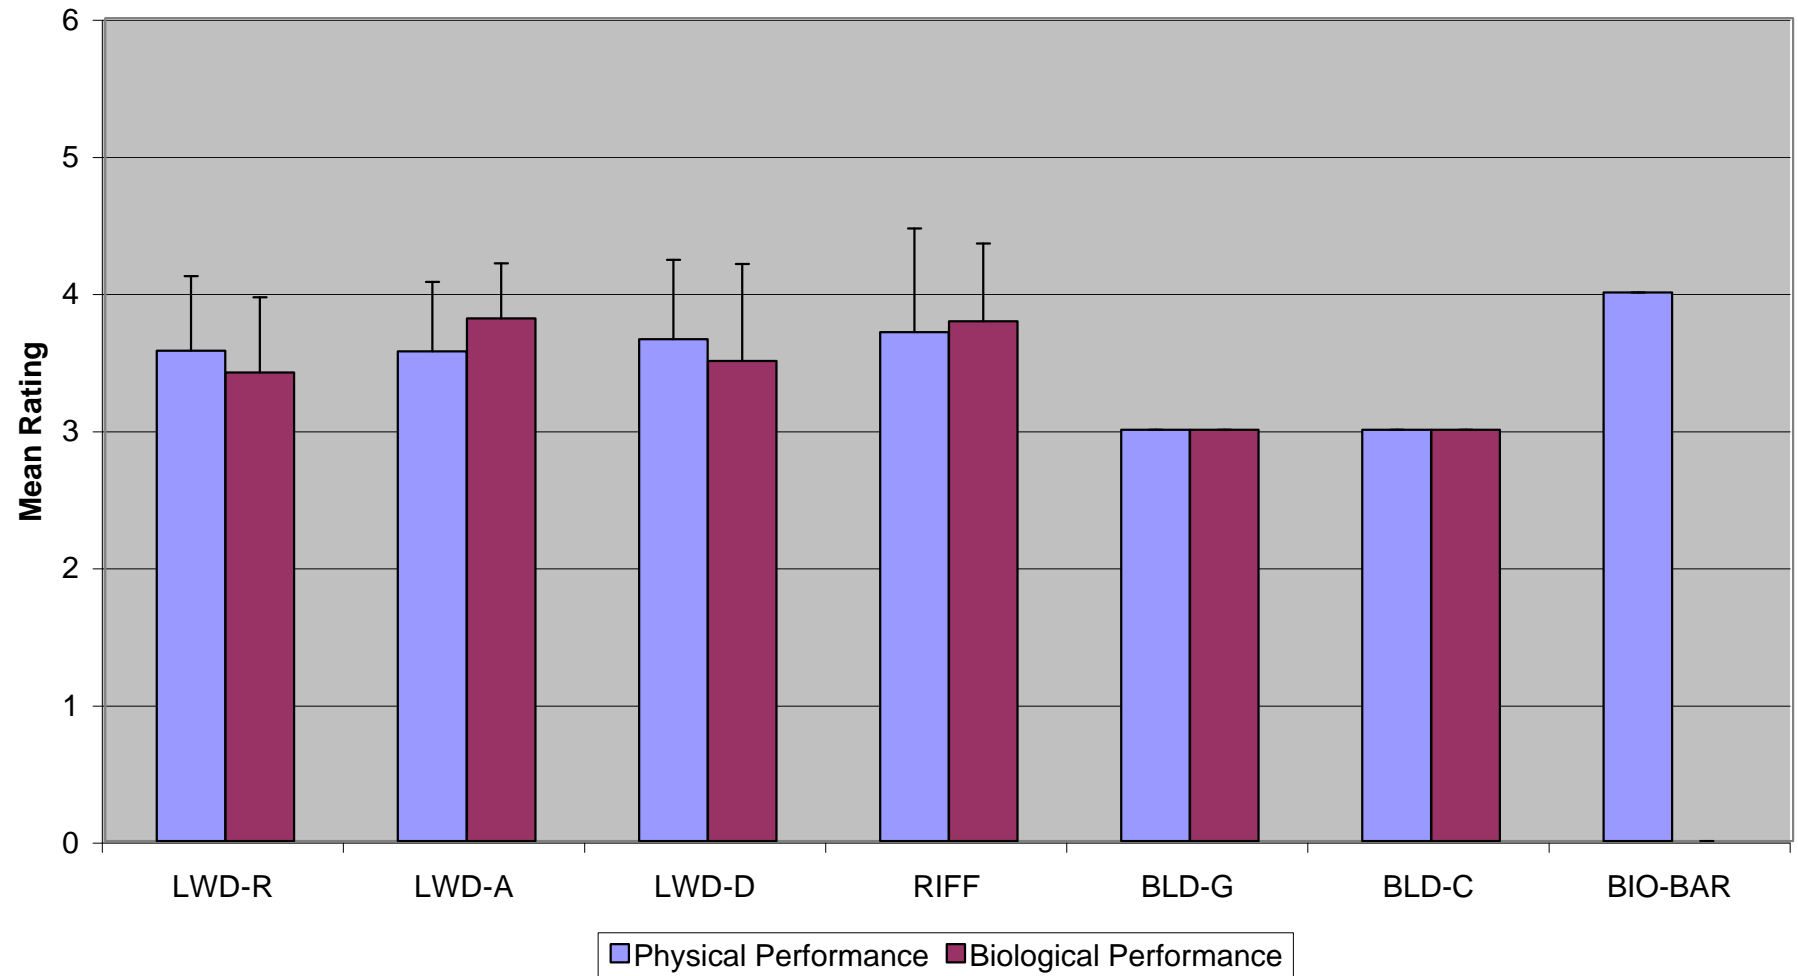
**Figure 4. Summary of performance ratings for individual structure types  
( $\pm$  one standard deviation)**

The 59 structures represented eight structure categories as follows: revetments (LWD-R, n = 20), lateral jams (LWD-A, n = 21), deflectors (LWD-D, n = 3), riffles (RIFF, n = 7), boulder groynes (BLD-G, n = 3), boulder clusters (BLD-C, n = 2), bar stabilizers (BIO-BAR, n = 2) and rock weir (RWEIR, n = 1). Physical and biological performance for each structure category is summarized in Table 3 and illustrated in Figure 4. Although small sample size precludes meaningful discussion, it is interesting to note that highest biological performance occurred among the lateral jam structures.

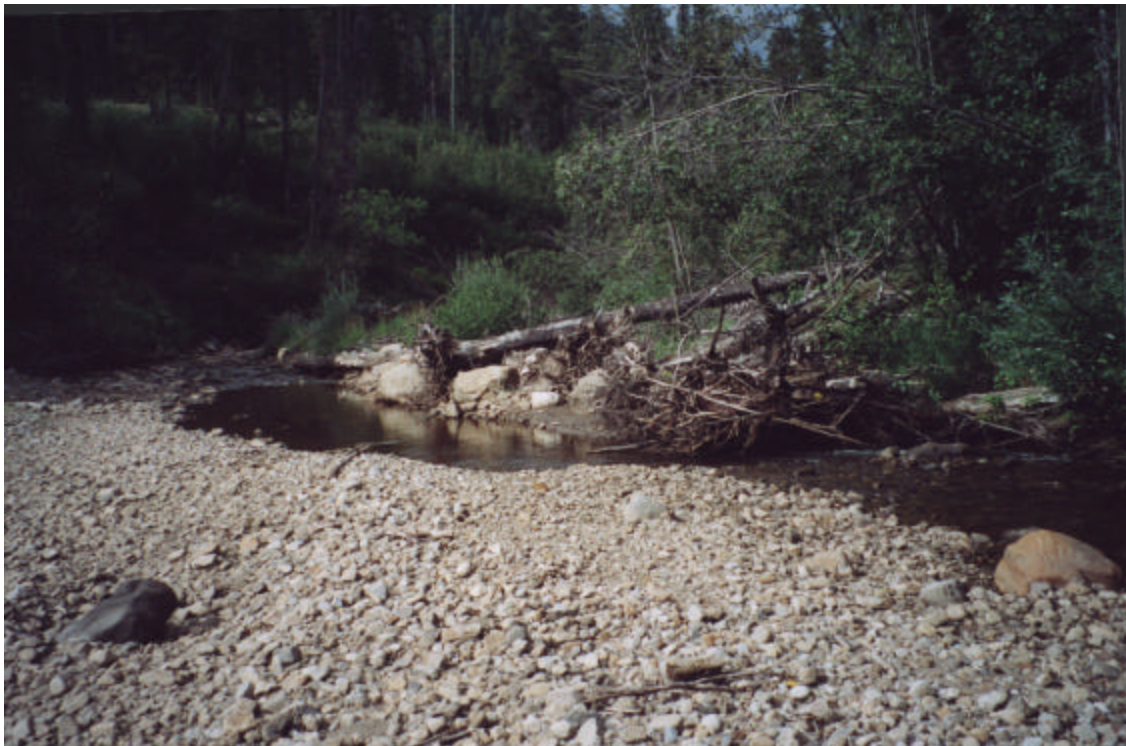
Photo 1. Downstream view of LWD-R (LBJ5) on RB West Kobes Creek at chainage 0+260 m (N 56°19.944 W 122°23.999). Photo ref. 154-23A, 24 Sept 2001.

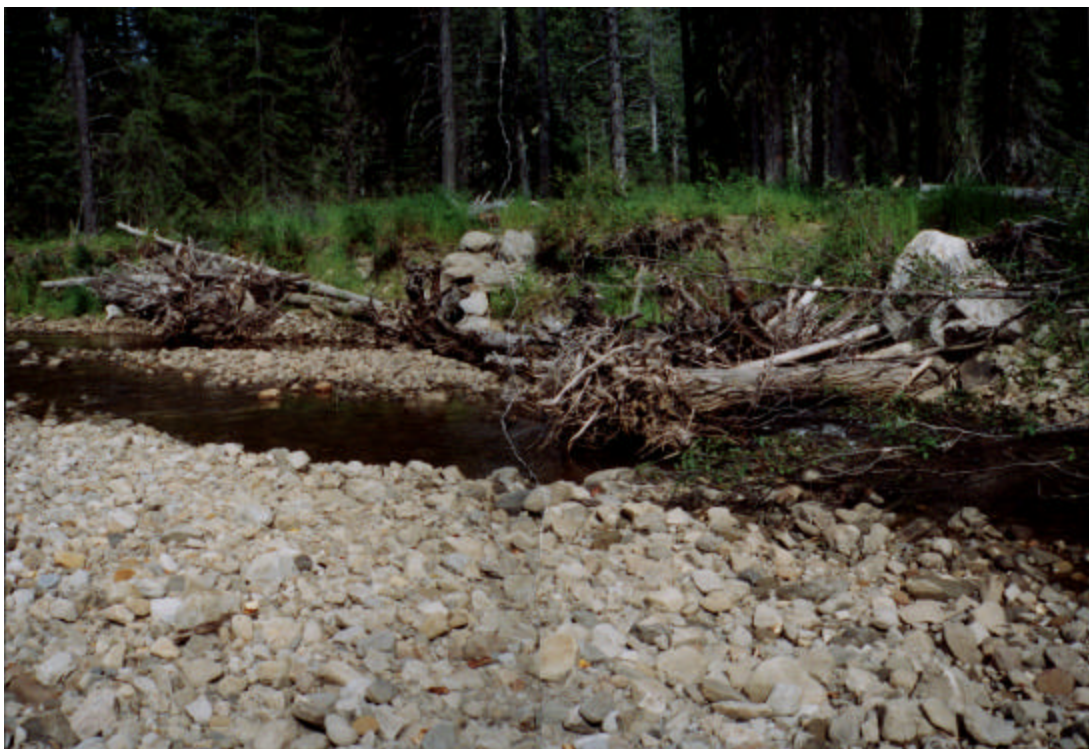
Photo 2. Downstream view of LWD-A (LT7) on RB West Kobes Creek at chainage 0+340 m (N 56°19.900 W 122°24.001). Photo ref. 154-20/21A, 24 Sept 2001.
