Clisbako River Restoration

Objectives

The objectives of this project were to create a more complex habitat for salmonids through the introduction of large woody debris (LWD) structures and the construction or improvement of rock riffles.

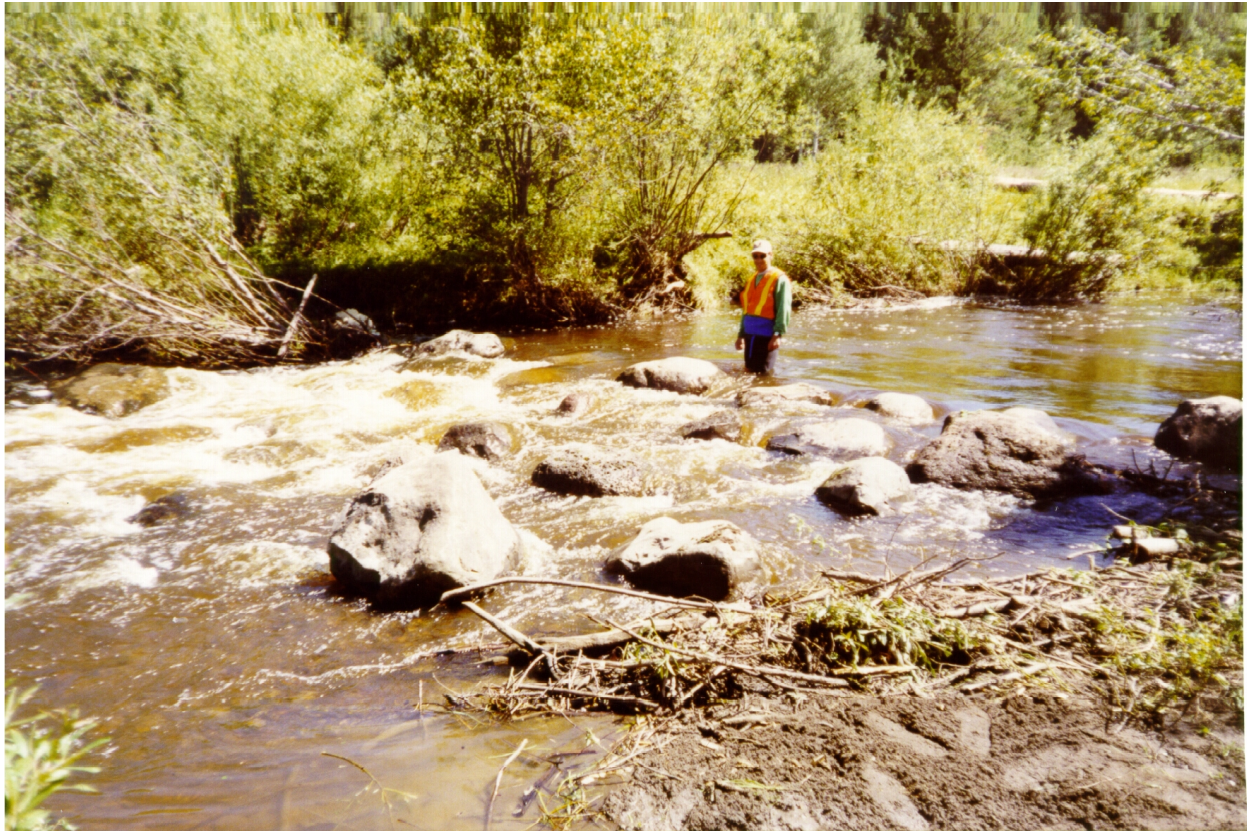
Figure 1: Rock riffle construction on the Clisbako River, Cariboo Region.

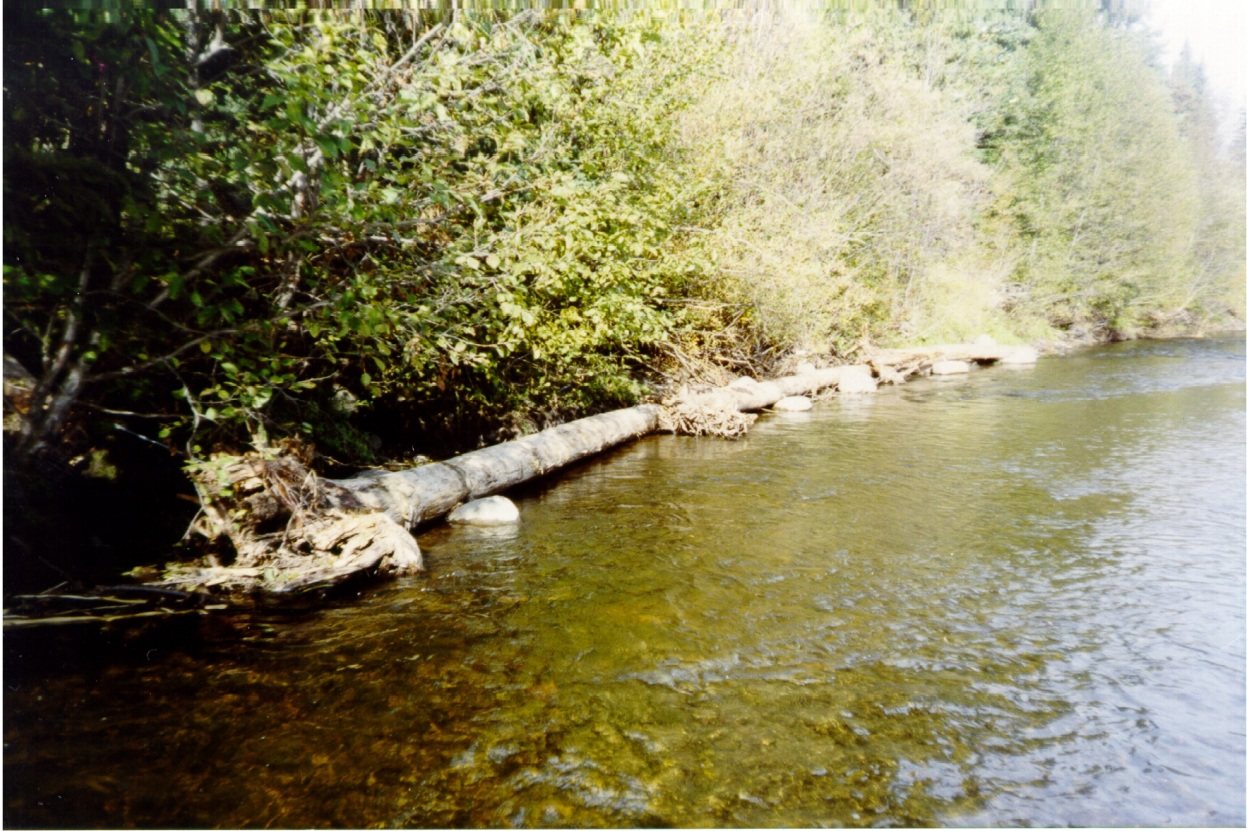
Figure 2: Lateral LWD placement on the Clisbako River.
