# **Fontaine Creek Restoration**

# **Objective:**

Project objectives were to restore natural thalweg function, stabilize stream banks and increase stream cover through restoration of LWD to selected reaches of Fontaine, Font, and Horan Creek's. Methods included LWD, rootwad and boulder cluster placement.

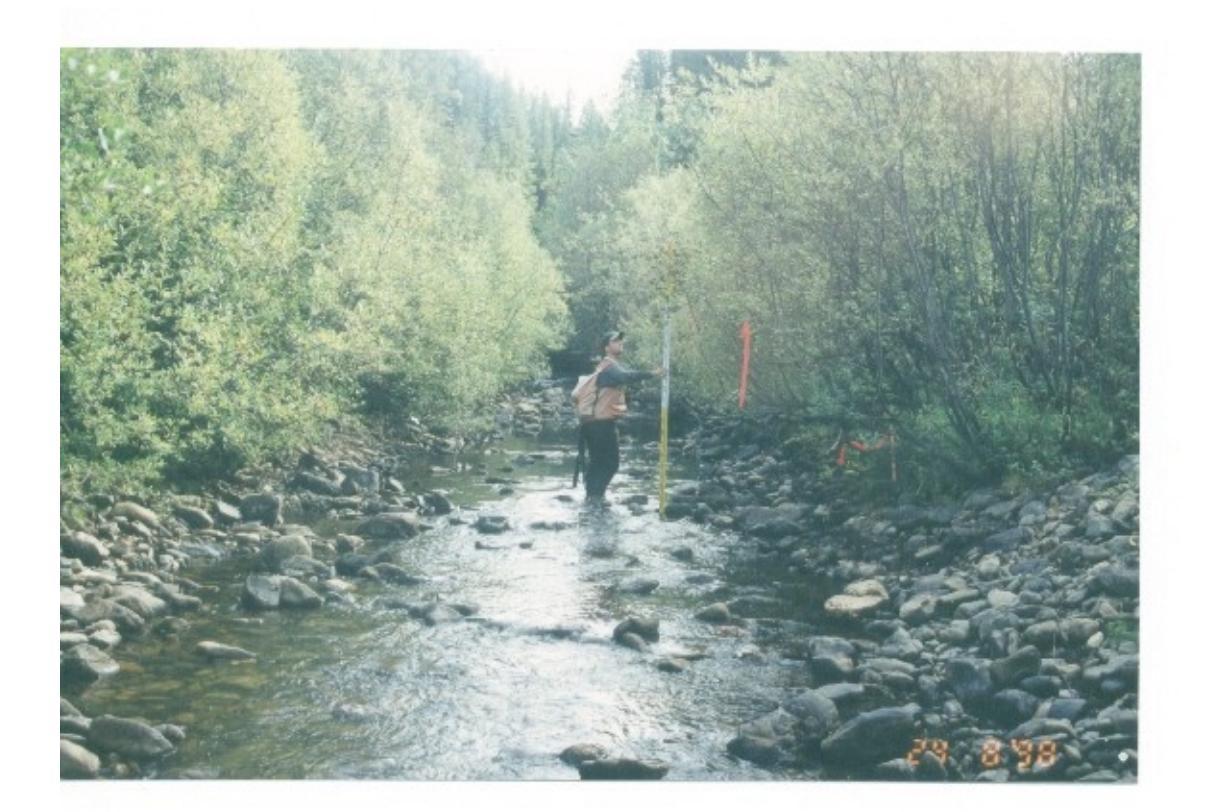
In 1998, G3 conducted a Level 2 FAHP at the five sites specified by MELP and WFM as requiring fish habitat restoration. LWD abundance and distribution was limited at sites, limiting primary pool distribution and size and fish habitat cover. Bank instability was noted at three sites, and 150 m of channelization had occurred at another site.

## Figure 1: Fontaine Creek Site E: Upstream view of channelized stream section prior to restoration.

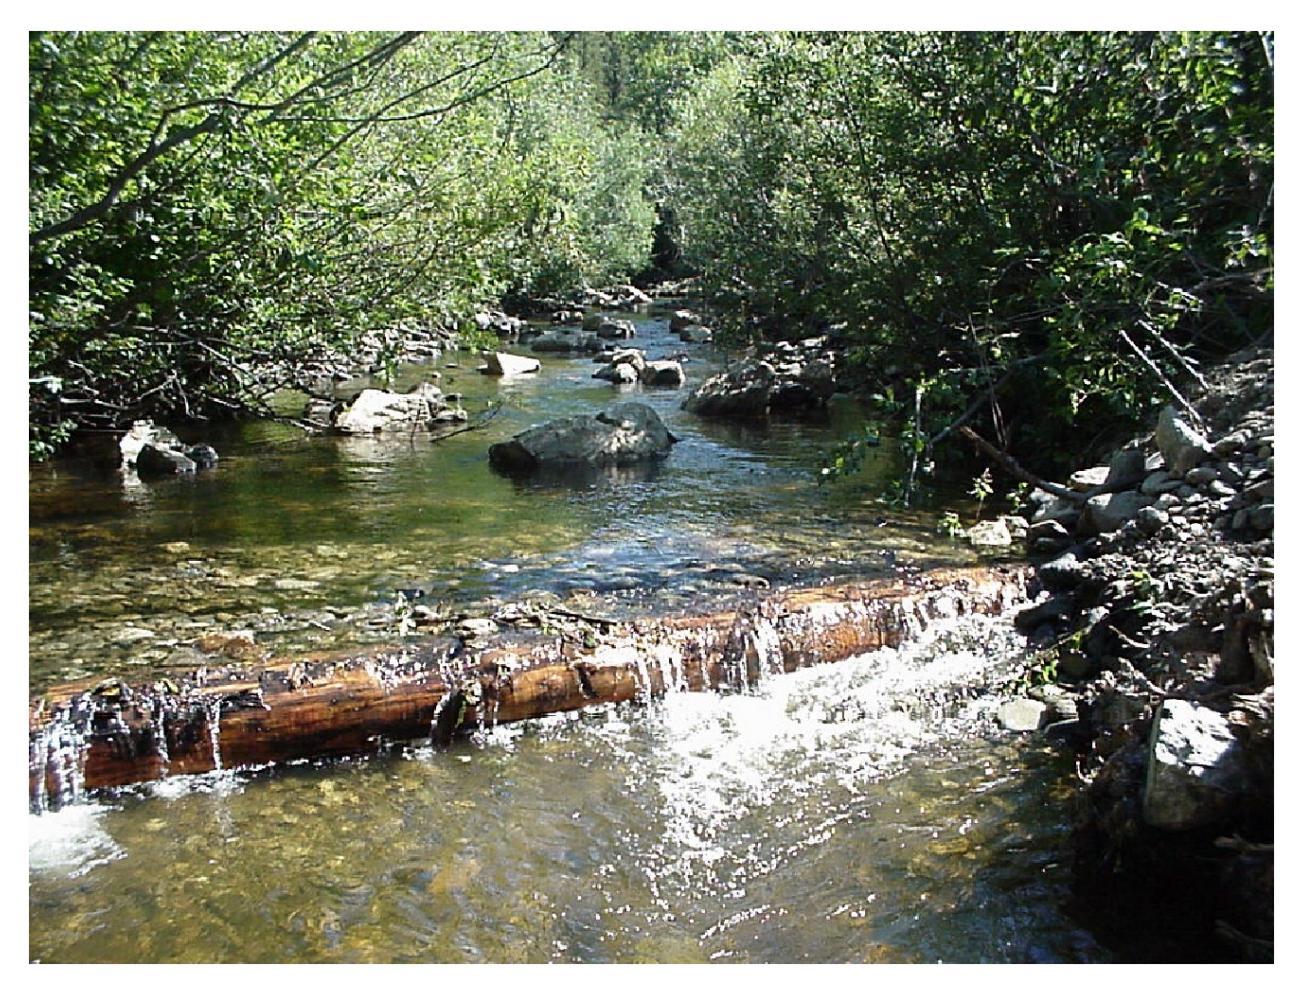
Figure 2: Fontaine Creek Site E: Upstream view of LWD scour log and boulder clusters placed to restore pool habitat.
