## Removing Fish Barriers – Crescent Creek Culverts

To remove the fish barrier on Crescent Creek created by the culverts under the 24P Road.

Crescent Creek, a Tributary of the Willow River

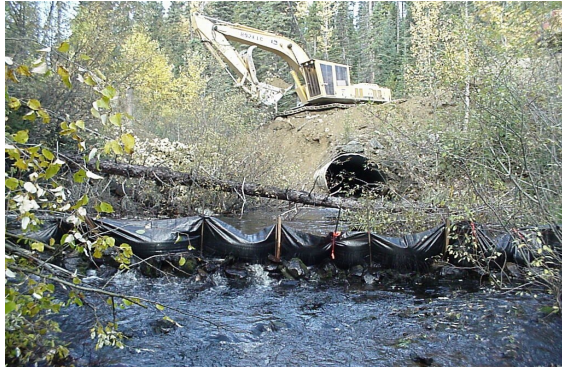
**Figure 1 Silt fence downstream**

Remediation of this problem was identified as a priority by Ministry of Environment staff several years ago. Approval to remove the culverts and replace them with a 17 m bridge was given in the summer of 1999. Because of the inability to have design work and fabrication done in time to install the bridge in the July-August fish window, approval was given by MELP and DFO for installation in early October. A sediment fence was installed downstream of the culverts, and a fine-mesh net

was installed upstream of the culverts. Electroshocking was done between the barriers, and collected fish were released downstream of the sediment fence.

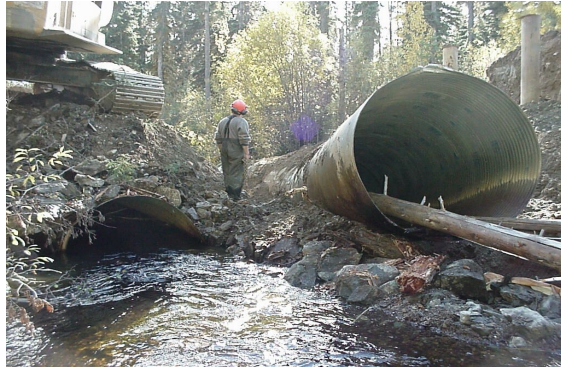
**Figure 2 Diversion into one culvert**

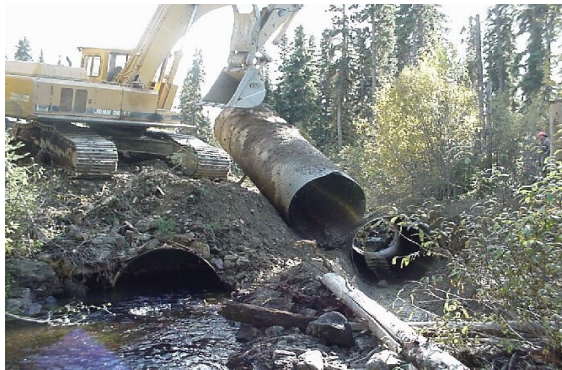
**Figure 3 Lifting first culvert**

Two 60 inch (1525mm) culverts were removed and replaced with a 17 m prefabricated concrete bridge. The bridge is mounted on steel piles. The stream channel and banks were lined with rip-rap to prevent scourings and to mimic, as closely as possible, a natural stream bed.

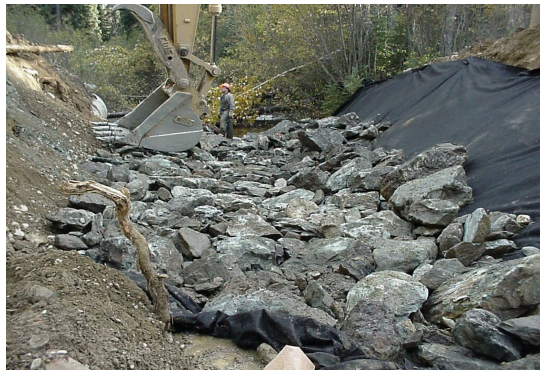
**Figure 4 Rip-rap placed on top of geotextile**

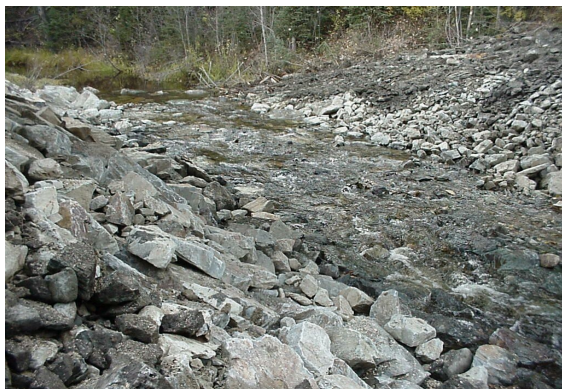
**Figure 5 Prepared stream bed after culvert removed**

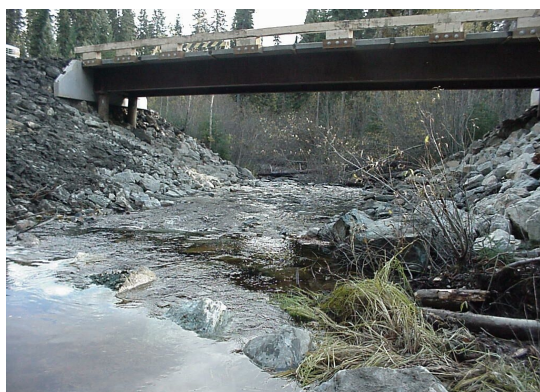
**Figure 6 Bridge installed, channel completed**
