Homathko / Mosley Rivers Restoration

Project objectives were to stabilize stream banks and increase riparian vegetation and stream cover of selected reaches of the Homathko River. Methods included bioengineering of stream banks, riparian vegetation planting, and placement of LED/rootwad revetments.

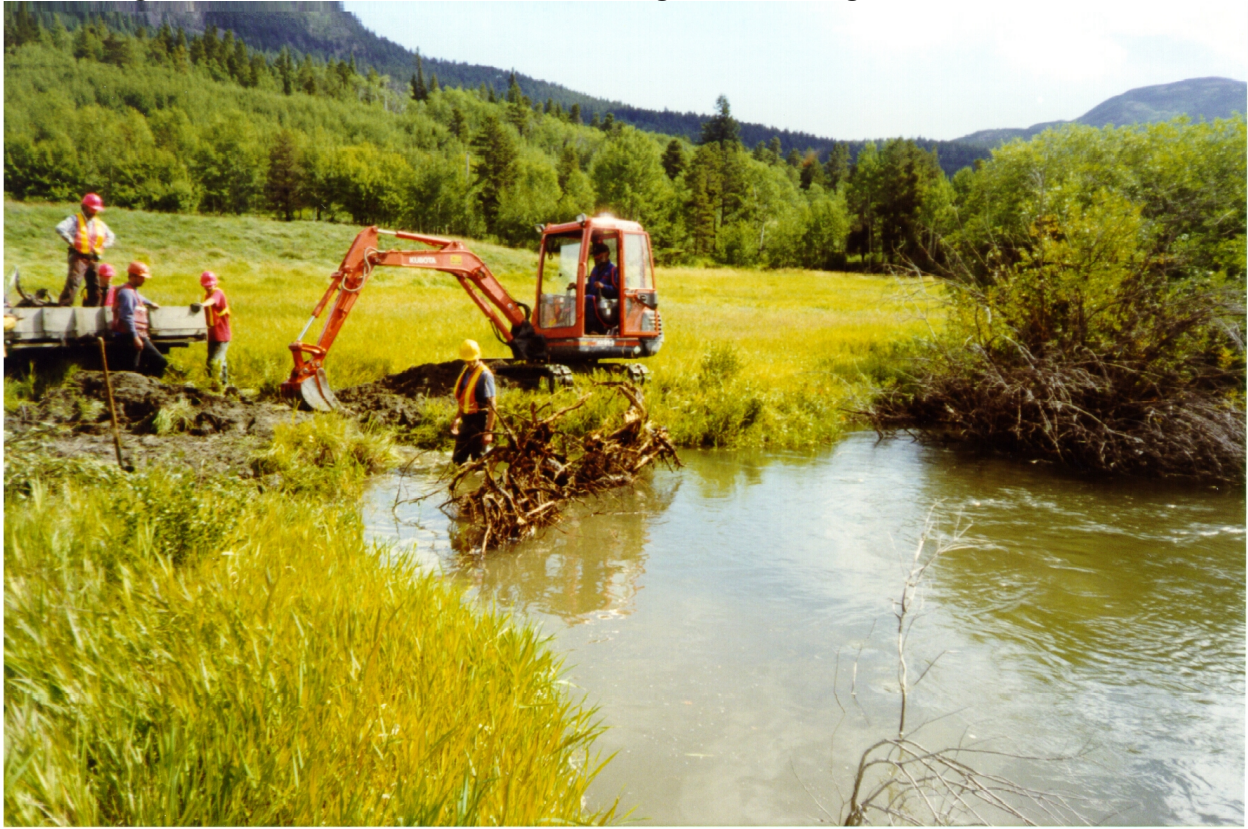
Figure 1: Installation of LWD revetement during late summer high flow, Homathko River.

An Environmental Youth Team (E-Team) provided labour support for bioengineering, riparian planting and structure placement. A Kubota KX91-2 rubber track excavator was used for rootwad and revetment placement. Reaches 4,5 and 11 were selected for restoration activities.

Reach4: Restoration included placing LWD / rootwad revetments at 10 sites, including bioengineering at nine sites, and two areas for riparian tree planting. In total 19 rootwads and 18 tree revetments (eight with rootwads) were placed in the river channel, approximately 170 me of stream bank was revegetated with live stakes, seven facines were installed and approximately 1,500m² planted with 700 tree stems.
