# Assessment of the Vanderhoof South Drinking Water Supply: Source Wa- ter Characteristics

James Jacklin, September 2005

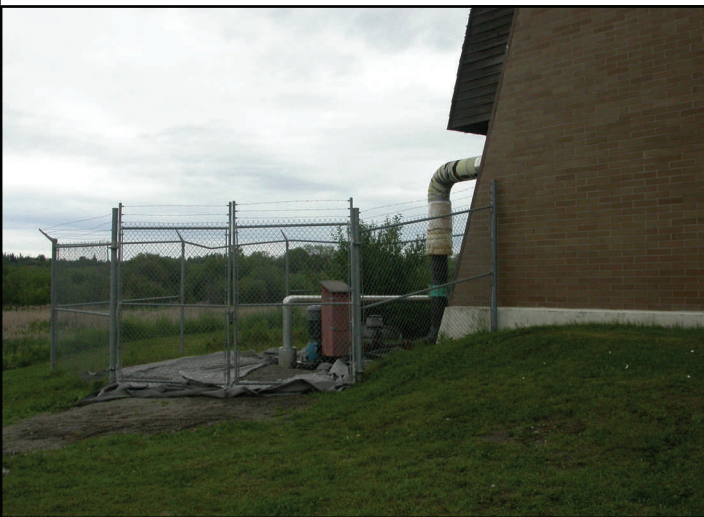
Plate 1. A view of the Vanderhoof South pump house where the raw water samples were collected.

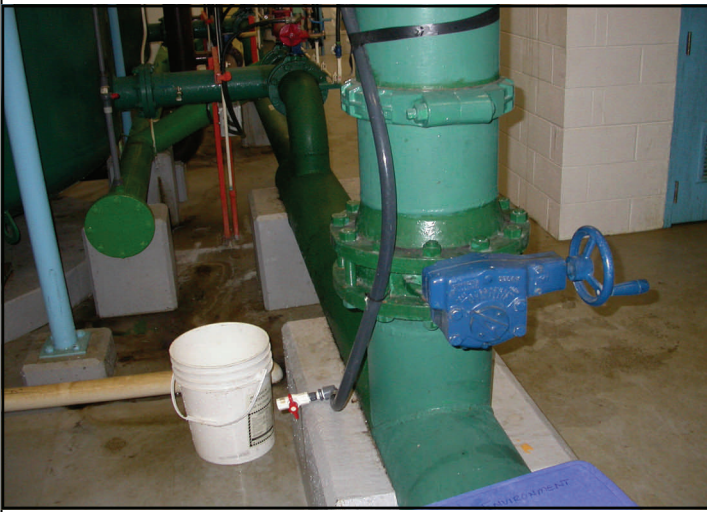
An experienced B.C. Environment staff member collected water samples in laboratory certified polyethylene bottles for a variety of chemical and bacterial analyses. Representative grab samples were collected from the raw water tap (Plate 2) inside the pump house (EMS site E257074).

Plate 2. The raw water tap inside the Vanderhoof pump house.
