WATER QUALITY MONITORING AGREEMENT

WATER QUALITY ASSESSMENT OF Elk River AT HIGHWAY 93 NEAR ELKO (1968 – 2005)

Prepared by:
L. G. Swain, P. Eng.
B.C. Ministry of Environment

March 2007

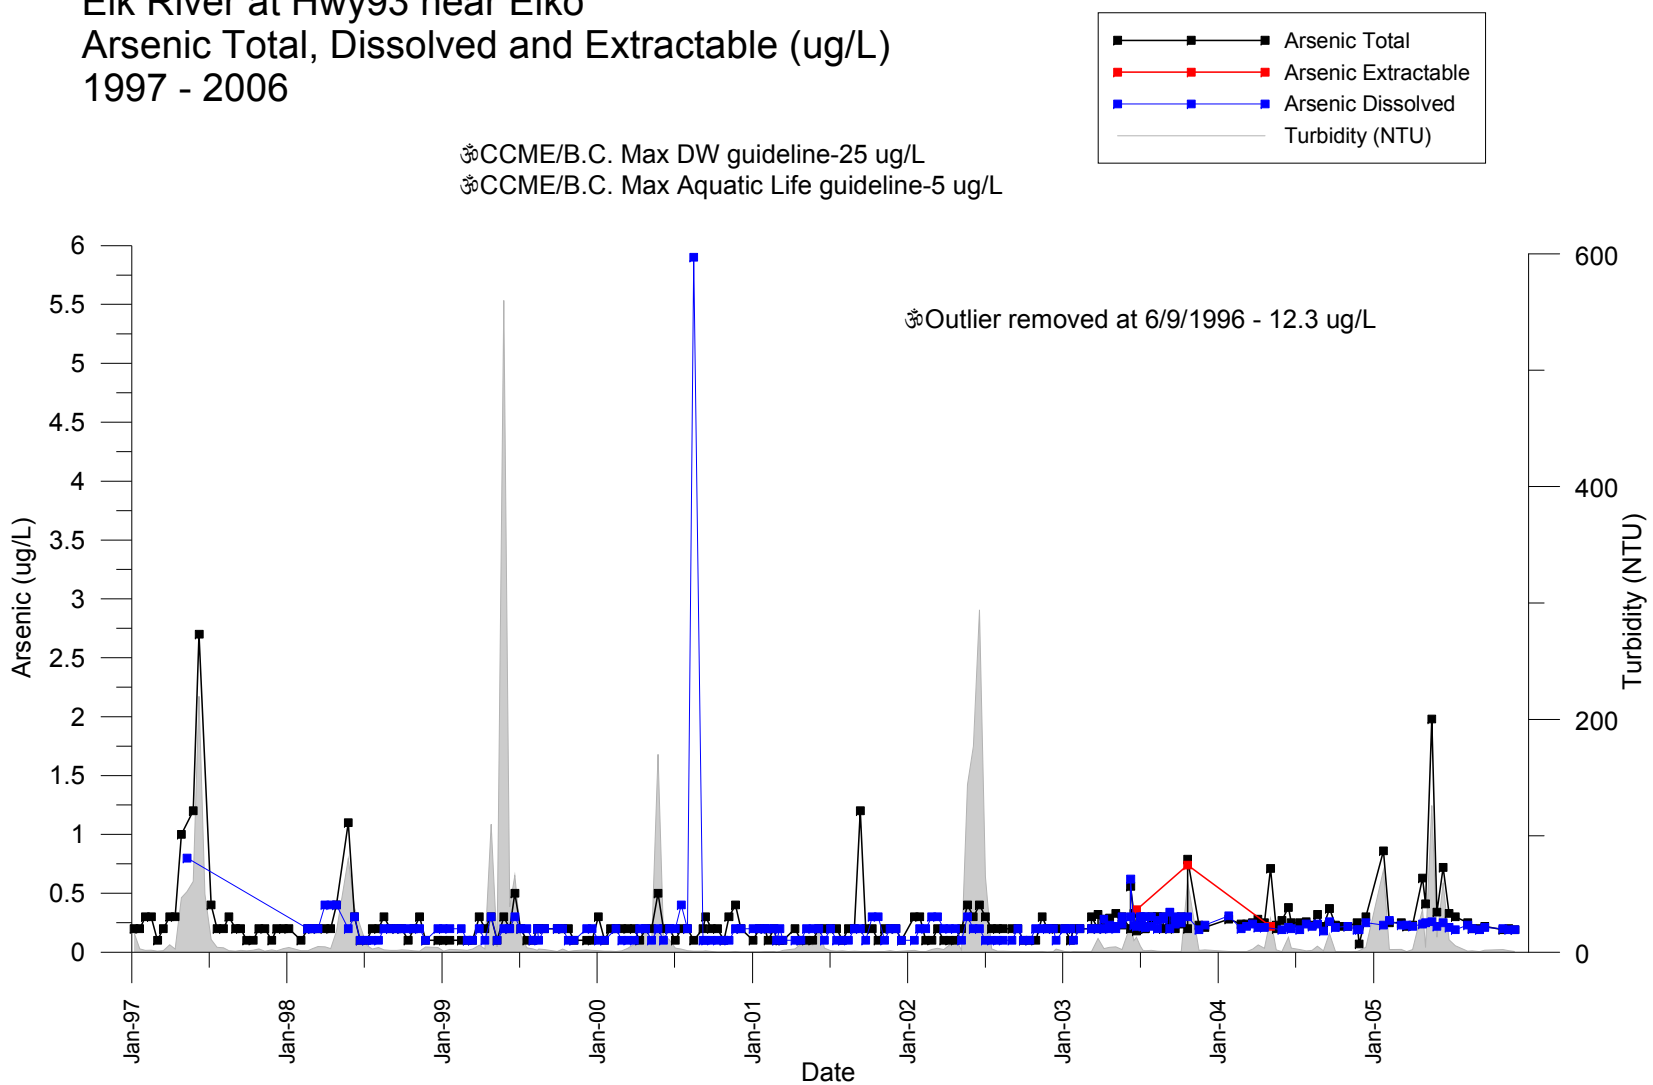
Figure 9
 Elk River at Hwy93 near Elko
 Arsenic Total, Dissolved and Extractable (ug/L)
 1997 - 2006

Arsenic (Figures 8 and 9) values were generally below the source water guideline for drinking water supplies of 5 µg/L; however one dissolved value (omitting the outlier) did exceed the guideline. Considering the fact that no other total or dissolved values have exceeded 3.5 µg/L since 1984, this one high value is questionable.

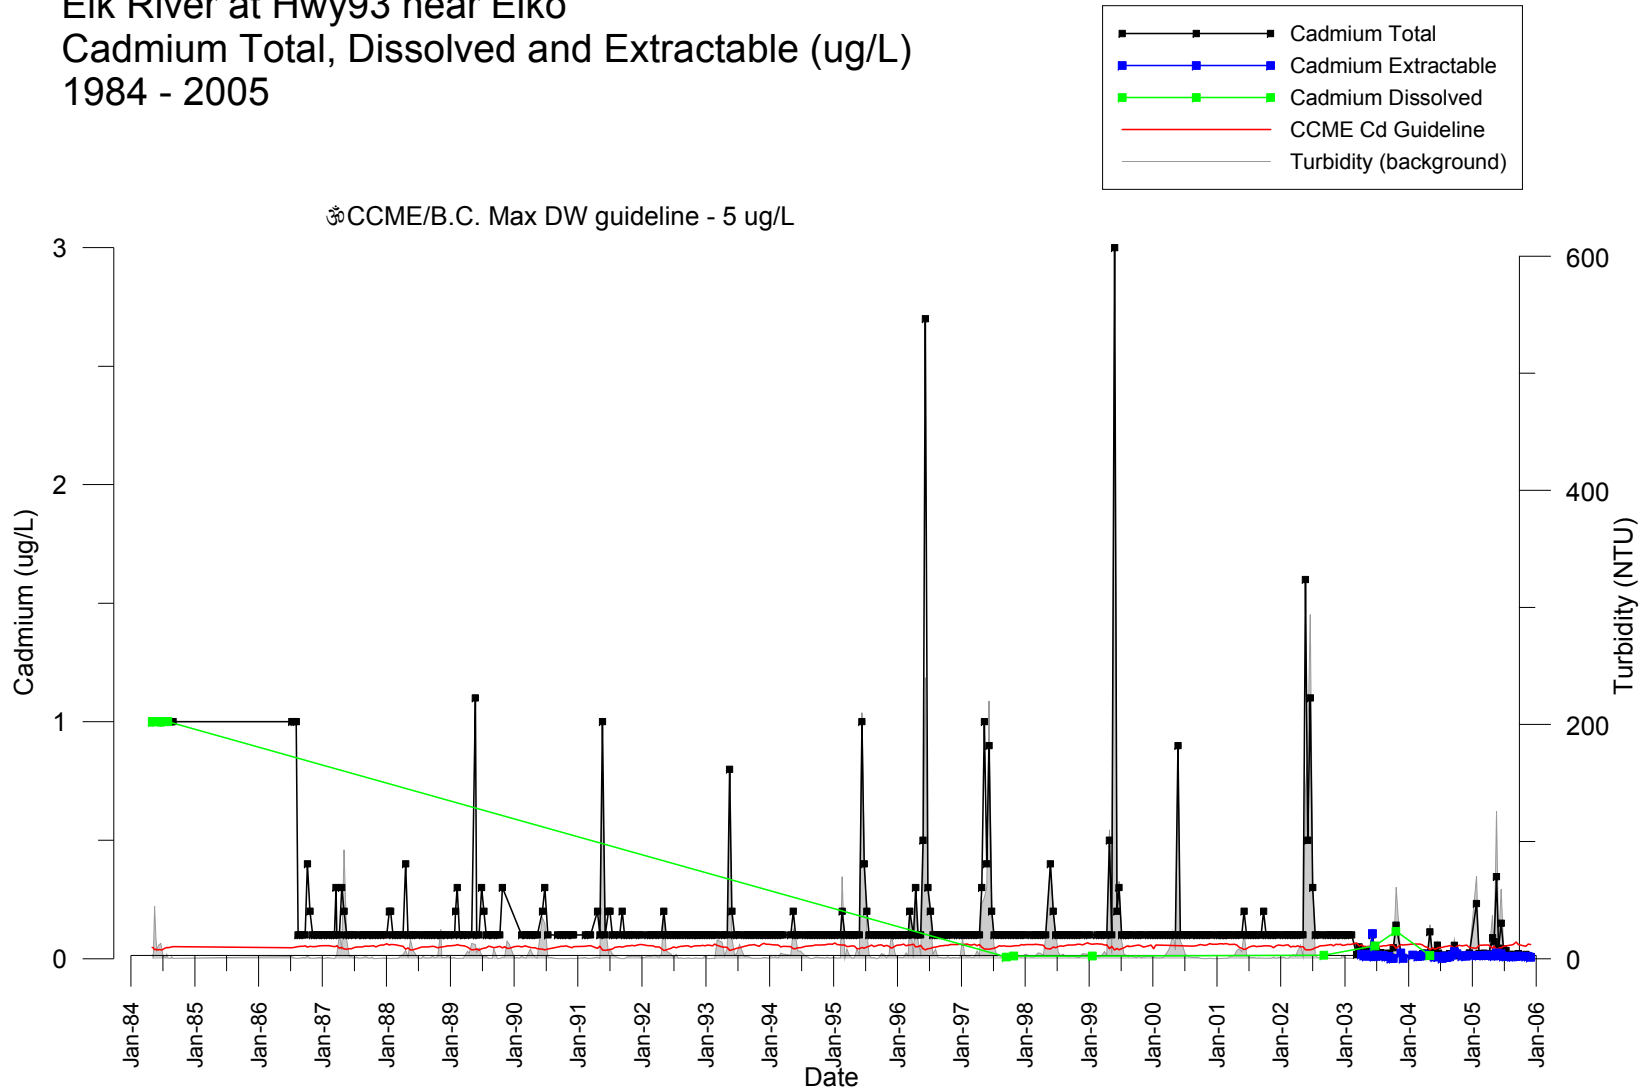
Figure 17
 Elk River at Hwy93 near Elko
 Cadmium Total, Dissolved and Extractable (ug/L)
 1984 - 2005

Cadmium (Figures 17 and 18) values occasionally exceeded the guideline to protect aquatic life that is based on water hardness. Most values that exceeded the guideline were total cadmium values, which were correlated with turbidity, where the cadmium would be in particulate form and not biologically available.

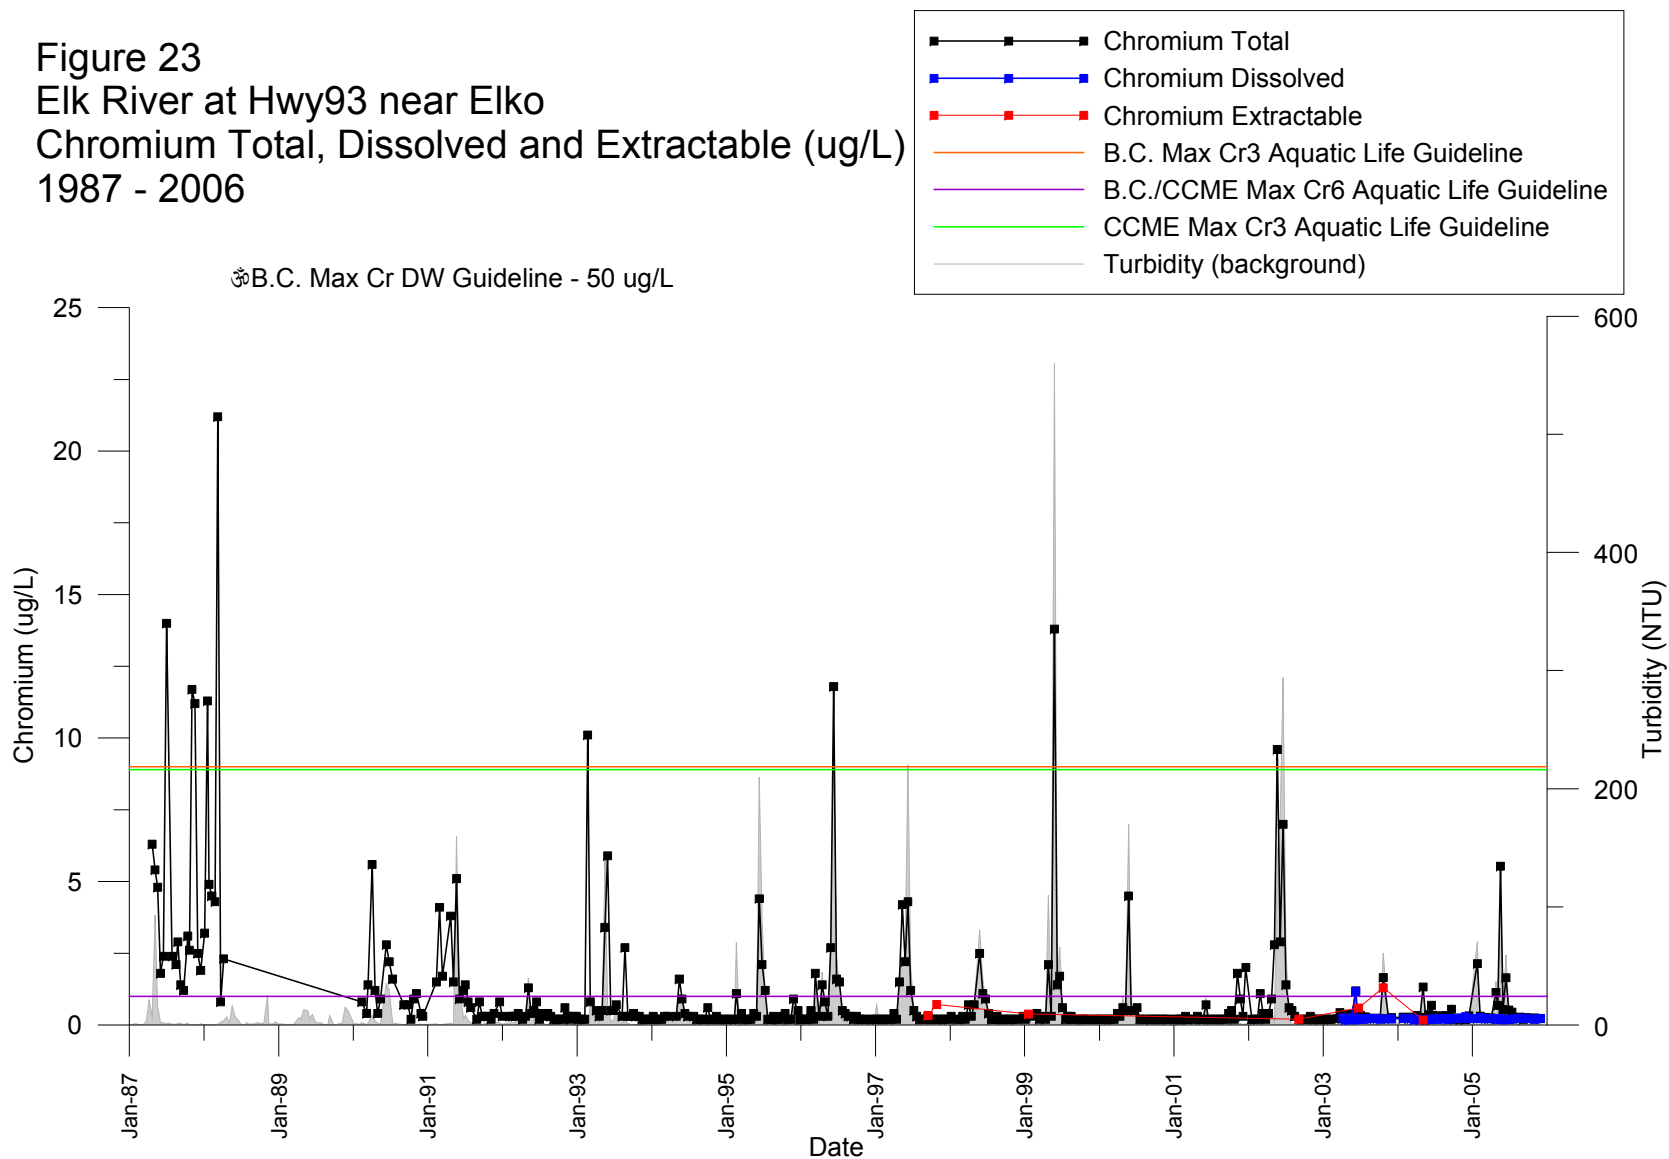
Figure 23
 Elk River at Hwy93 near Elko
 Chromium Total, Dissolved and Extractable (ug/L)
 1987 - 2006

Chromium (Figures 23 and 24) values should be measured in hexavalent and trivalent forms for direct comparison to guidelines; however, these tests are not available. Total chromium, which is correlated with turbidity concentrations, occasionally exceeded both the trivalent and hexavalent guidelines; however, the chromium would be in particulate form and would not be biologically available. Virtually all extractable and dissolved chromium values met both guidelines all the time.

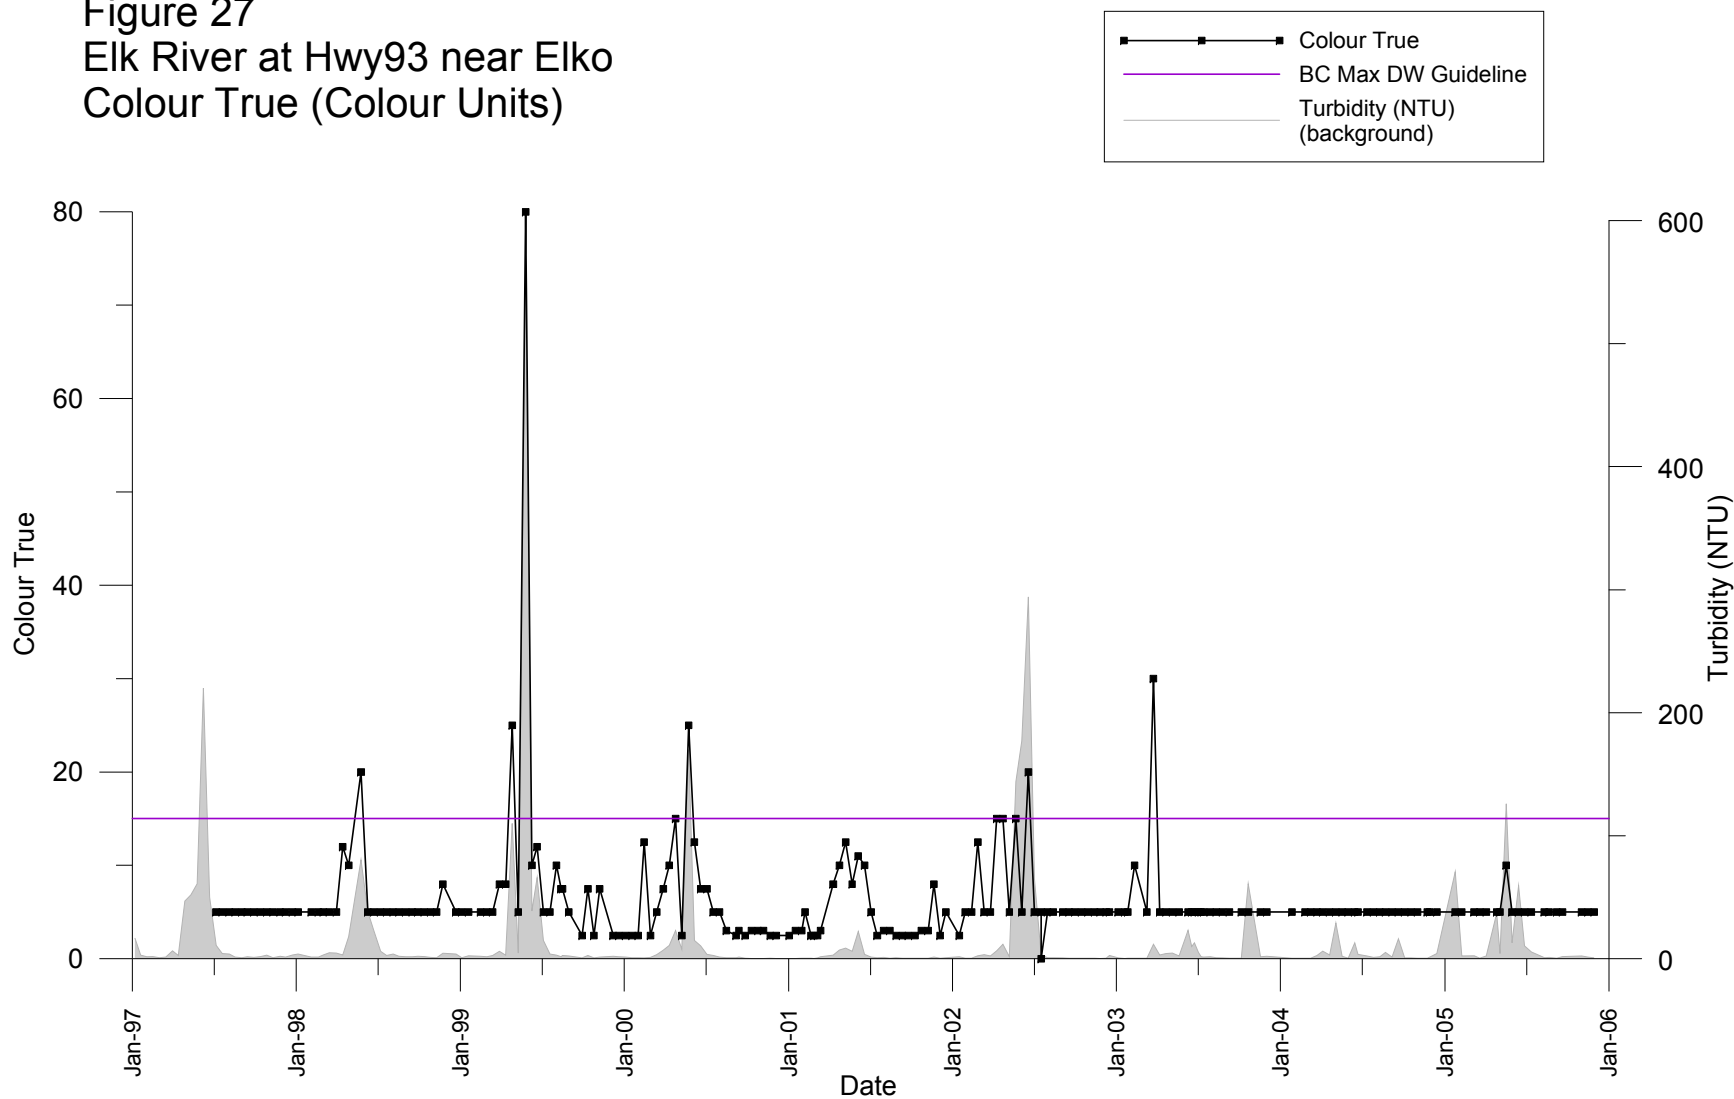
Figure 27
Elk River at Hwy93 near Elko
Colour True (Colour Units)

True colour (Figure 27) values generally met the guideline for source waters used for drinking although there were some occasions when the guideline was exceeded. The guideline is based on aesthetics of the water supply, not health considerations.

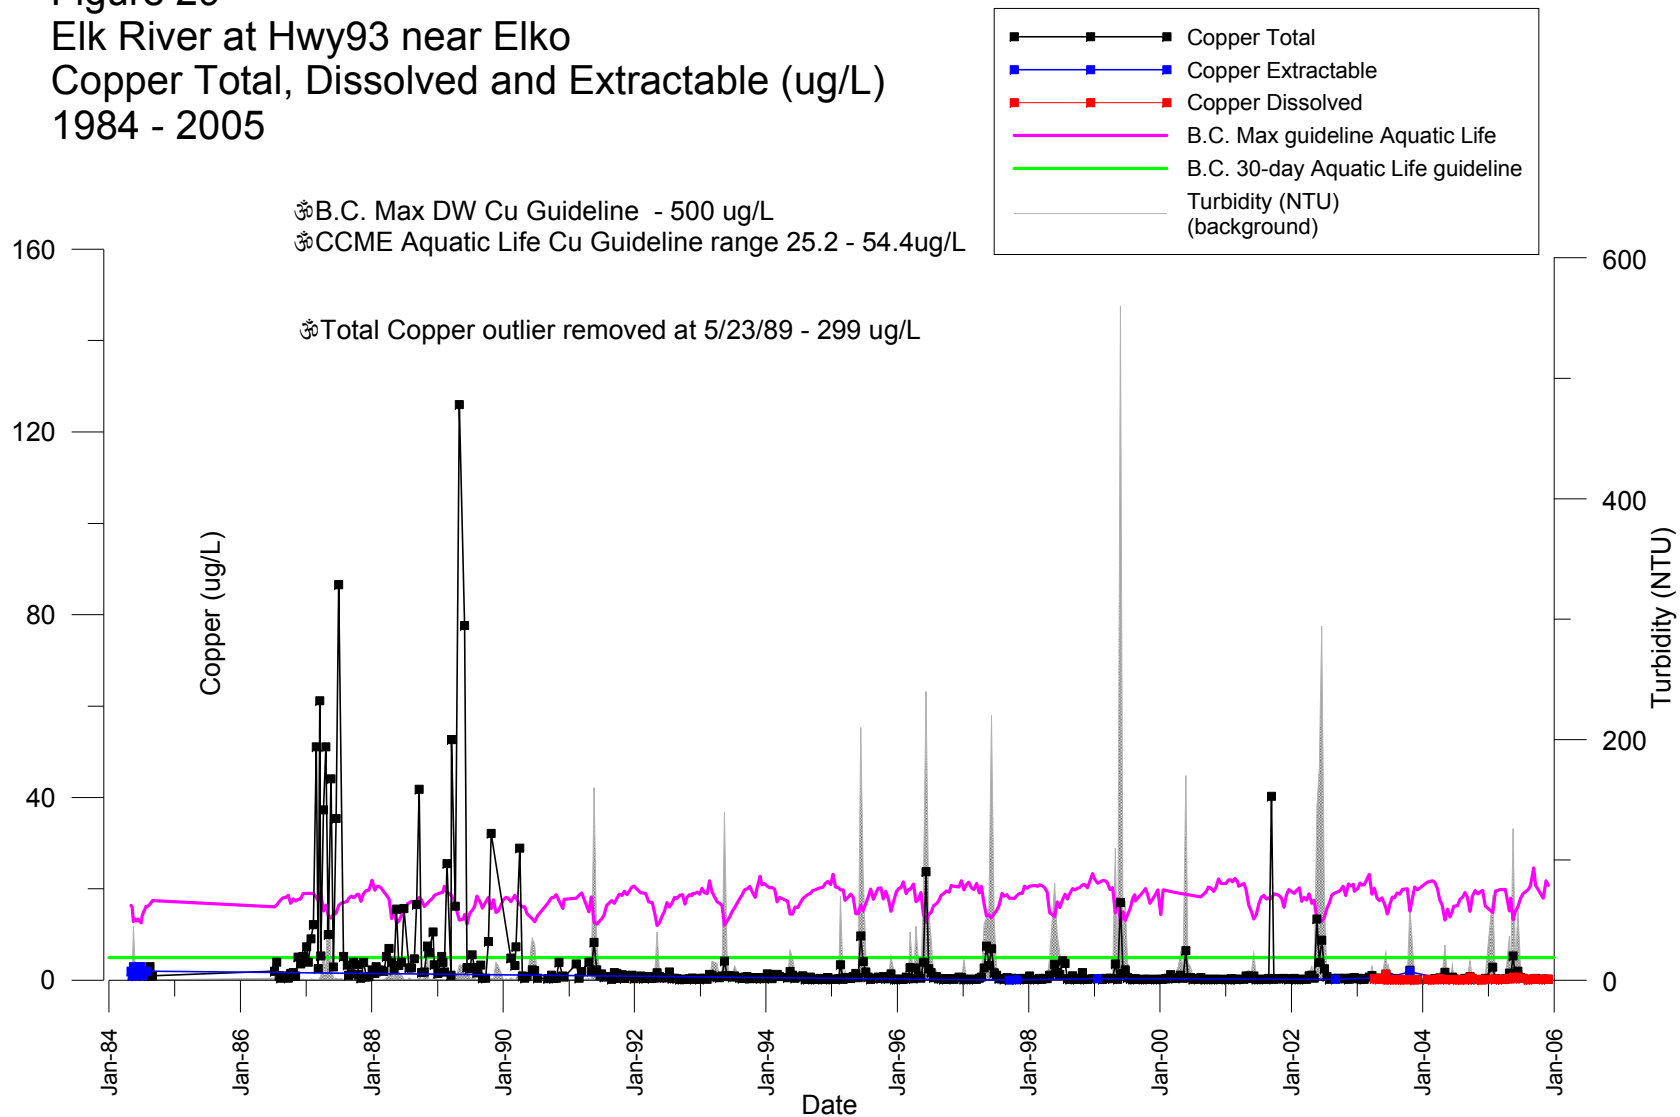
Figure 29
 Elk River at Hwy93 near Elko
 Copper Total, Dissolved and Extractable (ug/L)
 1984 - 2005

Copper (Figures 29 and 30) concentrations were correlated with turbidity values and total values sometimes exceeded the B.C. guideline for maximum concentrations. This means that the copper was in particulate form and not likely biologically available. Between 2003 and 2005 all values (except one) were well below the 30-day mean B.C. guideline.

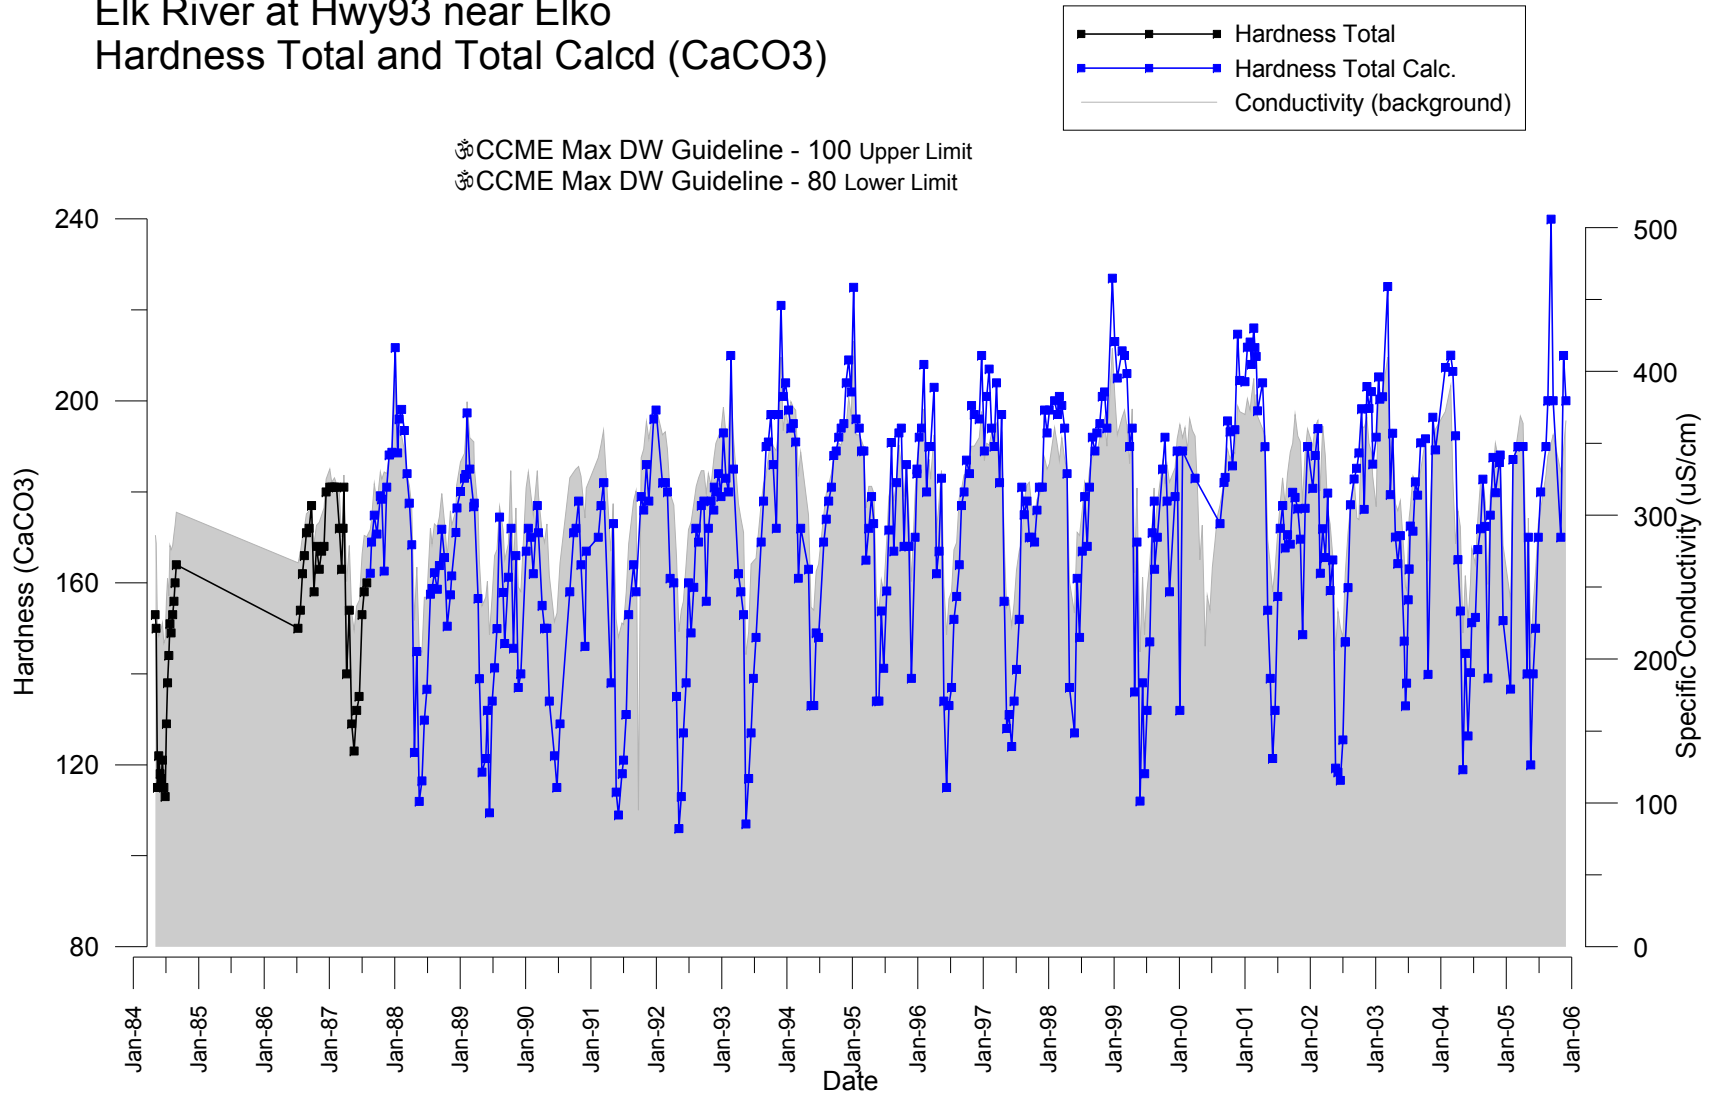
Figure 35
 Elk River at Hwy93 near Elko
 Hardness Total and Total Calcd (CaCO3)

Hardness (Figure 35) values exceeded the guideline for source waters, meaning that the water from the river should be softened for aesthetic considerations in households. Hardness values may have been increasing during the period of record.

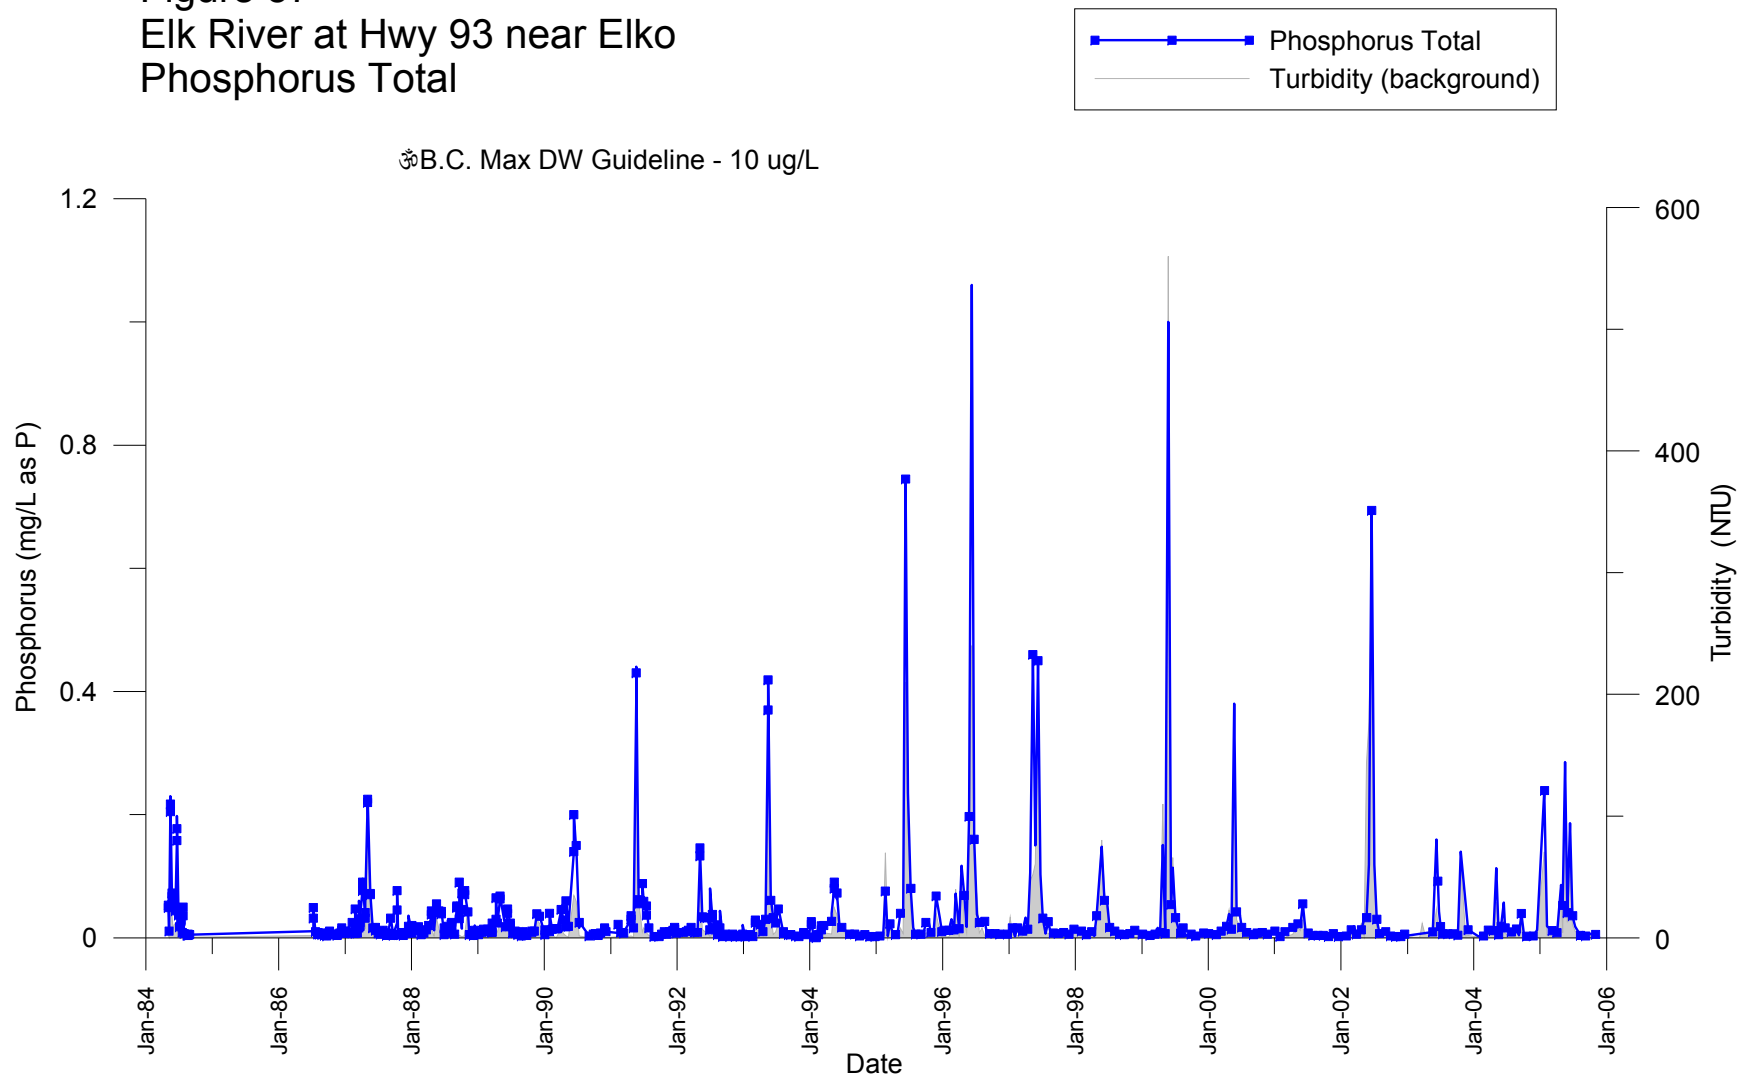
Figure 57
Elk River at Hwy 93 near Elko
Phosphorus Total

Phosphorus (Figure 57) often exceeds the source water for drinking water guideline of 0.01 mg/L, likely due to it being associated with higher turbidity concentrations. Drinking water supplies would need some form of treatment prior to the use of this water as a supply.

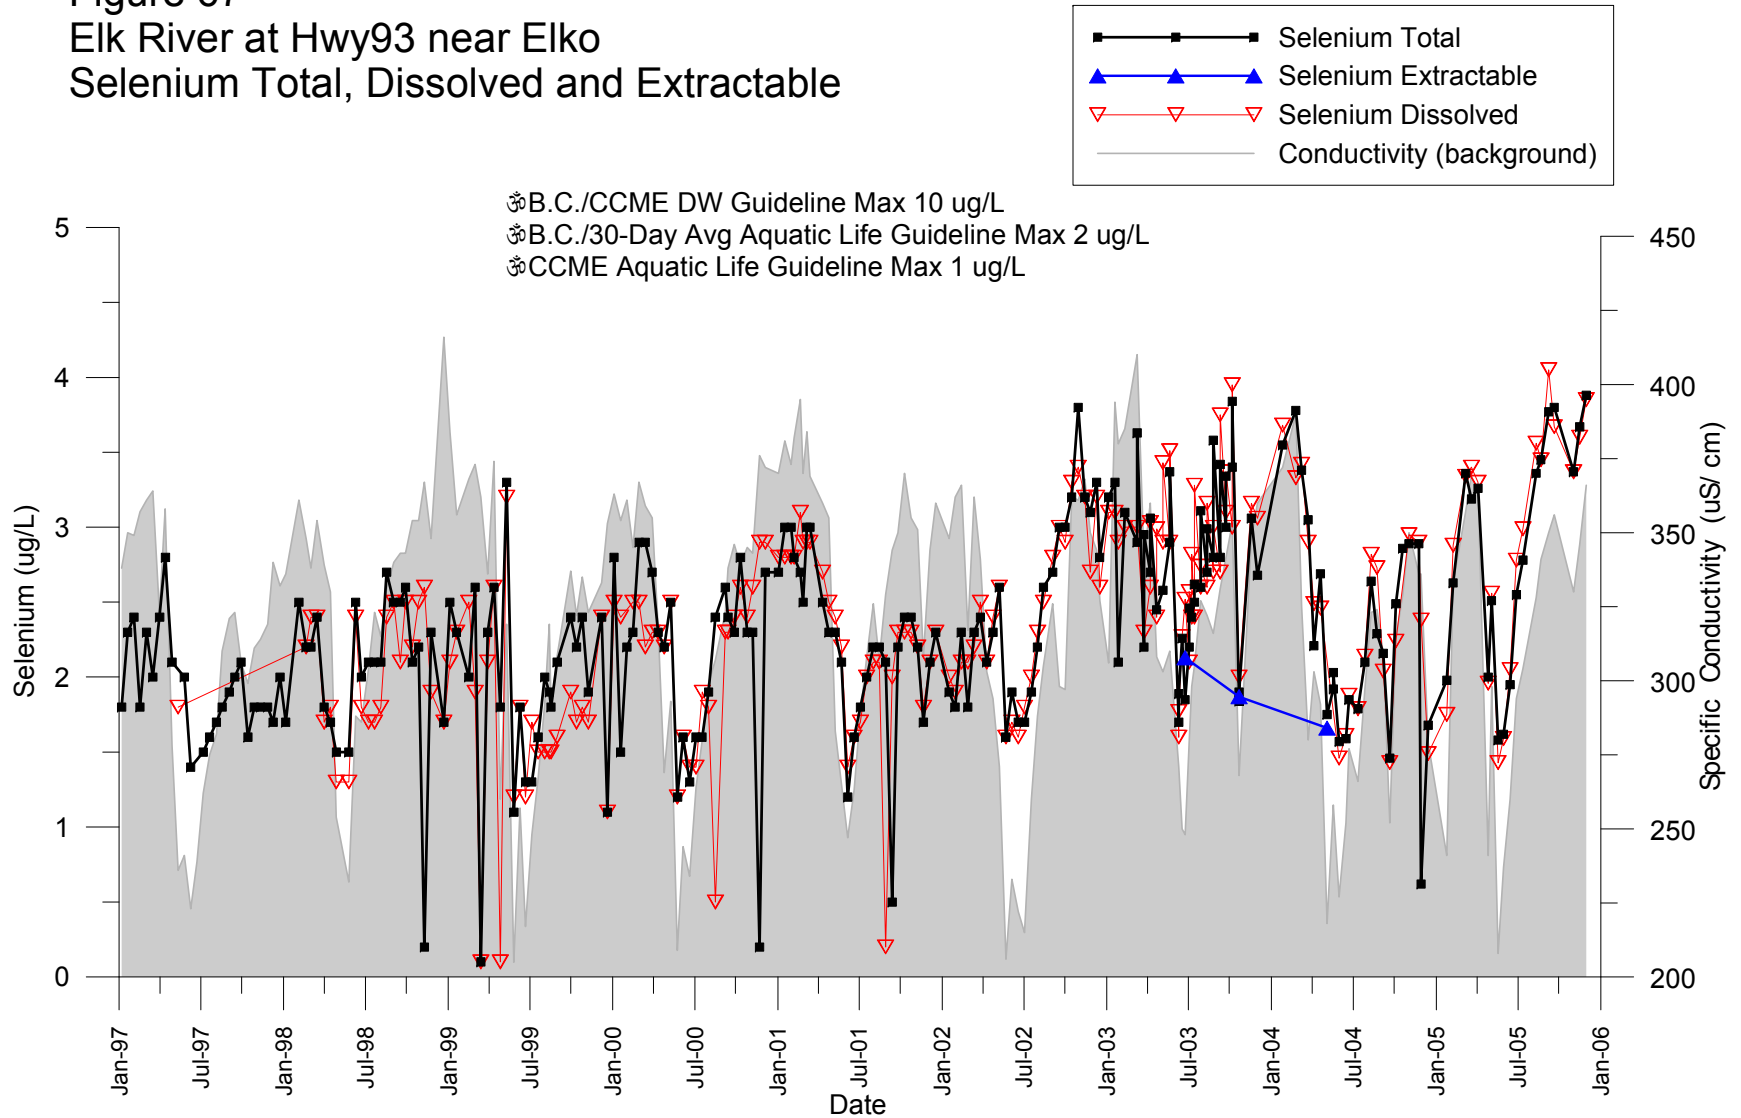
Figure 67
 Elk River at Hwy93 near Elko
 Selenium Total, Dissolved and Extractable

Selenium (Figure 67) values regularly exceeded the CCME guideline of 1.0 µg/L and the B.C. 30-day mean guideline of 2 µg/L. Values have increased considerably since 1984 but this increase appears to have slowed but continues to the end of 2005. This needs to be verified statistically.

- Selenium concentrations continue to show an increasing trend to higher concentrations and generally always exceeded both CCME and B.C. guidelines for the protection of aquatic life. Work is underway to determine whether these high levels are impacting aquatic life in the Elk River. These high values are associated with surface runoff from open pit coal mining.

We recommend monitoring be continued for the Elk River near Elko since selenium continues to increase and the success of any management steps undertaken can be tracked at this site.

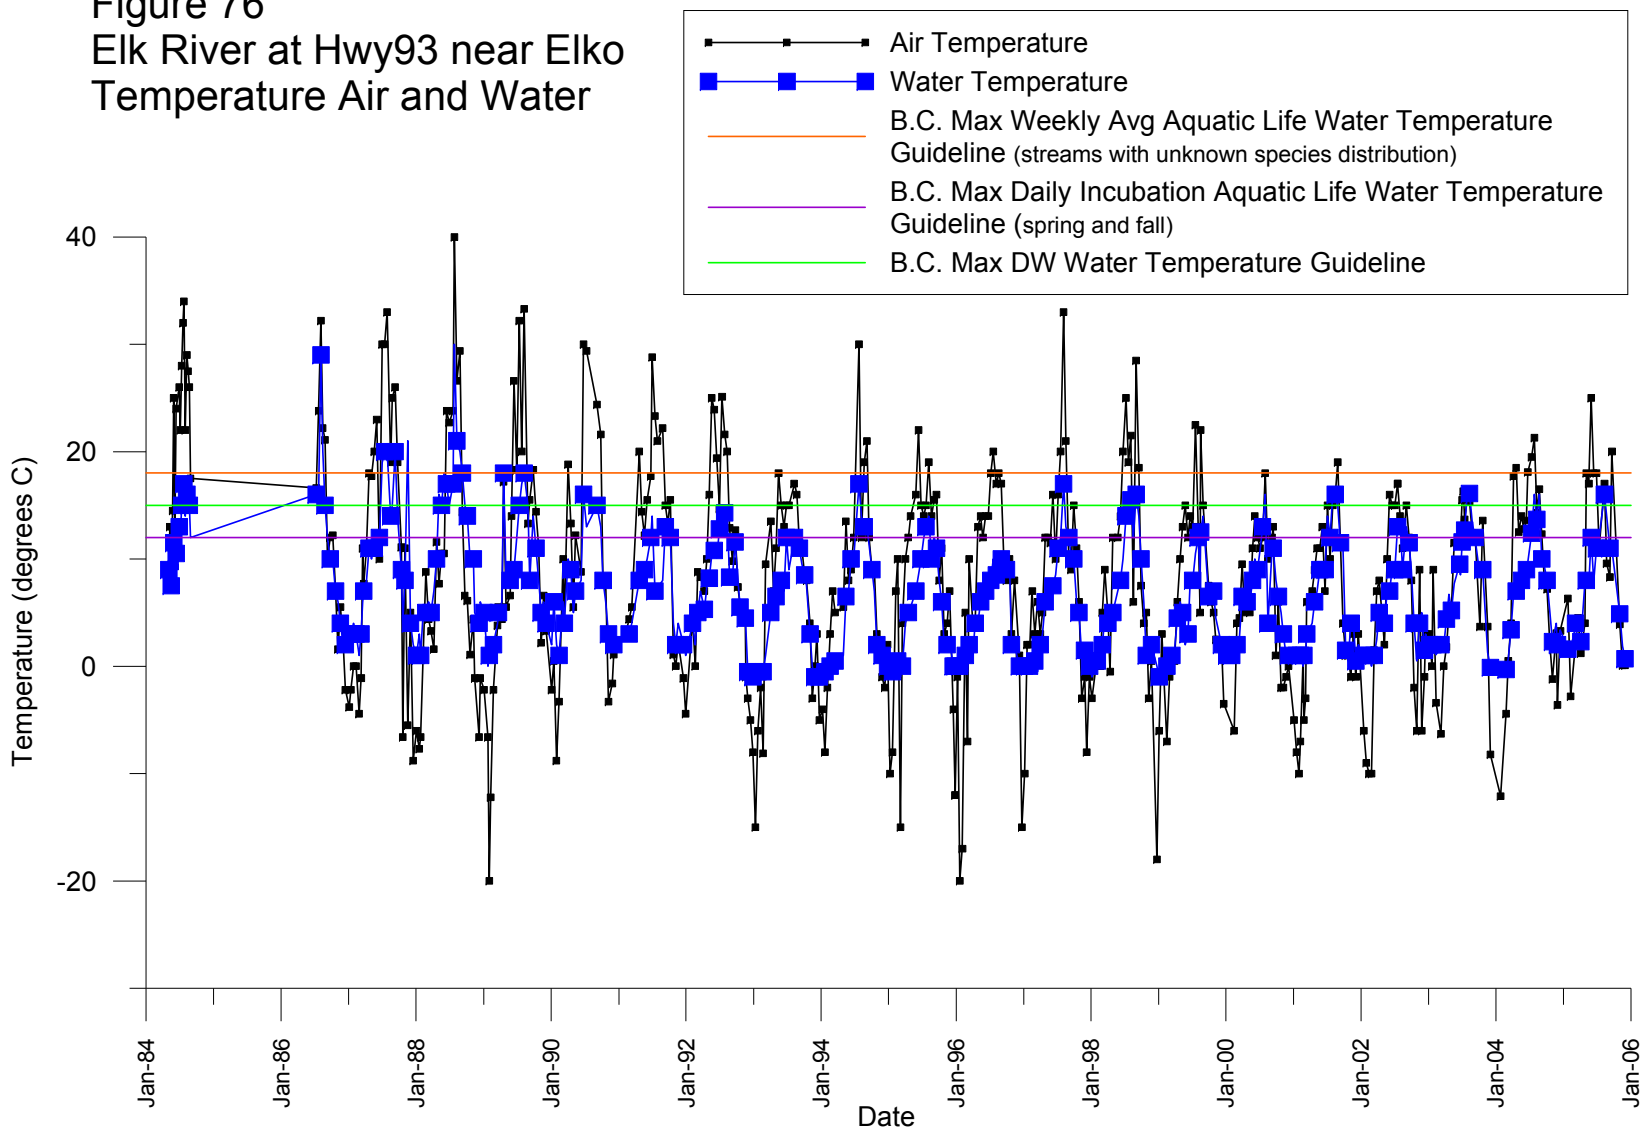
Figure 76
Elk River at Hwy93 near Elko
Temperature Air and Water

Temperature (Figure 76) maxima occasionally exceeded the guideline for the maximum temperature for streams with unknown species distribution. These values were higher than recorded at the upstream site at Sparwood during comparable periods. Stream bank

remediation and planting of shade trees may be a needed management step between these two sites in order to reduce peak summer temperatures.
