## **WATER QUALITY MONITORING AGREEMENT**

### **WATER QUALITY ASSESSMENT OF Thompson River AT SPENCES BRIDGE (1984 – 2004)**

Prepared by:  
L. G. Swain, P. Eng.  
B.C. Ministry of Environment

March 2007

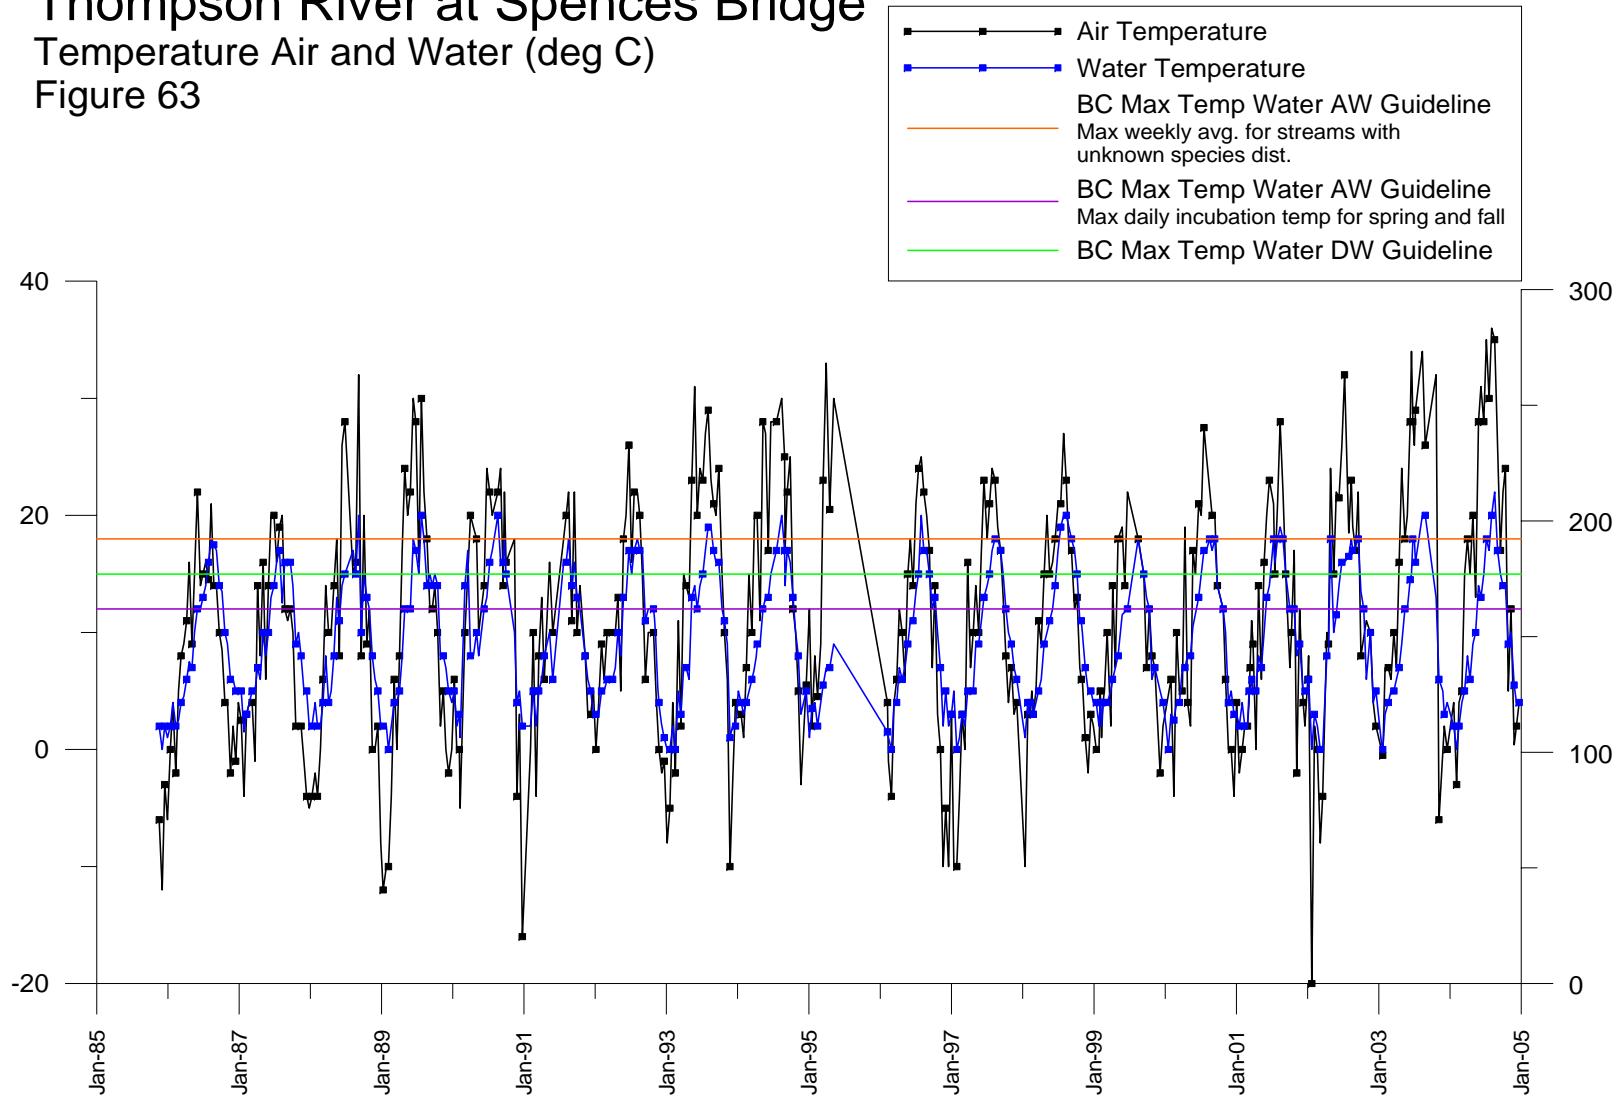
Thompson River at Spences Bridge  
 Temperature Air and Water (deg C)  
 Figure 63

**Water temperature** values (Figure 63) often exceeded the 15 °C drinking water guideline (aesthetics) and the 18 °C aquatic life guideline for streams with unknown fish species present. Water temperature should continue to be monitored due to the impact it has on recreational activities, drinking water aesthetics, fisheries, organism physiology, and on other water quality variables.

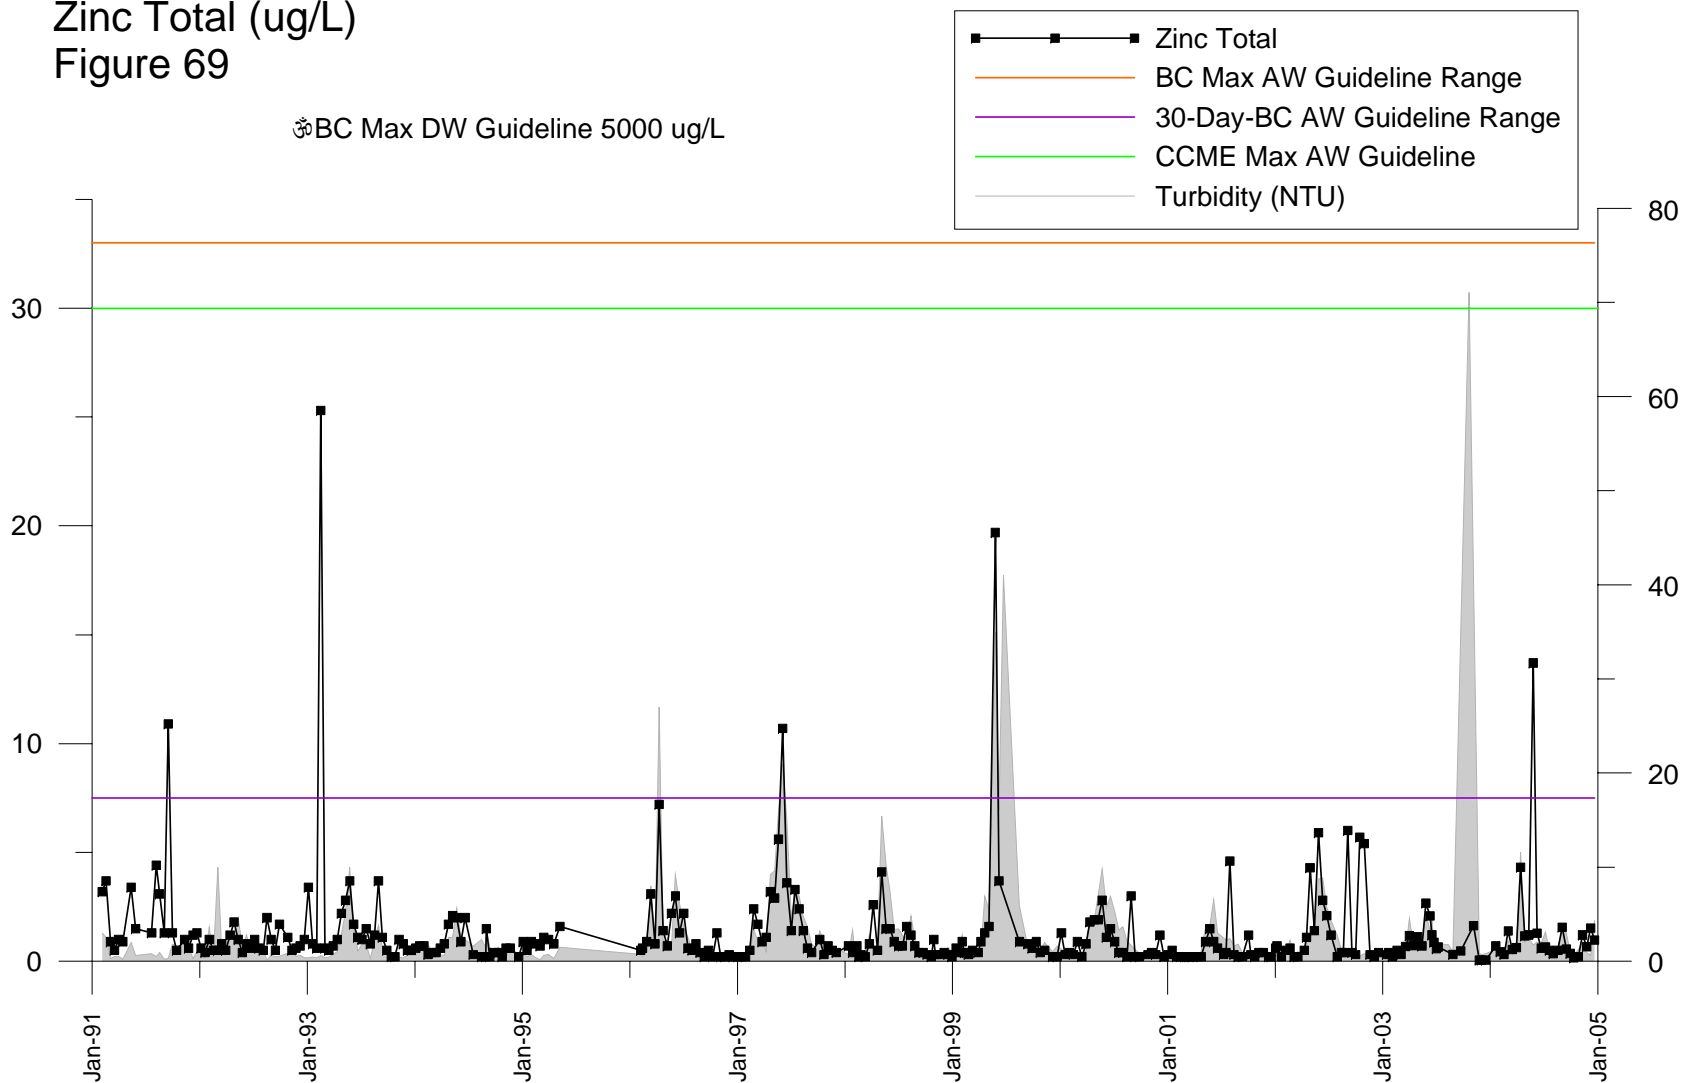
Figure 69

**Total zinc** values (Figure 69) occasionally exceeded the chronic effects aquatic life guideline at 7.5 µg/L after 1991 when vial contamination was eliminated. High zinc concentrations seem to be related to high turbidity values. Since 1991, there does not appear to be increasing or decreasing zinc concentrations. Total and dissolved zinc should be measured in the future.
