WATER QUALITY MONITORING AGREEMENT

WATER QUALITY ASSESSMENT OF Fraser River

AT RED PASS (1984 – 2004)

March 2007

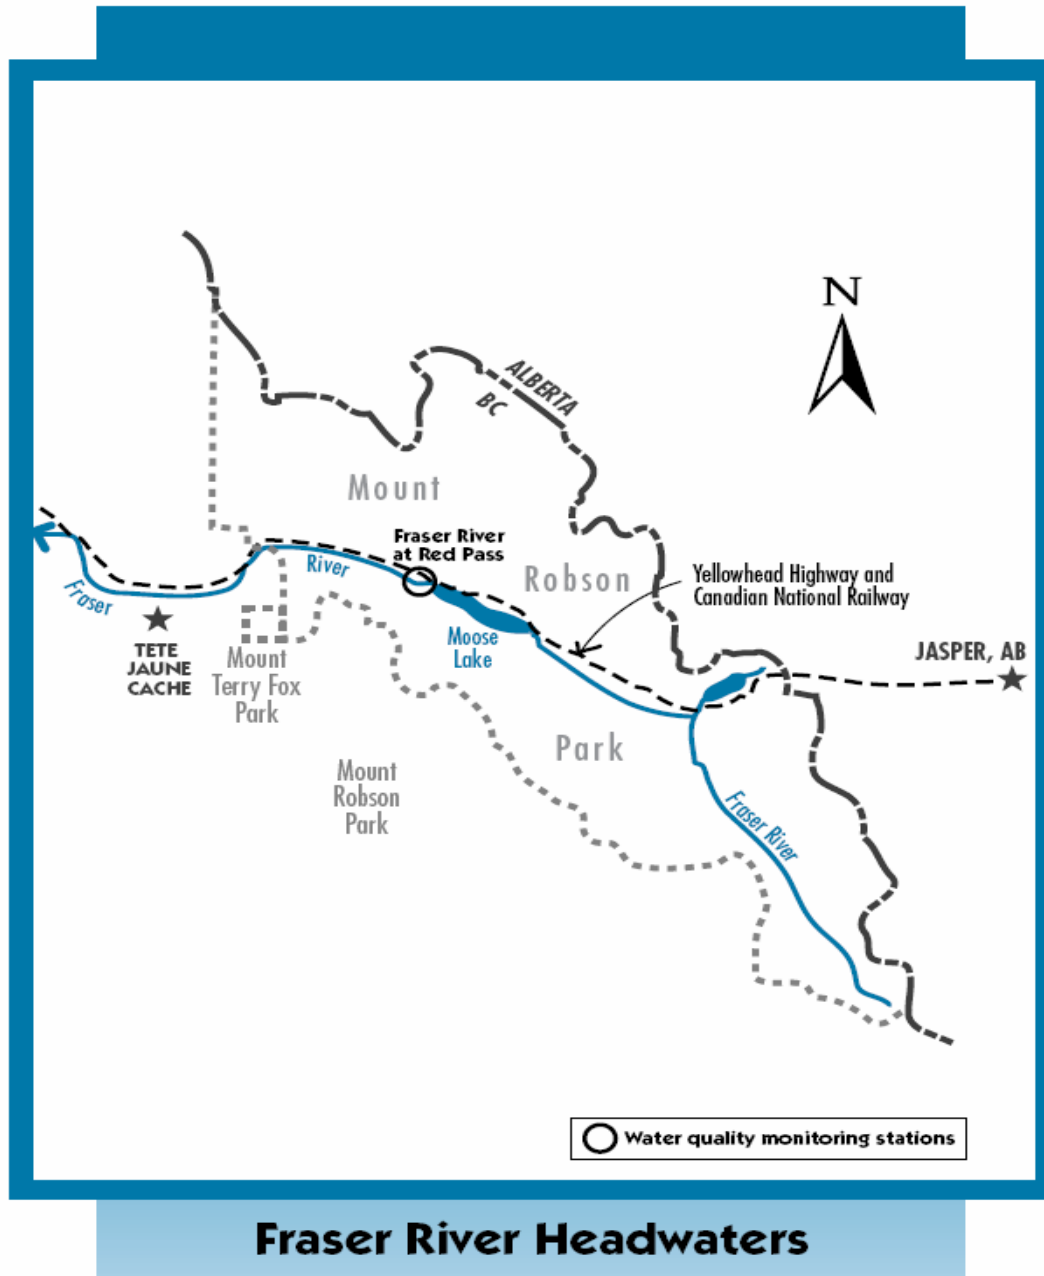
Figure 1: Fraser River at Red Pass

There are five long-term federal-provincial water quality monitoring sites on the Fraser River (Fraser River at Red Pass, Hansard, Stoner, Marguerite, and Hope). Also, there are long-term sites on both the Nechako and Thompson rivers. This report deals with the site on the Fraser River at Red Pass (Figure 1). Red Pass is located upstream from Hansard in a sparsely populated reach of the river. The drainage area for the site is 1,700 km², and is contained within the Mount Robson Provincial Park. There are no active water licences or permitted waste discharges between the headwaters of the Fraser River and Red Pass. The main potential human influences on water quality are the Yellowhead Highway and the Canadian National Railway, which run alongside the Fraser River and Moose Lake through Mt. Robson Park, recreational activities in the park, and atmospheric deposition of contaminants carried by rain and snow.

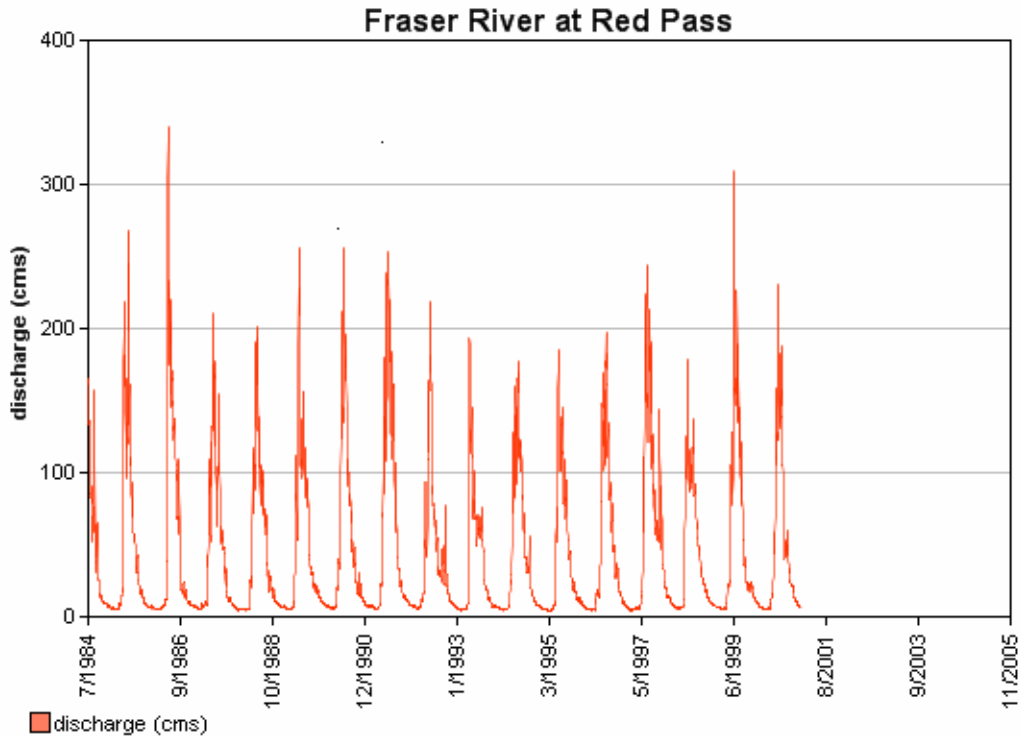
Figure 2: Water Survey of Canada Flow Data for Fraser River at Red Pass

www.waterquality.ec.gc.ca. Flow data for the Fraser River at Red Pass (station no. BC08KA007), collected by the Water Survey of Canada, are plotted in Figure 2 for 1984-2004. Water quality data are plotted in Figures 3 to 54.

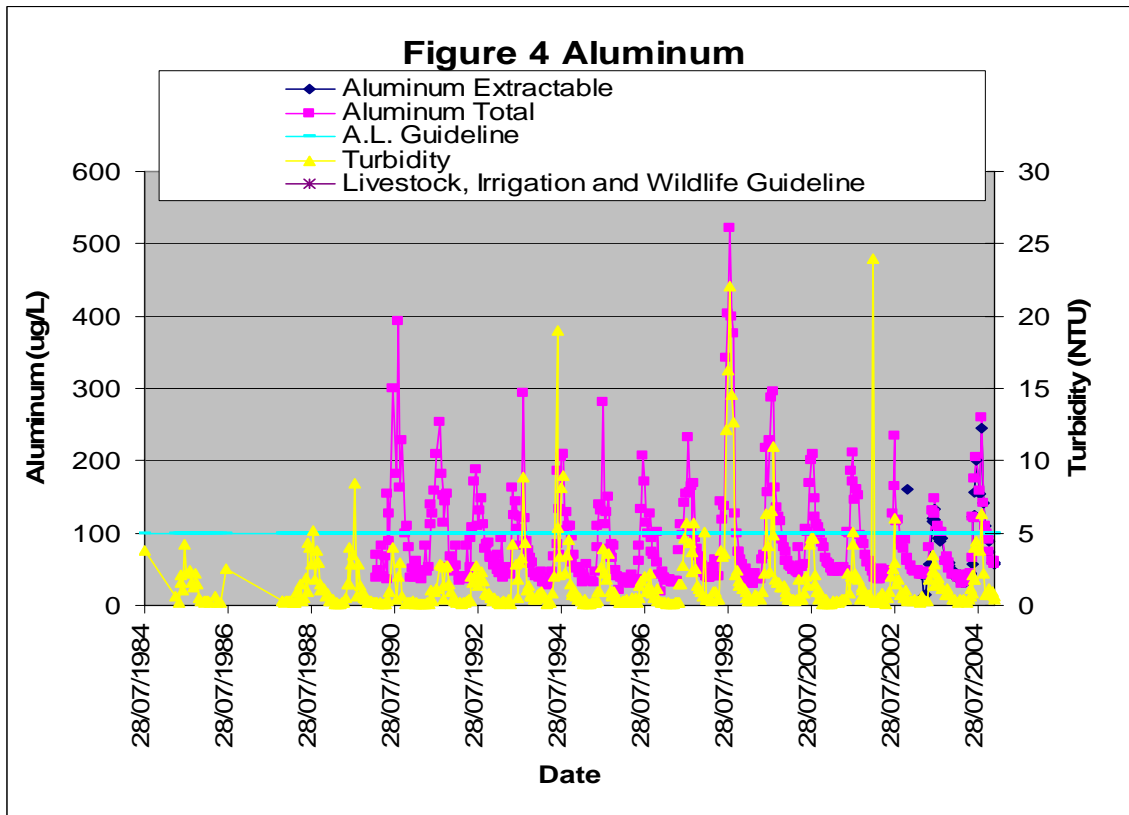
Total aluminum (Figure 4) exceeded the water quality guideline for the protection of wildlife, livestock and irrigation (5 mg/L) once. The highest values occurred in August and September of 1998, concurrent with high turbidity values (see Figure 4), which suggests that the majority of the aluminum was associated with particulate matter and not in the dissolved form. Aluminum is the most common metal on the planet, comprising 7-8% of the earth's crust, so it is not surprising to find that levels vary in proportion to the amount of sediment (turbidity) in the water. However, it is recommended that the concentration of dissolved aluminum be measured in the future to allow a useful comparison with the guidelines for aquatic life and drinking water. No change was noted in total aluminum concentrations over the duration of record.

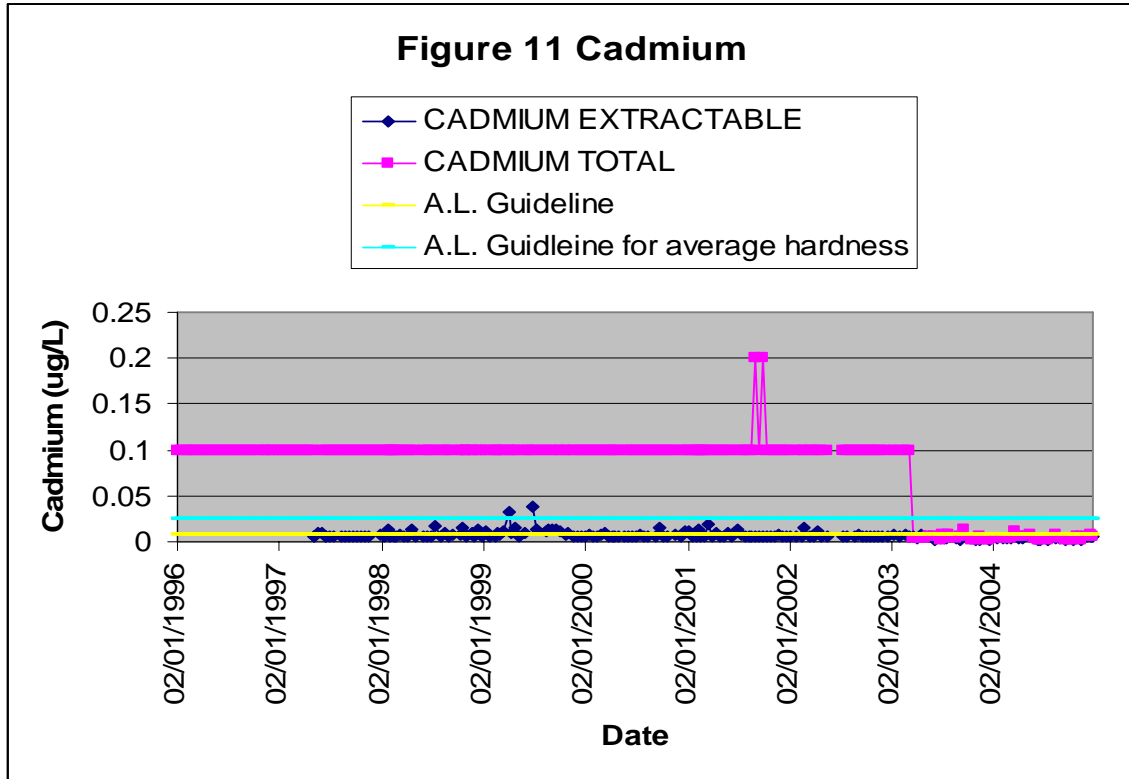
Cadmium concentrations (Figure 11) have been hampered by high levels of detection that have made interpretation of results difficult. Detection limits have improved in 2003

and 2004 to 0.001 µg/L and values usually are less than the guidelines for the protection of aquatic life (0.008 µg/L) at minimum hardness of 20 mg/L and 0.024 µg/L at average hardness of 70 mg/L. No values have exceeded the guideline for the respective hardness since the detection limit has changed. In our analysis, we removed one suspected error/outlier from the data set: a value of 4 µg/L on September 16, 1985 when the level of detection was 1 µg/L.

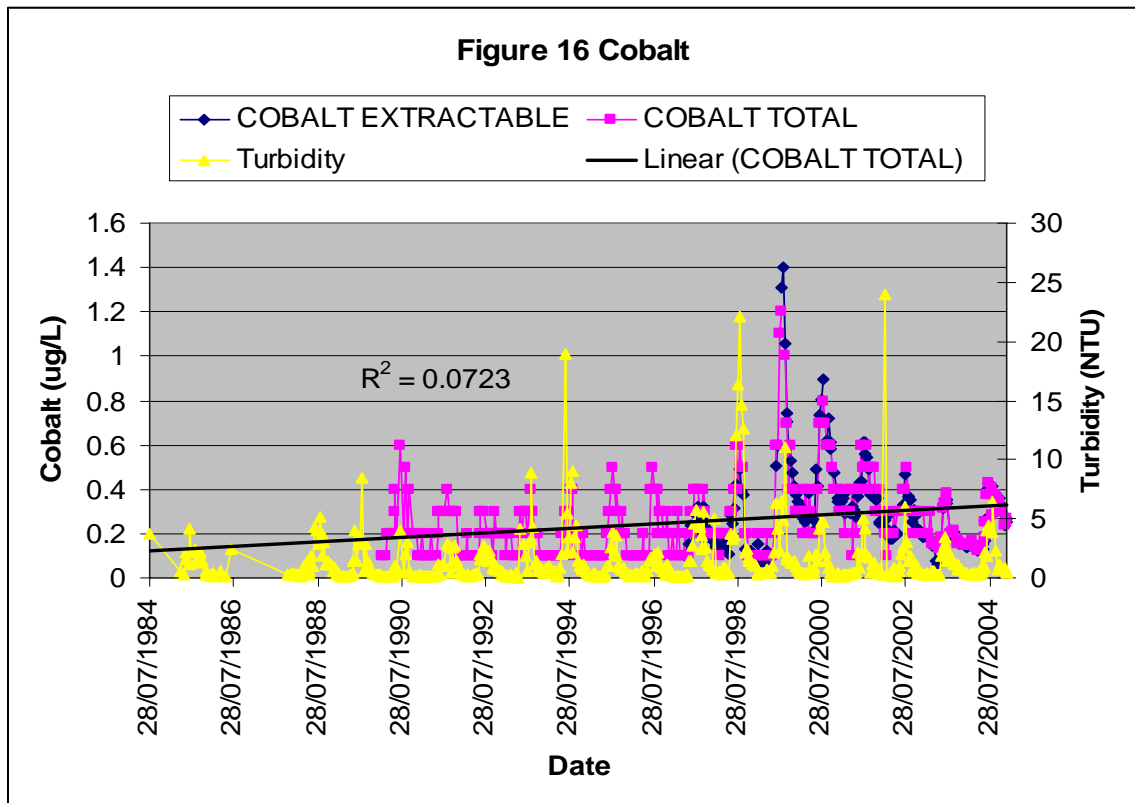
Total cobalt has shown a slight increase during the period of record (Figure 16), although concentrations have not exceeded the B.C. guidelines for the protection of aquatic life (4 µg/L).

- There may be slight increases in cobalt, rubidium, and dissolved nitrogen and dissolved sulphate.
- There appears to be a decreasing trend in lead concentrations and a possible increase in manganese. These trends may be related to the elimination of leaded gas and the use of a manganese-based additive.

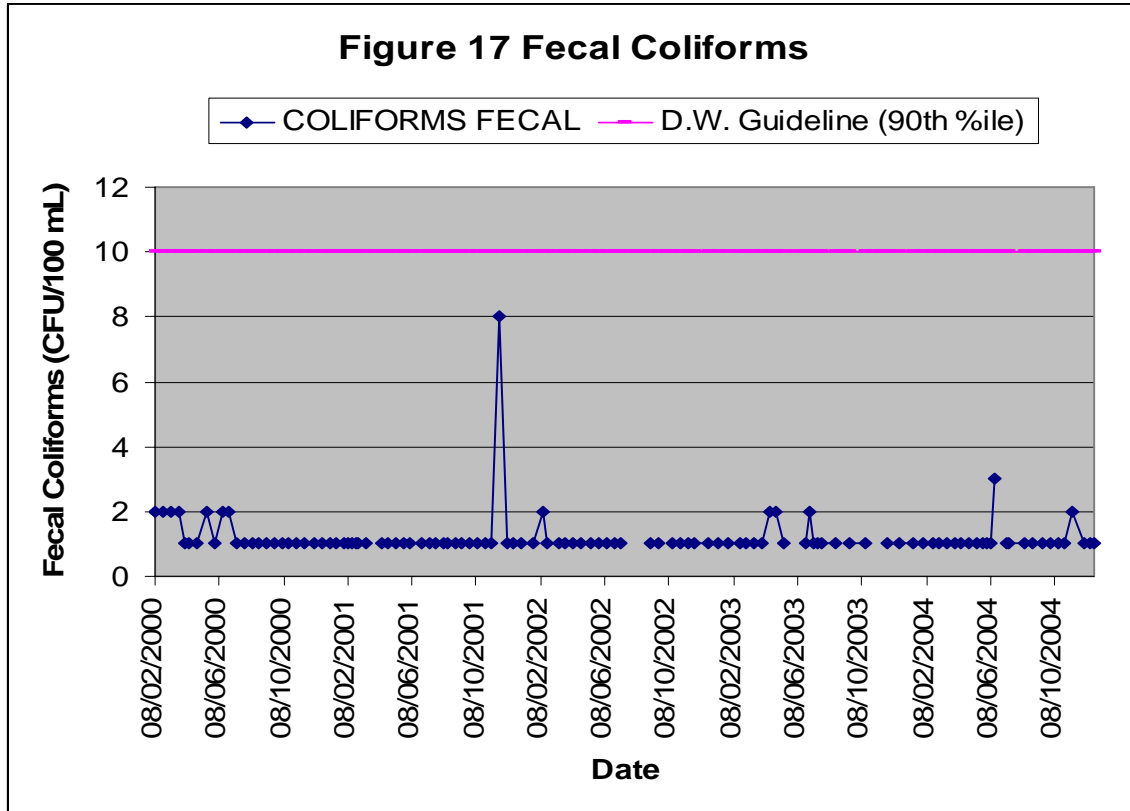
Fecal coliform concentrations have only been measured at Red Pass since early 2000 (Figure 17). All individual values were below the 90th percentile guideline for the protection of drinking water that will receive only disinfection (10 CFU/100 mL). Two suspected errors were removed from the data set: <59 CFU on September 3, 2003 and <13 CFU on November 12, 2003.

- All fecal coliform values were very low, indicating little fecal contamination of the Fraser River was occurring upstream from Red Pass.
- True colour has only been measured at Red Pass since 1997, but all values since that time have been below the aesthetic guideline for drinking water quality.

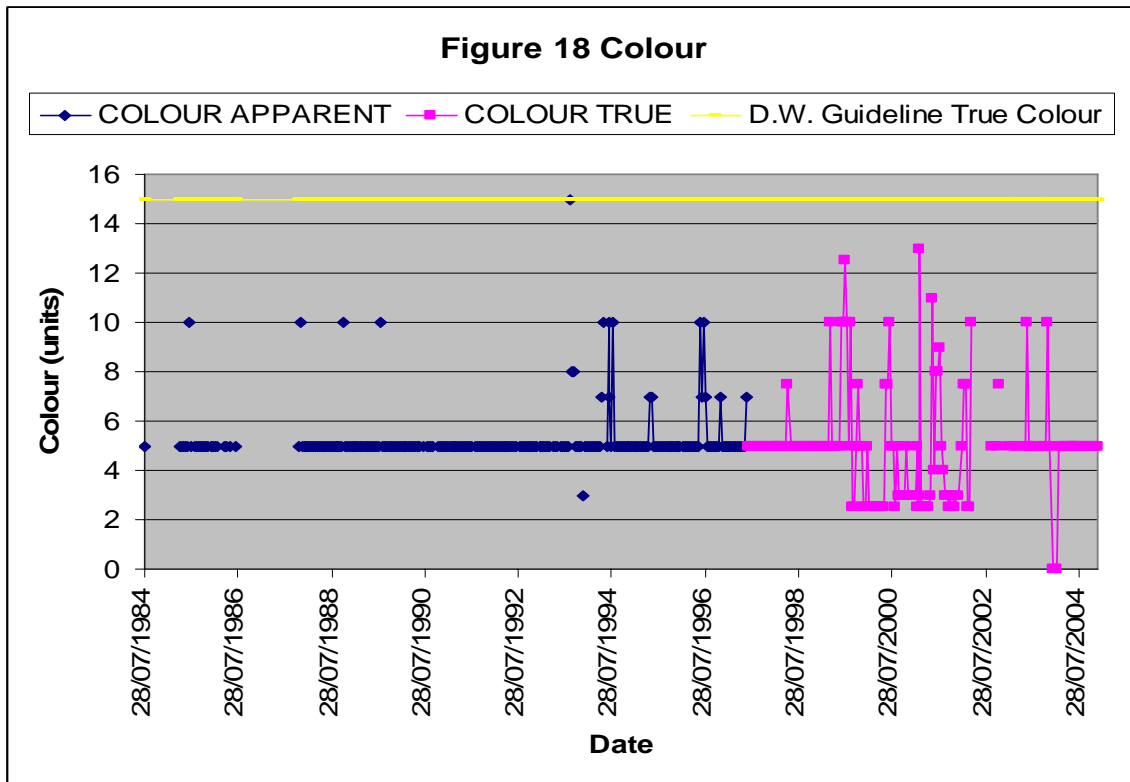
True colour values (Figure 18) are below the aesthetic guideline for drinking water of 15 TCU. All apparent colour values were at or below that guideline.

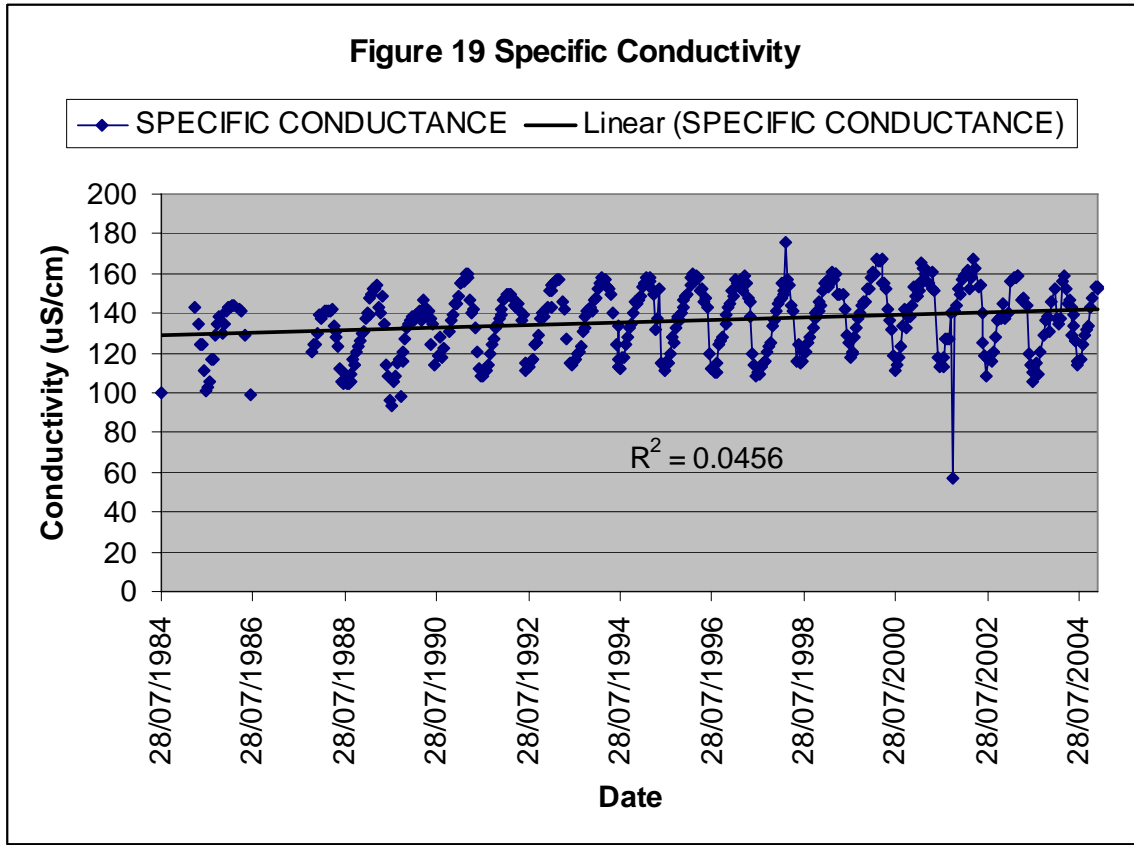
Specific conductivity values (Figure 19) appear to be increasing; however, when the data before 1992 are excluded, there is no increase. All values are well below guidelines values, and this increase is not a cause for concern. Conductivity values generally increase with lower water levels (ions become more concentrated). In our analysis, we removed one suspected error/outlier: 408 µS/cm on April 25, 2001

- Specific conductivity also appeared to be increasing over time, but the levels seem to have remained steady since about 1992. Similar patterns were noted for hardness.

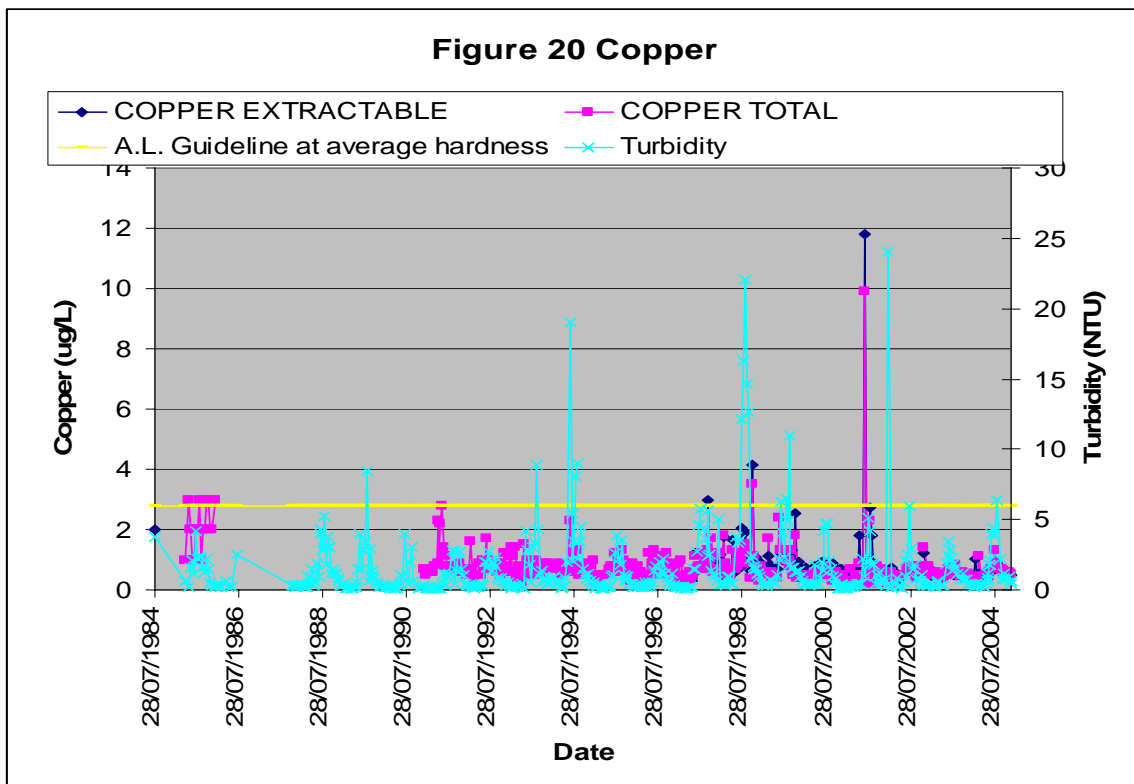
Total copper (Figure 20). The aquatic life guidelines for copper are hardness-dependent. The guideline corresponding to the average hardness was exceeded on only a couple of occasions by individual samples; however, these were related to high suspended solids concentrations. This suggests that much of the copper present at these times was associated with particulate matter which decreases its availability to biota. There does not appear to be any change in total or extractable copper concentrations over time.

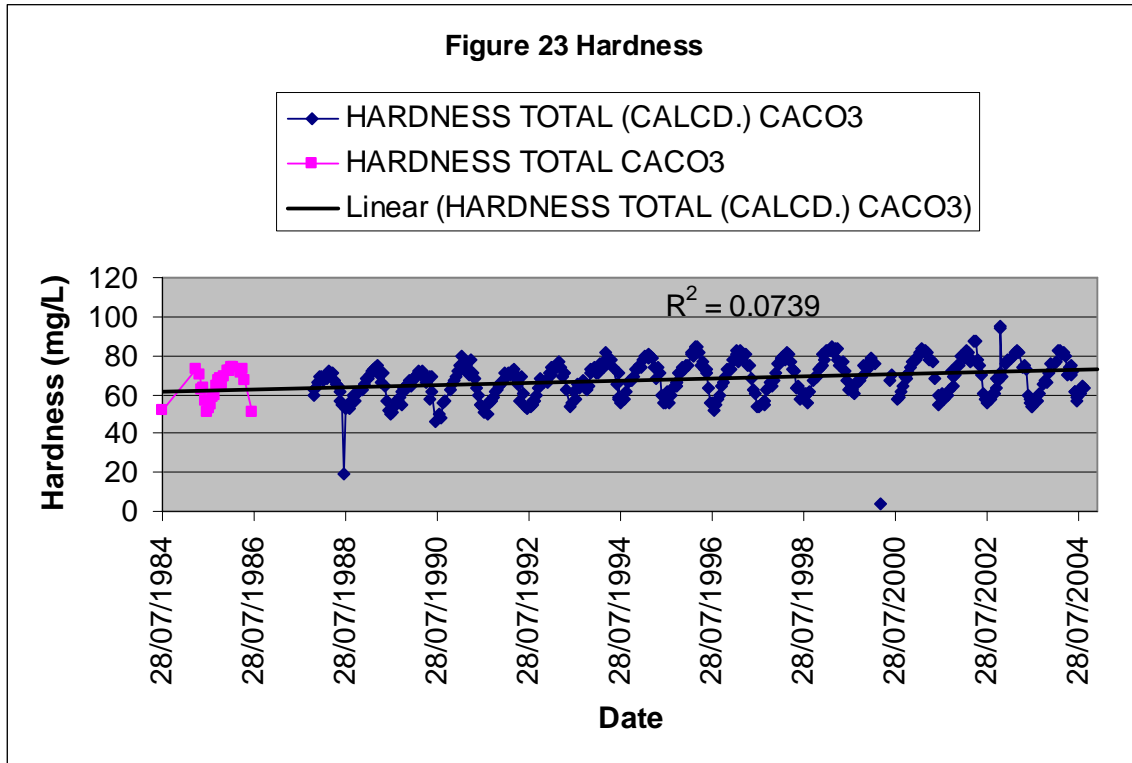
Hardness concentrations (Figure 23) appear to be increasing from the early 1980's; however, when the data before 1992 are excluded from our analysis as we did for specific conductivity, there is no apparent recent trend.

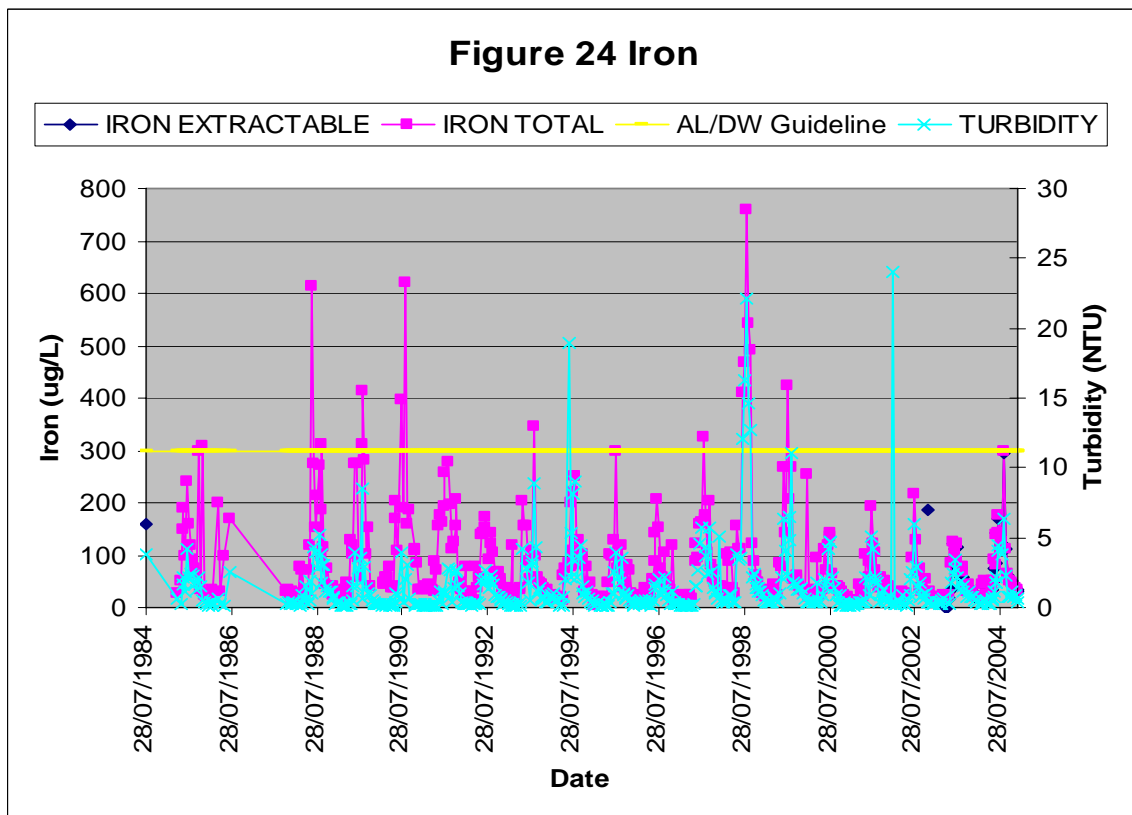
Total iron (Figure 24) concentrations exceeded the aesthetic drinking water and aquatic life guideline of 0.3 mg/L on occasion. These exceedances occurred almost invariably between July and September, when turbidity levels were relatively high. The occasional high concentrations of iron at Red Pass are due to natural sources, as there are no known human sources of iron upstream from this point. There was no apparent change in iron levels over time.

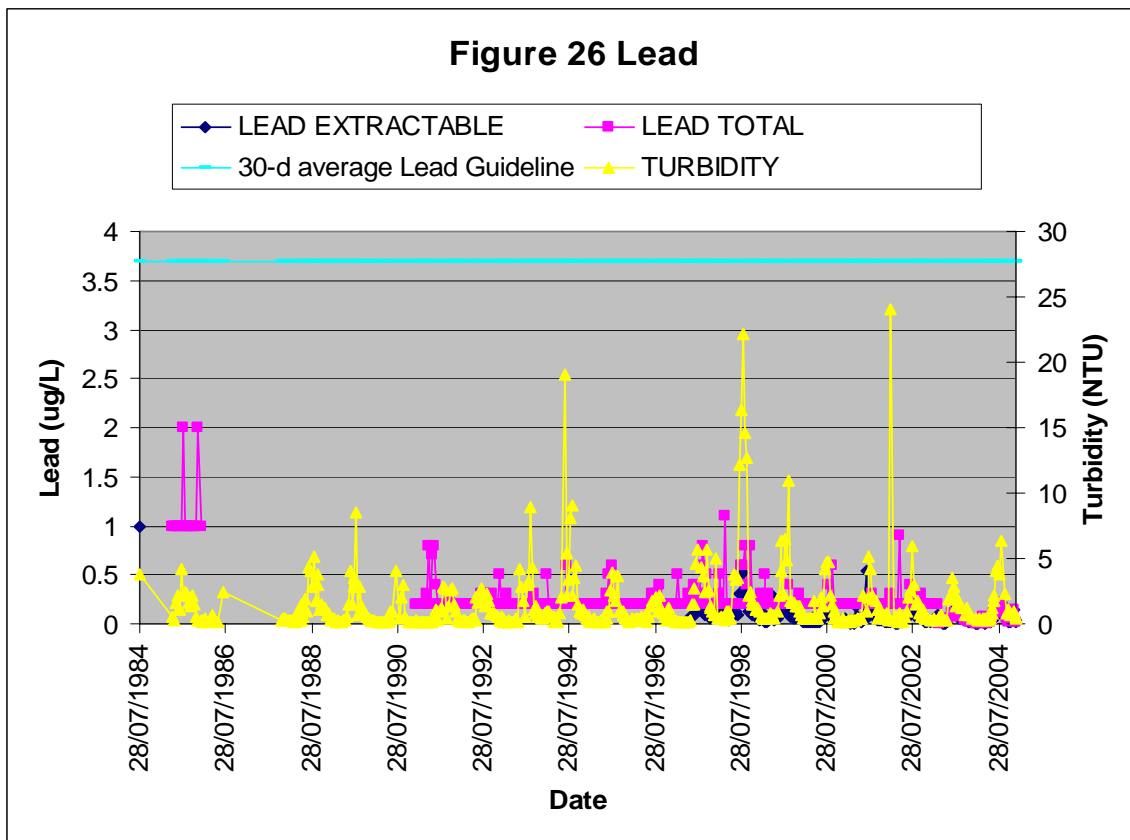
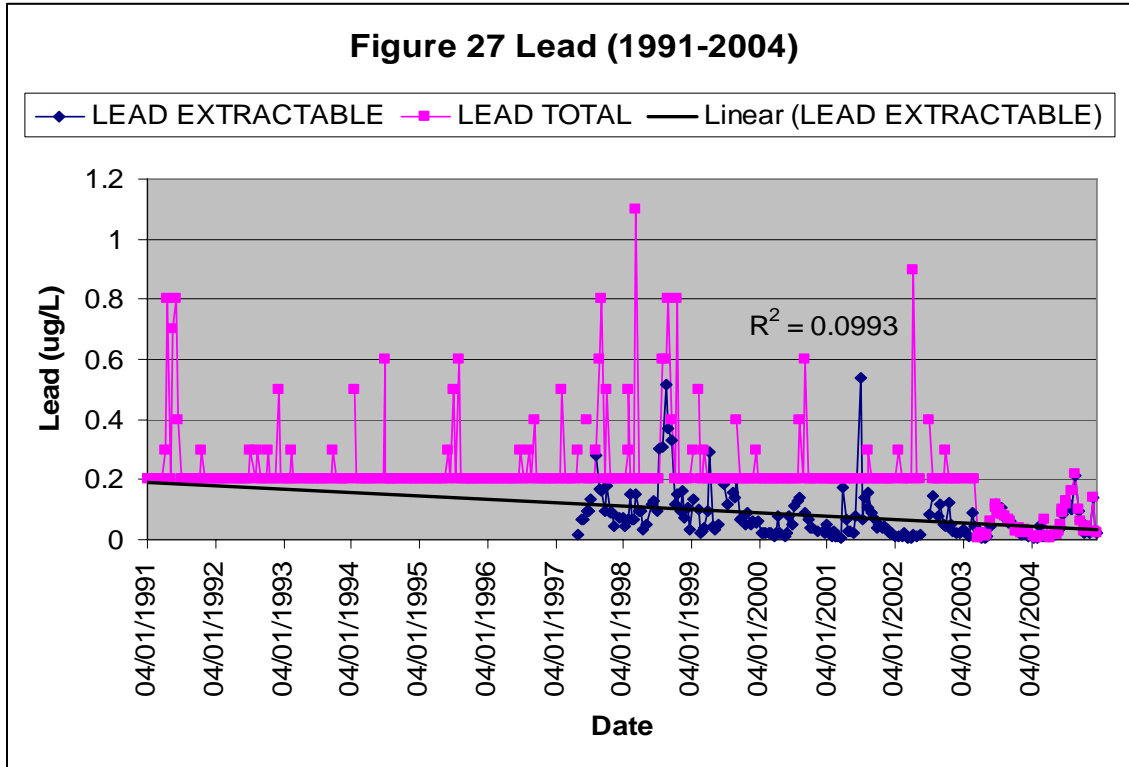
Guidelines for **total lead** (10 µg/L for drinking water and 30-day mean of 3.7 µg/L for aquatic life) were not exceeded by any samples collected between 1984 and 2004 (Figure 26). There appears (Figure 27) to be a trend of lower extractable lead concentrations during the 1991-2004 period. There seems to be some correlation between total lead concentrations and turbidity.

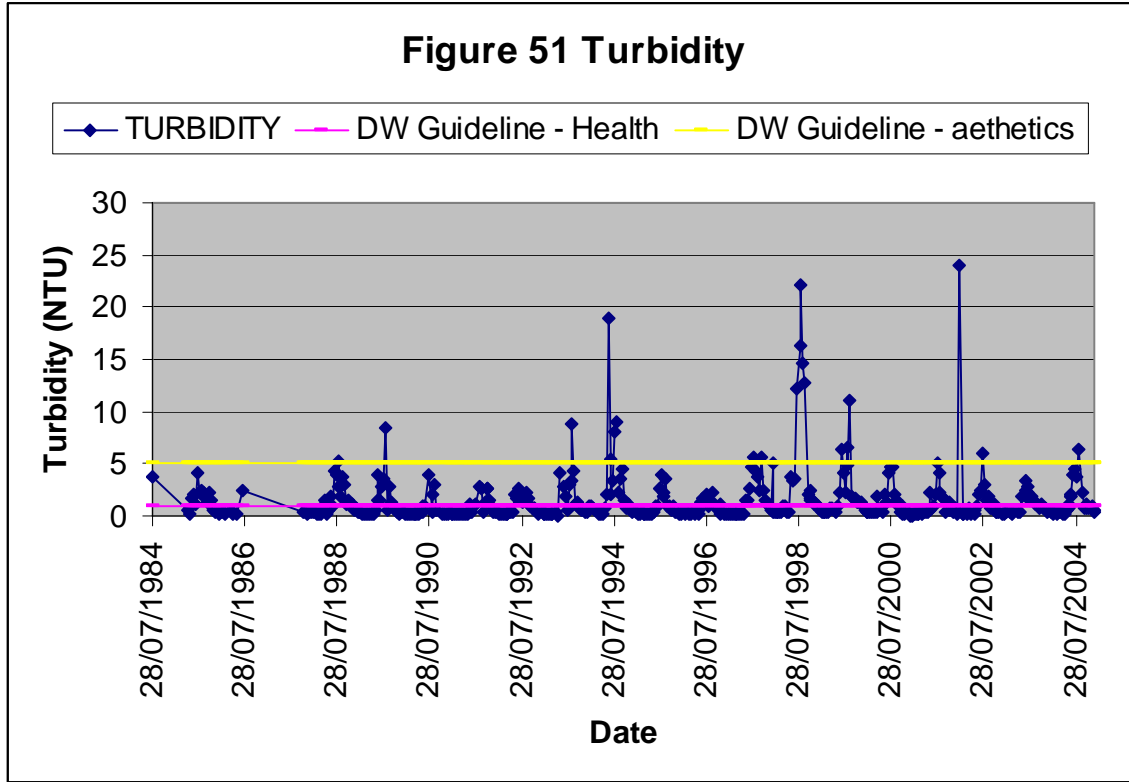
Turbidity values frequently exceeded both the drinking water guideline for health (1 NTU), and occasionally exceeded the aesthetic drinking water guideline (5 NTU) (Figure

51). This indicates that the water would require partial treatment (*e.g.*, filtration) plus disinfection before use as drinking water.

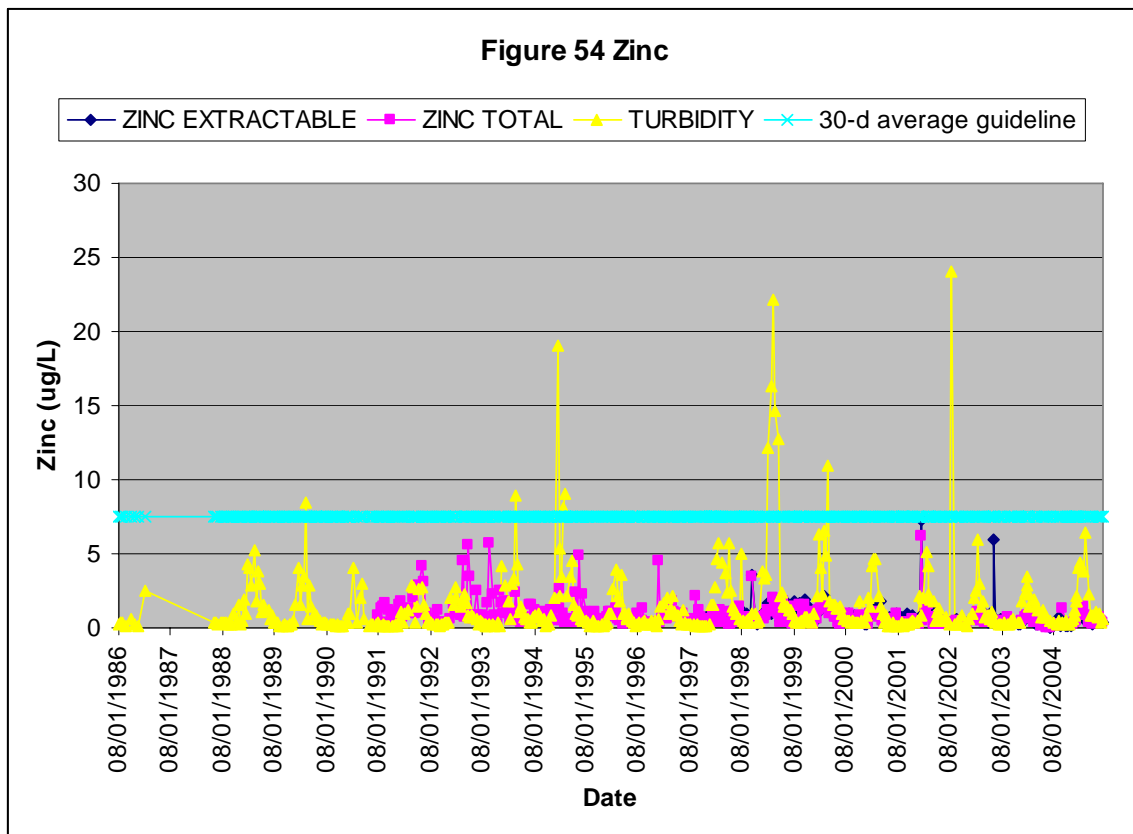
The aquatic guidelines for **total zinc** are dependent on hardness and zinc concentrations appear to be correlated with turbidity events. The aquatic life guideline is a 30-day average of ≤ 7.5 $\mu\text{g/L}$. No individual zinc values have exceeded this guideline over the period of record (Figure 54). It does not appear that zinc concentrations are changing over time at this site. Concentrations of extractable zinc were similar to those of total zinc. There are no known human sources of zinc in the upper Fraser River watershed.
