WATER QUALITY MONITORING AGREEMENT

WATER QUALITY ASSESSMENT OF Columbia River AT BIRCHBANK (1983 – 2005)

Prepared for:
B.C. Ministry of Environment
and
Environment Canada

January 2008

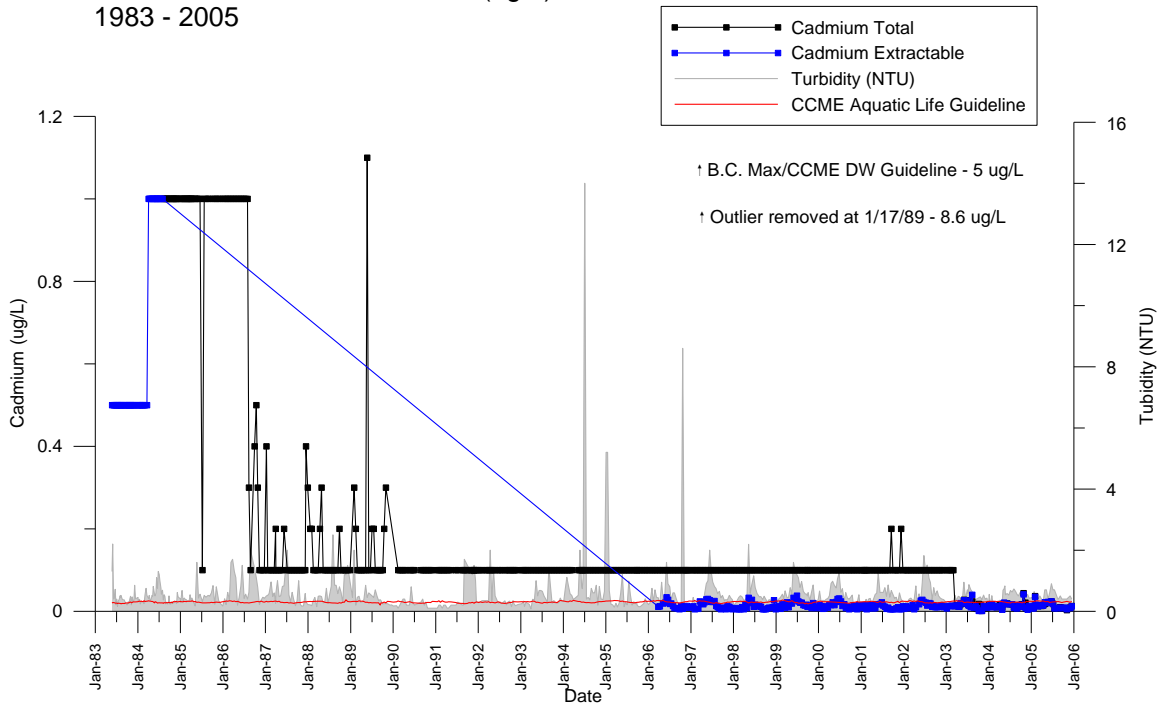
Figure 17
Columbia River at Birchbank
Cadmium Total and Extractable (ug/L)
1983 - 2005

Cadmium (figures 17 and 18) occasionally exceeded the CCME guideline for the protection of aquatic life. When this happened, turbidity levels were also higher. This means that the cadmium may have been associated with the turbidity and may not have been biologically available.

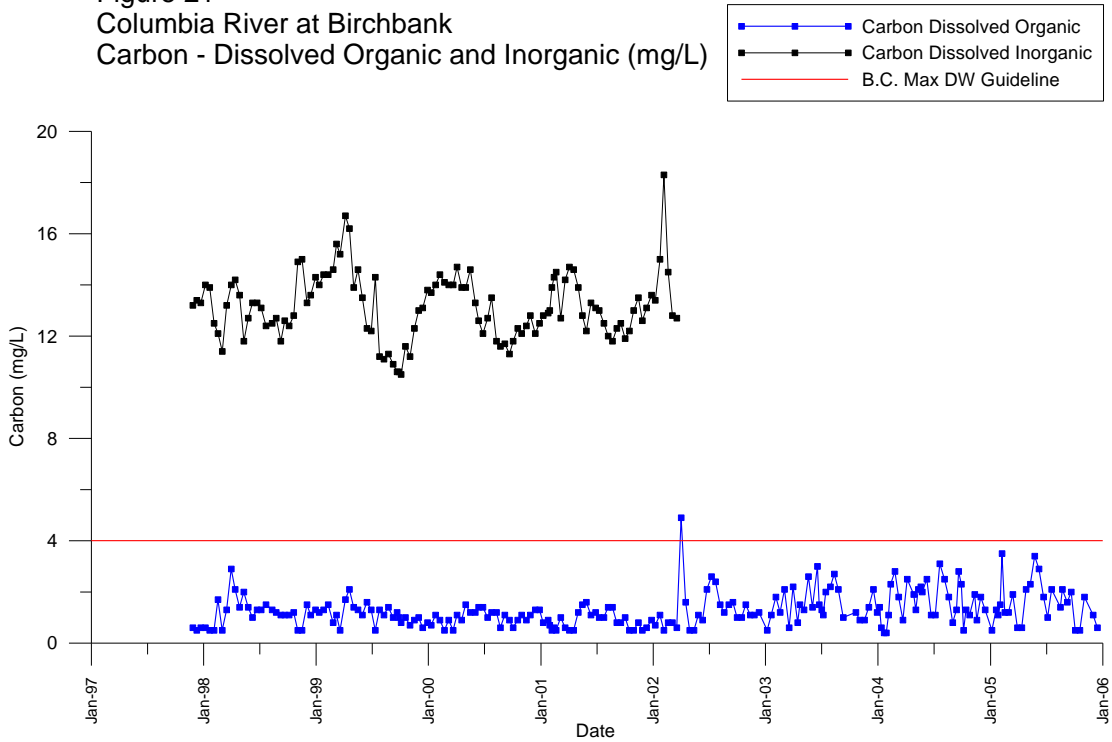
Figure 21
Columbia River at Birchbank
Carbon - Dissolved Organic and Inorganic (mg/L)

Dissolved organic carbon (Figures 21, 21(a) and 23) fluctuated with turbidity and exceeded the guideline for the protection of source waters used for drinking on one occasion since 1997. This is not considered to be a concern.

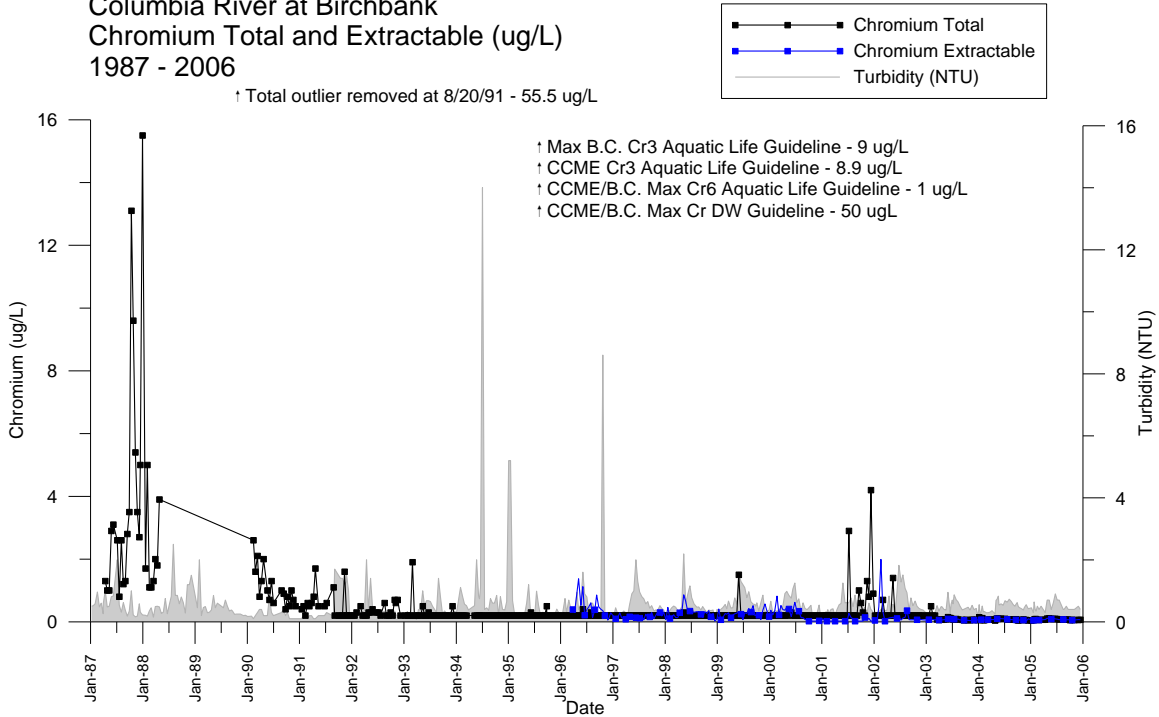
Figure 25
Columbia River at Birchbank
Chromium Total and Extractable (ug/L)
1987 - 2006

Chromium (Figures 25 – 27) (total and extractable) has not exceeded the guidelines for the protection of aquatic life (expressed in terms of Cr^{+3} and Cr^{+6}) since lower analytical detection limits were used beginning in 2003. Prior to that time, some values on occasion exceeded the Cr^{+6} guideline; however, these values are questionable since they were quite close to the detection limits.

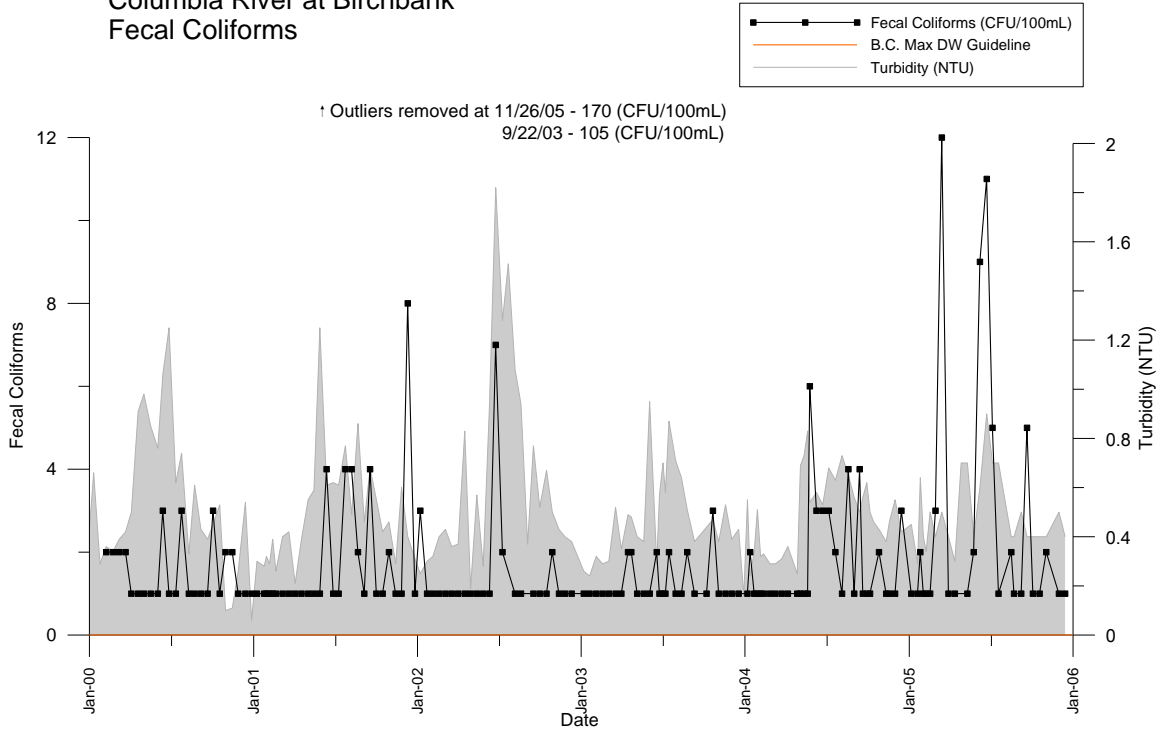
Figure 30
Columbia River at Birchbank
Fecal Coliforms

Fecal Coliforms (Figure 30) occasionally exceeded the guideline to protect source waters used for drinking water supplies by a small amount. Concentrations appear to be correlated with turbidity levels

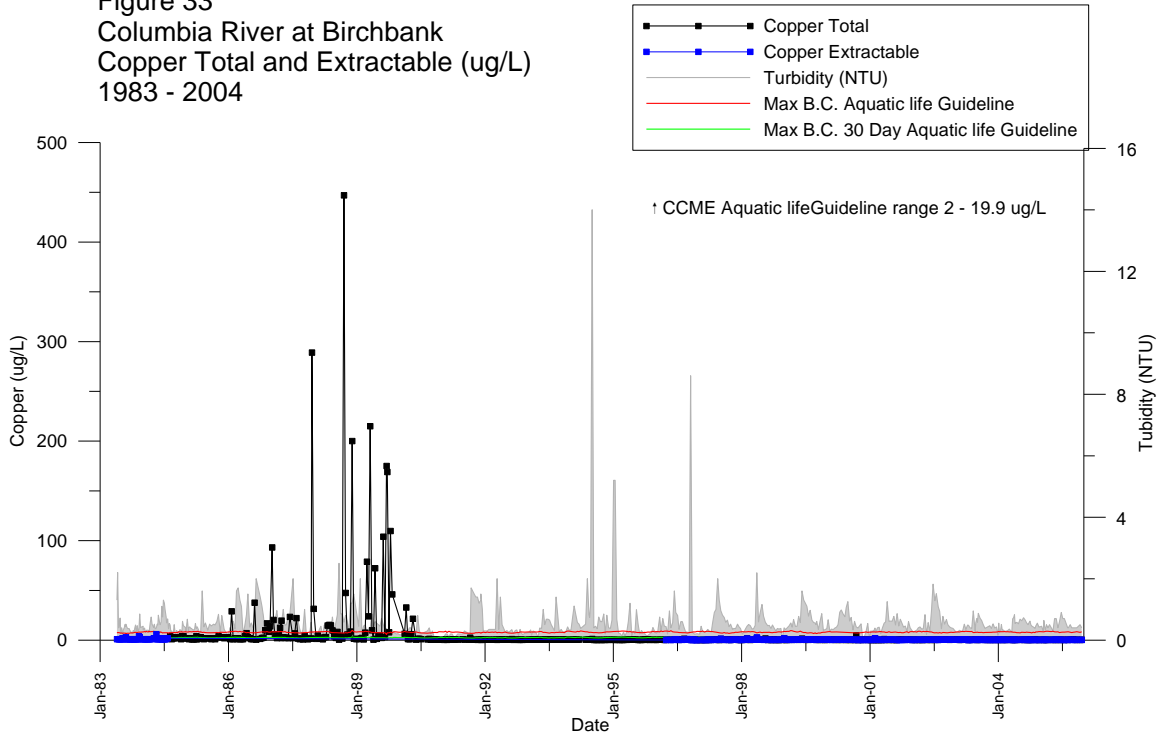
Figure 33
Columbia River at Birchbank
Copper Total and Extractable (ug/L)
1983 - 2004

Copper (Figures 33 – 35) (total and extractable) has not exceeded the guidelines for the protection of aquatic life since lower analytical detection limits were used beginning in 2003. Prior to that time, some values on occasion exceeded the guideline; however, these values are questionable since they were quite close to the detection limits. Copper concentrations appear to be correlated to turbidity levels.

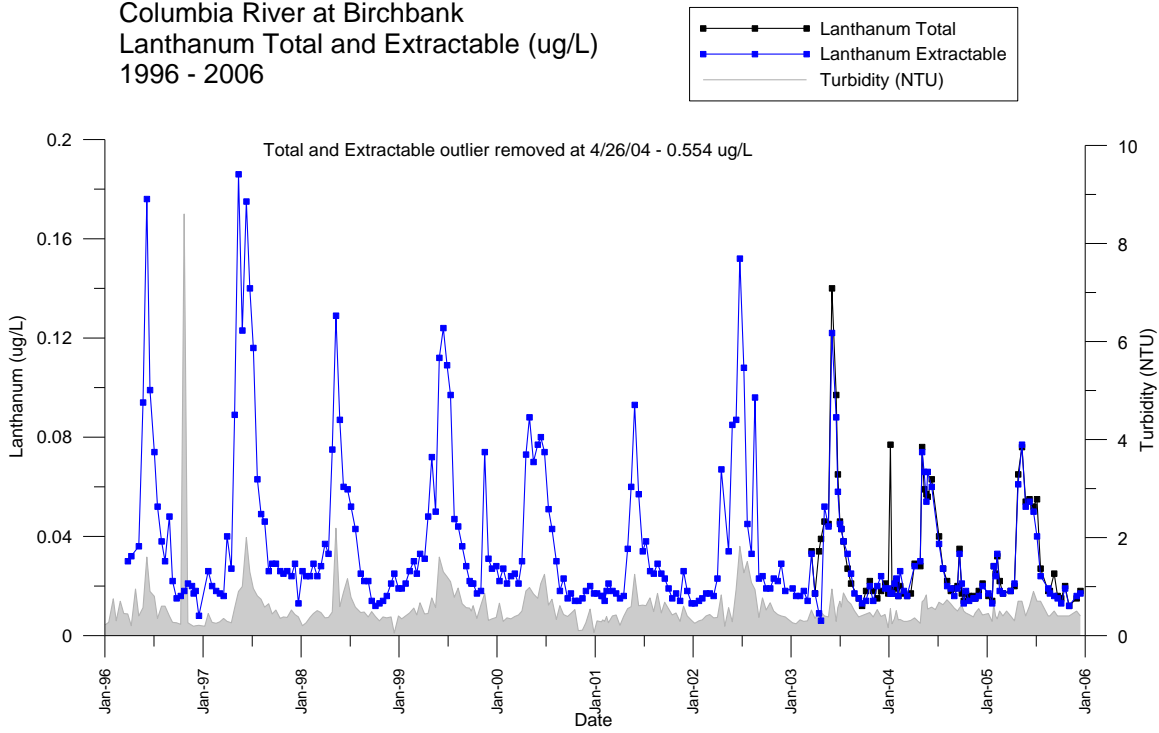
Figure 42
Columbia River at Birchbank
Lanthanum Total and Extractable (ug/L)
1996 - 2006

Lanthanum (Figure 42) shows a potential declining trend in concentrations since 1996. The reason for this is not known at this time. This visually-identified trend needs to be confirmed statistically.

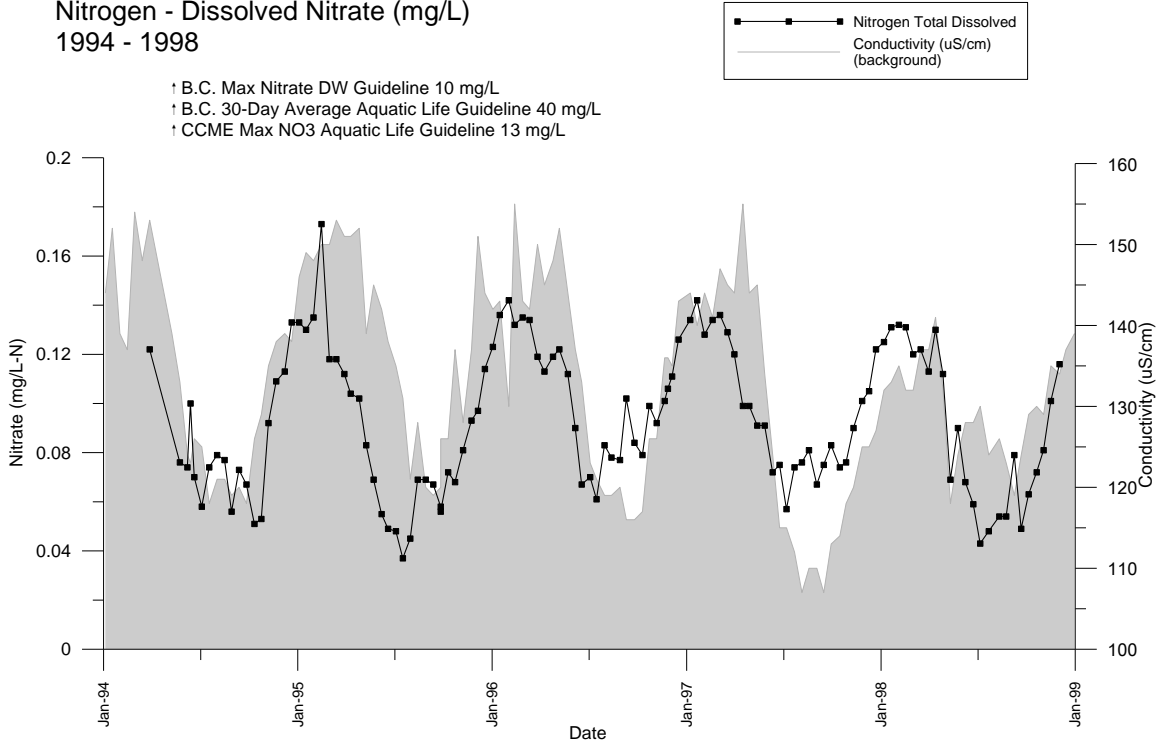
Figure 54
Columbia River at Birchbank
Nitrogen - Dissolved Nitrate (mg/L)
1994 - 1998

Nitrate (Figures 54 and 55) concentrations fluctuate with specific conductivity; however all values are less than guidelines.

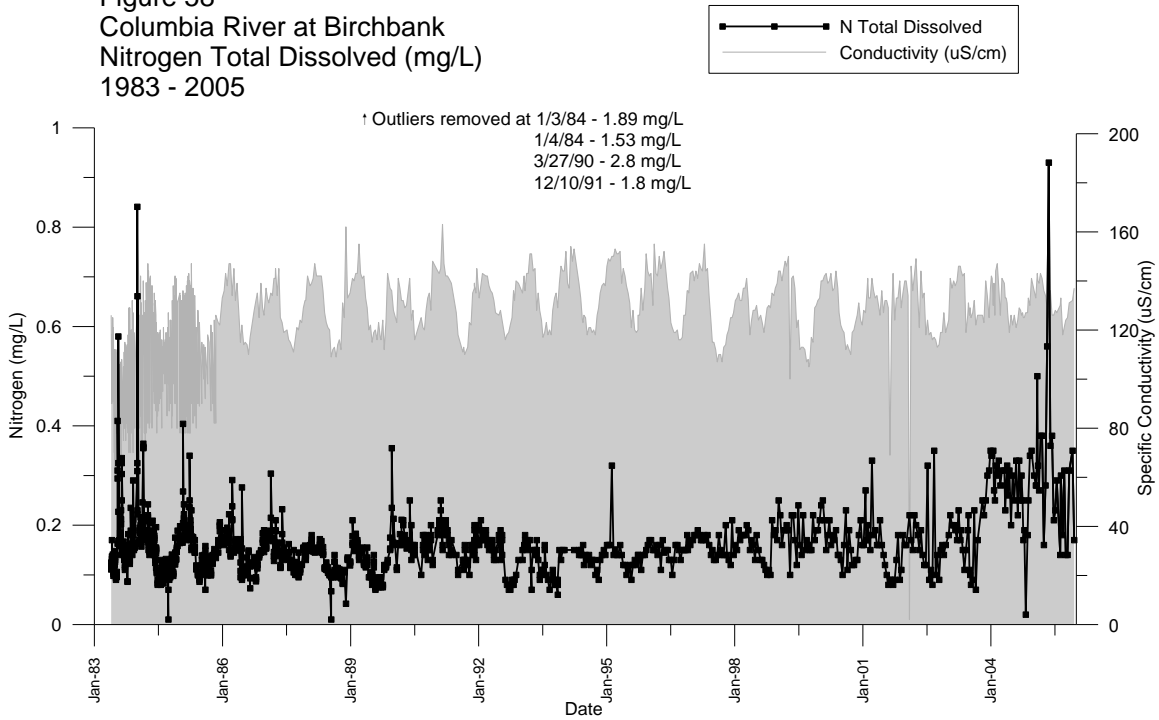
Figure 58
Columbia River at Birchbank
Nitrogen Total Dissolved (mg/L)
1983 - 2005

Total Dissolved Nitrogen (Figure 58) appears to have increased in recent years. However this is likely a result of known filtration contamination in the laboratory, which originated in about 2004. These data are in the process of being flagged in the database.

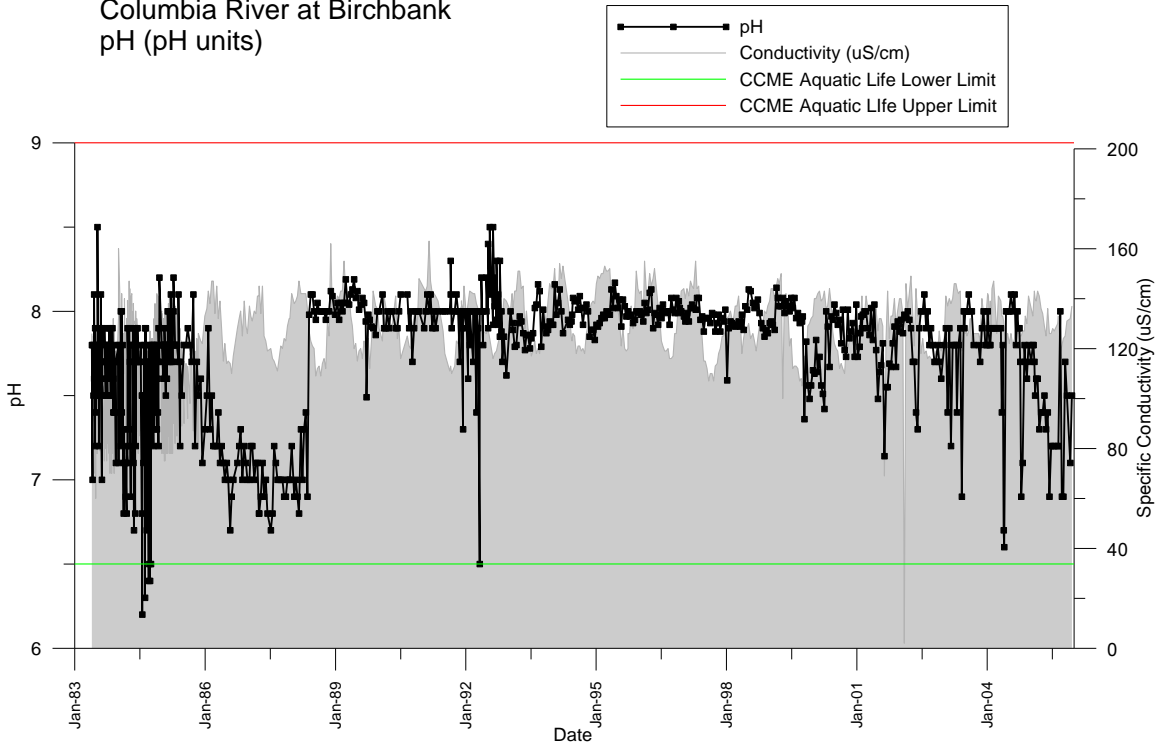
Figure 59
Columbia River at Birchbank
pH (pH units)

pH (Figure 59) has on occasion been measured below the lower guideline limit of 6.5 units; however, this only happened in the 1980's and only dropped as low as 6.2. Some lower values (still within the acceptable range for pH) have occurred since about the year 2000. It is not believed that pH is a concern in the river.

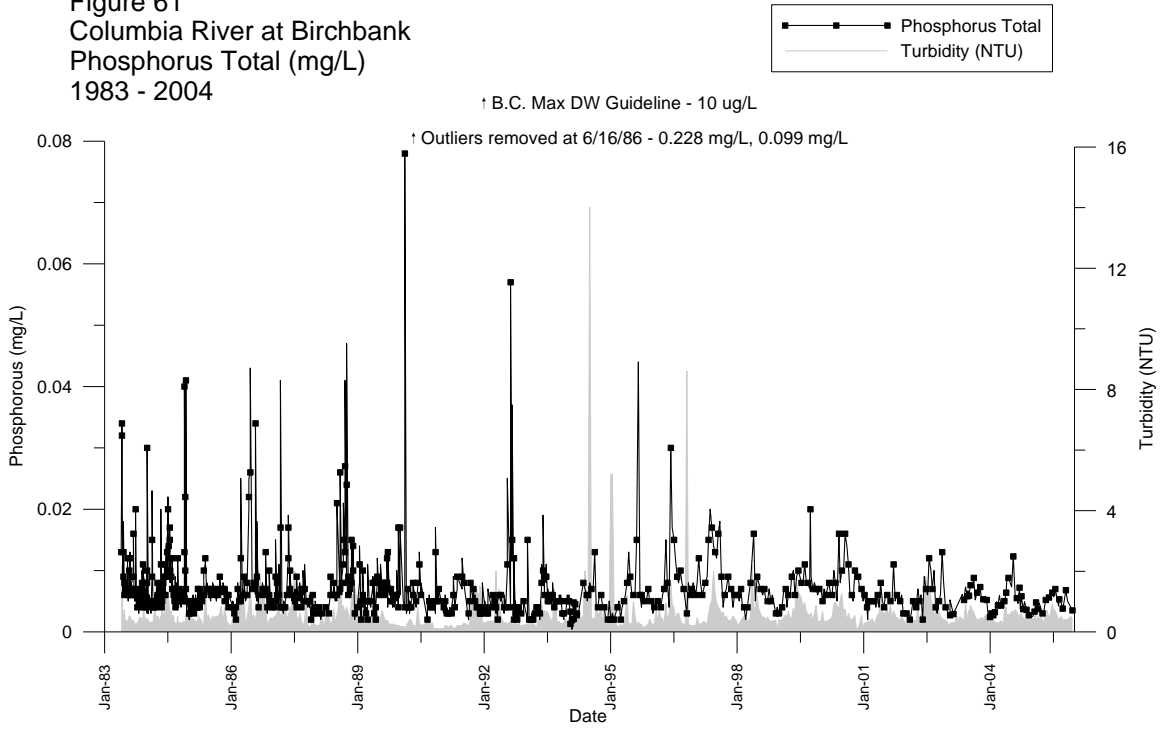
Figure 61
Columbia River at Birchbank
Phosphorus Total (mg/L)
1983 - 2004

Total Phosphorus (Figure 61) and **total dissolved phosphorus** (Figure 62) concentrations fluctuate with turbidity but all have been below the guideline for source

waters used for drinking. An apparent declining trend in phosphorus can be seen. This was noted in a previous report, and potentially attributed (at least in part) to the trapping effect of upstream dams, and waste abatement (Holms and Pommen, 1999).

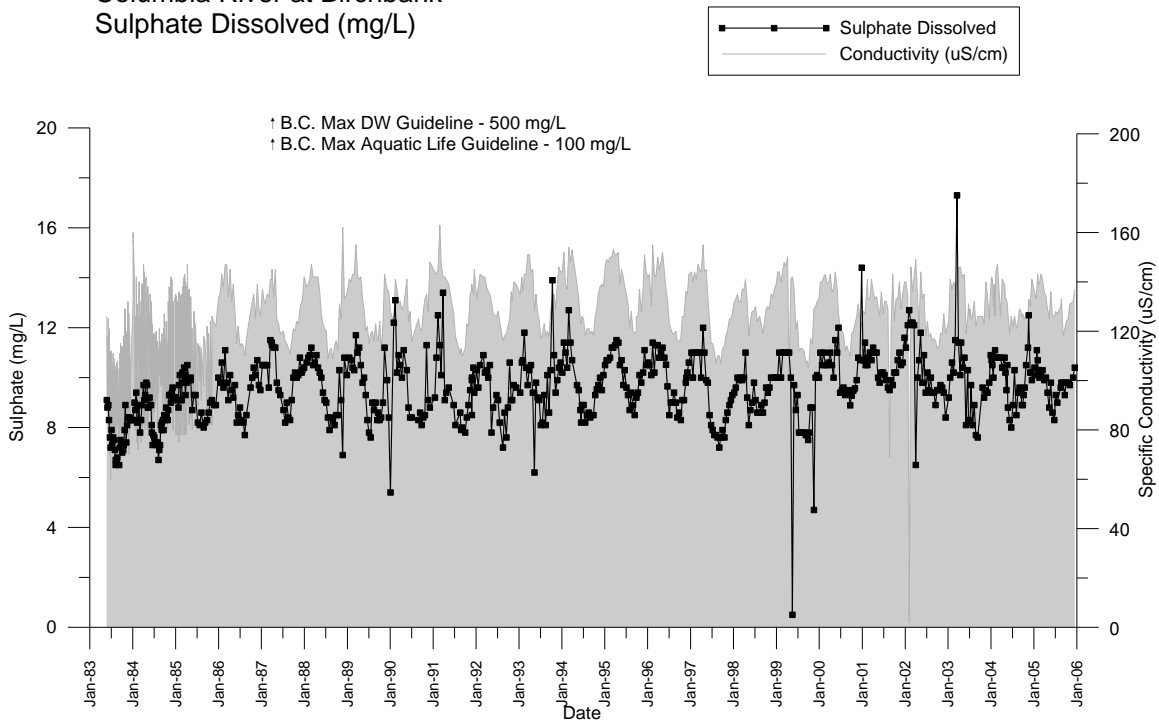
Figure 75
Columbia River at Birchbank
Sulphate Dissolved (mg/L)

Dissolved Sulphate (Figure 75) may be increasing through time. This needs to be confirmed with statistical testing: it also needs to be confirmed that any changes in concentrations are not the result of changes in analytical techniques.

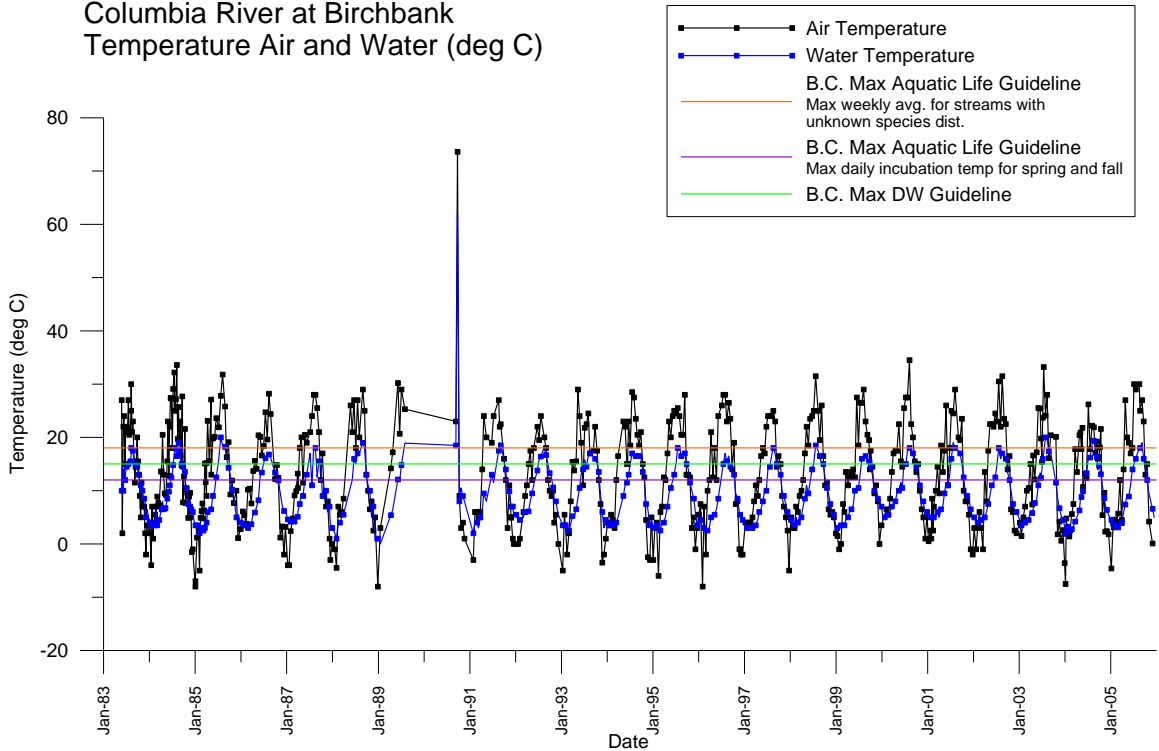
Figure 76
Columbia River at Birchbank
Temperature Air and Water (deg C)

Water Temperature (Figure 76) occasionally exceeded the guideline for protection of streams with unknown fish species. This occurred as would be expected during the warm summer months; however, the amount above the guideline was minimal and thus not a serious concern to aquatic life.
