A DESIGN BRIEF ON THE
FLOODPLAIN MAPPING STUDY OF THE
NICOLA RIVER

An Overview of the Study Undertaken to Produce
Floodplain Mapping for the Nicola River from
Spences Bridge to Nicola Lake

R. W. Nichols, P.Eng.
Senior Hydraulic Engineer
Special Projects Section

Victoria, British Columbia
July, 1988

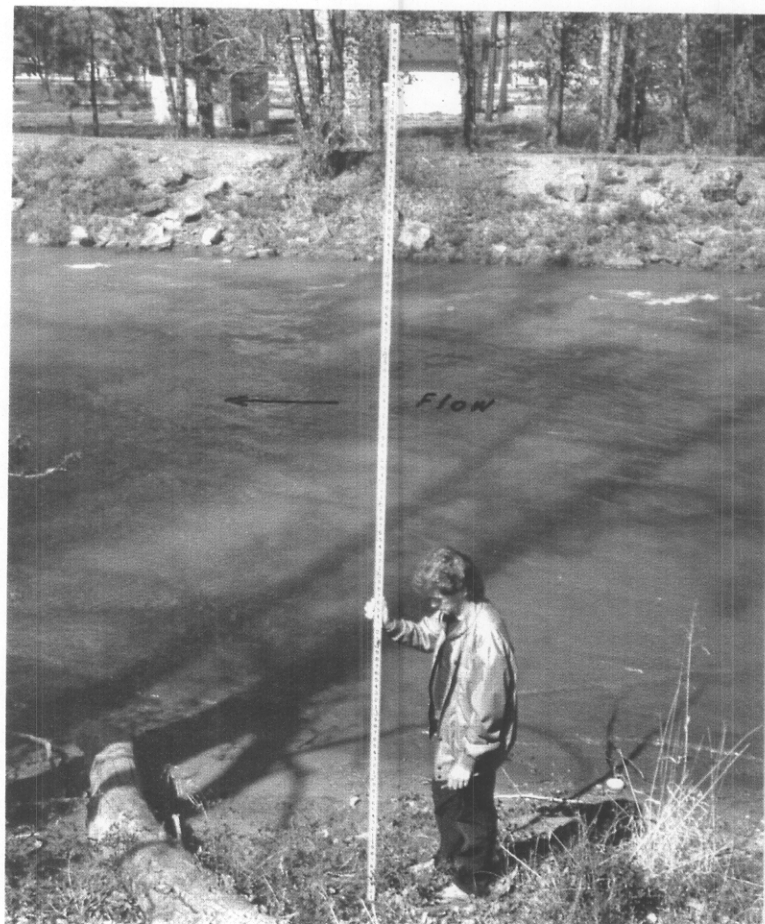
Photo 4

The Coldwater River floodplain averages 280 metres in width in the study area. Granular fill berms (See Photo 4) have been constructed over the years along the banks of the Coldwater River (Appendix 1.26) and are shown on Sheet 13. The berms are overgrown with trees and generally have very limited erosion protection.

Sensitivity studies of the above noted reach of the Nicola River and of the Coldwater River at Merritt indicate a similar order of magnitude as outlined in Section 6.6.1 with respect to increased flood levels with increased flow and Manning's "n" values. Photos 4 and 5 provide a view of the Coldwater and the Nicola Rivers in this portion of the study area.
