**COMPLETION REPORT FOR
MATSQUI AND VEDDER DIKE UPGRADES
ABBOTSFORD, BC**

City of Abbotsford
200-32315 South Fraser Way
Abbotsford, BC
V2T 1W7

December 13, 2007

07-1450-0039

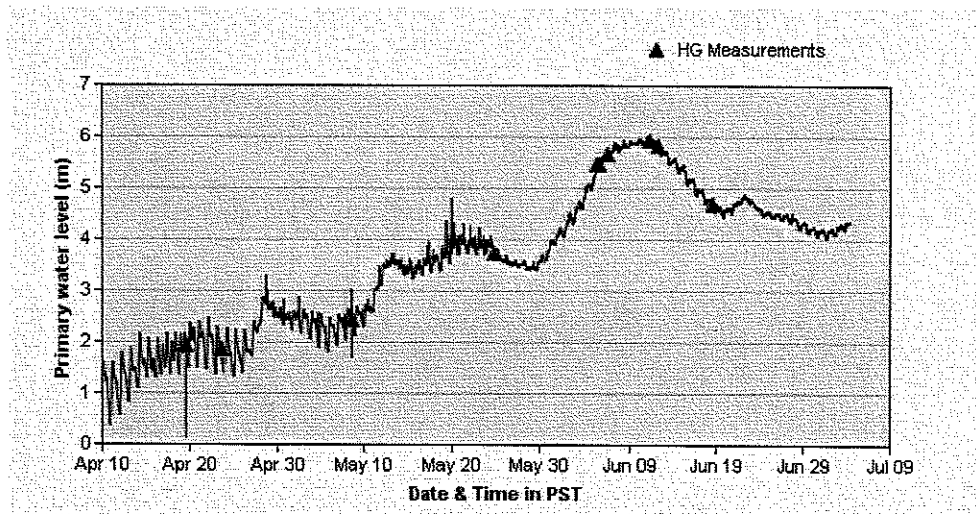
**Figure 1: Recorded Water Levels in the Fraser River Between April and July, 2007
(Monitoring Station at Mission, B.C.)**

During the construction period from 10 April to 31 May 2007, measured water levels in the Fraser River varied between about 1 m and 6 m GSC with the peak water level occurring between June 9 and 11, 2007. A plot of recorded water levels at the Mission, B.C. monitoring station (obtained from the Ministry of Environment website) during the 2007 Freshet period is shown in Figure 1 below.

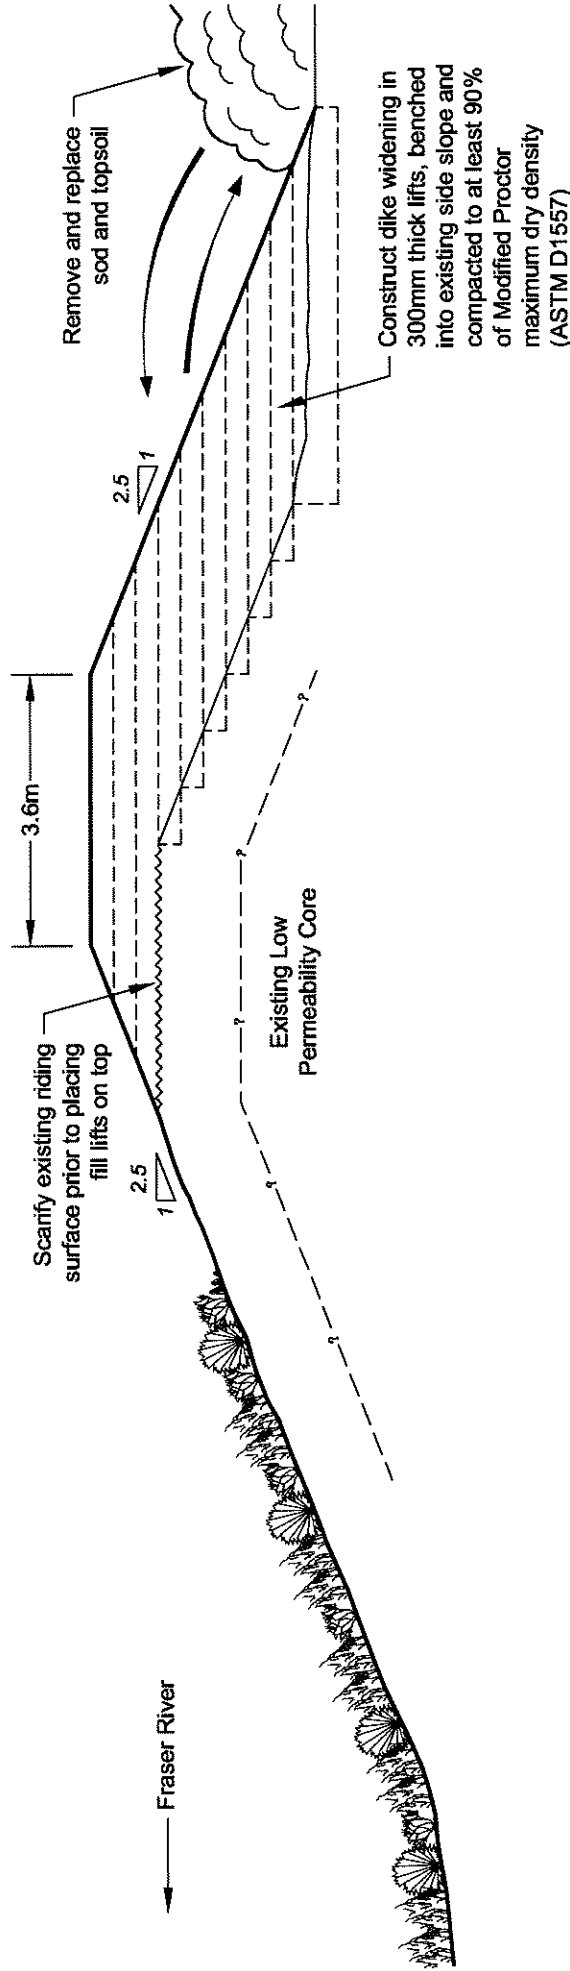
CITY OF ABBOTSFORD
 MATSQUI DIKE UPGRADE CONCEPT
 ABBOTSFORD, B.C.

The new dike fill materials shall be placed in loose lifts not exceeding 300 mm in thickness and compacted to at least 90 per cent of Modified Proctor maximum dry density (ASTM D1557). The thickness of the initial lift of fill placed near the toe of the side slope of the dike on the land side may need to be increased for construction trafficability purposes. Periodic field density testing will be carried out by Golder Associates Ltd. to confirm that the density specification is achieved. The top riding surface of the existing dike shall be scarified to a depth of 150 mm prior to placement of the initial lift of fill on top of the existing dike crest.

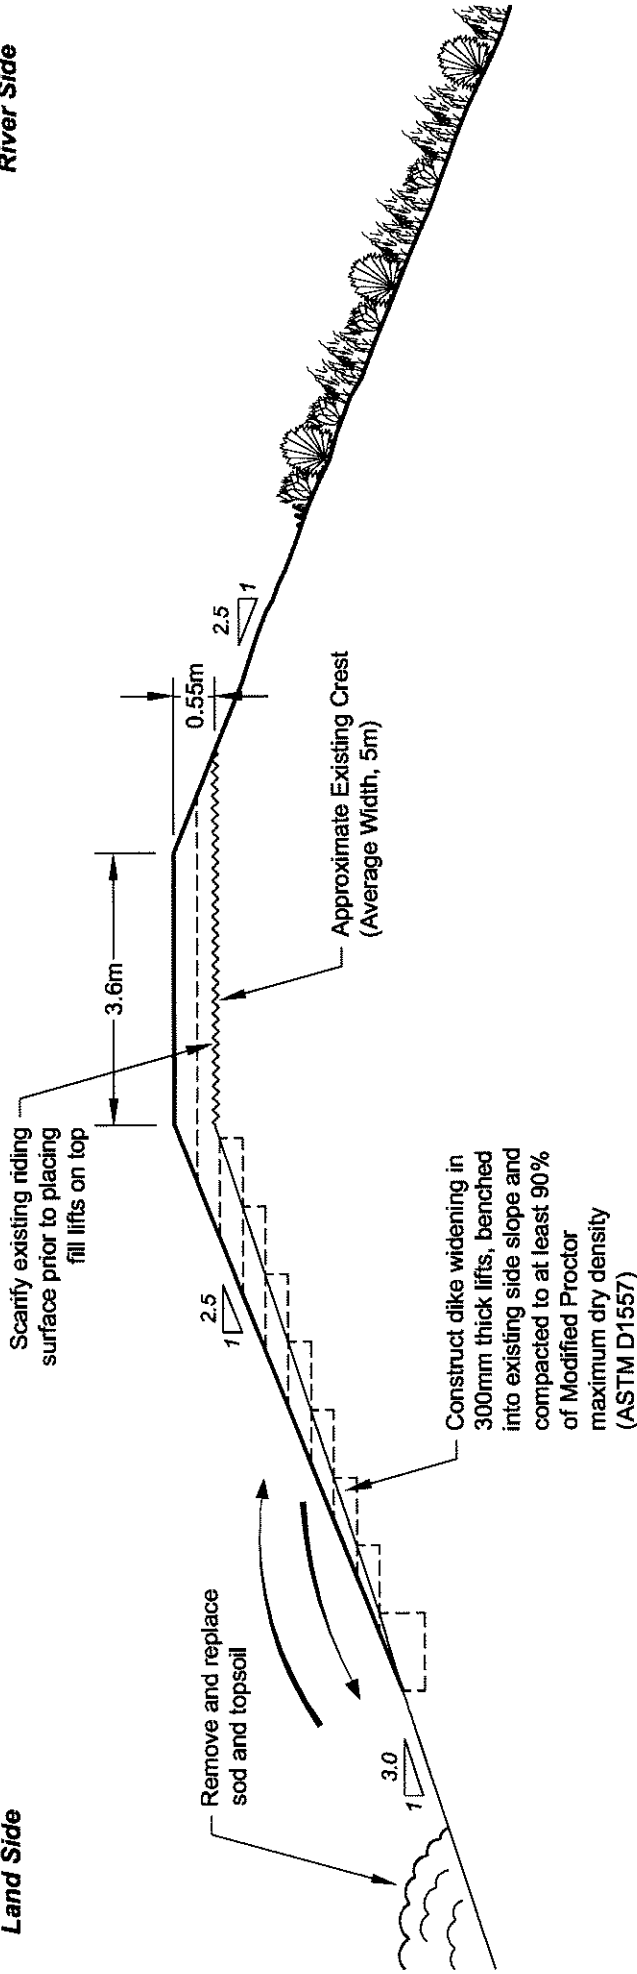
CITY OF ABBOTSFORD
VEDDER DIKE UPGRADE
ABBOTSFORD, B.C.

The new dike fill materials shall be placed in loose lifts not exceeding 300 mm in thickness and compacted to at least 90 per cent of Modified Proctor maximum dry density (ASTM D1557). Periodic field density testing will be carried out by Golder Associates Ltd. to confirm that the density specification is achieved. The top riding surface of the existing dike shall be scarified to a depth of 150 mm prior to placement of the initial lift of fill on top of the existing dike crest.

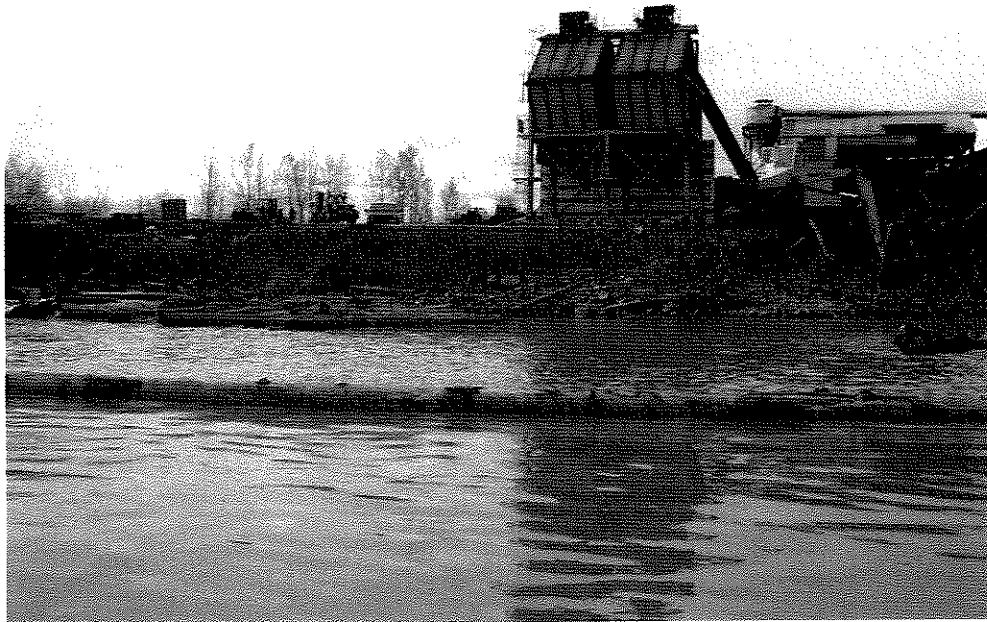
PHOTOGRAPH 1

Looking south, near Sta. 1+650. Cedar Shake & Shingle Mill.

Bank protection was observed along the existing shoreline from the existing Cedar Shake and Shingle Mill (See Photograph 1) near the west end of the existing Matsqui Dike to the GVRD Park located near the Mission Bridge (Highway No. 11 crossing over the Fraser River). In the area of the GVRD Park, the foreshore gradients are flat. The majority of armour stone bank protection downstream of the Mission Bridge has large patches of moss cover (see Photograph 2) inferring that this material has been in place and relatively undisturbed for a number of years. A localized area of recently placed armour stone was observed along the foreshore near the existing flare at the JAMES PCC (see Photograph 9). Armour stone bank protection, brush and trees were observed along the existing foreshore at the JAMES PCC (see Photographs 4 to 12). In many areas, the brush cover obscures the upper portions of the armour stone protection layer. Some minor sloughing was observed in several locations along the foreshore but no significant areas of concern were observed near the JAMES PCC.

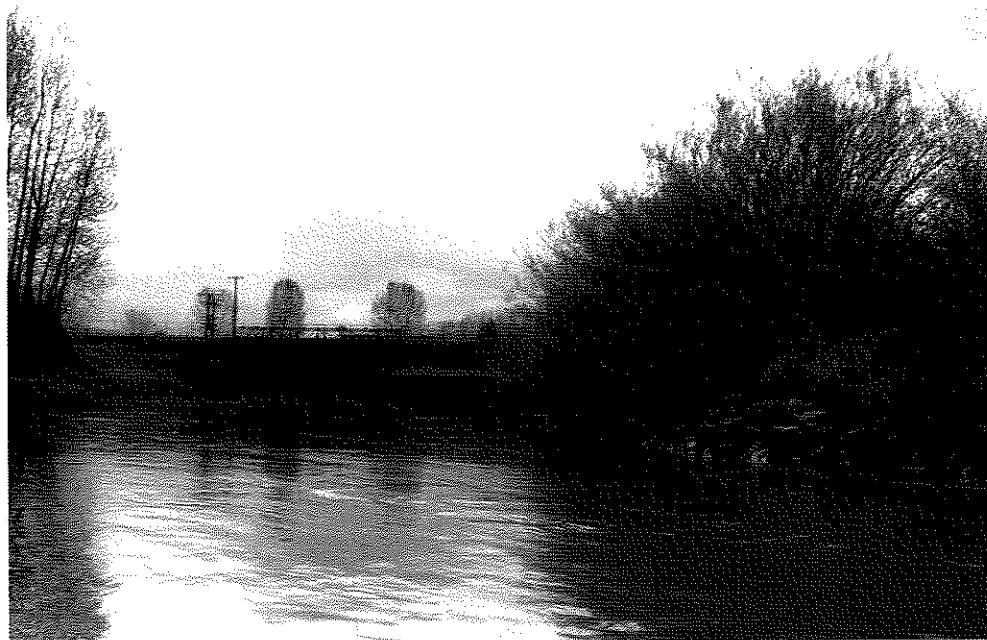
PHOTOGRAPH 10

Looking southeast, opposite Sta. 3+475. Slough at JAMES PCC.

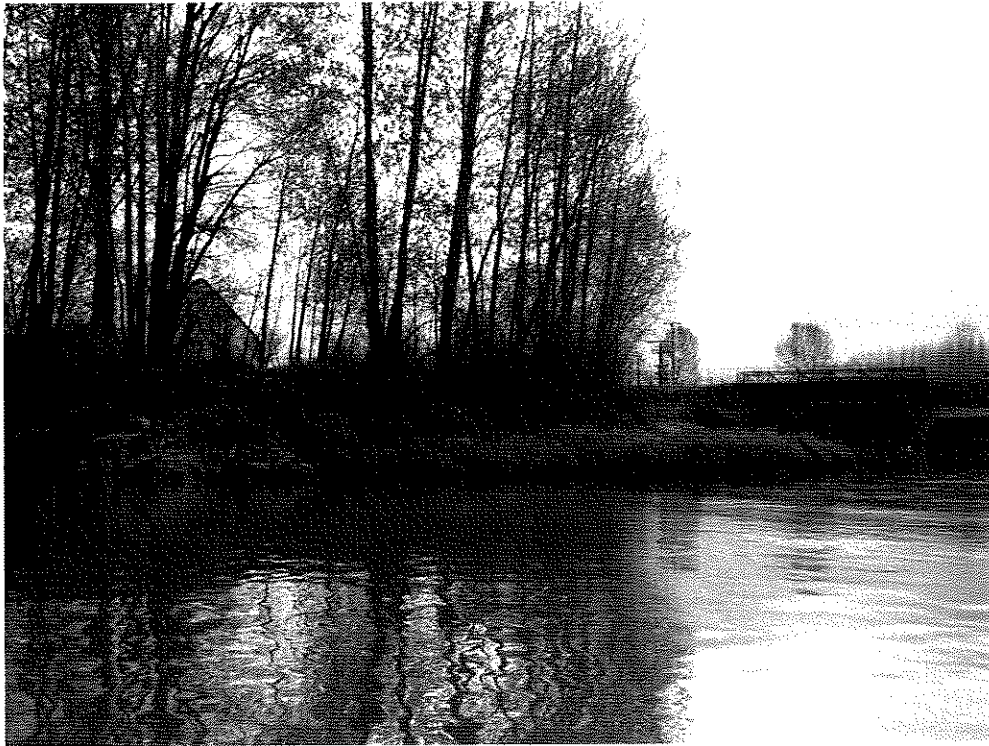
PHOTOGRAPH 11

Looking southeast, opposite Sta. 3+500. Slough at JAMES PCC.

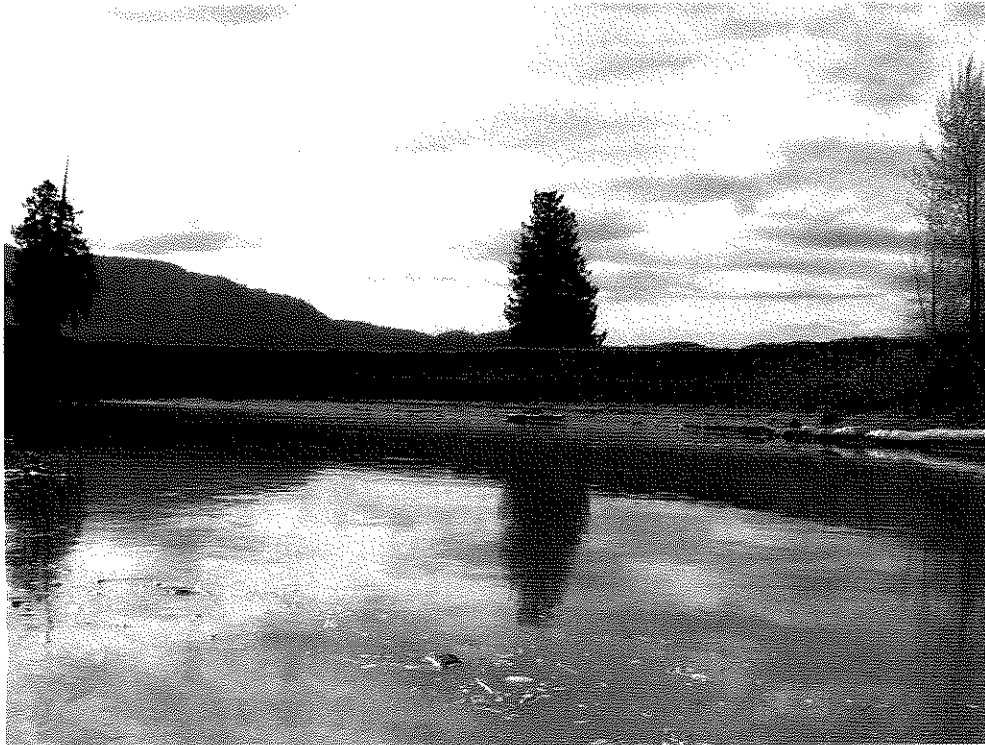
PHOTOGRAPH 16

Looking southeast, opposite Sta. 9+500 (western most "Hard Point Eddy").

No work is presently required. The above noted bank disturbances as seen today above w/l do not tell, however, submerged bank conditions. Therefore, the City should inspect riverbank conditions, including erosion at the 3 'scalped' eddies, again after this year's freshet when water levels are lower in the late summer.

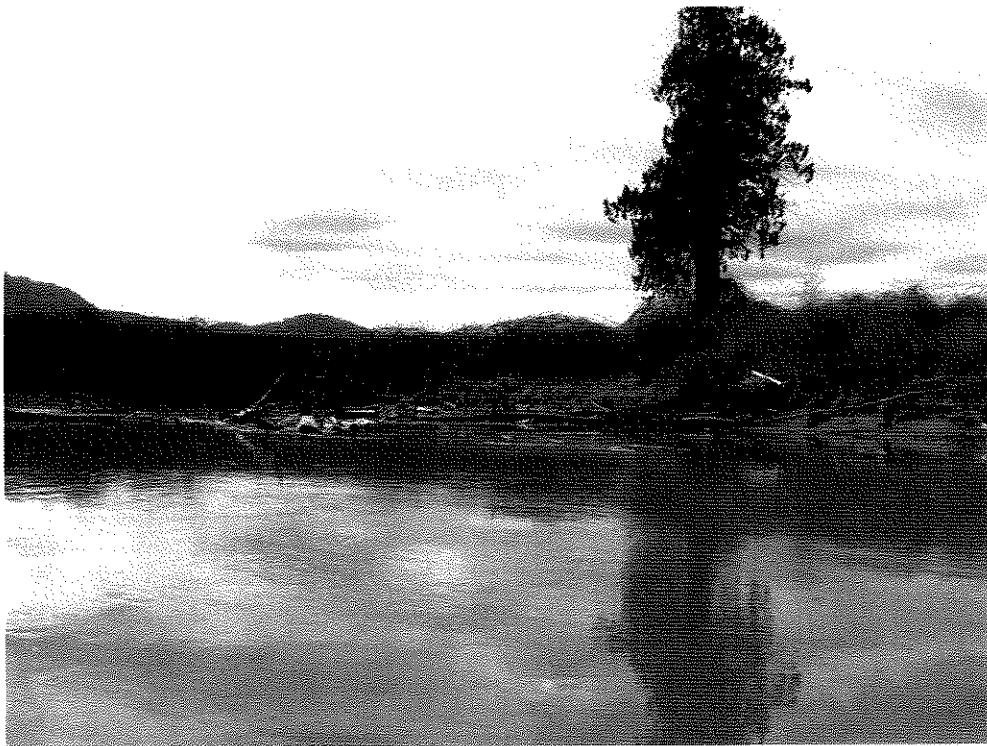
PHOTOGRAPH 17

Looking southeast, opposite Sta. 9+550 (middle “Hard Point Eddy”).

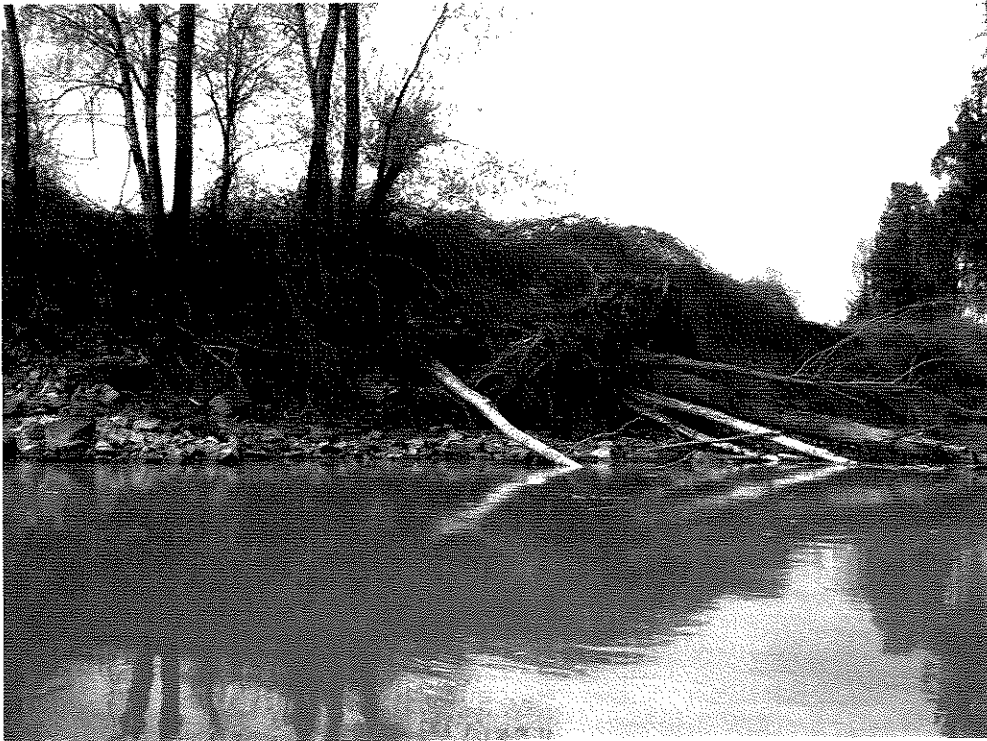
PHOTOGRAPH 18

Looking southwest, opposite Sta. 5+575 (toppled trees).

- Several trees were observed to be leaning and/or toppled into the river at the time of our site visit; but most were likely a result of the river currents impacting and undercutting the existing south bank (several toppled trees were noted near Beharrell Road and the Hard Point Eddies; however, in this area the existing shoreline is about 130 to 150 m away from the dikes); and,

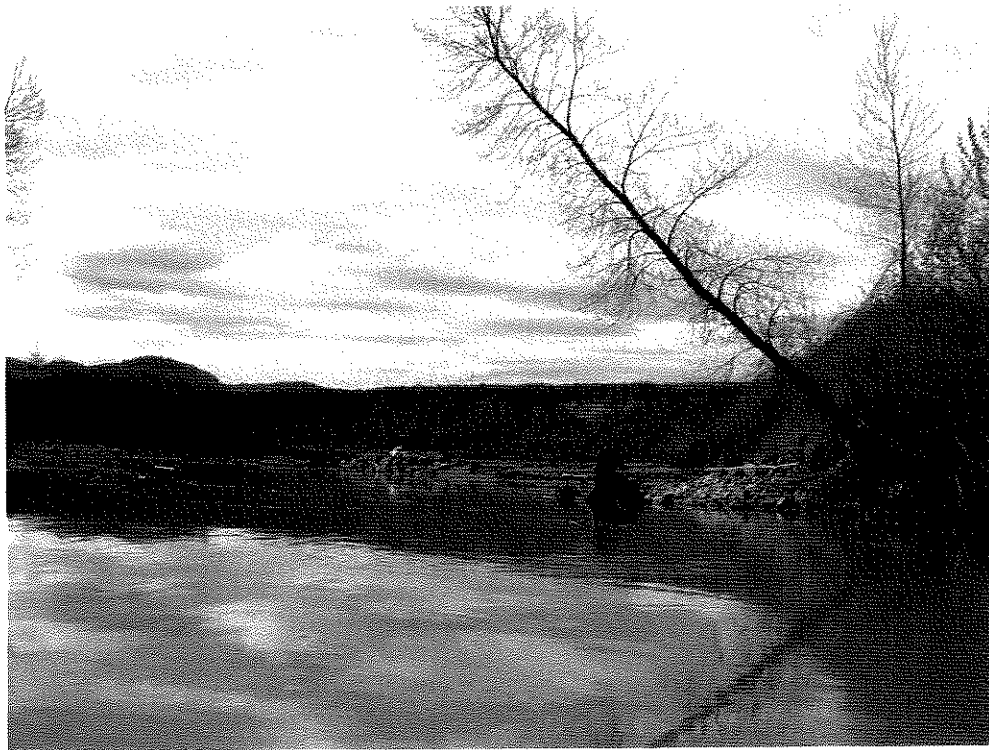
PHOTOGRAPH 19

Looking southeast, opposite Sta. 9+625 (eastern most "Hard Point Eddy").

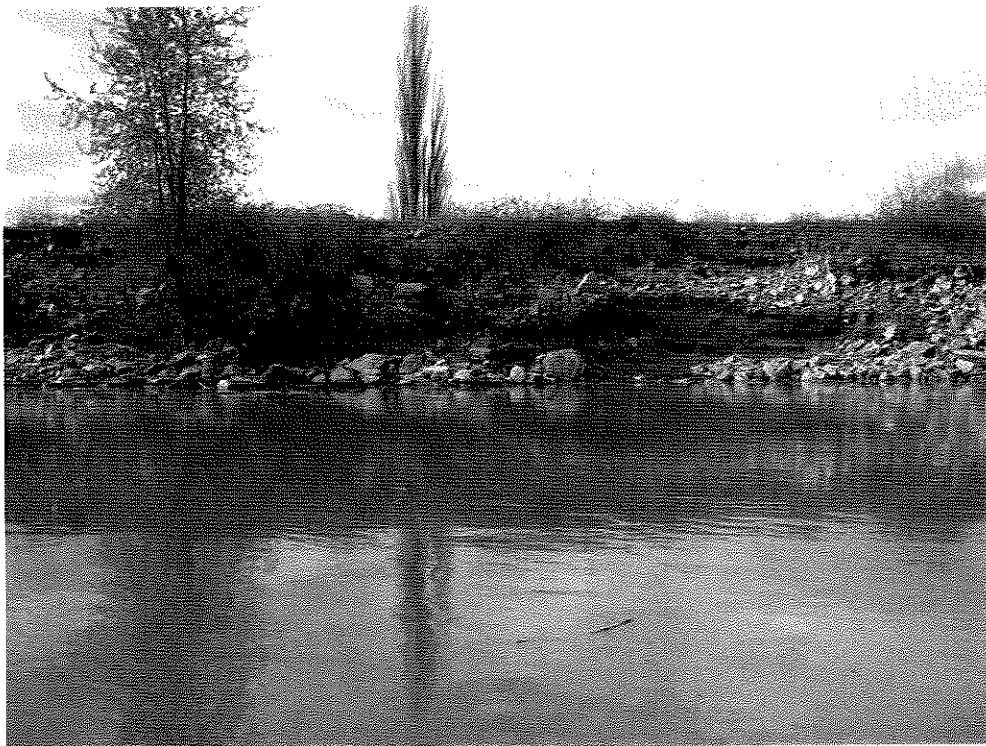
PHOTOGRAPH 20

Looking south, near Sta. 9+900.

Some sloughing of the riverbank, about 10 m or so in width, was observed near Beharrell Road (see Photograph 20). In this area, the existing dike is setback at least 80 m to the south of the riverbank and hence this feature does not currently threaten the dike.

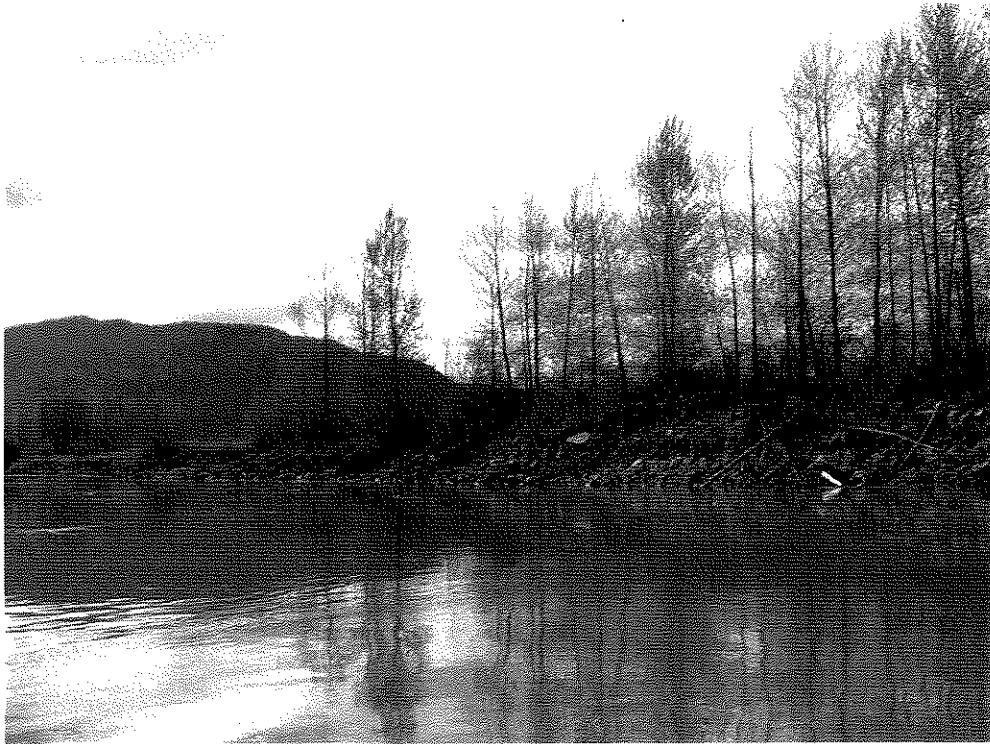
PHOTOGRAPH 21

Looking southeast, near Sta. 10+000.

Photographs 21 to 23 show the typical condition of present shoreline protection upstream of Beharrell Road to Page Road. Some shoreline protection work has been carried out in recent years and this area appears to be stable.

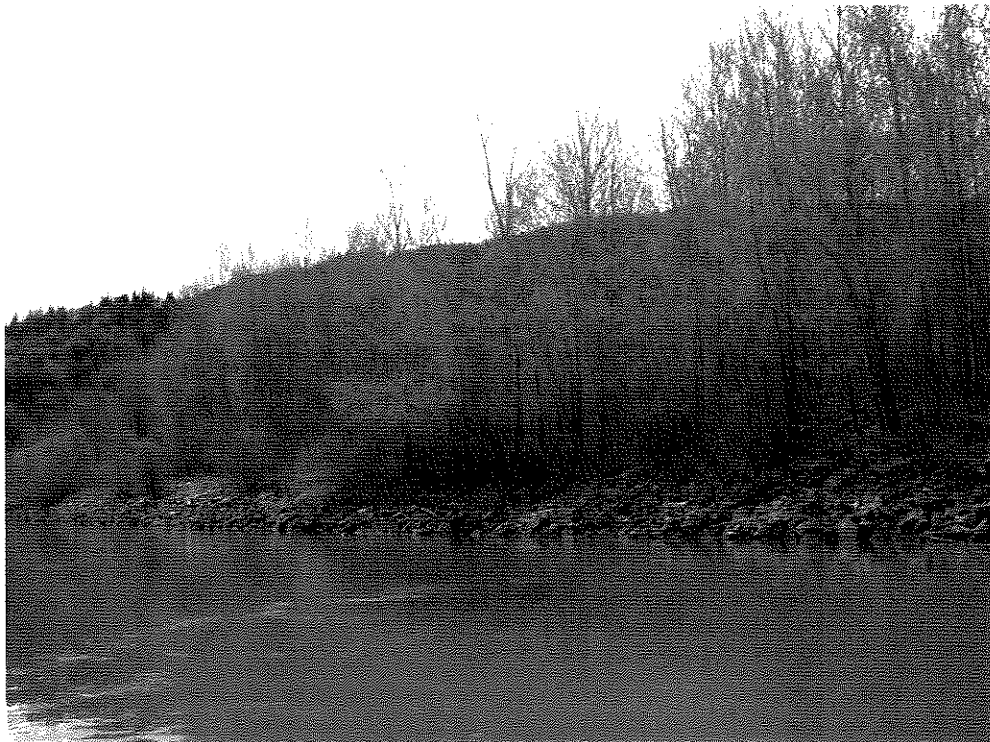
PHOTOGRAPH 22

Looking southeast, opposite about Sta. 12+200.

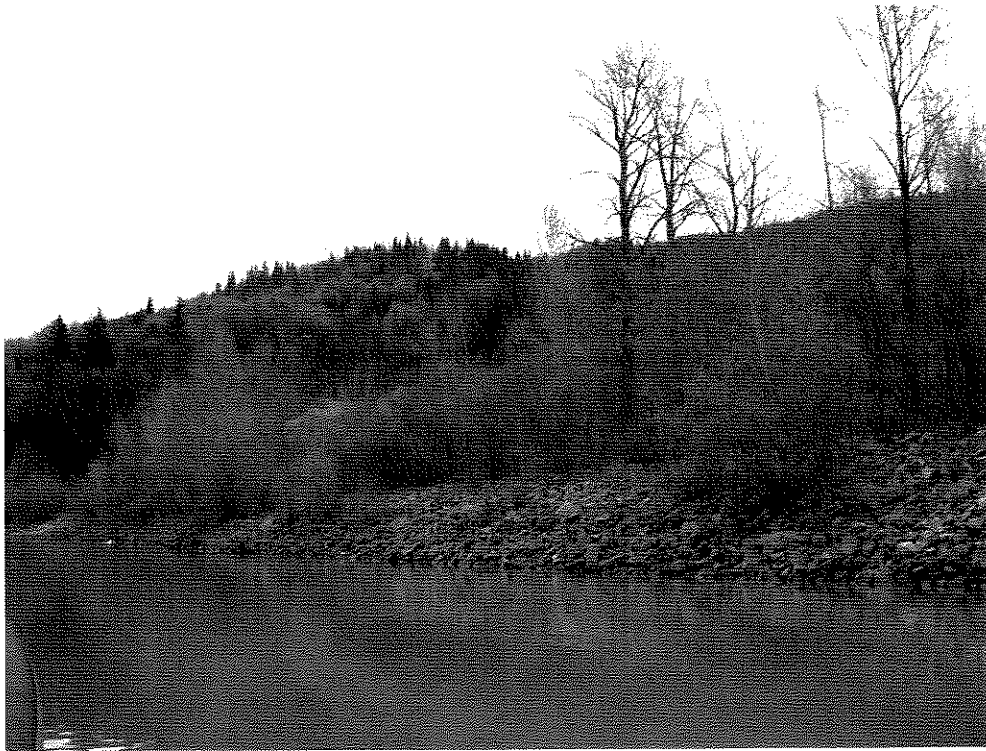
PHOTOGRAPH 23

Looking southeast, opposite about Sta. 12+400.

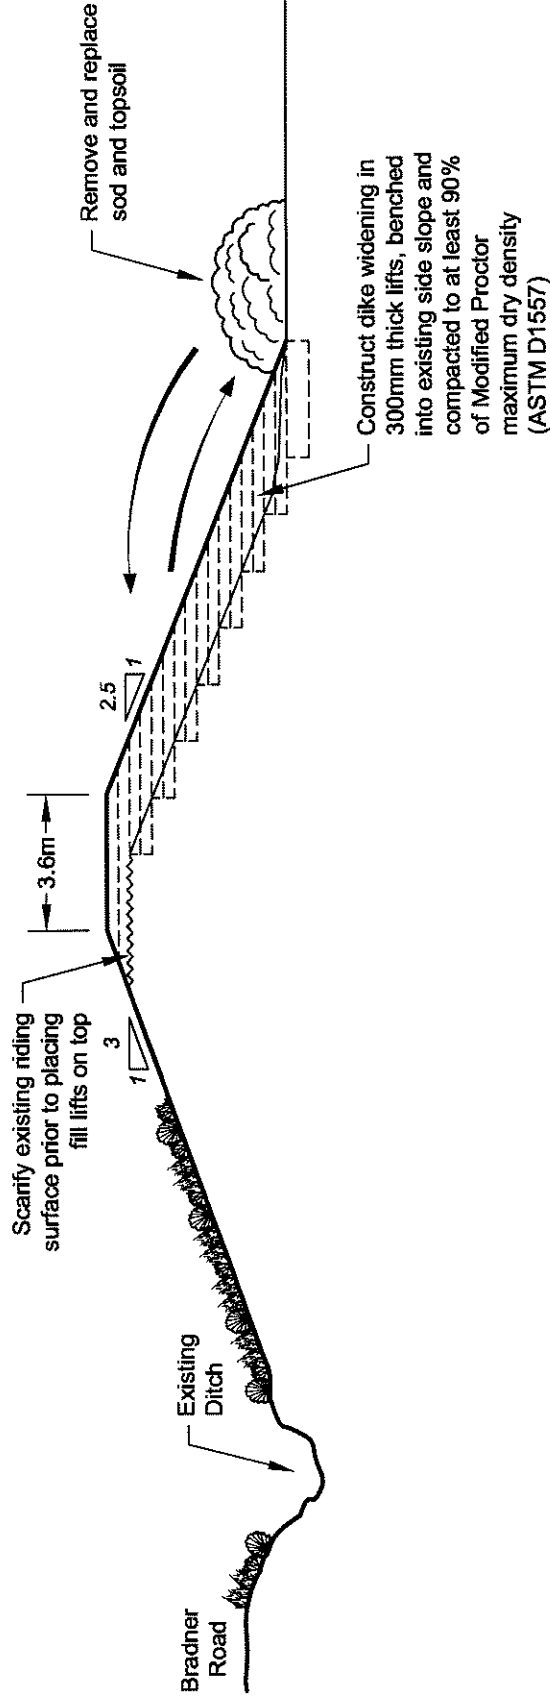
CITY OF ABBOTSFORD
MATSQUI DIKE UPGRADE
ABBOTSFORD, B.C.

The new dike fill materials shall be placed in loose lifts not exceeding 300 mm in thickness and compacted to at least 90 per cent of Modified Proctor maximum dry density (ASTM D1557). Periodic field density testing will be carried out by Golder Associates Ltd. to confirm that the density specification is achieved. The top riding surface of the existing dike shall be scarified to a depth of 150 mm prior to placement of the initial lift of fill on top of the existing dike crest.
