**Flood Protection
and Beach Retention
Boundary Bay
Village Area
Delta, B.C.**

Fraser River Flood
Control Program

February 1987

**Hay and Co.
Consultants Inc.**

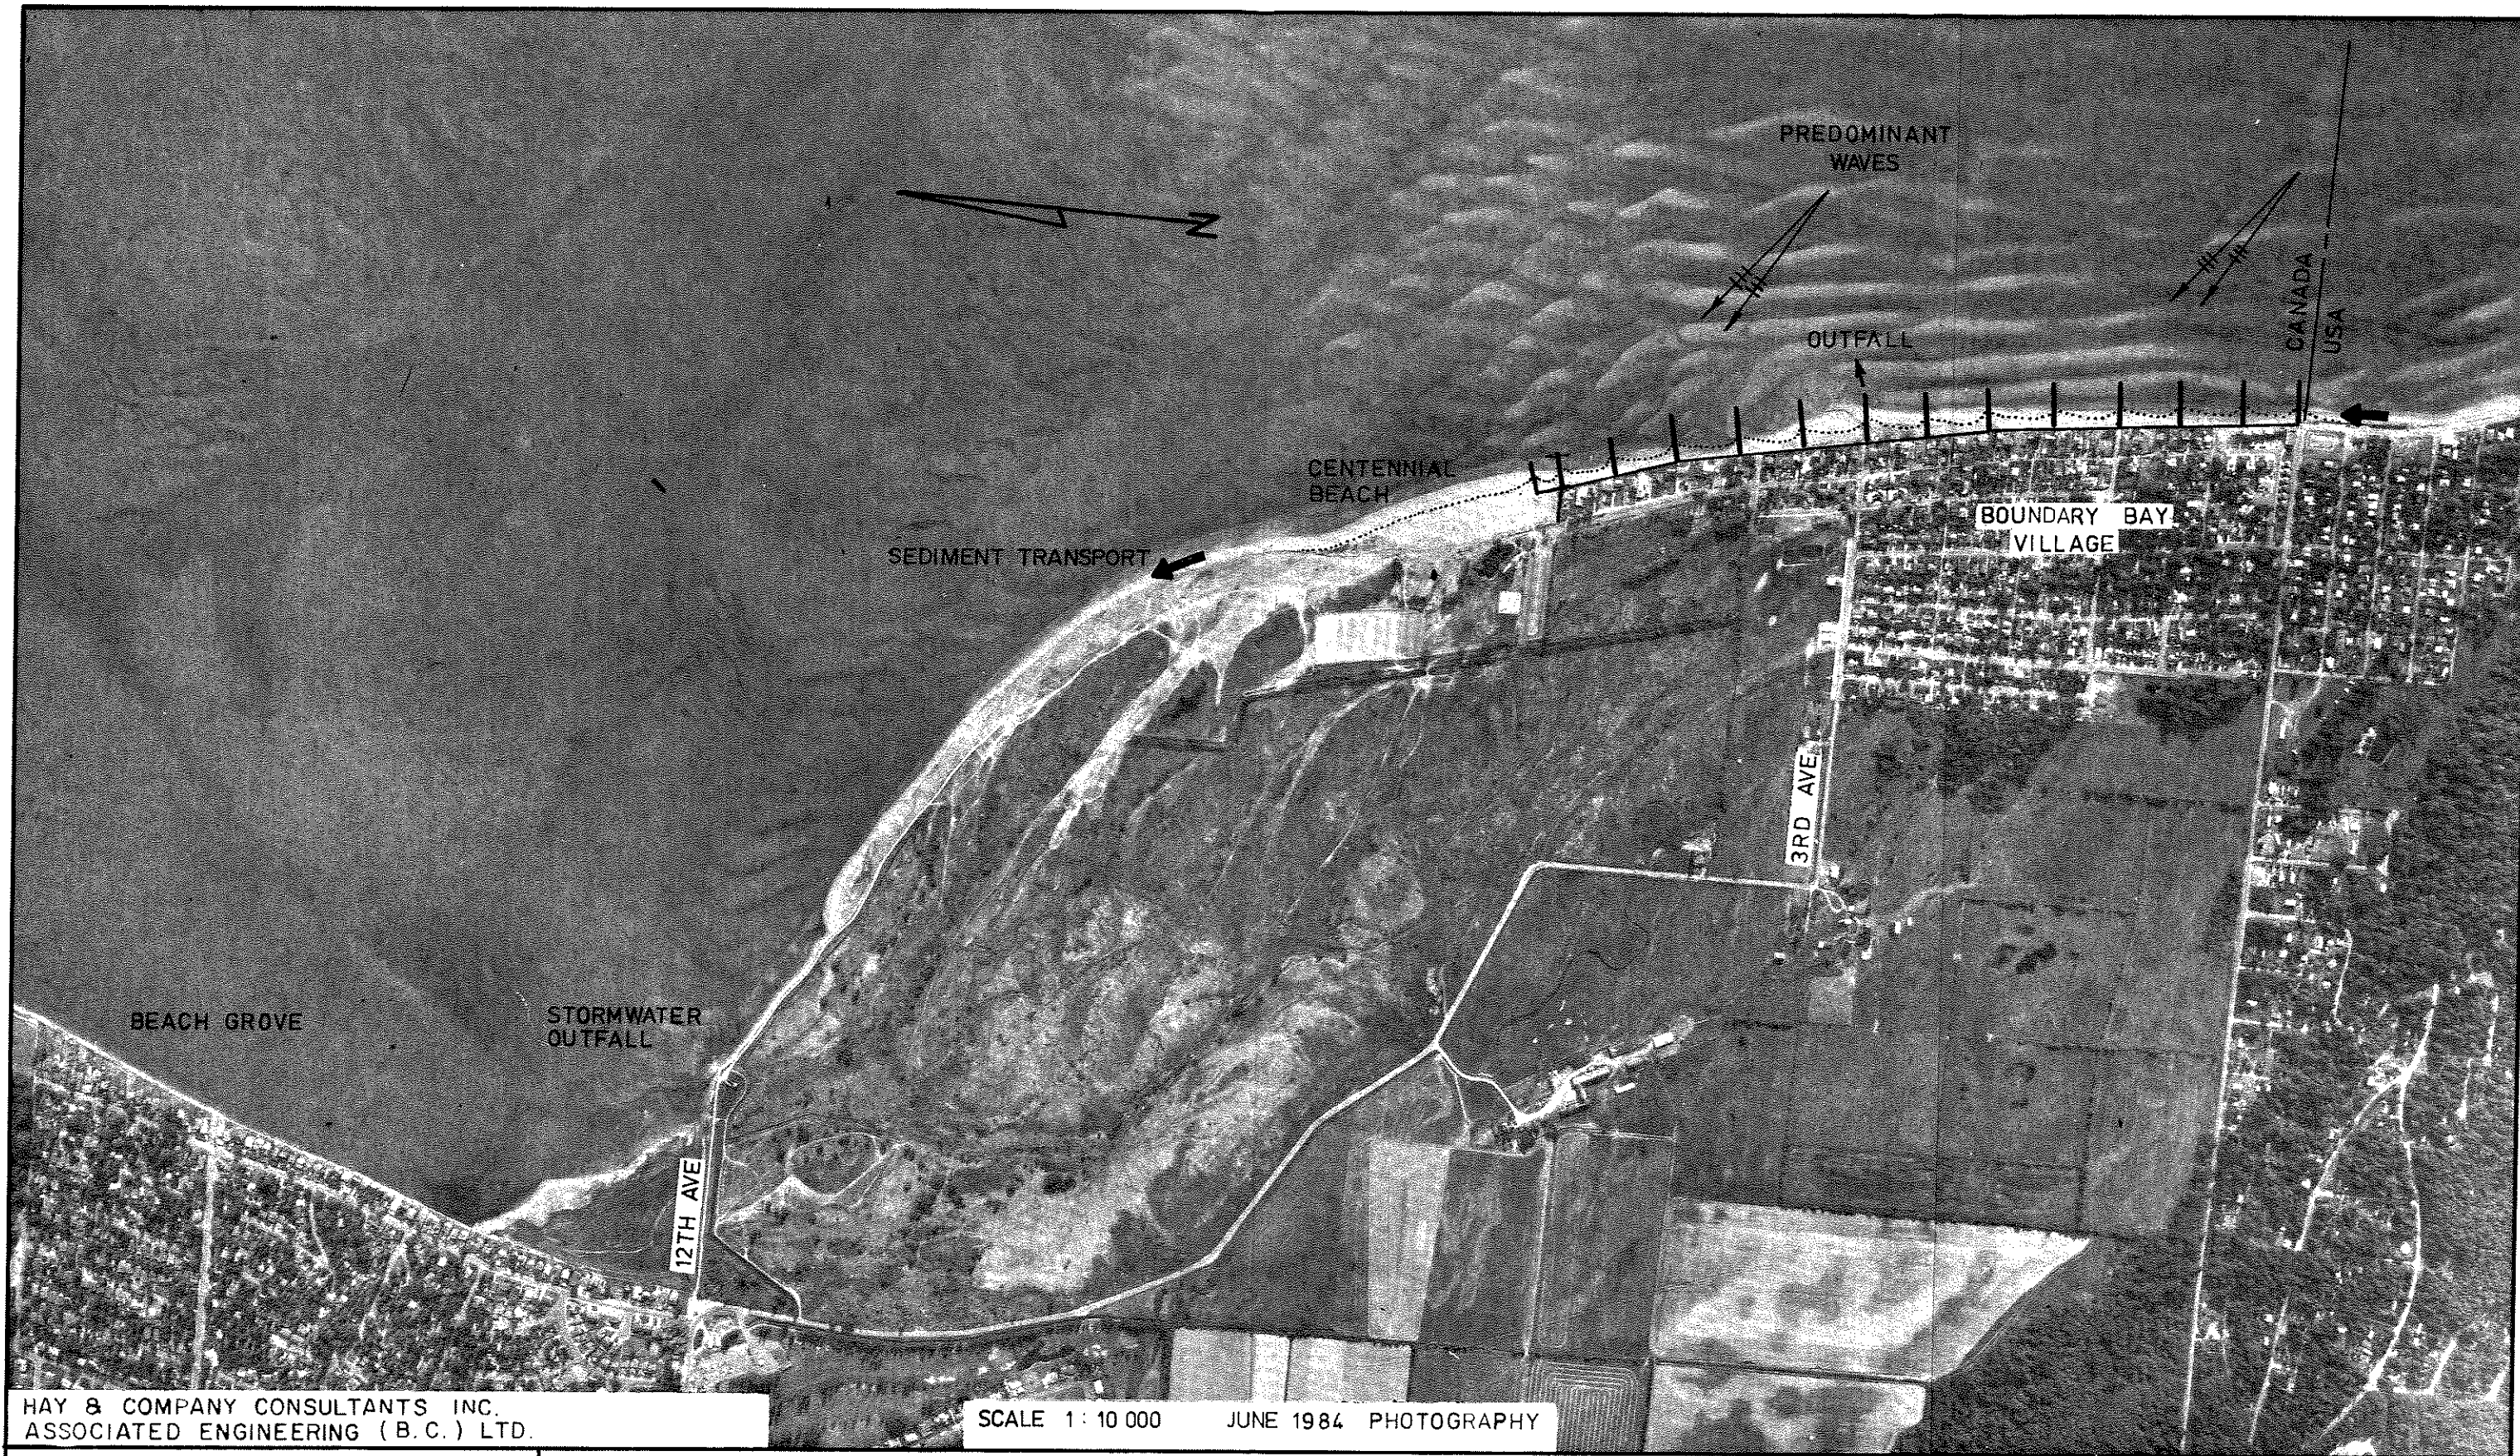
FIGURE
10

CLOSE SPACED GROUYNE FIELD
LAYOUT

The number of groynes needed to stabilize the shoreline requires further discussion and study. The two possible extremes; numerous short structures closely spaced and few long structures are shown in Figures 10 and 11 respectively. A suggested approach to finalizing the groyne concept would be to select a length, spacing and location using the layouts in the above figures as limits. The 3rd Avenue outfall has been incorporated into one of the groynes in both layouts. The outfall would need to be extended to the high-water line of the new shoreline if not incorporated into one of the groynes.

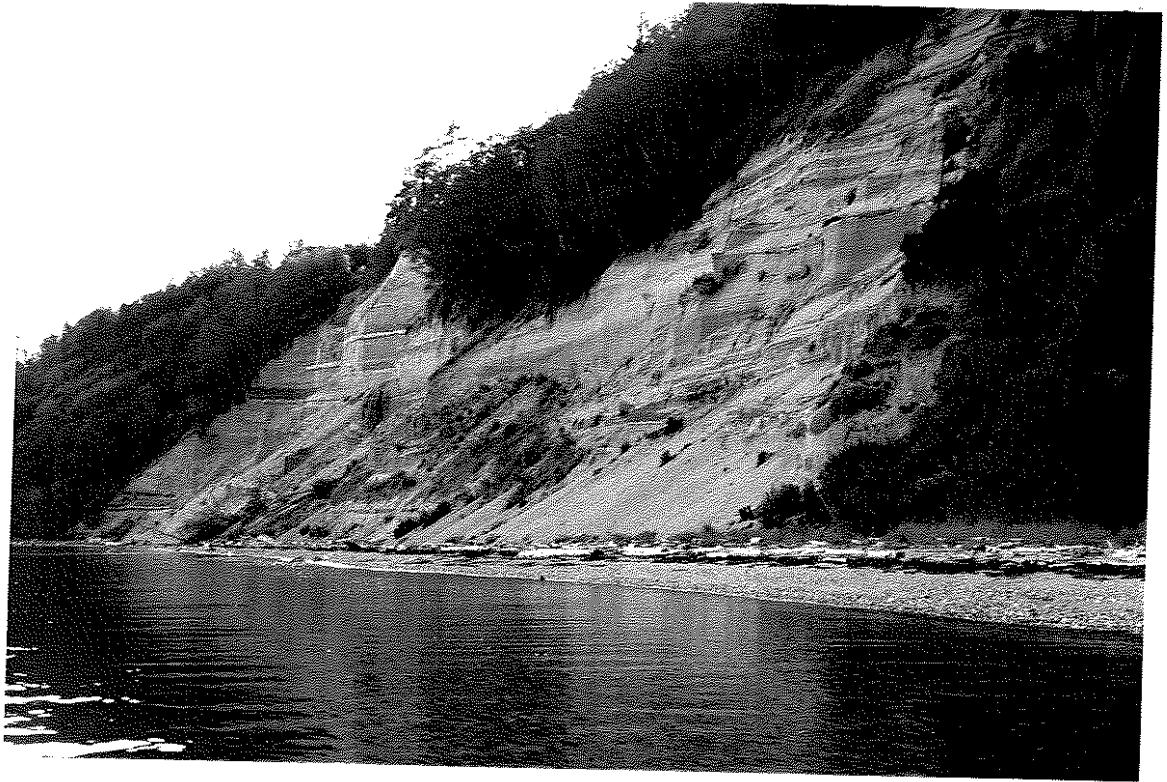
Eroding sand bluffs, south of Canada - USA
border. Major supply of littoral sediments
to western shore of Boundary Bay.

Erosion of the bluffs at the southeast tip of Point Roberts, Photo 1 provides a source of material for development of the shoreline between Boundary Bay Village and Beach Grove. The predominant southeasterly waves create a northerly littoral drift or longshore sediment transport. Figure 5, which diminishes in magnitude to the north, as the waves traverse a greater portion of the tidal flats. Transport of the bluff material after the stabilization of Boundary Bay has resulted in a progressive development of the shoreline with a convex platform, Figure 2. The littoral sediments migrate along the coast as longshore bars and are deposited over the tidal flats formed by the Fraser River. Evidence of the transport and deposition process can be seen in the longshore bar currently approaching 12th Avenue and in the strata exposed in several test pits excavated across the foreshore. The test pit logs, Figure 3, show a layer of black silty sand at an elevation similar to the tidal flats. The locations of the test pits are shown on Figure 2.

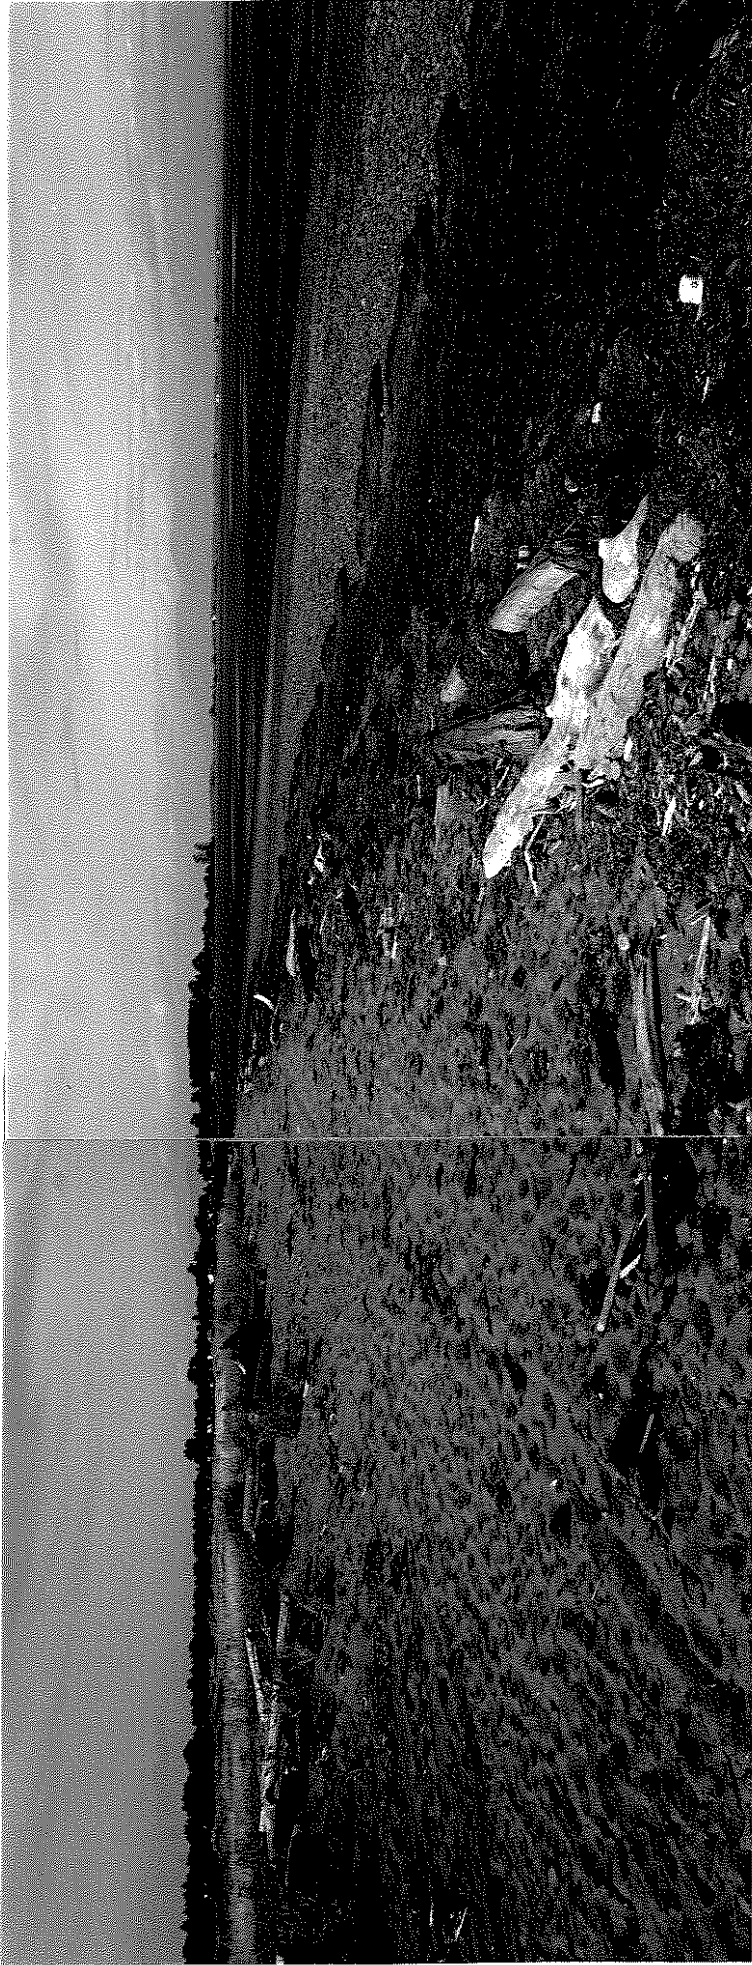
PHOTO 2

Typical foreshore profile north of Centennial Beach

The foreshore zone or beach is characterized by a sandy upper portion with a cobble covered or armoured lower section leading to the tidal flats. Typical beach profiles are shown in Figure 4 and the characteristic segments of the foreshore are shown in Photo 2. The upper foreshore slopes at around 1V:10H extending from the crest of the frontal dune to around elevation 3.3 ft geodetic (GSC). The lower foreshore flattens to a slope of 1V:20H and is armoured with 1 inch to 3 inch cobble. The tidal flats lie at around elevation 0 ft GSC and are composed of a fine uniform sand. Test pits tp2 and tp4 indicate the cobble armour layer of the lower

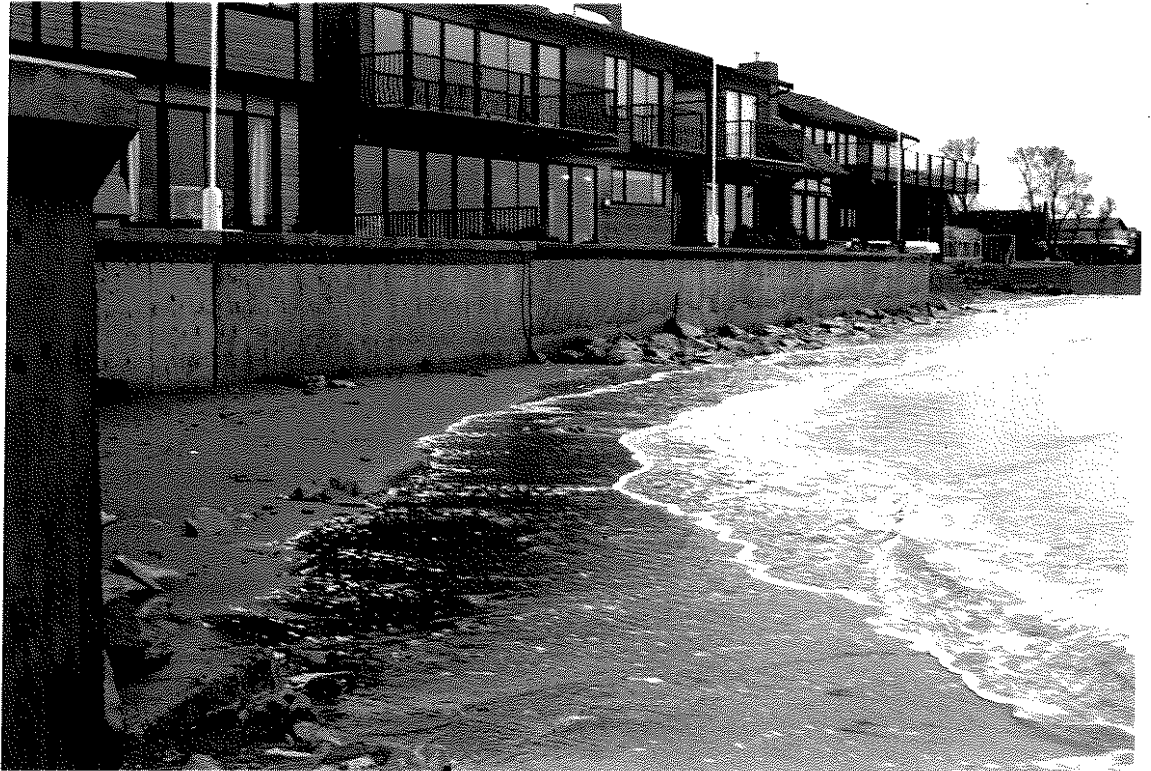
- Looking north from Canada - USA border - note riprap
at toe of wall. 1984 12 13

The section at line 1 Figure 4, Photo 3, is an exception to the typical foreshore profile. The upper foreshore is essentially nonexistent having been replaced by a wall and the armoured lower foreshore extends into a shallow trench scoured into the tidal flats along the front of the wall. the scour along this section of the foreshore adjacent to the Canada - USA border is caused through reflection southeasterly waves approaching the shoreline obliquely. Where the reflected wave crosses the incident wave, Photo 4, the wave height is almost doubled with a subsequent increase in sediment transport capability.

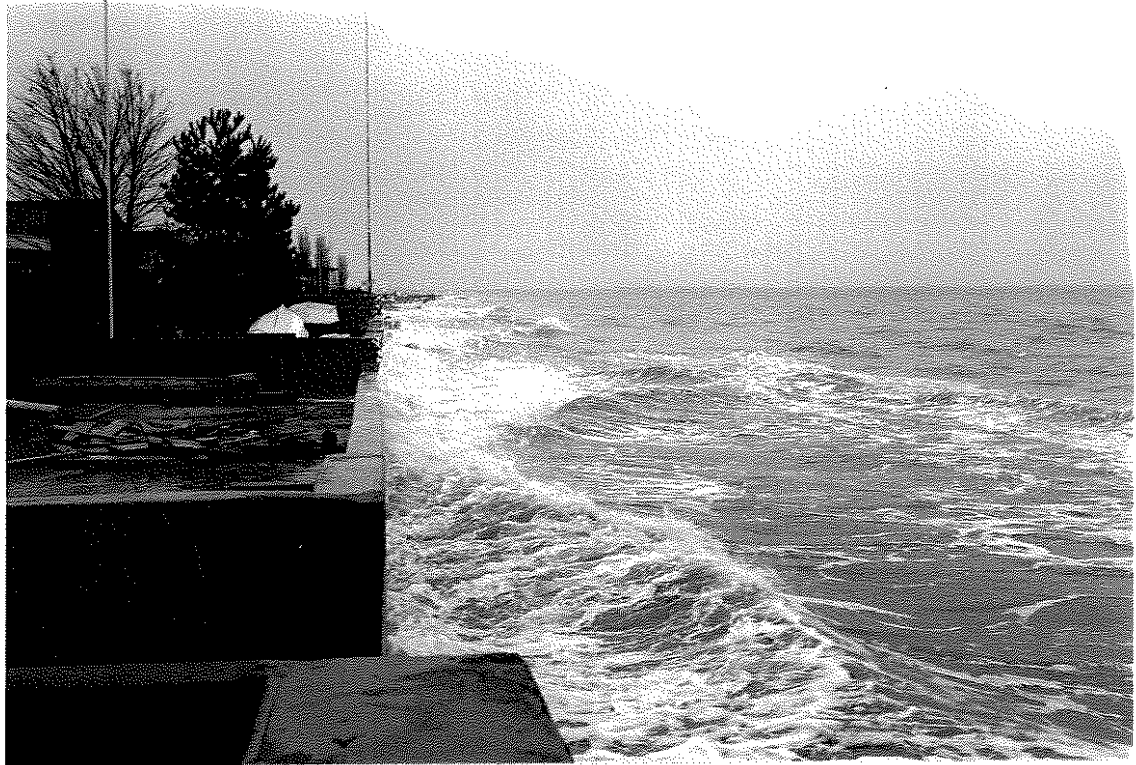
Interaction of incident and reflected waves at wall.
1986 12 14

The wave period for the 1984 event was observed to be between 3 and 4 seconds and as Photo 4 shows the waves overtopped some of the lower walls. The 1984 event can be classed as a typical winter storm resulting from a Pacific low pressure system crossing the coast. The high water level was slightly less than that of a large tide and the winds were moderate, whereas the 1982 and 1967 storms were more extreme events. Figure 6 indicates the high water level recorded for the extreme events to have a probability of occurring once in 50 years. The wind speeds recorded during the extreme tides although stronger than the 1984 storm are not severe and occur frequently each winter.
