Fish Stream Crossing Structures recently installed in the Quesnel Forest District

Cris Guppy
Forest Ecosystem Specialist
Quesnel Forest District
Habitat Protection Branch
Ministry of Environment, Lands and Parks

Final Report - February 9, 2001

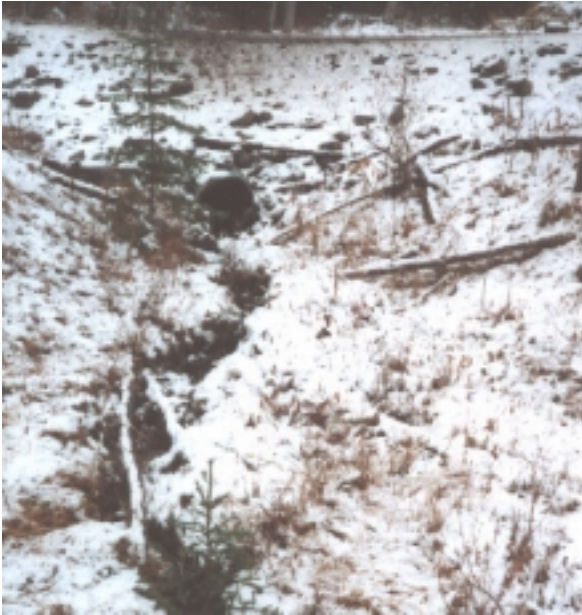
Comments: This culvert may have replaced a pre-FPC culvert passing a tributary of Merston Creek. The culvert will block fish passage (10% gradient), if fish are present.

Photograph 12.09: Site 3, stream channel below outlet.

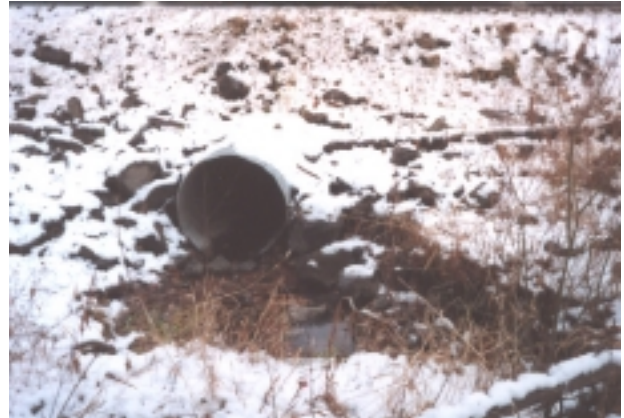
Photograph 12.07: Site 3, inlet of culvert.

Stream width = 0.5 m
Culvert width = 0.8 m
Culvert slope = 10%

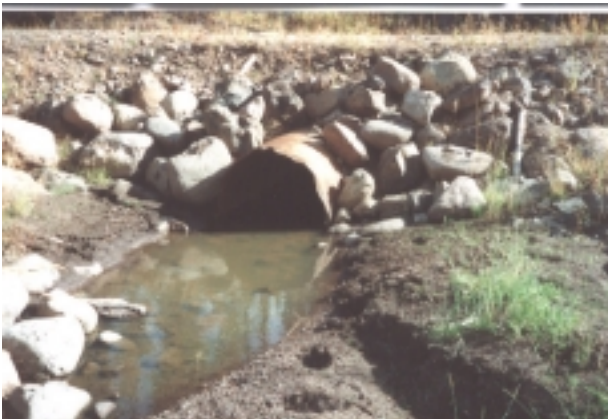
Comments: Round culvert in a very “flashy” stream, embedded 20%, substrate of large rock placed in the upstream half of the culvert. The culvert will block fish passage at low water flows, due to the large rock.

Photograph 2.08: Site 10, culvert outlet. Note the ponding at the outlet that has resulted from scouring.

Stream width = 1.2 m
Culvert width = 1.1 m; Culvert slope = 1%

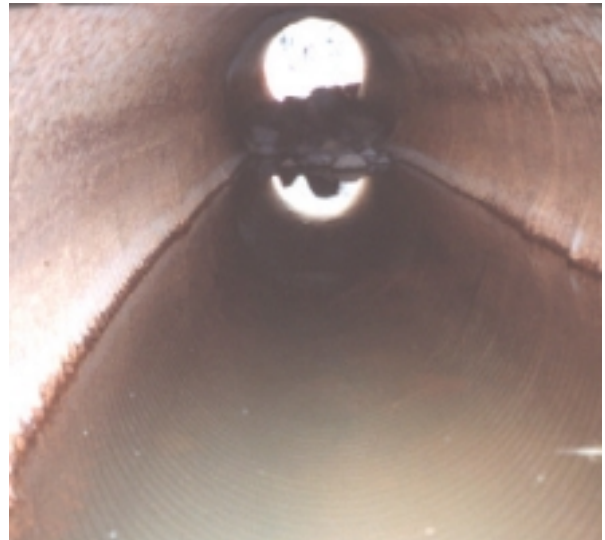
Photograph 2.09: Site 10, culvert interior (from outlet).

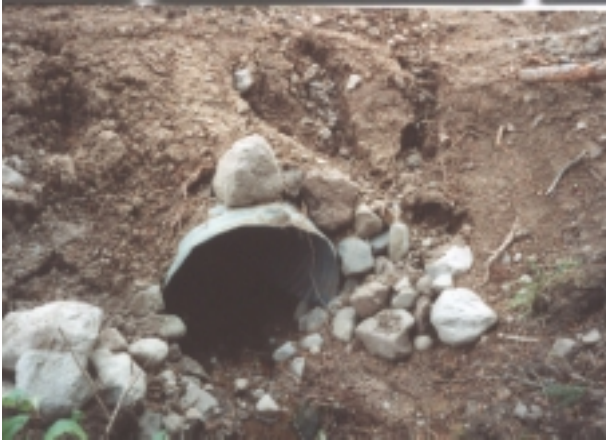
Comments: This culvert was installed at a new in-block crossing, and passes a small, low gradient tributary of Ramsey Creek. The culvert has now been removed.

Photograph 2.10: Site 11, culvert inlet. Note the erosion of the road surface and roadbed.

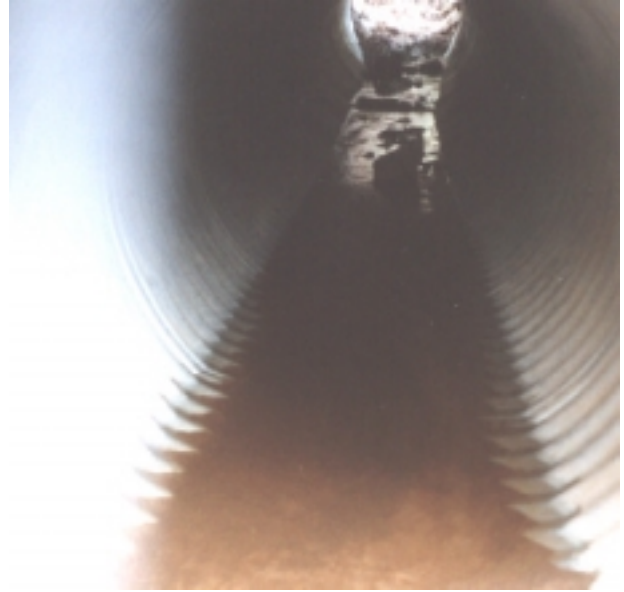
Photograph 2.12: Site 11, culvert interior from outlet.

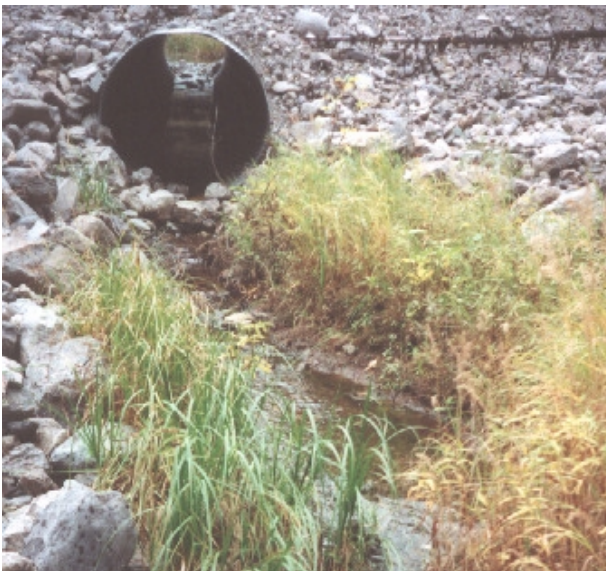
Comments: The gravel and rock substrate has flushed out. Maps are contradictory regarding stream name. Stream width = 0.8 m; Culvert width = 1.2 m; Culvert slope = 4%.

Photograph 3.07: Site 16, outlet.

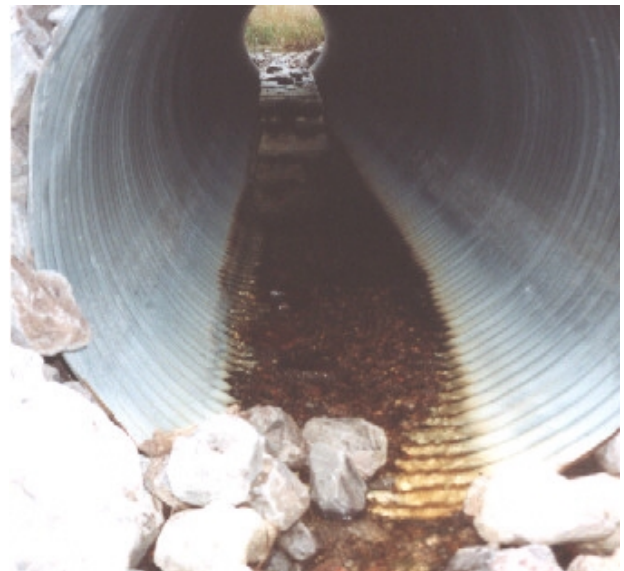
Photograph 3.08: Site 16, interior from outlet.

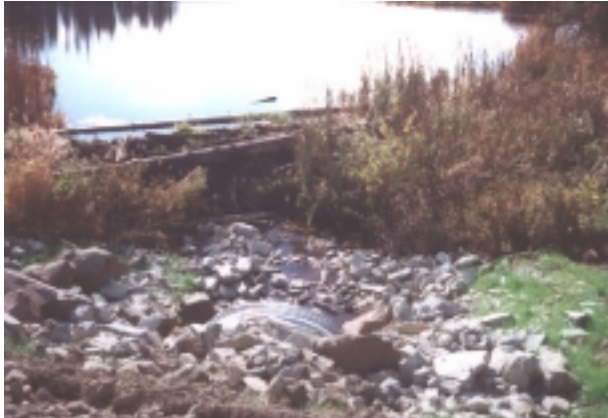
Comments: This round metal pipe was installed in 2000 to replace an undersize culvert. It was embedded 20% and rock substrate placed in it. The rock substrate blocks fish passage at low water, but the beaver dam immediately upstream also prevents fish passage at low water.

Photograph 4.06: Site 19, inlet. Note that the beaver dam is blocking fish passage upstream during low stream flow. Fifteen Mile Lake is behind the beaver dam.

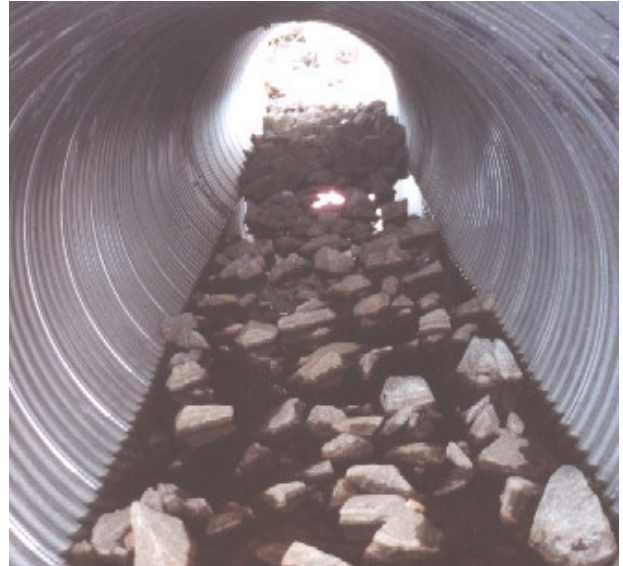
Photograph 4.07: Site 19, interior from outlet. Note the rock near the inlet is blocking fish passage.

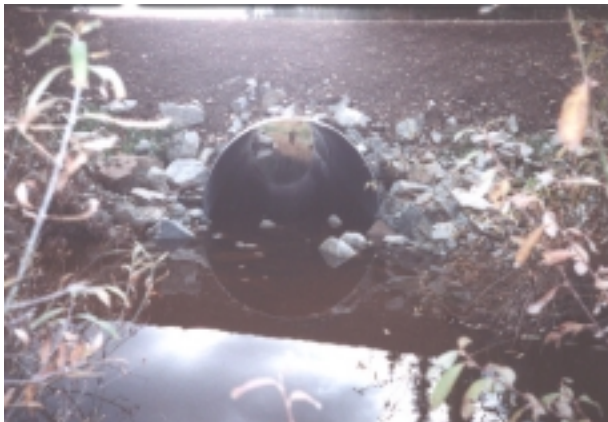
Comments: This round metal pipe was installed in 2000 to replace an undersize culvert. It was embedded 20% and rock substrate placed in it. A downstream beaver dam results in ponded water through the culvert. Stream width = 1.4 m (?); Culvert width = 2.0 m; Culvert slope = 0%.

Photograph 4.09: Site 20, inlet.

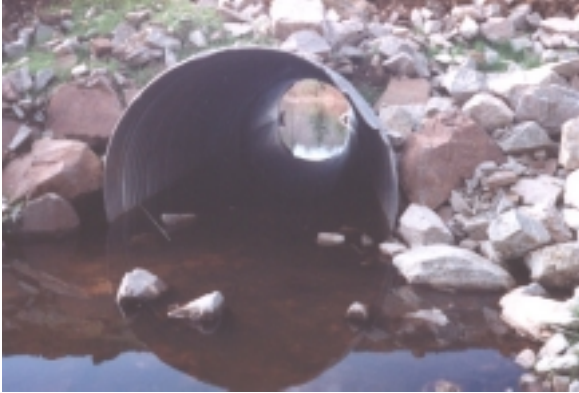
Comments: This round metal pipe was installed in 2000 to replace an undersize culvert. It was embedded 20% and rock substrate placed in it. A downstream beaver dam results in ponded water through the culvert.

Photograph 4.10: Site 21, outlet.

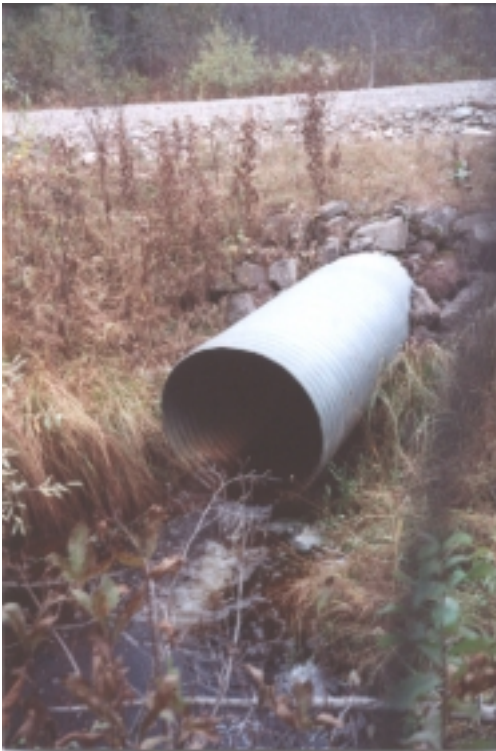
Comments: This round metal pipe was installed in 1995, or may have been pre-FPC. It is not embedded and outlet is perched. Stream width = 1.5 m; Culvert width = 1.0 m; Culvert slope = 0%

Photograph 5.06: Site 25, outlet showing plunge.

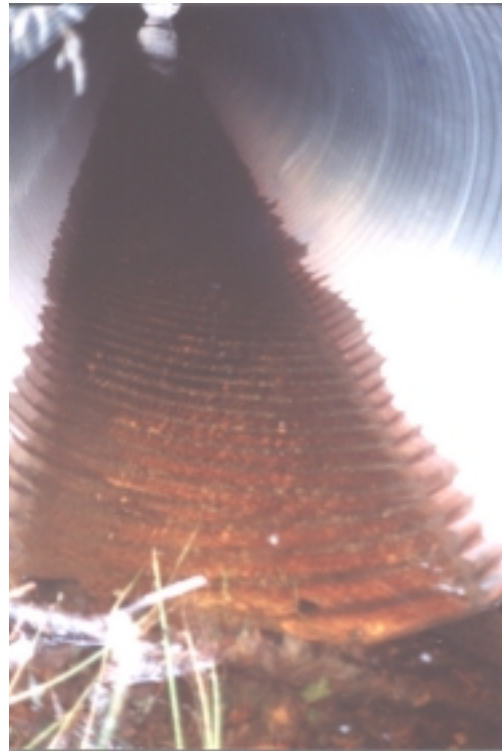
Photograph 5.05: Site 25, interior from inlet.

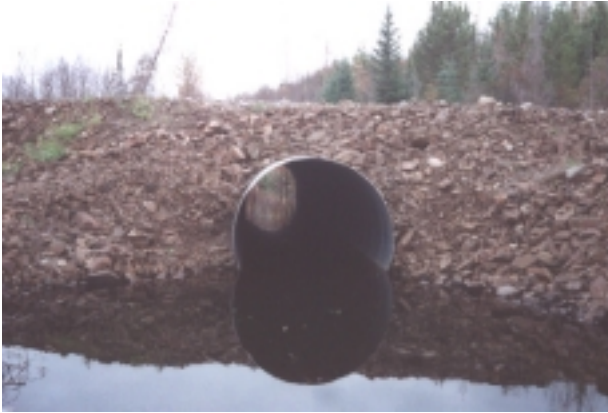
Photograph 5.11: Site 26, outlet.

Comments: This round metal pipe was installed in 2000 after a burst beaver dam washed out the road. It was embedded 20% and rock substrate placed in it, and then pool created above and below the culvert (negating the embedding). A downstream beaver dam results in ponded water through the culvert.

Stream width = 1.8 m (?); Culvert width = 1.8 m; Culvert slope = 0%.

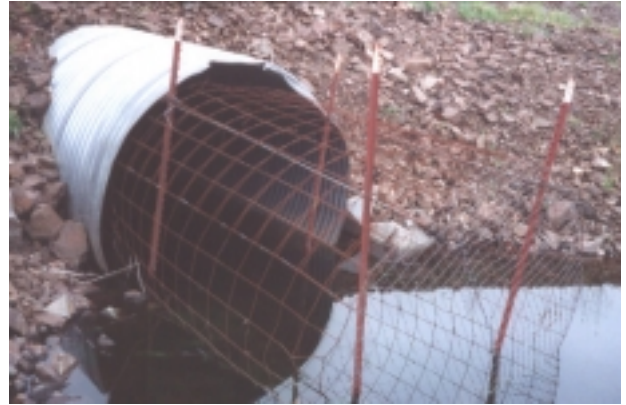
Photograph 0.01: Site 26, inlet with "beaver stop".

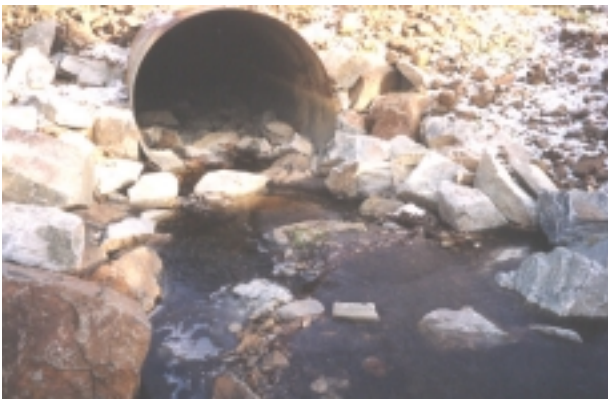
Stream width = 1.8 m (?); Culvert width = 1.8 m; Culvert slope = 5%.

Photograph 5.11: Site 27, inlet of culvert, fish passage blocked at low water by rock substrate.

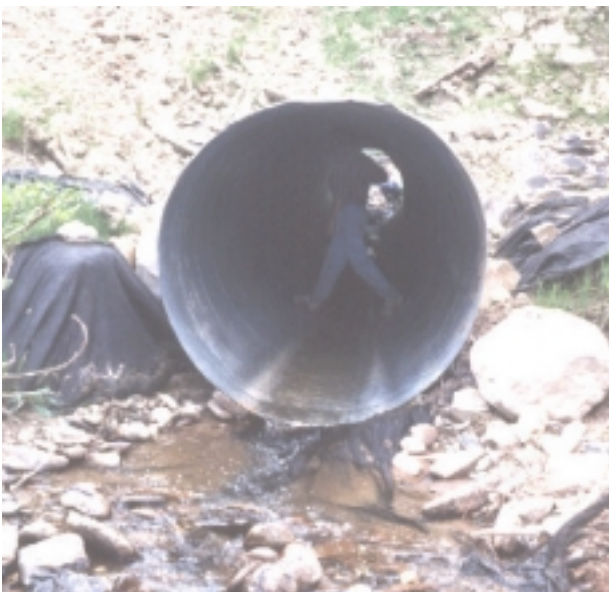
Comments: This round metal culvert was installed in 1998, and was then upgraded to eliminate the perched outlet and provide rock substrate within the culvert. Natural bed-load is augmenting the rock the culvert. Stream width = 1.8 m; Culvert width = 1.8 m; Culvert slope = 3%.

Photograph 0.05: Site 29, original 1998 installation showing perched outlet and lack of substrate in the pipe.

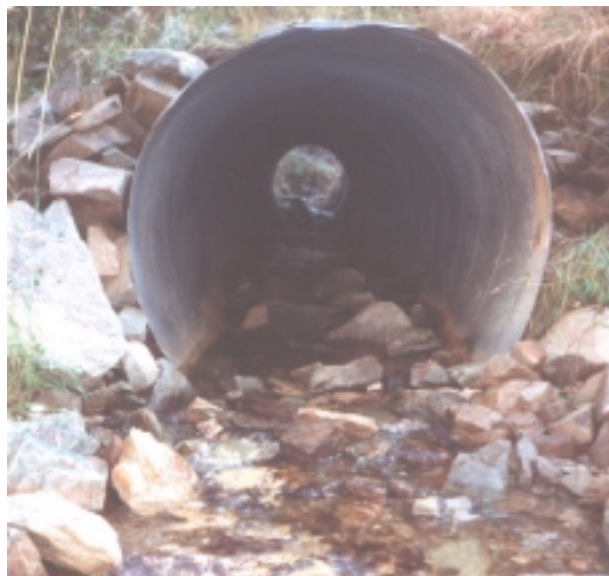
Photograph 6.04: Site 29, the culvert outlet in 2000, two years after remedial substrate placement.

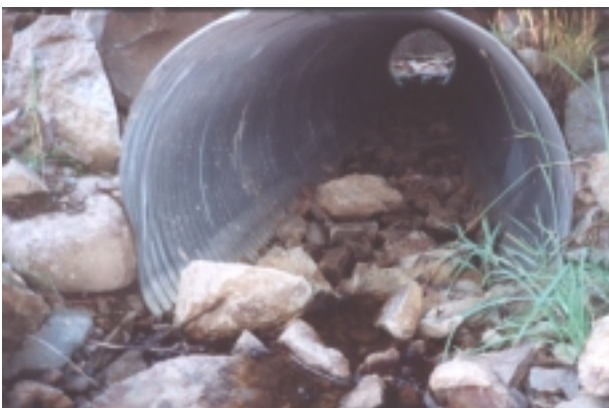
Comments: This round metal culvert was installed in 1999. Rock substrate was placed in the culvert. Fish passage is impeded at low water. Current speed at high flows may be too high.

Photograph 6.09: Site 30, inlet. Note that large rocks used as substrate impede fish passage.

Stream width = 1.4 m

Culvert width = 1.4 m; Culvert slope = 2%.

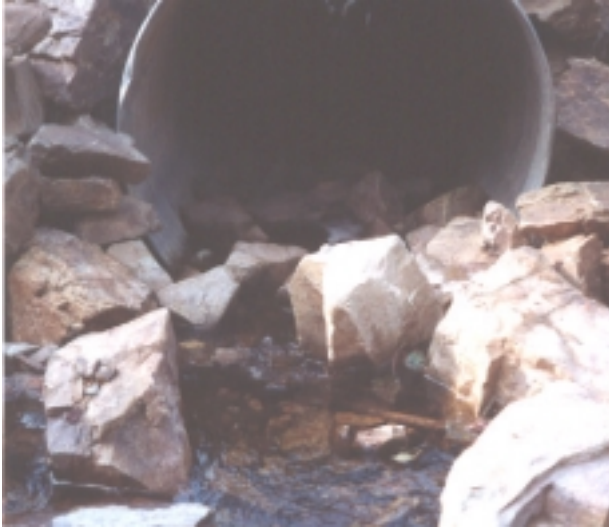
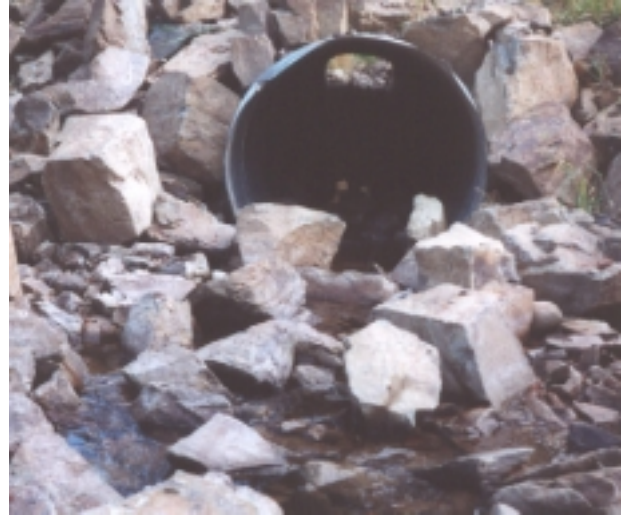
Comments: This round metal culvert was installed in 1999. Rock substrate was placed in the culvert. Fish passage is impeded at low water. Current speed at high flows may be too high.

Photograph 6.11: Site 31, inlet.

Photograph 6.12: Site 31, outlet.

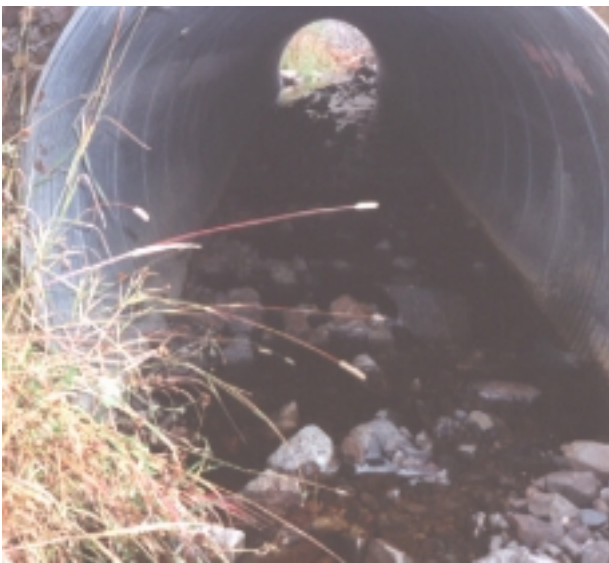
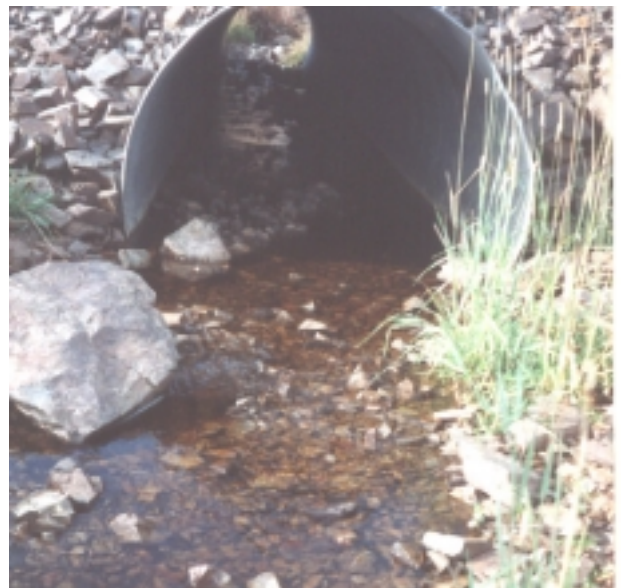
Comments: This round metal culvert was installed in 1998. Gravel and rock substrate was placed in the culvert. The condition of the substrate is excellent.

Photograph 6.13: Site 32, inlet.

Photograph 6.14: Site 32, outlet.

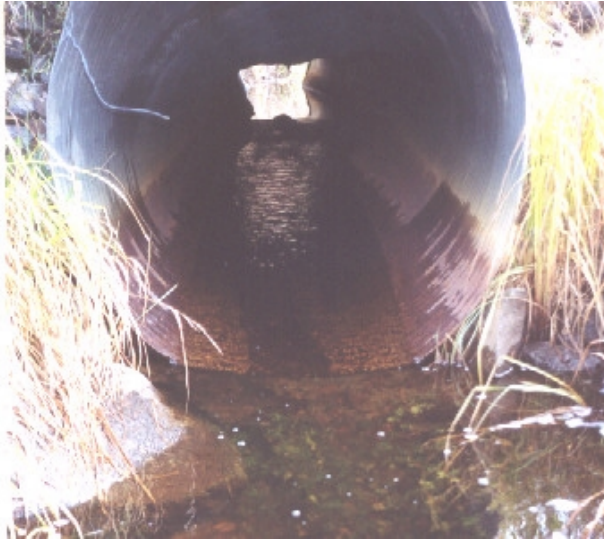
Comments: This round metal culvert was installed in 1995 or 1996 (possibly pre-FPC). The water is ponded through the pipe.

Photograph 7.02: Site 34, outlet.

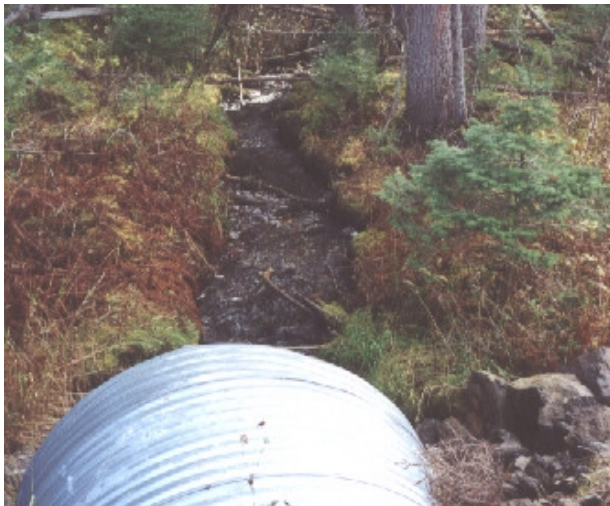
Photograph 7.03: Site 35, upstream from inlet.

Comments: This round metal culvert was installed in 1997. Stream width = 1.2 m; Culvert width = 1.8 m; Culvert slope = 2%.

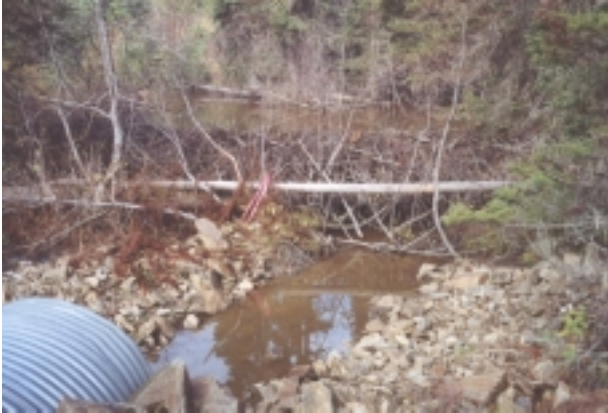
Photograph 7.07: Site 36, inlet.

Comments: This round metal culvert was installed in 2000. A freshly built beaver dam immediately upstream has contributed to sedimentation.

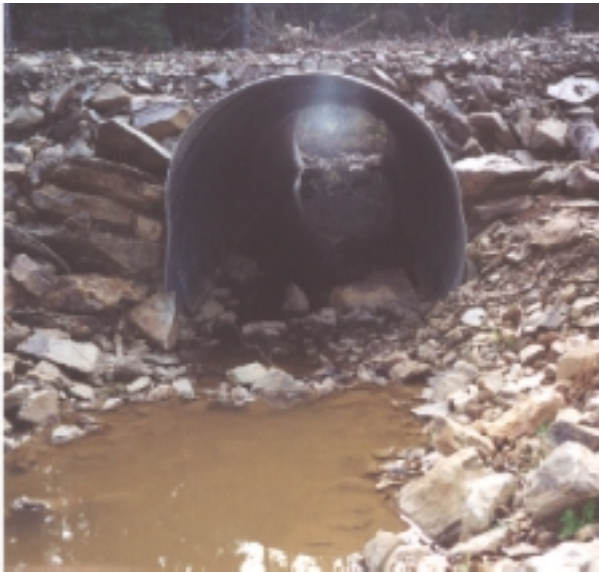
Photograph 7.08: Site 36, inlet.

Stream width = 1.2 m
Culvert width = 1.8 m
Culvert slope = 0%

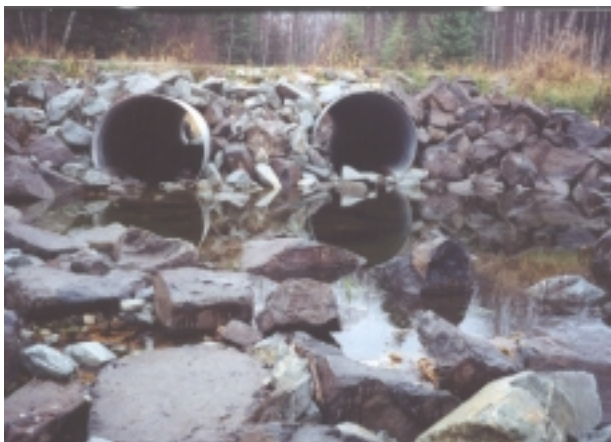
Comments: One culvert already existed and had a perched outlet. In 1999 the second culvert (on left) was installed and a weir built at the outlet to the plunge pool, to permit fish passage.

Photograph 8.07: Site 43, retrofitted culvert crossing.
Culvert width = 1.6 m ; 1.8 m; Culvert slope = 1%.

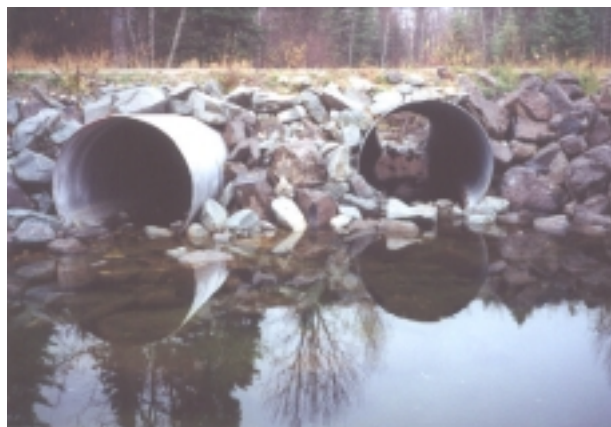
Photograph 8.08: Site 43, retrofitted culvert crossing.
Stream width = 3.0 m;

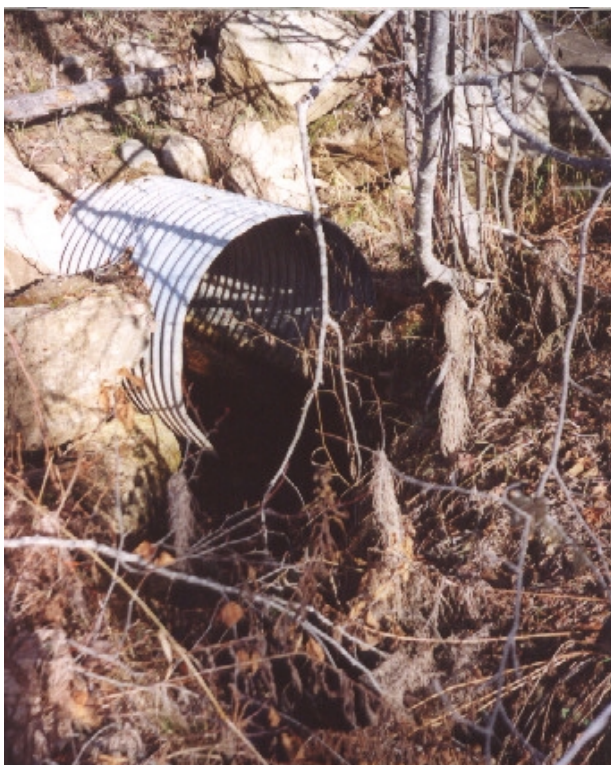
Photograph 9.01: Site 49, inlet.

Comments: This round metal culvert may have been installed in 1998. Culvert width = 1.0 m

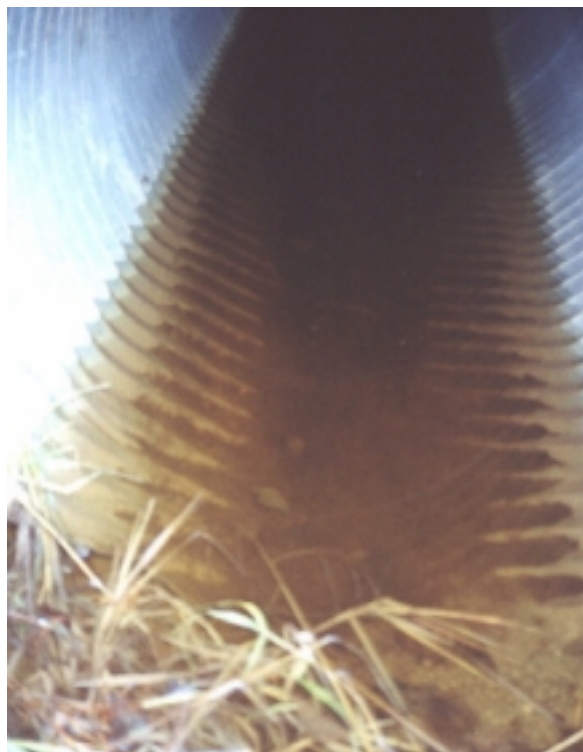
Photograph 8.25: Site 49, outlet. Note sedimentation.

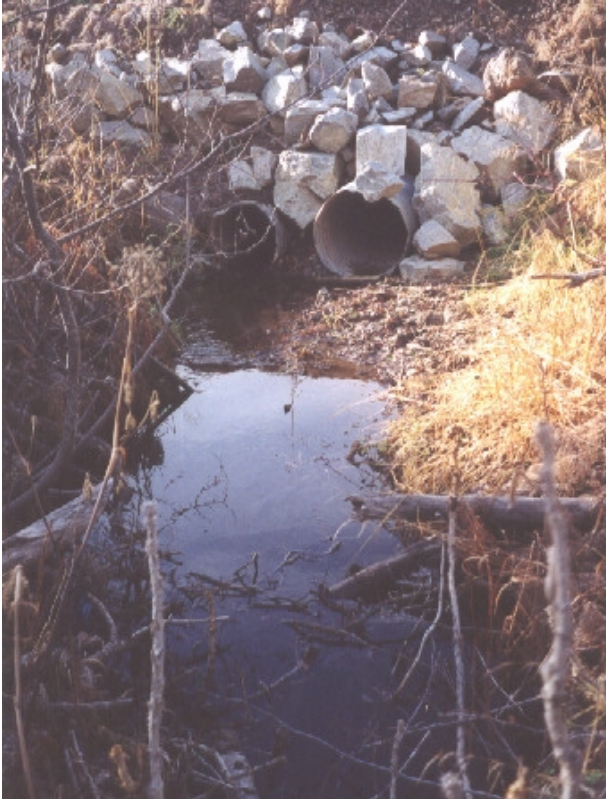
Photograph 9.03: Site 50, inlet.

Comments: A new round metal culvert was installed in 2000 (?). Culvert width = 0.6 m; 0.5 m

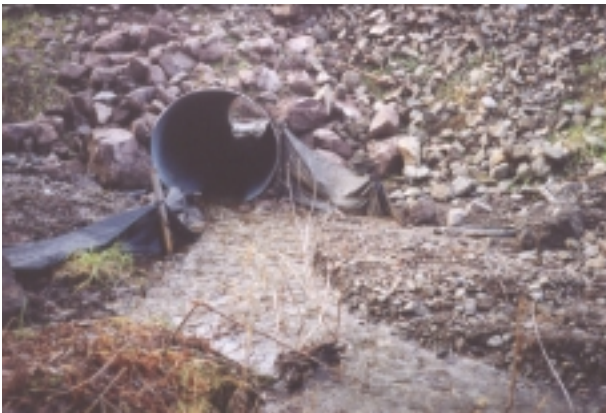
Photograph 9.09: Site 51, inlet.

Comments: The new round metal culvert was installed in 2000. Culvert width = 1.2 m

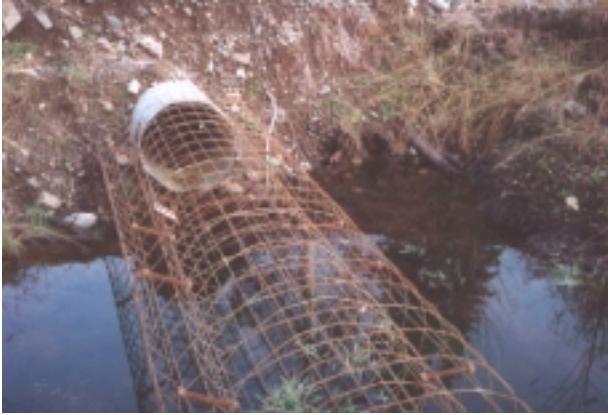
Comments: The new round metal culvert was installed in 2000.

Stream width = 0.5 m
Culvert width = 0.6 m; 0.4 m
Culvert slope = 2%

Photograph 10.02: Site 52, inlet. All the water is flowing through a crushed pipe to the right of the new culvert.

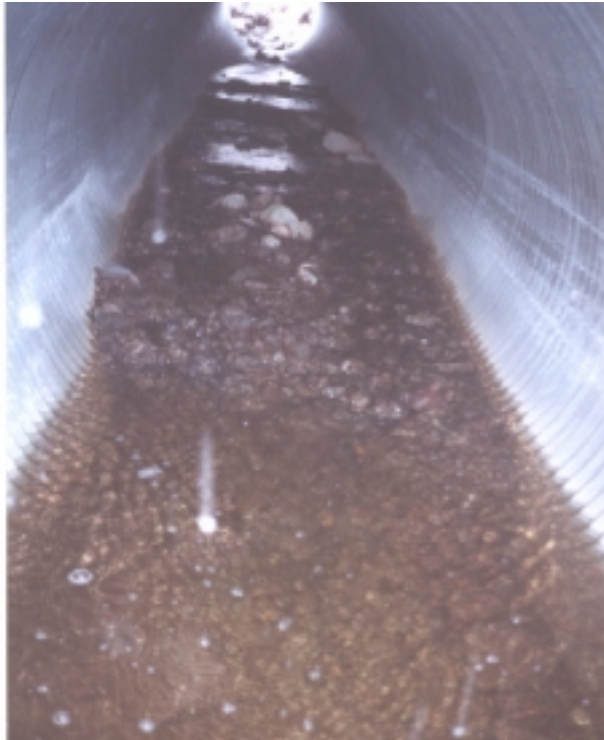
Photograph 10.04: Site 54, interior from outlet. Note that much of the substrate has flushed from the outlet end.

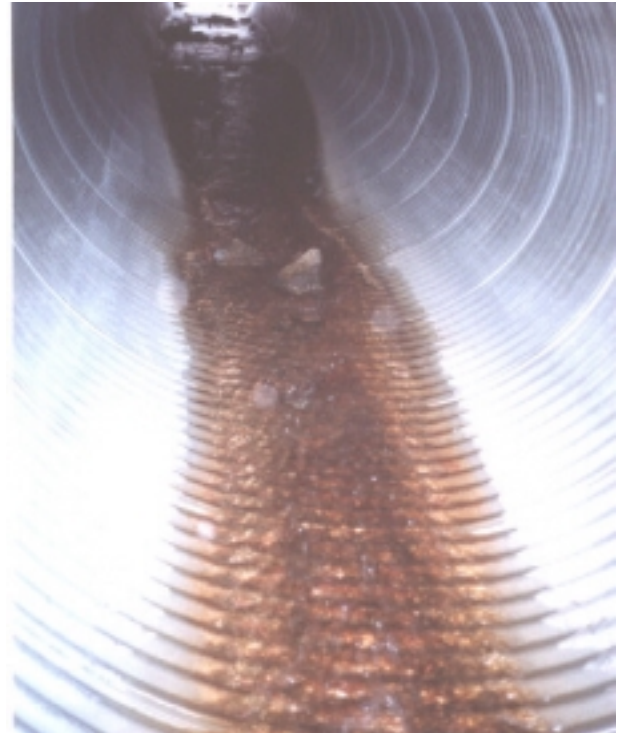
Photograph 10.05: Site 54, interior from inlet. Note the substrate has flushed out of the top end of the pipe.

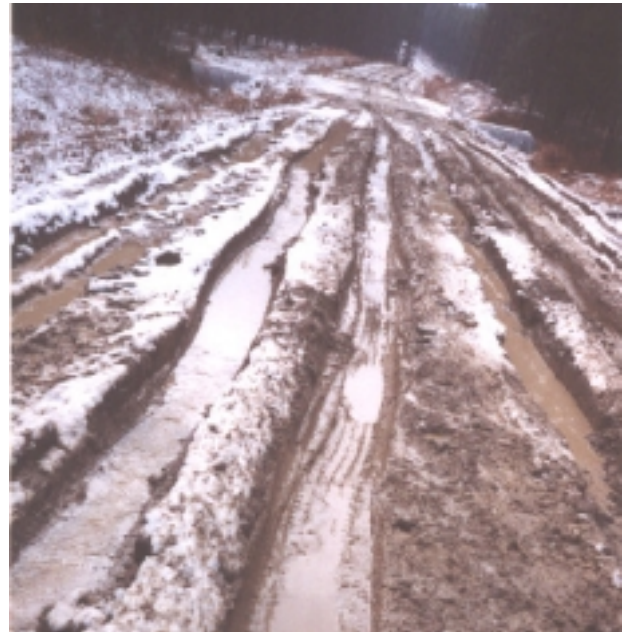
Photograph 11.05: Site 59, sediment from road surface is entering stream (the culvert in right background).

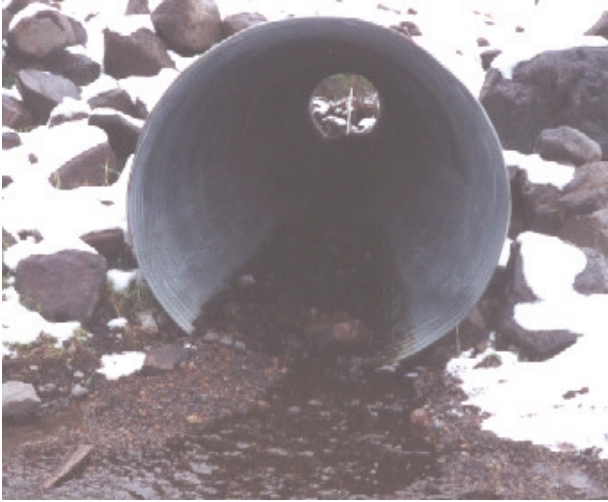
Photograph 14.05: Site 68, outlet.

Comments: This round culvert was installed in 1998.

Stream width = 0.8 m
Culvert width = 1.4 m
Culvert slope = 4%

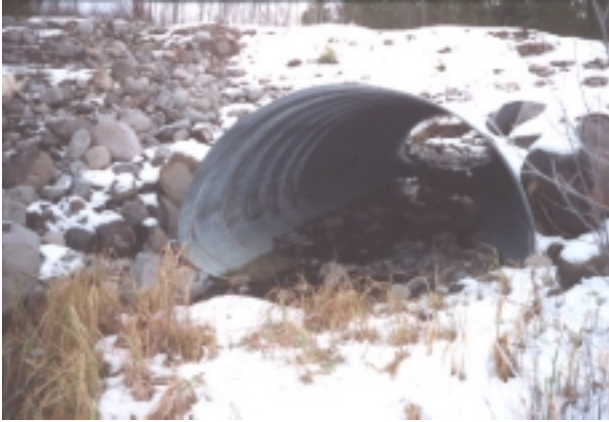
Comments: The culvert was embedded 20%, and substrate comprised of gravel and large rock was placed over the entire bottom of the culvert.

Stream width = 1.0 m; Culvert width = 2.0 m; Culvert slope = 2%.

Photograph 15.07: Site 7, outlet. Note that little substrate remains within the culvert.

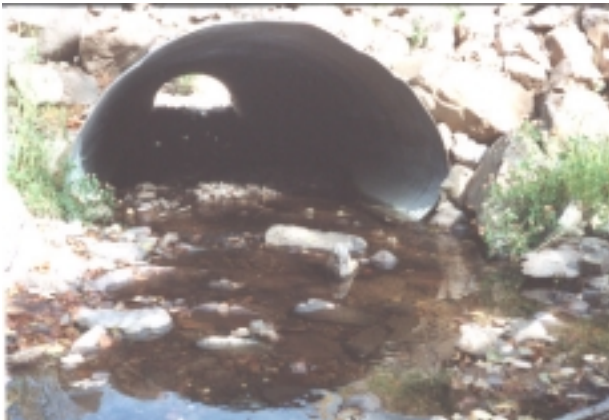
Comments: The pipe-arch culvert was embedded 20%, and substrate comprised of gravel and large rock was placed over the bottom of the culvert only at the inlet and outlet (with DEO approval). The culvert bottom is now completely covered with gravel, to about 20% of culvert height, from natural bed-load.

Stream width = 1.0 m; Culvert width = 2.0 m; Culvert slope = 3%.

Photograph 2.07: Site 9, culvert outlet. Note ponding at the outlet resulting from high outlet water velocity.

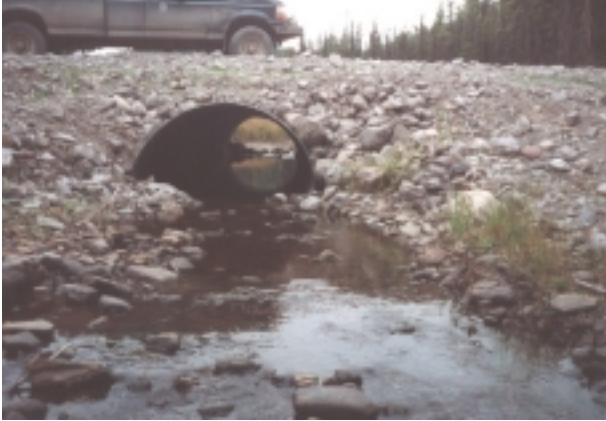
Comments: The pipe-arch culvert was installed in 2000, to replace old culverts. The pipe was placed at 0% gradient, and embedded 20%, without substrate being placed in the culvert. The stream is ponded above the culvert. Maps are contradictory regarding stream name.

Photograph 3.: Site 14, outlet.
Stream width = 2.0 m
Culvert width = 2.0 m
Culvert slope = 0%

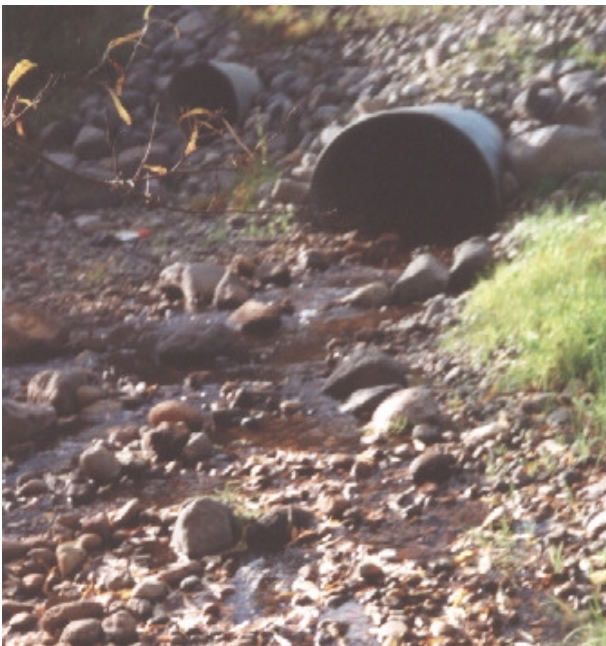
Comments: This D-pipe was installed in 1999 to replace an old culvert.

Photograph 4.01: Site 18, outlet (new culvert on right).

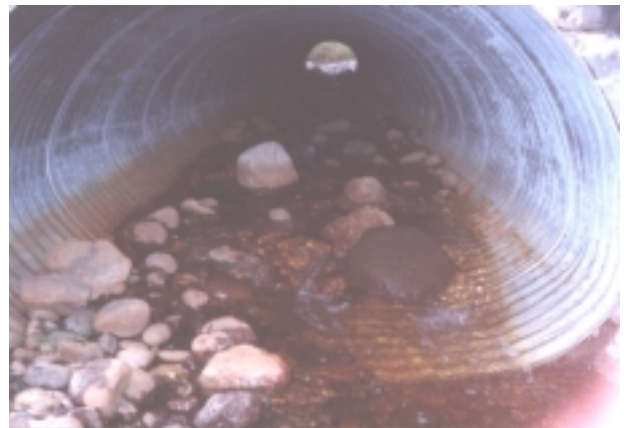
Photograph 4.03: Site 18, interior from outlet. Note that the substrate has flushed out of part of the lower end of the culvert; some scouring has occurred below the pipe.
Stream width = 1.2 m
Culvert width = 1.5 m
Culvert slope = 5%

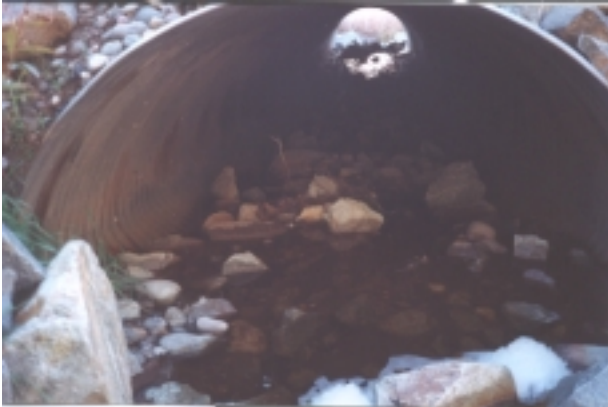
Comments: This D-pipe culvert was installed in 2000 to replace an old round culvert. Gravel and rock substrate was placed in the culvert. The substrate is flushing out.

Photograph 5.13: Site 28, outlet. Note that some of the substrate has flushed out despite large rock size.
Stream width = 0.5 m
Culvert width = 1.5 m
Culvert slope = 3%

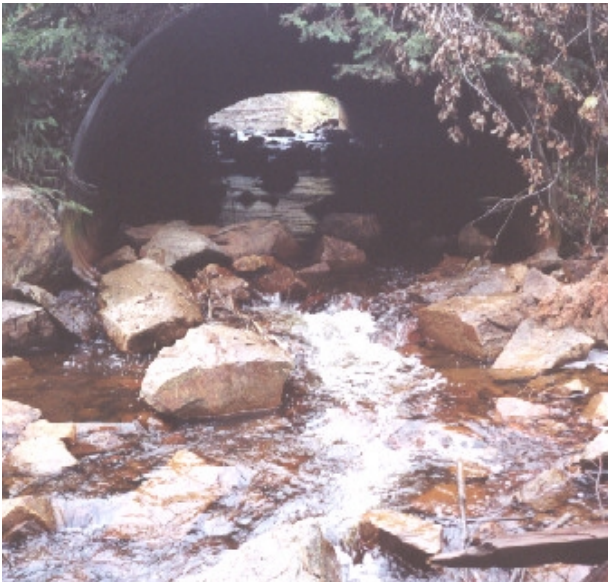
Comments: This pipe-arch culvert had a perched outlet, and a downstream weir was installed in 1998 to permit fish passage. The culvert is probably too small for a 100-year flood.

Photograph 7.13: Site 38, outlet.

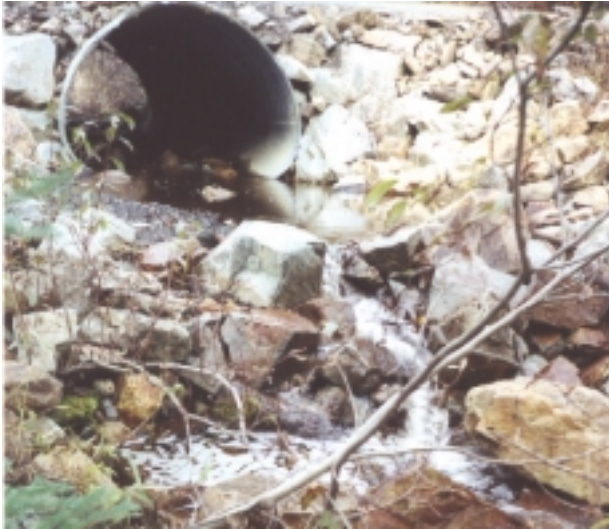
Photograph 8.02: Site 39, outlet.

Comments: This pipe-arch culvert had a perched outlet, and a weir was installed in 1998 to permit fish passage. The culvert is probably too small for a 100-year flood.

Stream width = 2.7 m
Culvert width = 2.3 m
Culvert slope = 2%

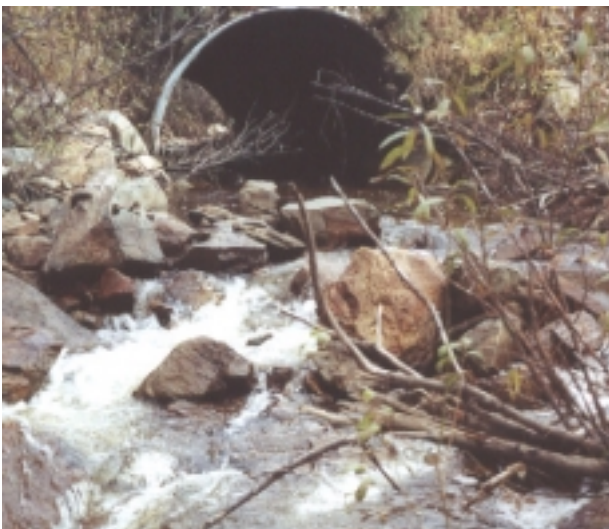
Photograph 8.03: Site 40,

Comments: This pipe-arch culvert had a perched outlet, and a weir was installed in 1998 to permit fish passage. The culvert is probably too small for a 100-year flood.

Stream width = 4 m
Culvert width = 3.5 m
Culvert slope = 2%

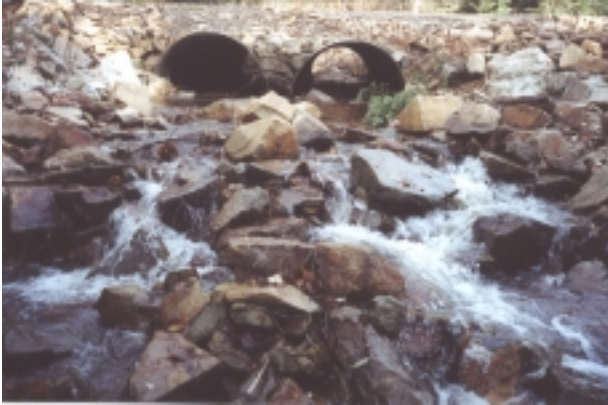
Photograph 8.04: Site 41, outlet.

Comments: These two multiplate pipe-arch culverts had perched outlets, and a weir was installed in 1998 to permit fish passage. The culverts are probably too small for a 100-year flood.

Stream width = 2.5 m

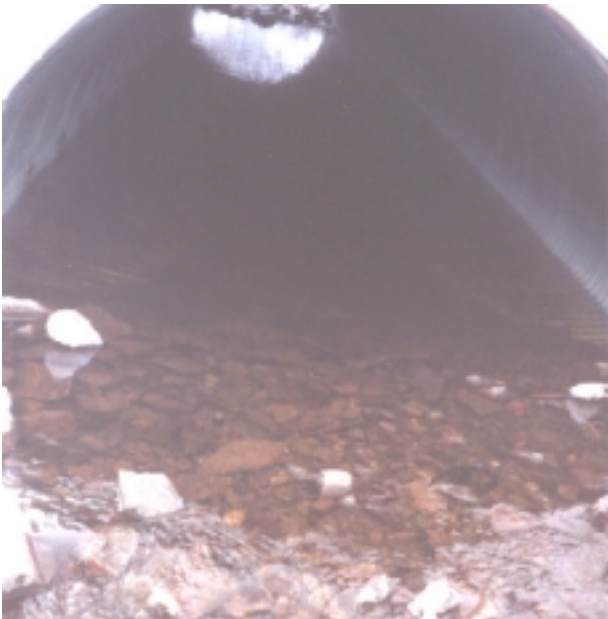
Comments: This D-pipe culvert was installed in 1999 to replace an old round culvert. Gravel and rock substrate was placed in the culvert. The substrate is flushing out.

Photograph 11.10: Site 60, interior viewed from outlet.

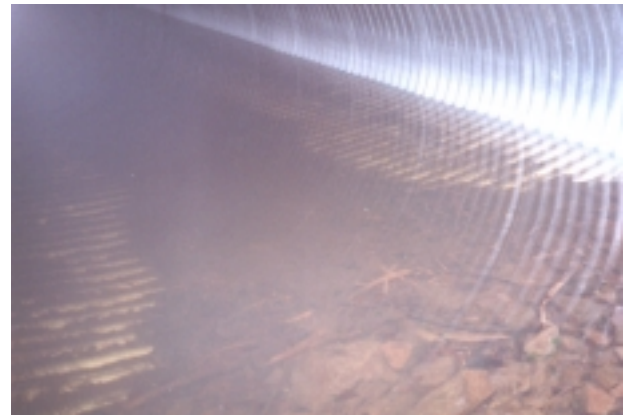
Photograph 11.11: Site 60, interior of culvert. Note that much of the substrate has flushed out of the pipe.

Stream width = 2.0 m

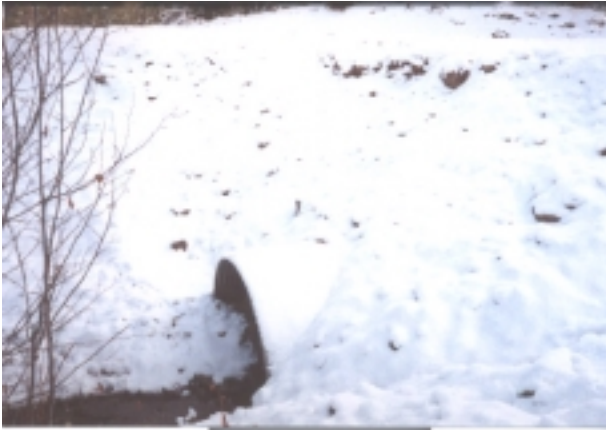
Comments: This D-pipe culvert was installed in 1999 to replace an old round culvert. Gravel and rock substrate was placed in the culvert. The roadbed failed and slid into the outlet.

Photograph 11.13 (above): Site 61, culvert outlet with roadbed failure.

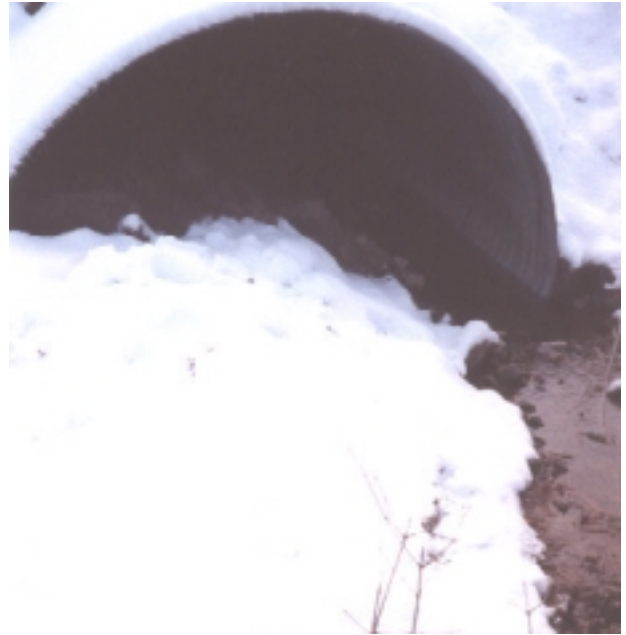
Photograph 11.12 (to right): Site 61, culvert outlet partly filled with roadbed material.

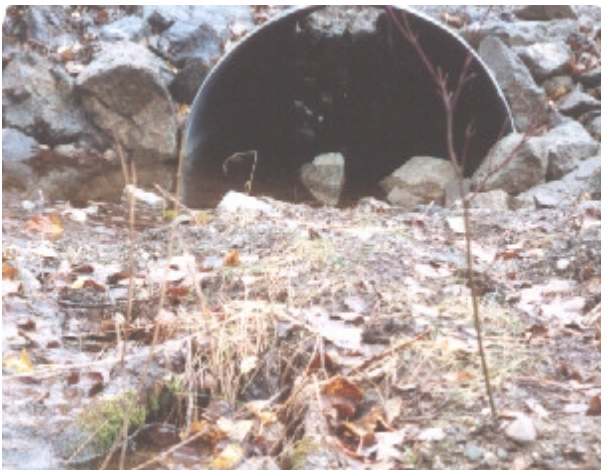
Photograph 15.10: Site 62, culvert inlet.

Comments: This D-pipe culvert was installed in 2000. Gravel and rock substrate was placed in the culvert. Stream width = 1.0 m; Culvert width = 1.6 m; Culvert slope = 4%

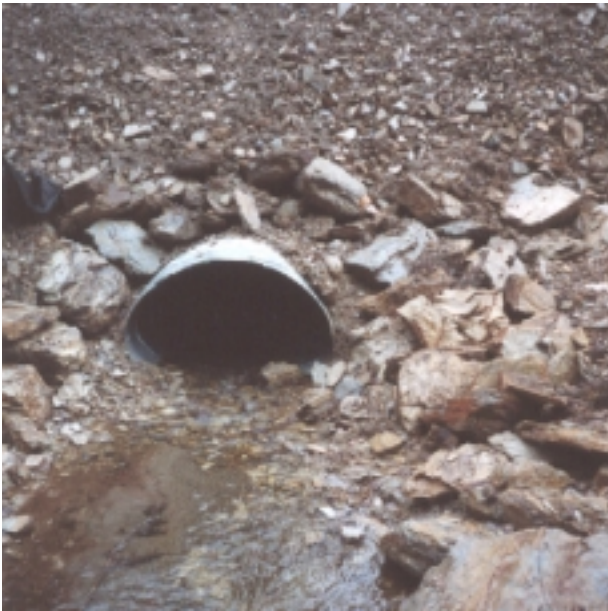
Photograph 13.08: Site 65, inlet.

Comments: This D-pipe culvert was installed in 1999. Culvert width = 1.4 m

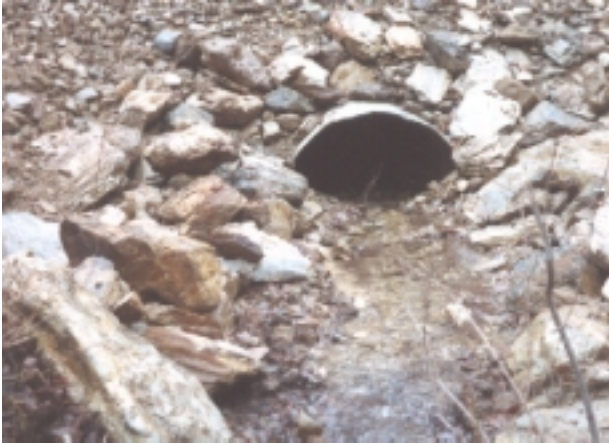
Photograph 13.12: Site 66, inlet.

Comments: This D-pipe culvert was installed in 1999.

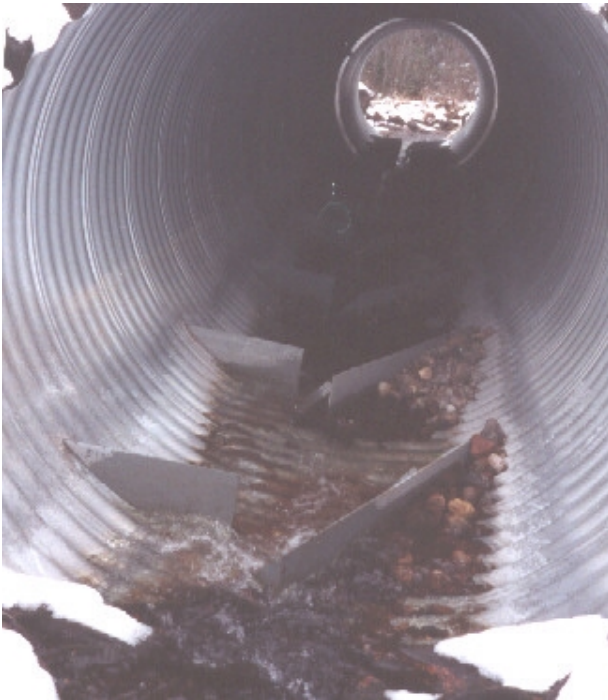
Photograph 14.03: Site 67, interior from inlet.

Comments: This baffled round culvert was installed in 1998. Fish passage is impeded for juveniles and adults at low water, and may be for adults at moderate to high flows.

Stream width = 1.6 m; Culvert width = 2.5 m; Culvert slope = 5%.

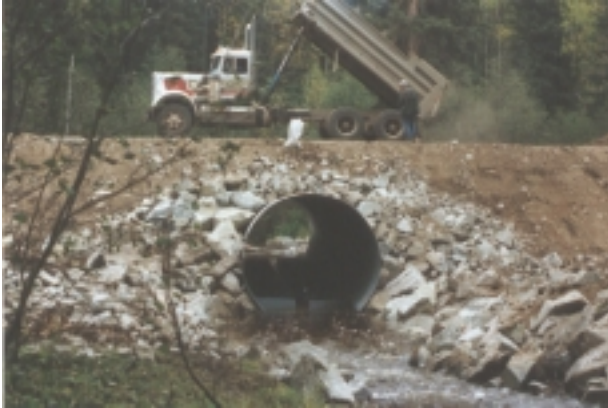
Comments: This baffled culvert was installed in 1998. It was not examined for this report, however current speeds have been found to be too high and a prescription is in place to backwater the culvert with a downstream weir.

Photograph 0.16: Site 72, inlet during installation.

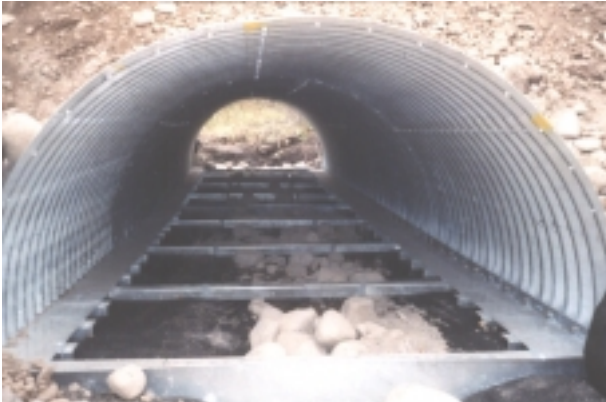
Photograph 0.14: Site 8, mini-span installation in 1998.

Comments: This mini-span (open-bottom metal culvert with struts across the bottom) had substrate comprised of angular gravel and angular large rock placed over the entire bottom to cover the cross-struts. Poor ditch maintenance and lack of a ditch cross-drain resulted in substantial additional water volume passing through the structure, as well as sedimentation [problem now corrected]. About half of the substrate, both gravel and large rocks, has washed out of the culvert.

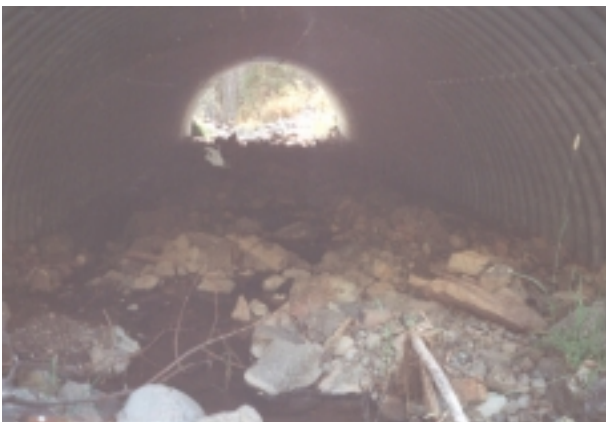
Photograph 2.02: Site 8, interior from inlet, showing eroded substrate.
