Fish Stream Crossing Structures recently installed in the Quesnel Forest District

Cris Guppy
Forest Ecosystem Specialist
Quesnel Forest District
Habitat Protection Branch
Ministry of Environment, Lands and Parks

Final Report - February 9, 2001

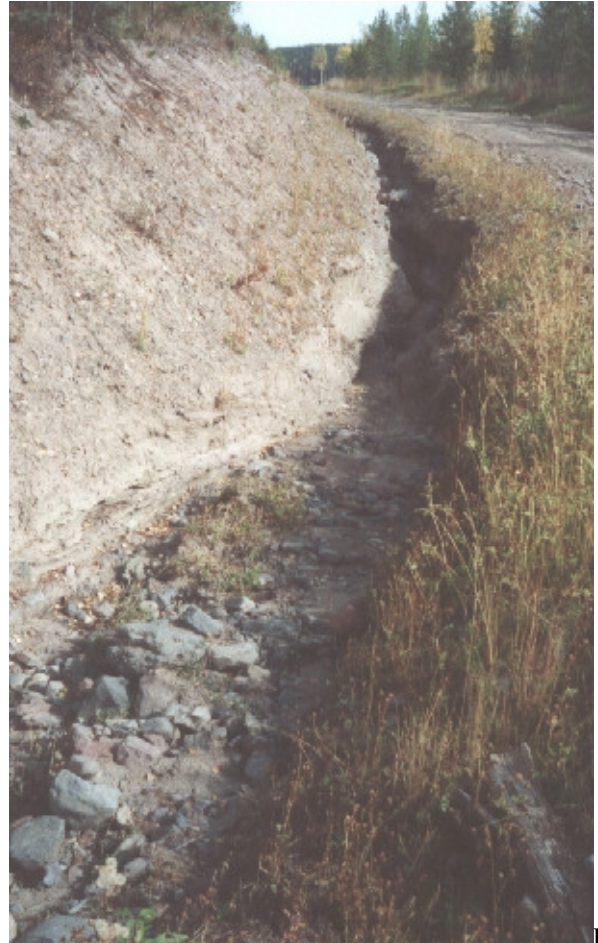
Comments: This mini-span (open-bottom metal culvert with struts across the bottom) had substrate comprised of angular gravel and angular large rock placed over the entire bottom to cover the cross-struts. Poor ditch maintenance and lack of a ditch cross-drain resulted in substantial additional water volume passing through the structure, as well as sedimentation [problem now corrected]. About half of the substrate, both gravel and large rocks, has washed out of the culvert.

Photograph 2.04: Site 8, ditchline leading to the inlet.

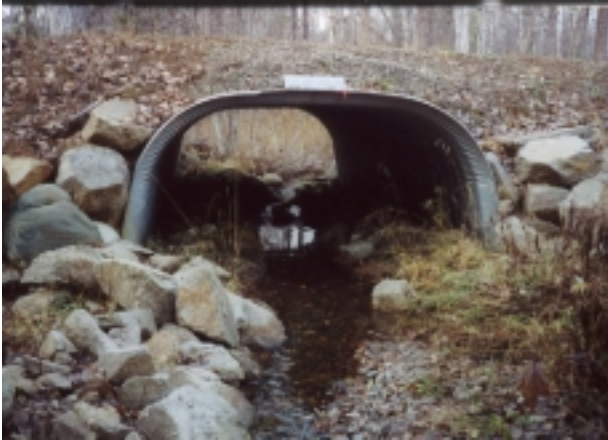
Photograph 8.11: Site 45, inlet.

Comments: This arch was installed in 1998.

Stream width = 1.5 m; Culvert width = 3.5 m; Culvert slope = 4%

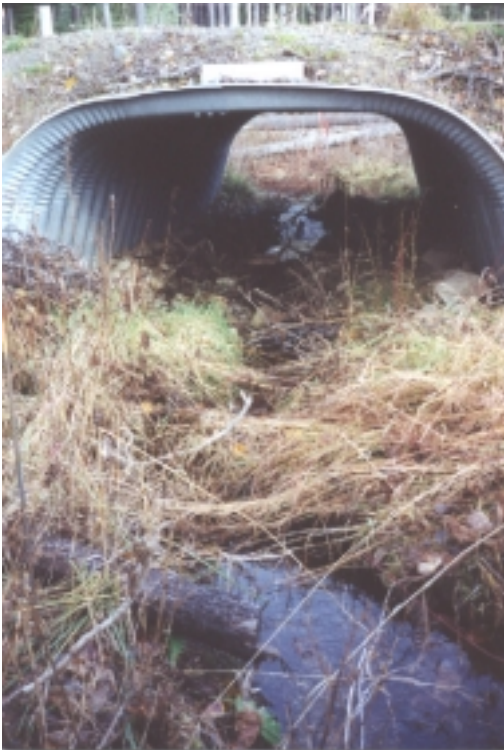
Photograph 8.14: Site 46, inlet.

Comments: This arch was installed in 1998. Culvert width = 3.5 m; Culvert slope = 5%

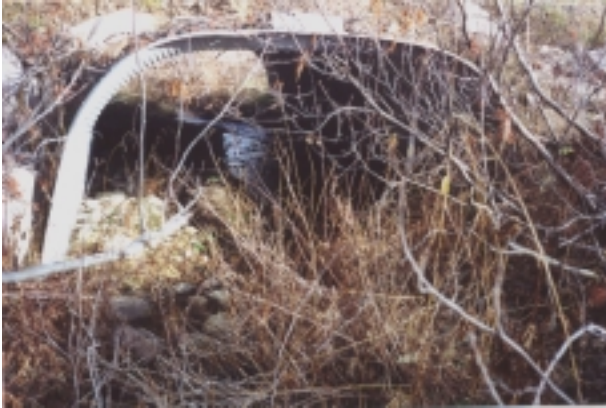
Photograph 8.18: Site 47, inlet.

Comments: This arch was installed in 1998. Culvert width = 3.5 m; Culvert slope = 5%

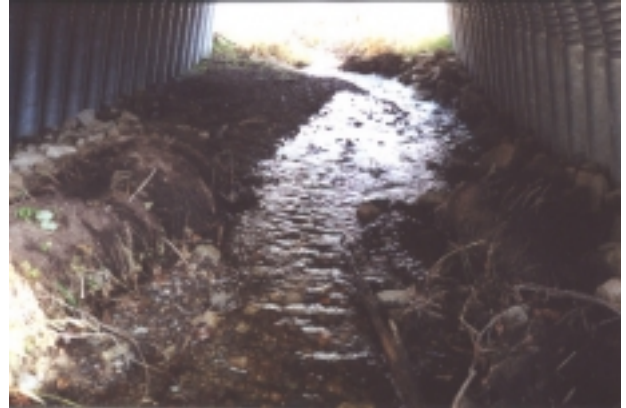
Photograph 8.19: Site 47, interior from inlet. The full width of the arch near the outlet is floodplain.

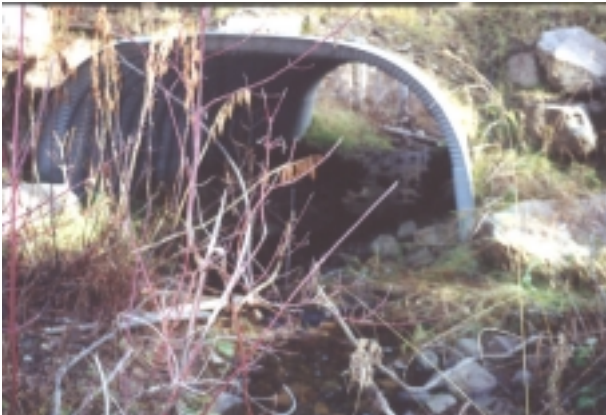
Photograph 0.01: Site 48, inlet.

Comments: This arch was installed in 1998. Culvert width = 3.5 m; Culvert slope = 5%

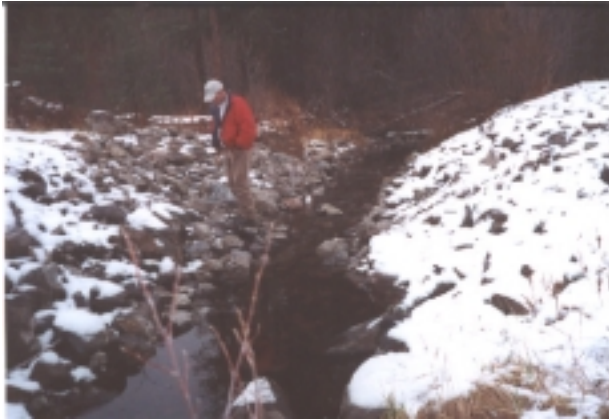
Comments: Ford armoured after my first visit, and the unarmoured cross-ditch installed. The cross-ditch is likely to deliver sediment into the stream during spring run-off.

Photograph 12.10: Site 4, armoured ford for ATVs.

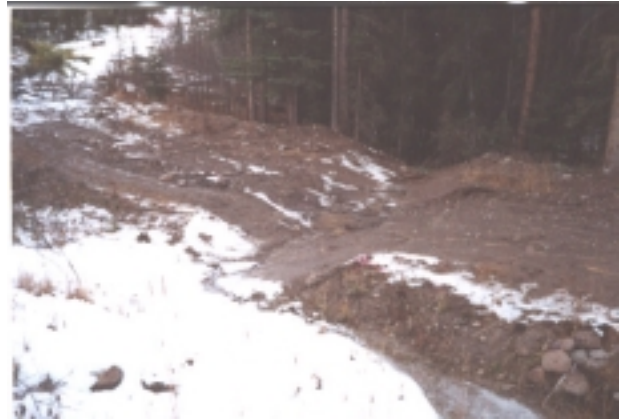
Photograph 12.12: Site 4, cross-ditch above the stream. Sediment will be delivered directly into the stream.

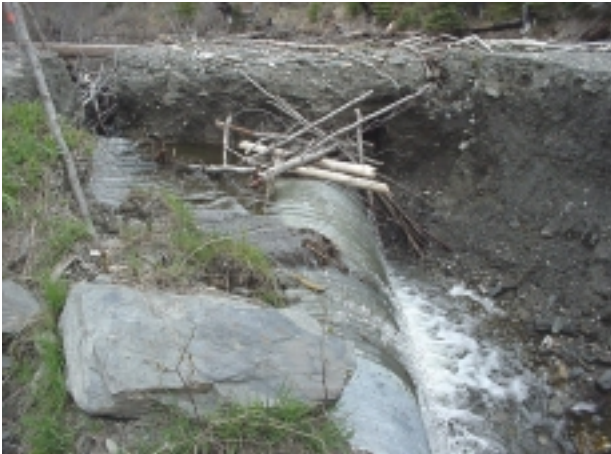
Photograph 0.01: Site 37, washed out culvert (beaver plugged).

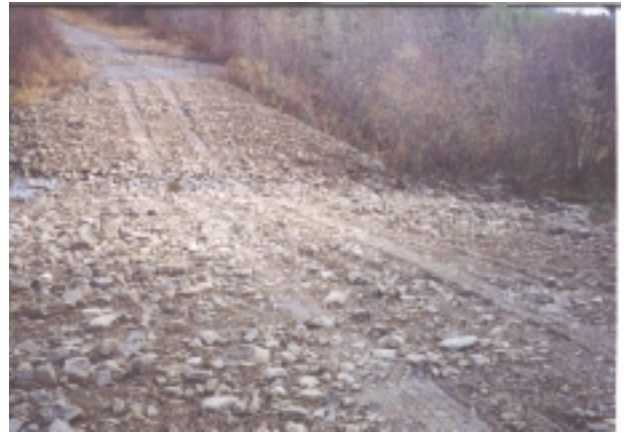
Comments: Pond and potential spawning habitat above the crossing site. The old culvert was plugged by beaver, resulting in the road washing out. The road is not presently used by the forest industry. As a result the washed out culvert was initially replaced by an unsuitable ford, which was then modified to permit fish passage and the road blocked to all except ATV traffic to minimise sedimentation.

Photograph 7.12: Site 37, ford blocking fish passage from use of uncompacted rock.

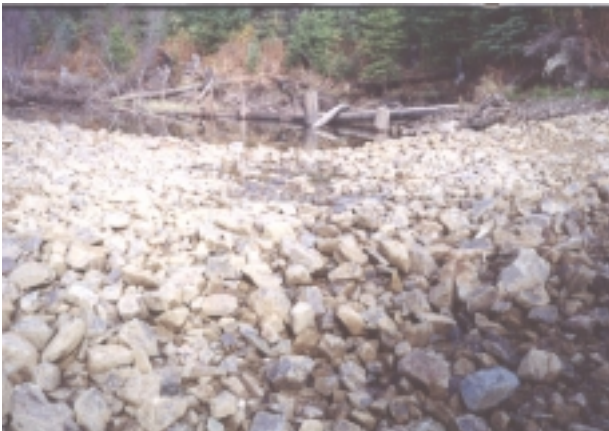
Photograph 7.10: Site 37, upstream view of ford showing rocks blocking fish passage.

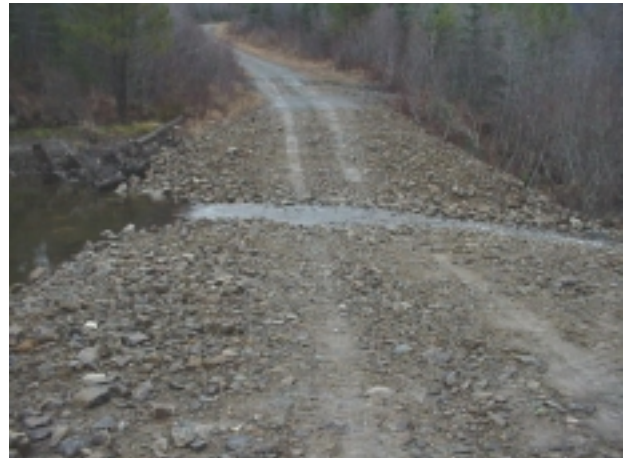
The fords were armoured to prevent erosion, although one (site 4) had an adjacent cross-ditch that lacked armour and will erode in the spring. The other ford (site 37) initially was constructed of loose pieces of large rock that blocked fish passage, which was later compacted to permit fish passage.

Photograph 0.02: Site 37, ford modified to permit fish passage (current speed at peak flows may be an issue). Pickup access to the ford has been blocked to prevent sedimentation..

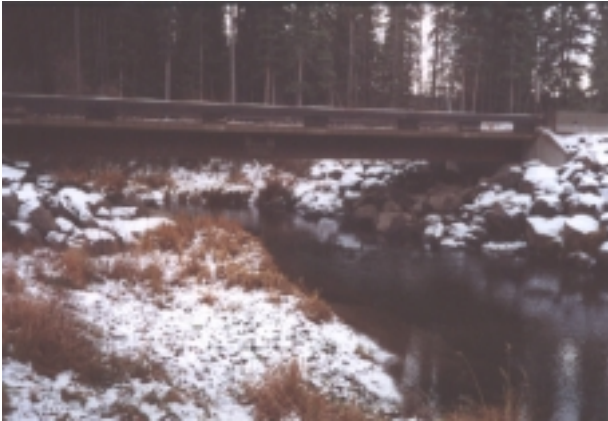
Photograph 12.03: Site 1, bridge across Merston Creek.

Comments: This bridge replaced a pre-FPC bridge across Merston Creek.

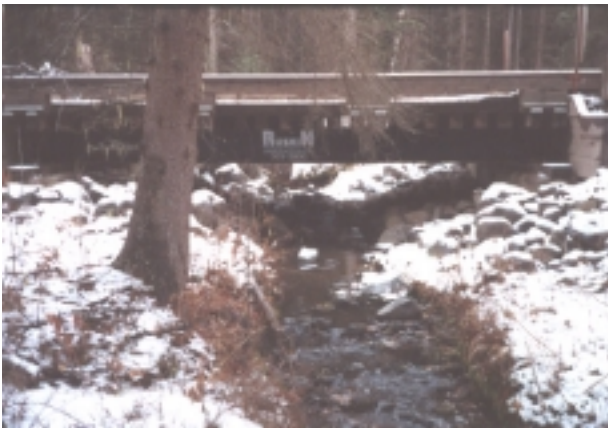
Comments: This bridge replaced a pre-FPC bridge across Mount Creek. There is excessive riprap in the channel.

Photograph 12.06: Site 2, bridge across Mount Creek.
The shadow of the bridge obscures the rip rap scattered across the entire width of the channel under the bridge.

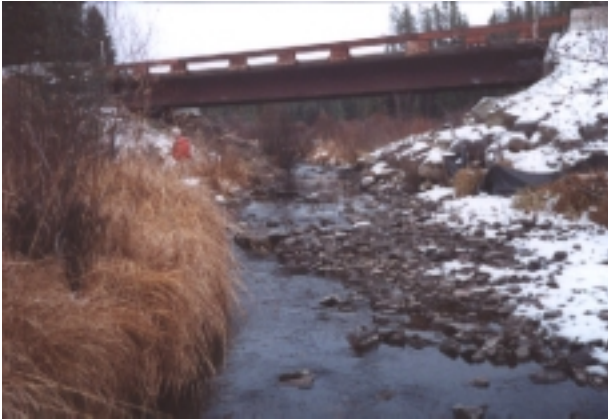
Photograph 15.08: Site 6, upstream view.

Comments: This bridge replaced a pre-FPC bridge across Merston Creek.

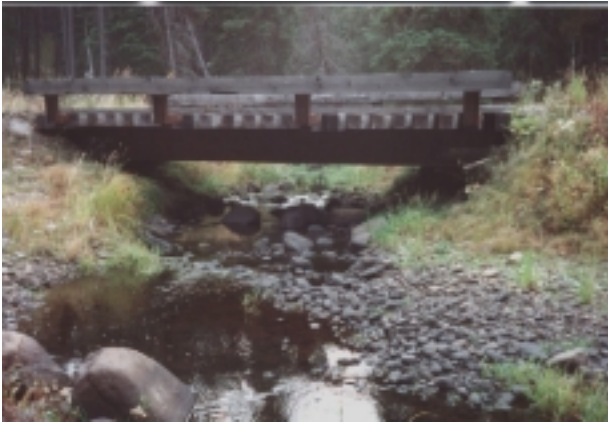
Photograph 3.01: Site 12, upstream view of bridge.

Comments: This bridge is a temporary installation, for silviculture purposes, across a tributary of Ramsey Creek, and replaced an existing ford that resulted from the original culverts washing out.

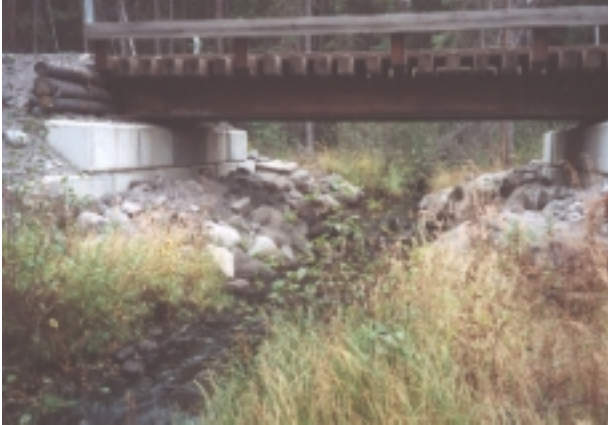
Photograph 3.03: Site 13, upstream view of bridge.

Comments: This bridge is a temporary installation. Maps are contradictory regarding stream name.

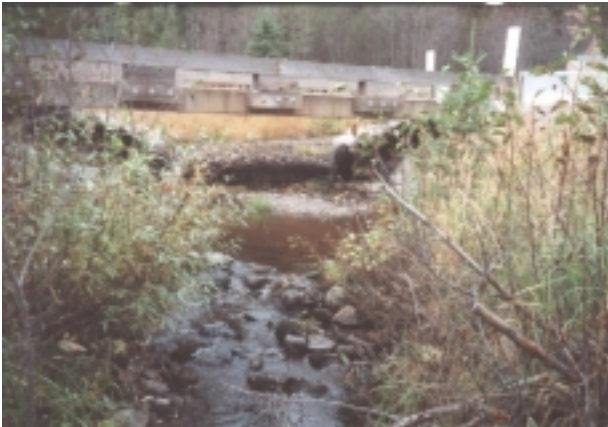
Photograph 3.06: Site 15, upstream view of bridge.

Comments: This bridge is a permanent installation. Maps are contradictory regarding stream name.

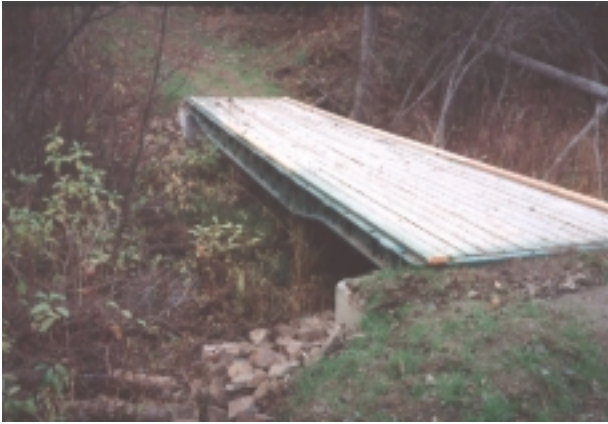
Photograph 4.11: Site 22, upstream side.

Comments: This bridge is for ATV and snowmobile use. It is made from an old semi-trailer deck, and spans most of the floodplain with a braided channel.

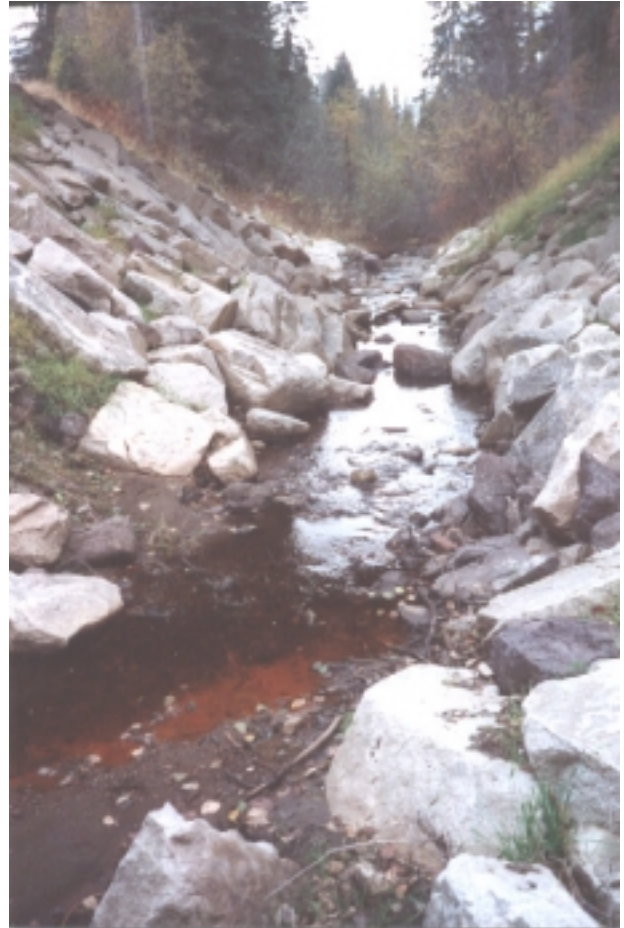
Photograph 5.01: Site 24, stream channel under the bridge, viewed from above the bridge. Note the highly constrained channel and steep rip rap armouring.

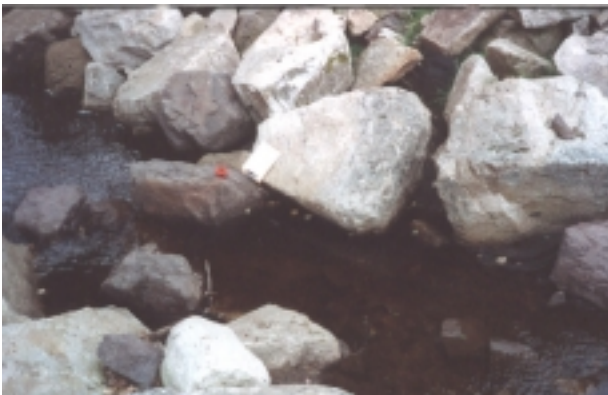
Comments: This bridge was installed in 1999 to replace an undersize baffled culvert. Channel width between rip rap is 1.7 meters, channel width of stream is 2.5 meters.

Photograph 5.02, Site 24, rip rap slipped into channel. Note white clipboard for scale.

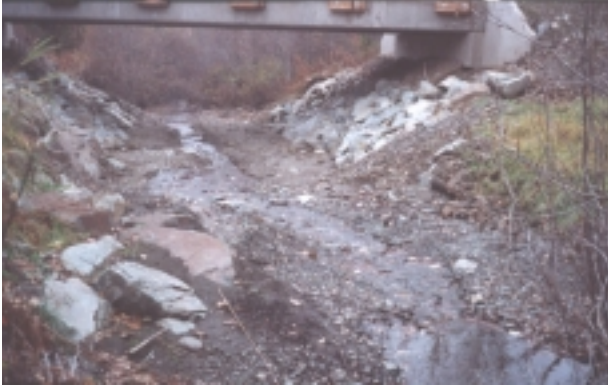
Comments: This bridge was installed in 2000 to replace an embedded round culvert (installed 1999) that had excessively high current speeds and in which the substrate blocked fish passage at low water (5% culvert gradient, large diameter rip rap, culvert diameter probably too small).

Photograph 5.11: Site 27, view from upstream.

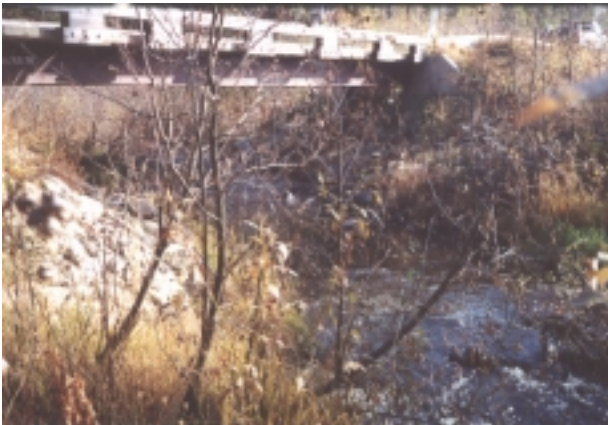
Photograph 7.01: Site 33, bridge from downstream.

Comments: This bridge was installed in 1997.

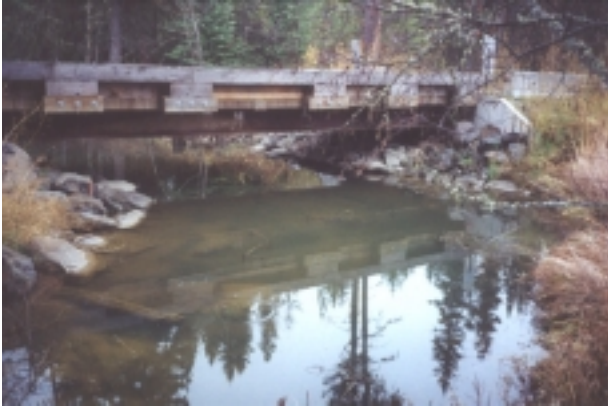
Photograph 8.05: Site 42, upstream view.

Comments: This bridge was installed in 1999. The stream is beaver ponded.

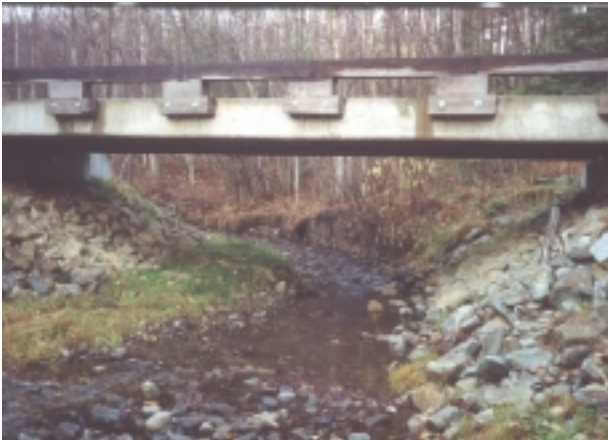
Photograph 8.09: Site 44, upstream view.

Comments: This bridge was installed in 1998.

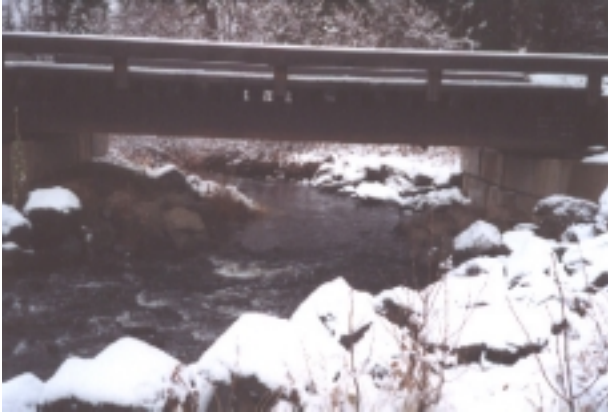
Photograph 10.03: Site 53, bridge.

Comments: The bridge was installed about 1997.

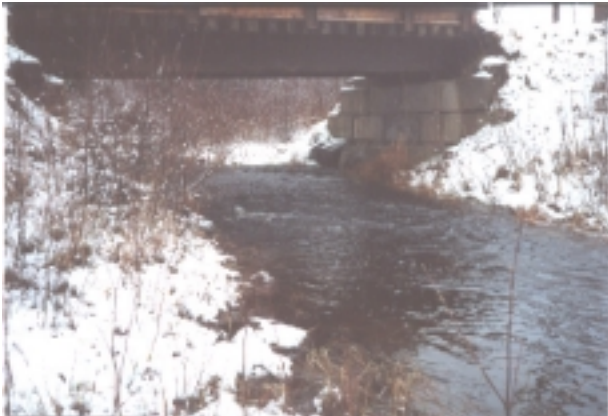
Comments: The bridge was installed in 1997.

Photograph 10.08: Site 55, bridge. Eroding ditchline just off the lower left corner of the photograph.

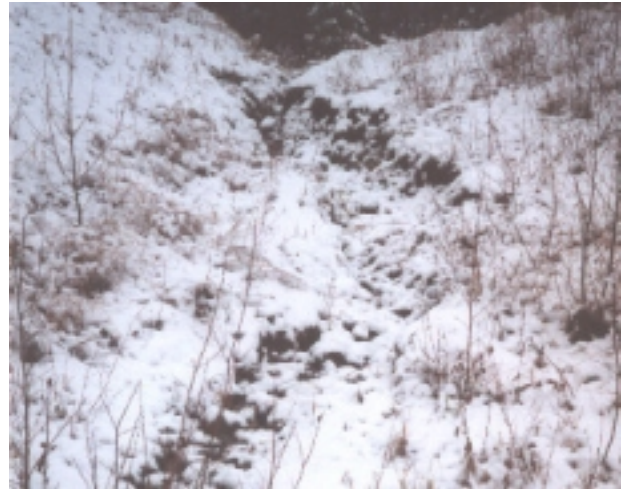
Photograph 10.09: Site 55, ditchline eroding into stream (stream just below bottom edge of photograph).

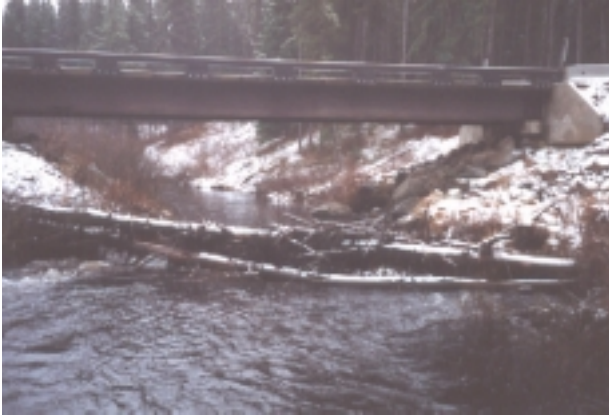
Comments: The bridge was installed in 1998.

Photograph 10.12: Site 57, bridge. The logjam is downstream of the bridge, and hence is not of concern.

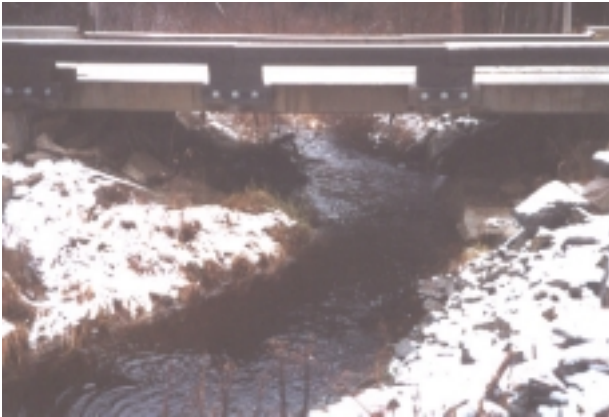
Photograph 10.13: Site 58,

Comments: The bridge was installed in 1998.

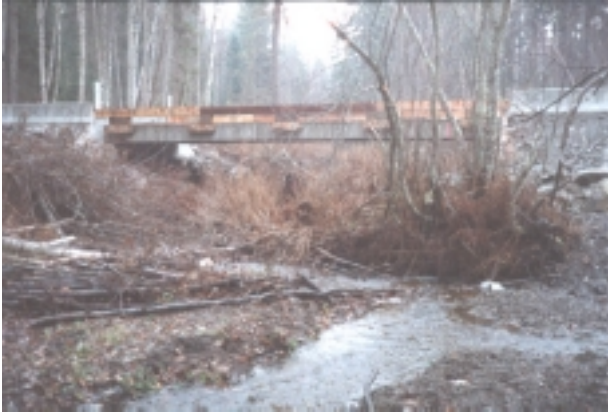
Photograph 13.05: Site 64, view from upstream.

Comments: This bridge was installed in 2000.

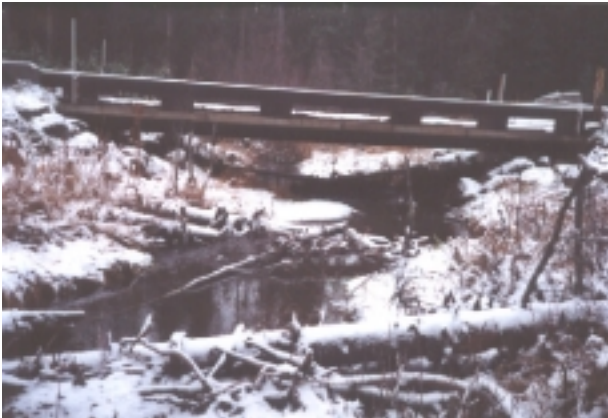
Photograph 14.08: Site 69, view from upstream.

Comments: This bridge was installed in 1998.

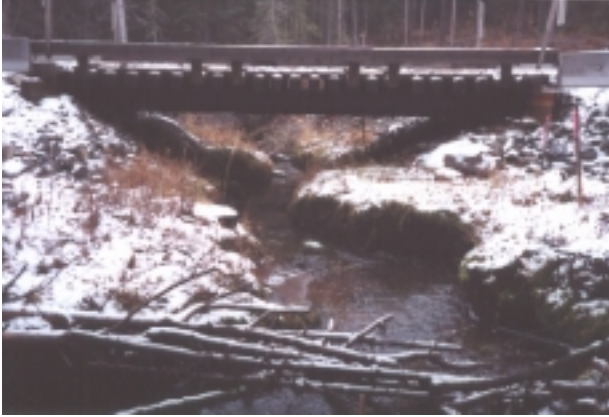
Photograph 14.09: Site 70,

Comments: This bridge was installed in 2000.

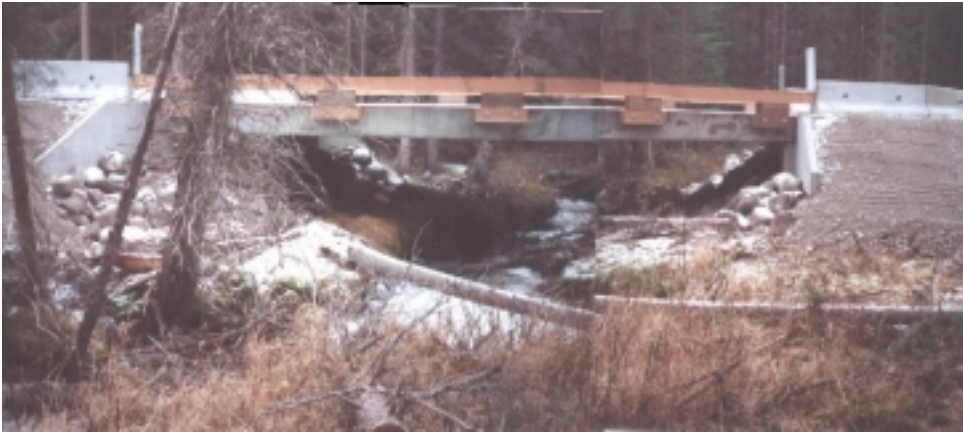
Photograph 16.02+03: Site 71, view from upstream.

Comments: This bridge was installed in 2000. Maps are contradictory regarding stream name.

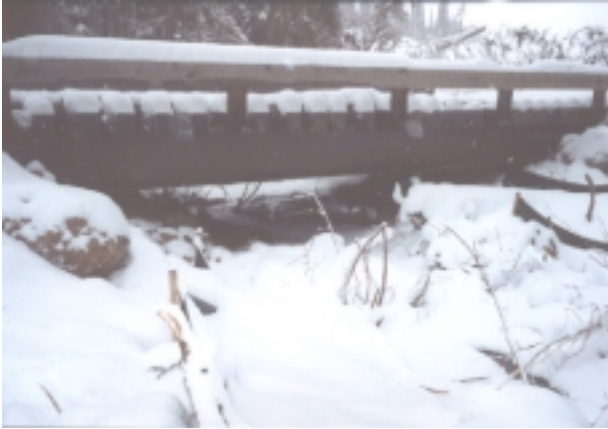
Photograph 16.05: Site 74, view from downstream.

Comments: This temporary bridge was installed in 2000.
