A DESIGN BRIEF ON THE  
Floodplain Mapping Study

BELLA COOLA RIVER

An Overview of the Study Undertaken  
to Produce Floodplain Mapping for the  
Bella Coola River from Tidewater to  
Burnt Bridge Creek

Victoria, British Columbia  
July, 1988

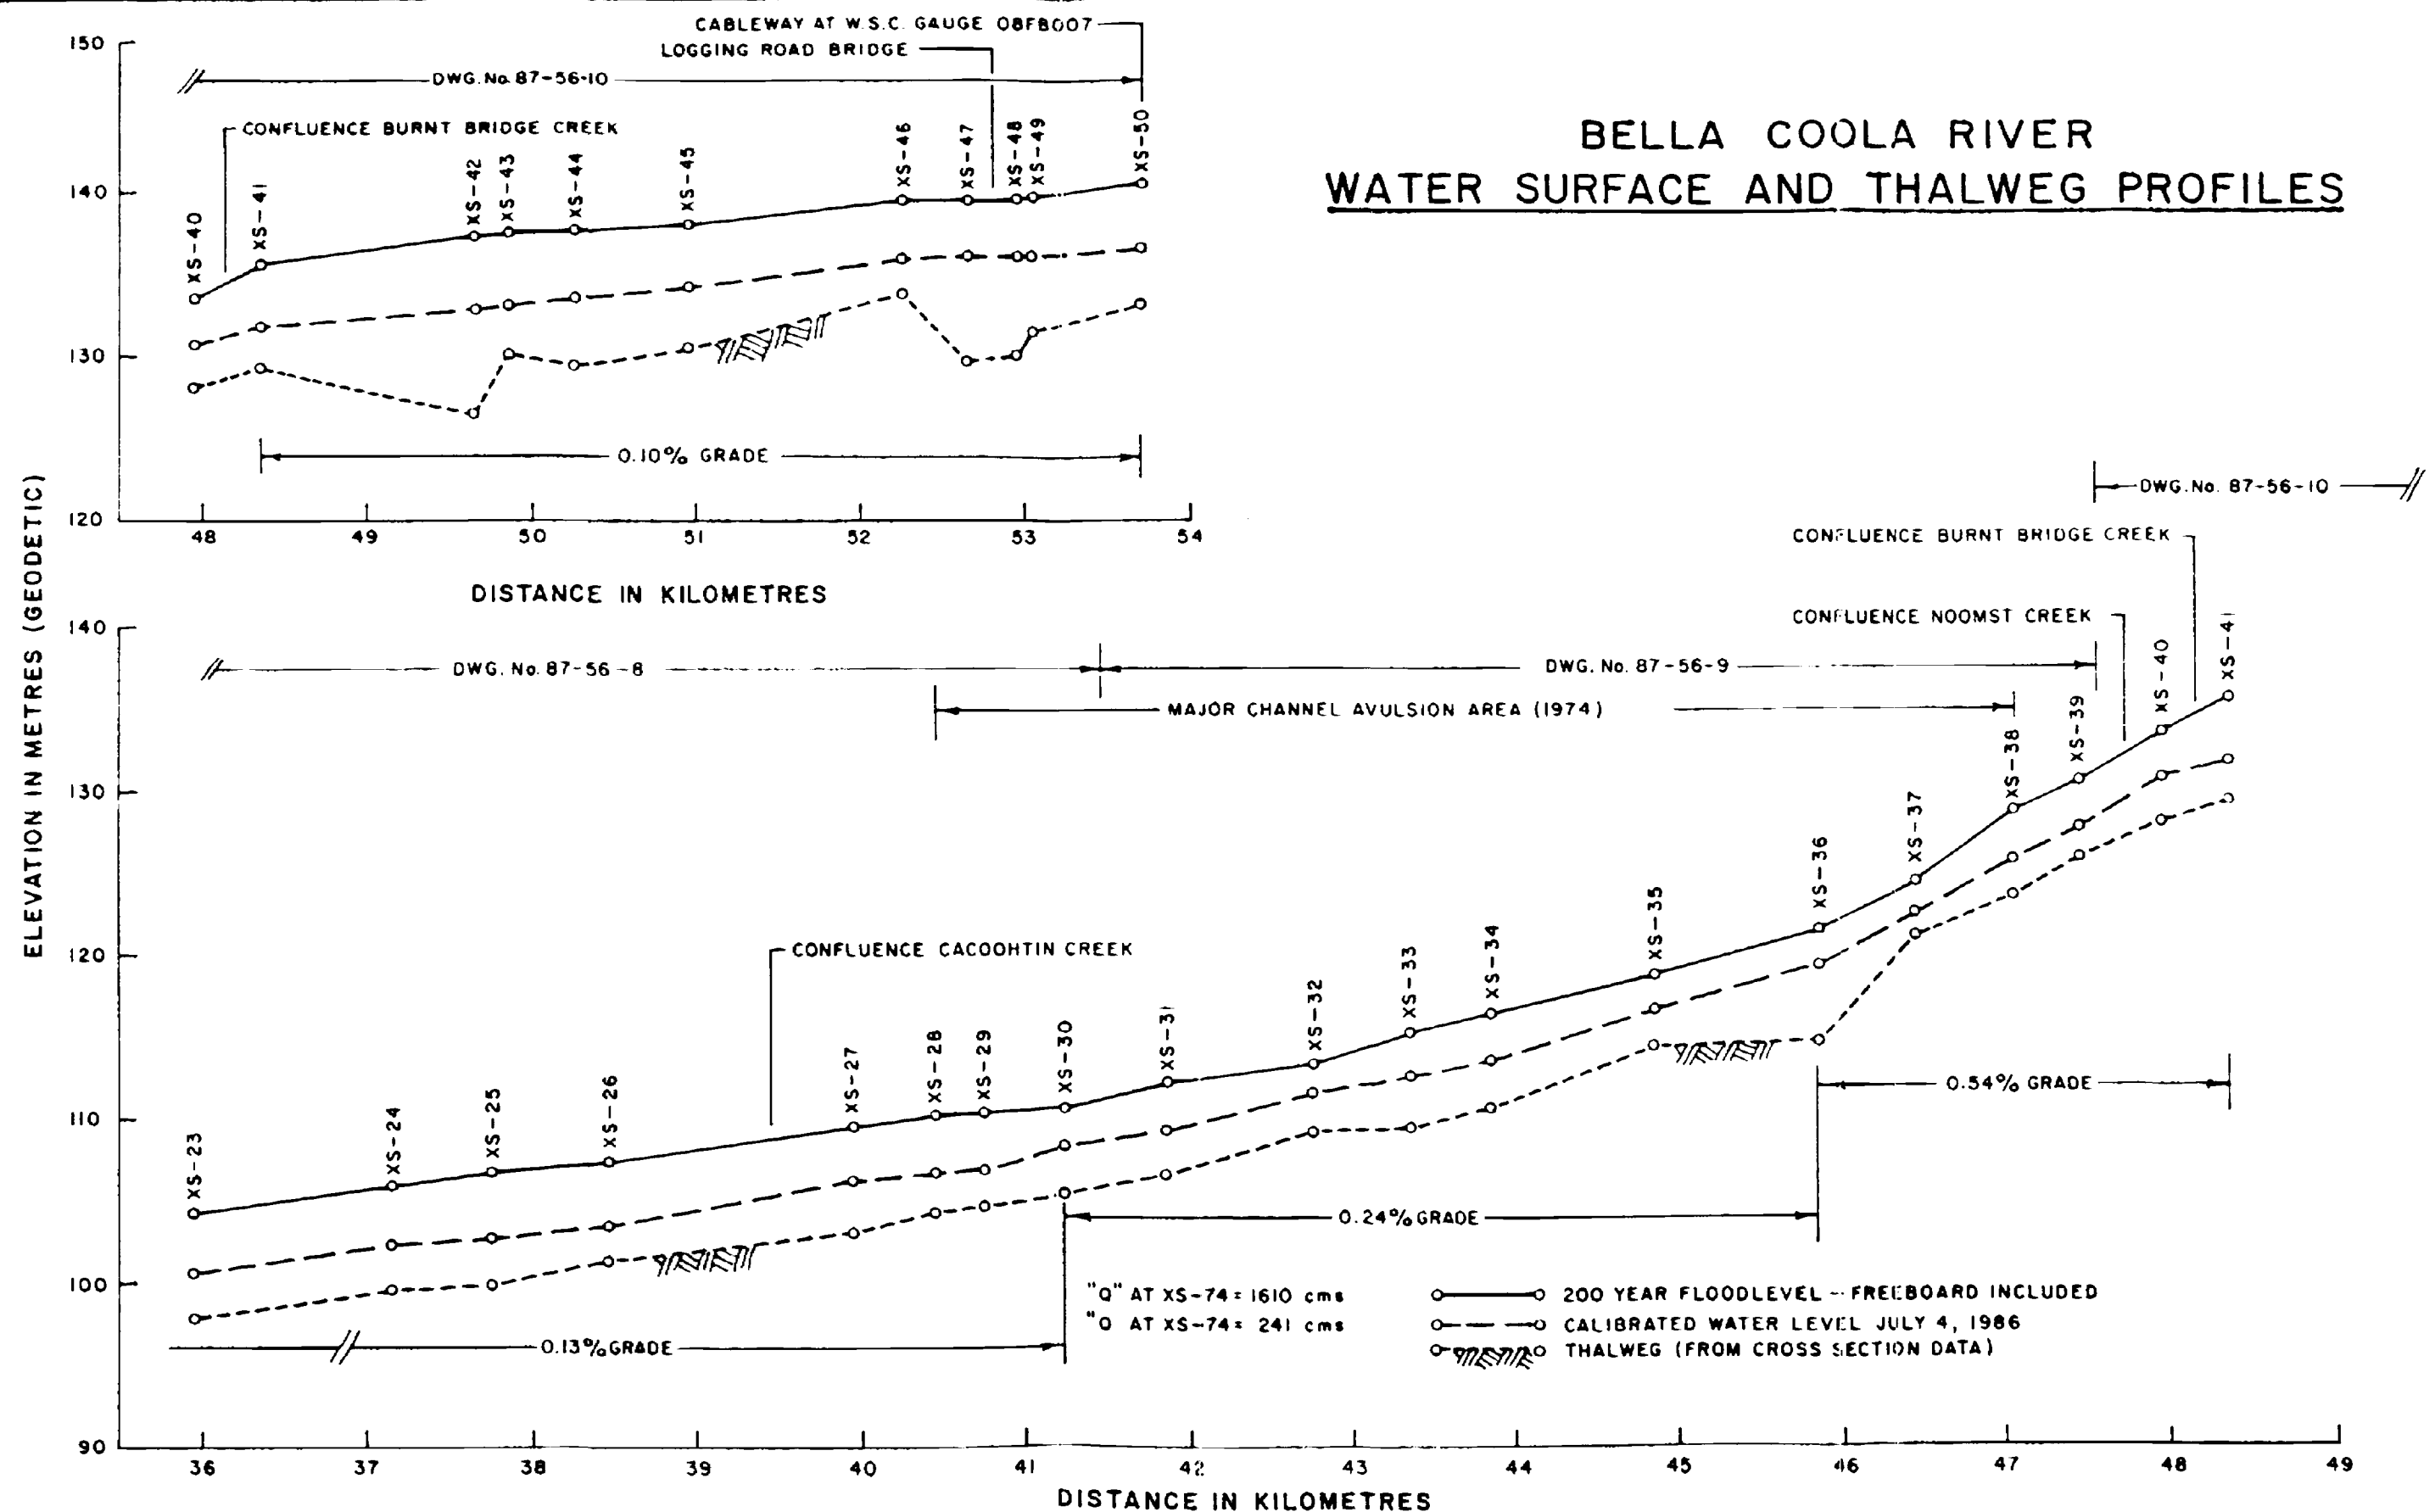
The water surface profiles for the calibration flow are indicated on Figures 3 and 4. The average gradient of the Bella Coola River is 0.24% and varies between 0.10 % to 0.54% in the study area.

The water surface profile for a 1:200 year daily flow (0.6 metre freeboard included) is shown on Figures 3 and 4.

# BELLA COOLA RIVER WATER SURFACE AND THALWEG PROFILES

- the Bella Coola River has a gradient which varies from 0.10% to 0.54% in the 30 kilometre reach (Sheets 6 to 10) as indicated in Figures 3 and 4. The average width of the floodplain in this reach is 700 metres and varies from a width of 100 metres (Burnt Bridge Creek alluvial fan area) to 1200 metres (1974 avulsion area downstream of the Burnt Bridge Creek confluence).

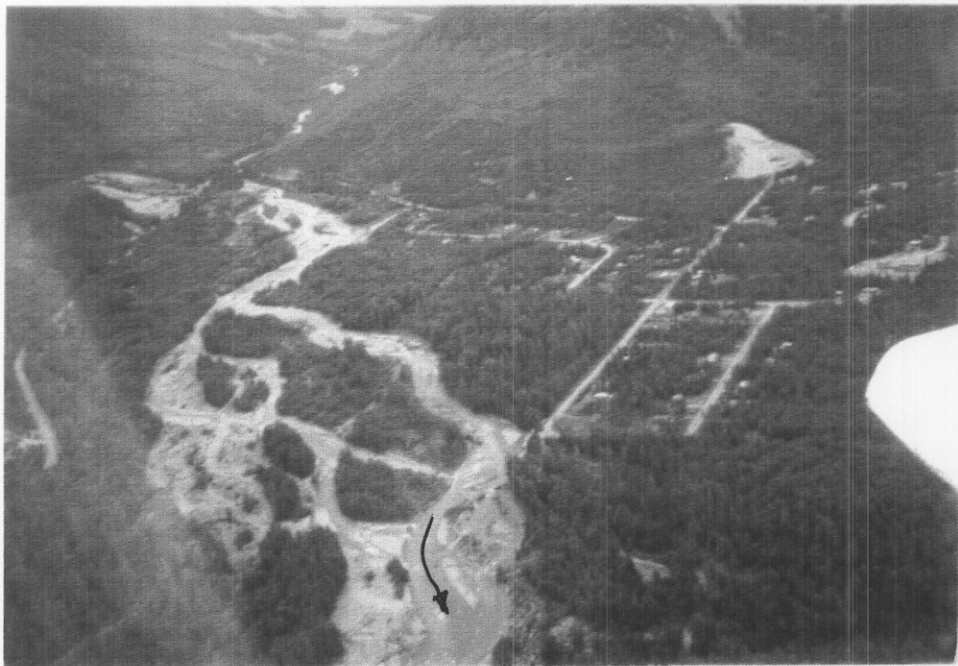
Photo 10

Photo Sheet Number	Photo Number	Description
5	9	Salloomt River, November 29, 1978. Debris in former channel. Location - Drwg. 87-56-5
5	10	Nusatsum River fan area upstream of Bella Coola River confluence, June 1986. Note evidence of channel avulsion, bank erosion and bed load deposition. Location - Drwg. 87-56-5
6	11	Abandoned home on right bank of Bella Coola River, June 1986. The main channel shown in the photo was farmland prior to the 1974 major channel avulsion in this reach. Location - Drwg. 87-56-6 between XS-31 and 32
6	12	Burnt Bridge Creek fan downstream of Highway 20 showing channel avulsion area, November 3, 1978. Location - Drwg. 87-56-10
