FLOODPLAIN MAPPING PROGRAM
COURTENAY, PUNTLEDGE AND TSOLUM RIVERS

DESIGN BRIEF

January, 1990

Ker, Priestman & Associates Ltd.
Consulting Engineers
300 - 2659 Douglas Street
Victoria, B. C.
V8T 4M3

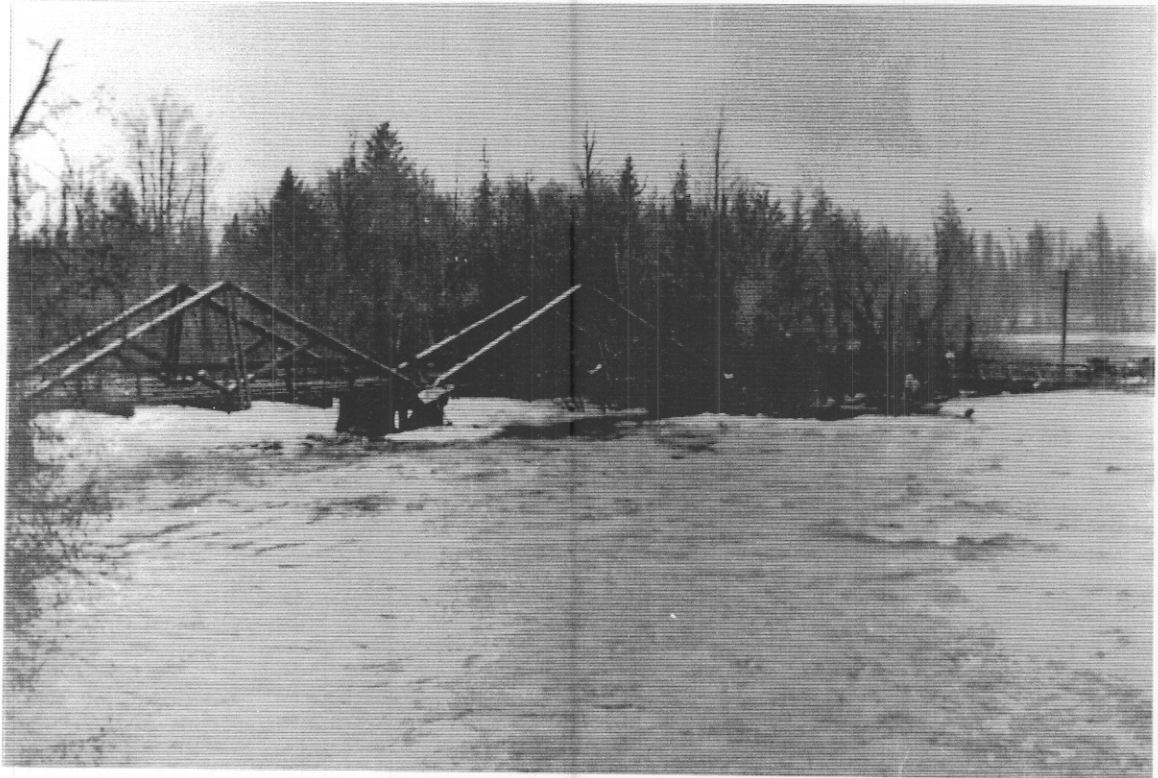
Photo 1 Looking downstream toward the Condensory Road Bridge over the Puntledge River. The centre pier was damaged by this flood and the bridge deck sagged deeply - 1 February 1935.

In addition to inundated roads and buildings, major damages included the partial collapse of the Condensory Road Bridge over the Puntledge River (Photo 1). The Comox Argus reported that a "battery of huge logs at a speed of seven to eight knots ... knocked out the centre pier of the road bridge and weakened another". A water main was also severed by a washout along Comox Road. Structures in Lewis Park were damaged by water and logs (Photo 2).

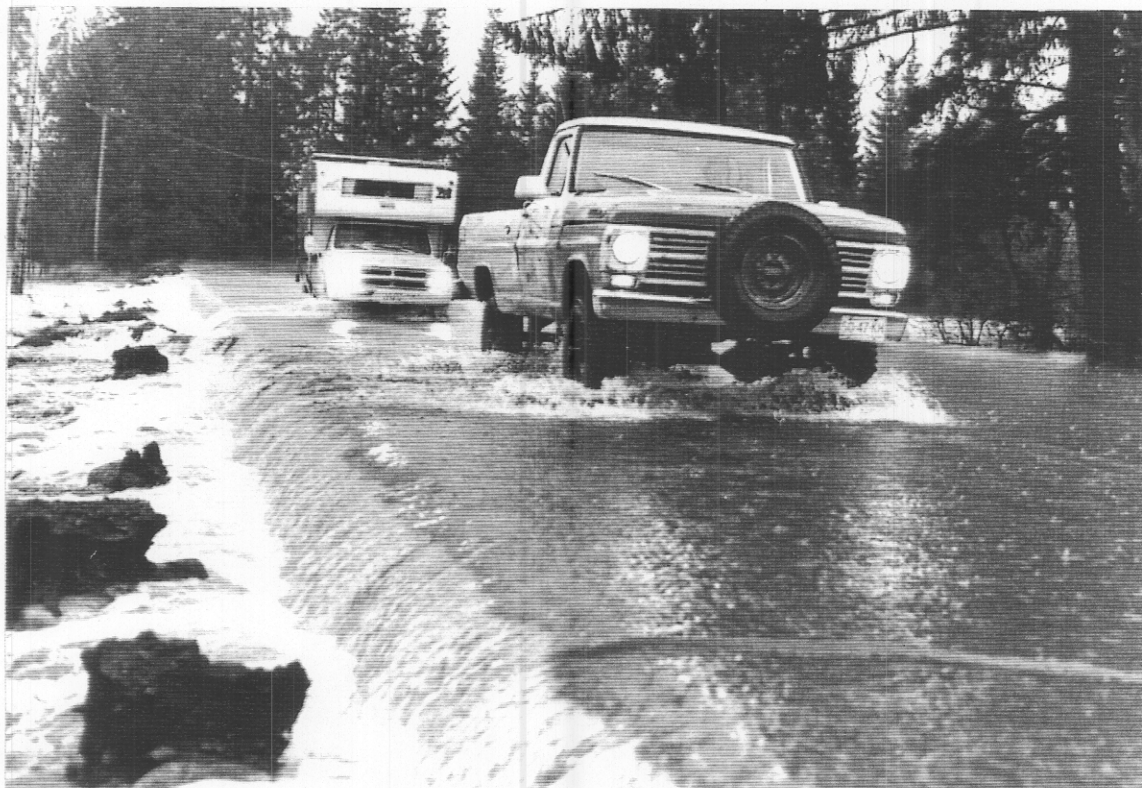
Photo 14 Looking west along Dove Creek Road near the bridge over the Tsolum River - 11 February, 1983.

- Mr. W. Edwards, the WSC Technician (17) who has serviced the Tsolum gauge for many years stated that the extrapolation of the stage-discharge rating curve may not have included the effect of flow over the left bank in a high flood, yet flow over the left bank was observed in 1983 (Photo 14).
