# **CANADA / BRITISH COLUMBIA FLOODPLAIN MAPPING AGREEMENT**

## **A Design Brief on the Floodplain Mapping Project Cowichan and Koksilah Rivers near Duncan and the Cowichan River (Riverbottom Road Area)**

Water Inventory Section  
Victoria, British Columbia  
March, 1997  
File: 35100-30/920-2577

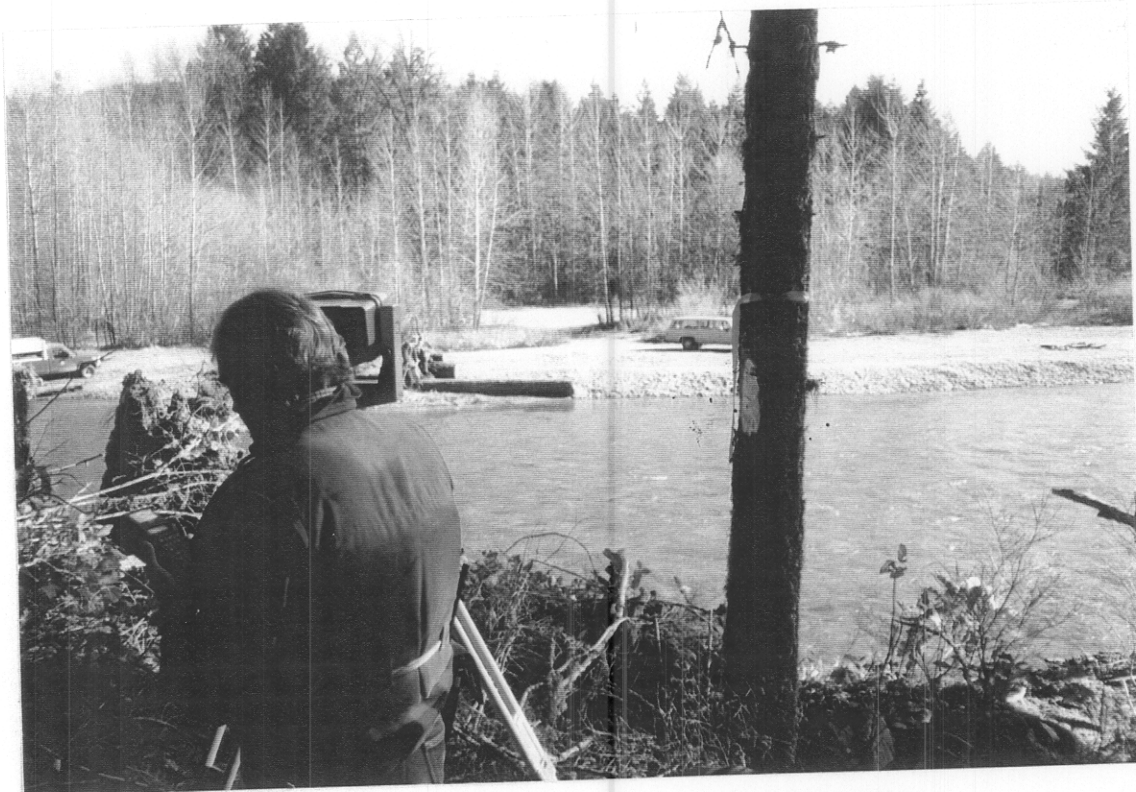
Photo 1 Looking to left bank at XS-3. Note gravel deposition.

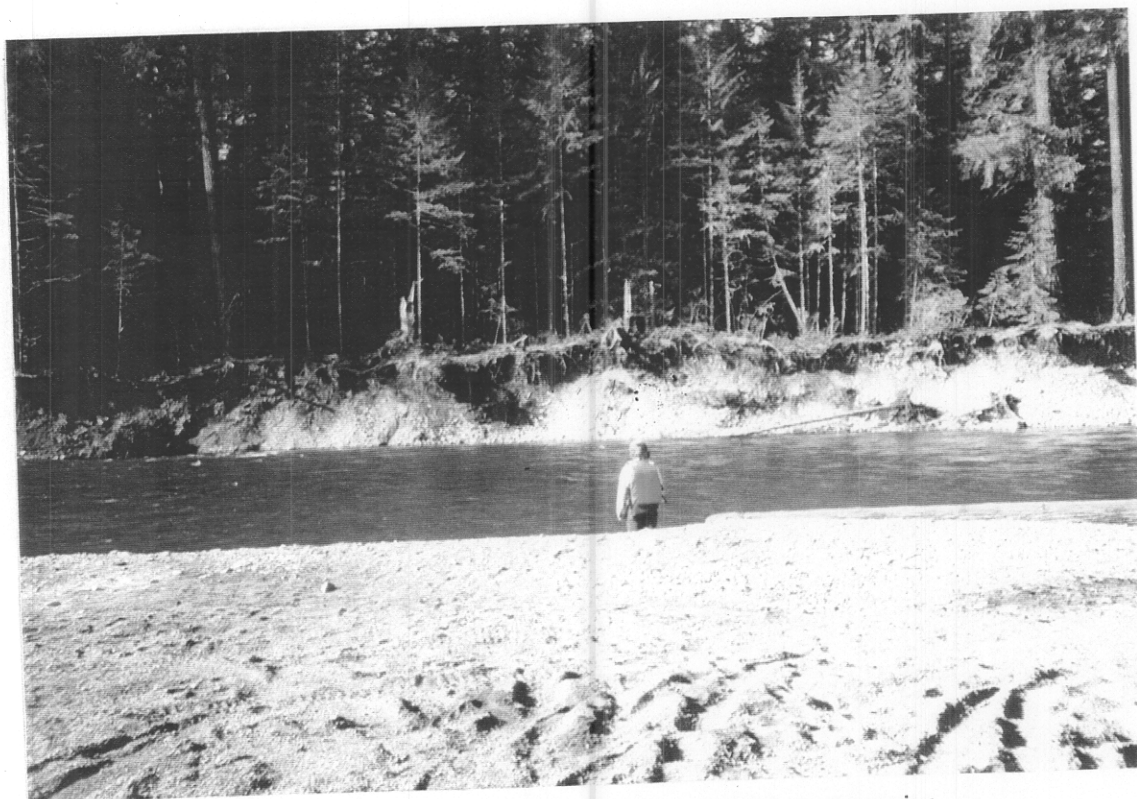
Photo 2 Looking at the right bank at XS-3. Note severe erosion.

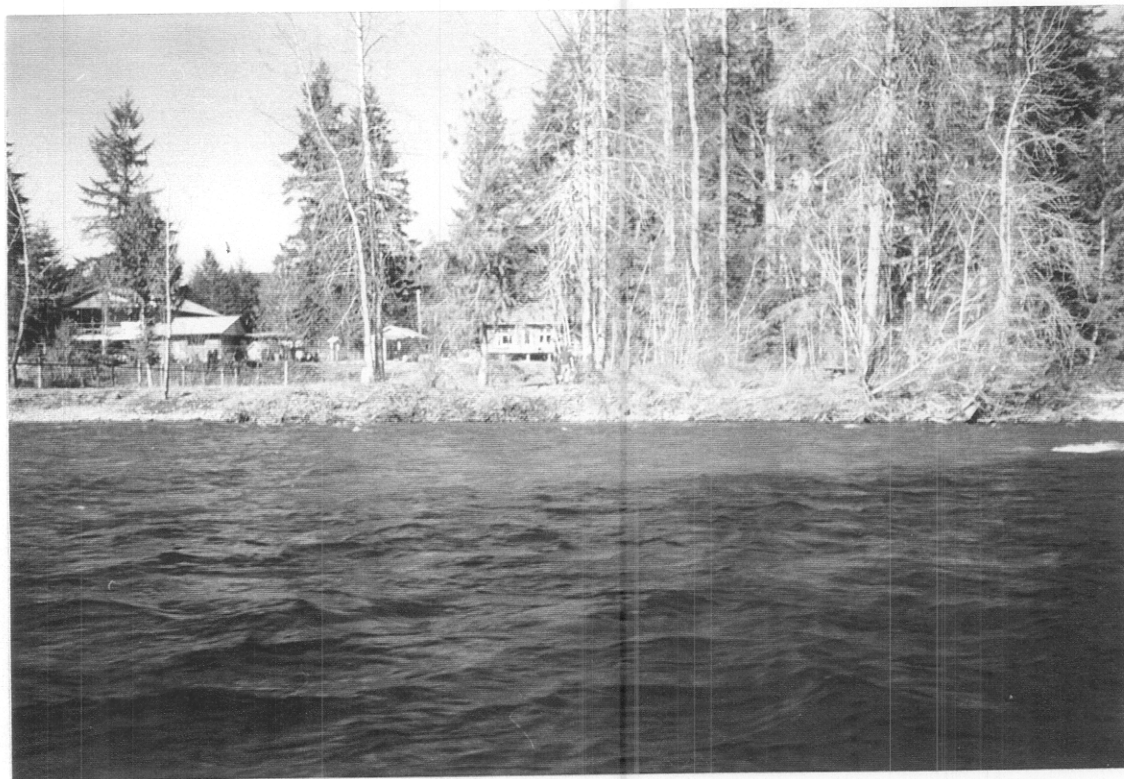
**Photo 3** Looking to left bank at XS-9. Flood boundary near top of bench where houses are situated.

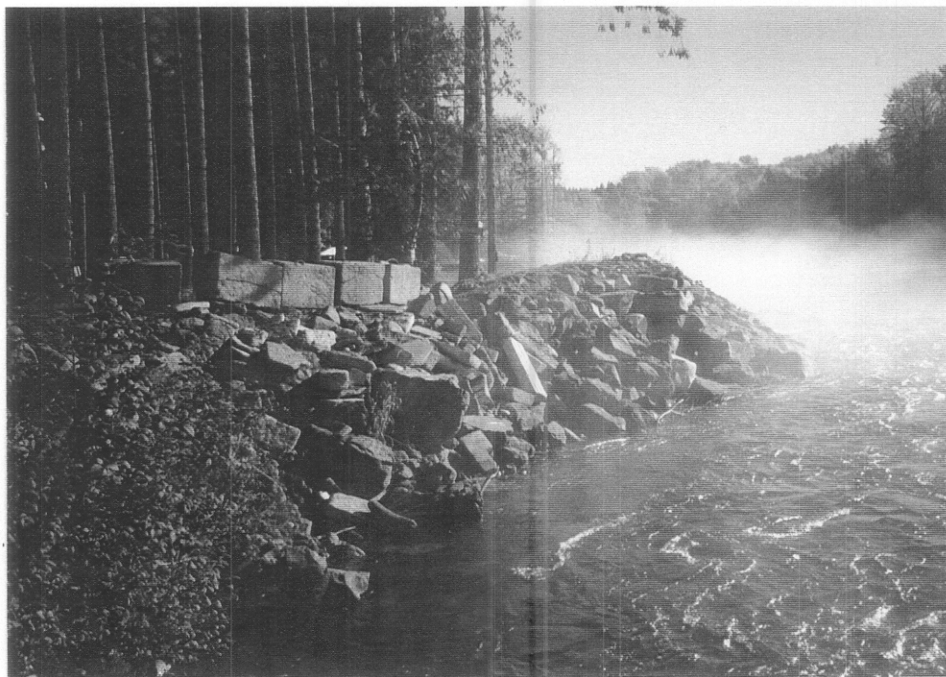
**Photo 5** Close-up of bank protection on left bank between XS-10 and XS-11.

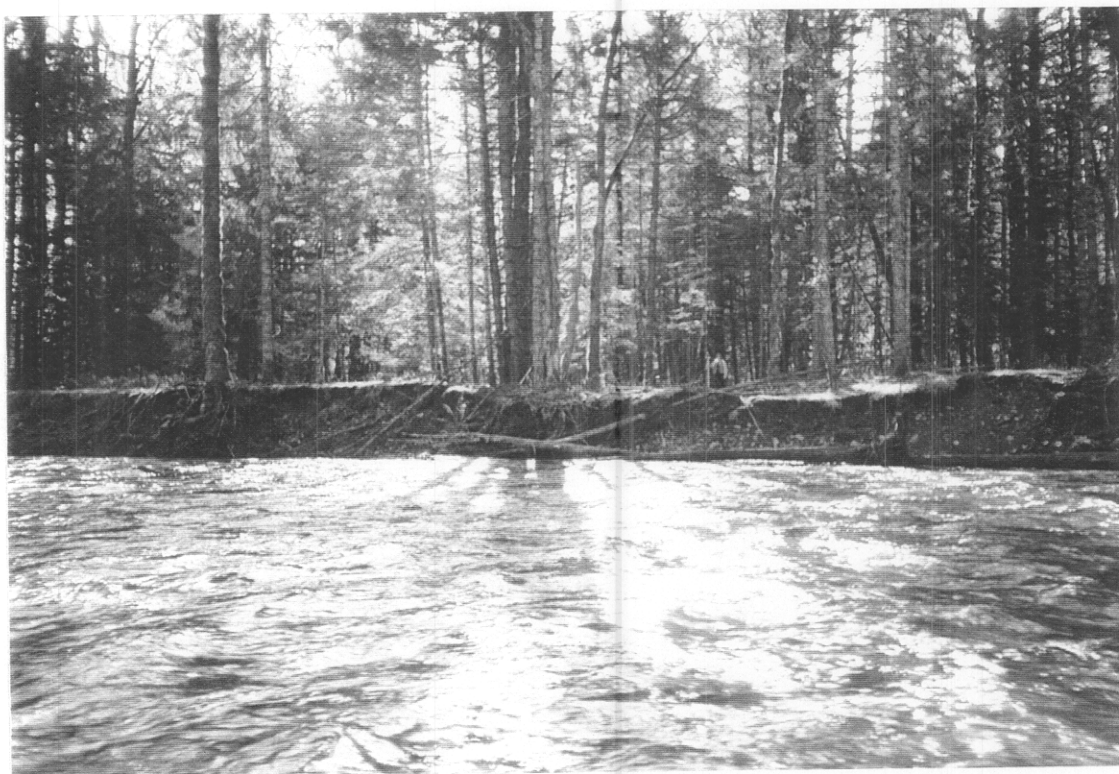
**Photo 6** Looking at the right bank at XS-12. Note severe erosion, exposed tree roots.

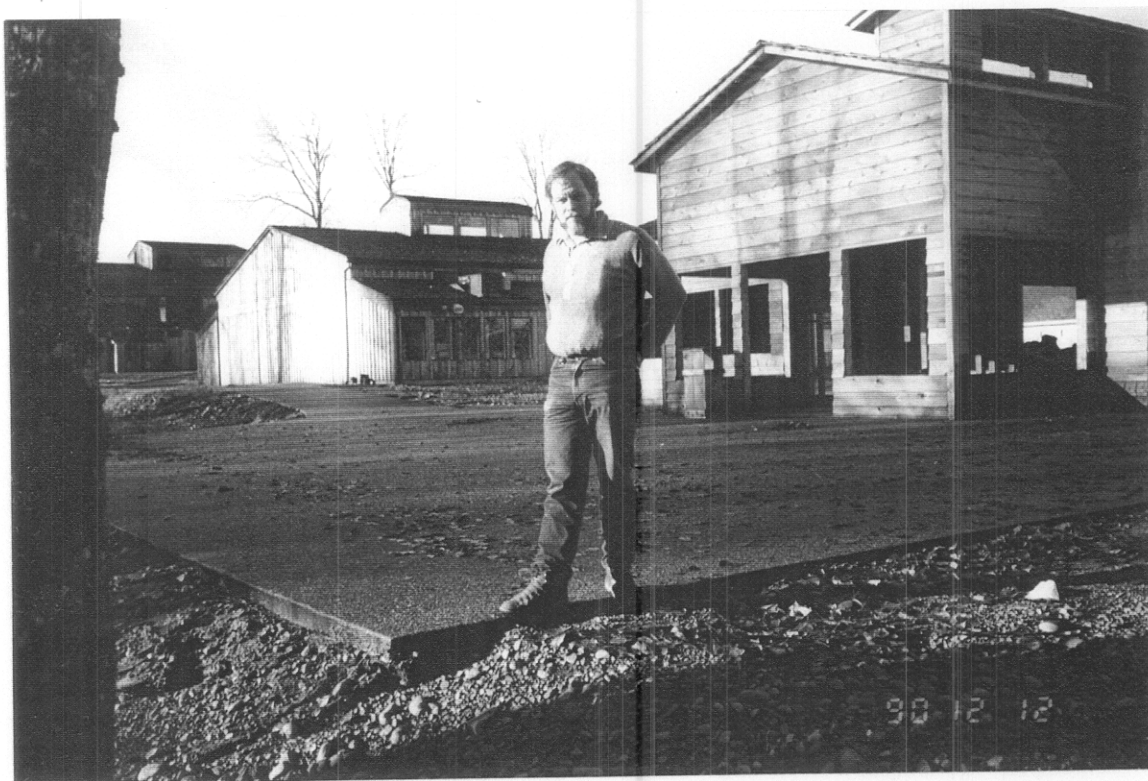
**Photo 13** Rear of Native Heritage Centre on Cowichan Way on the left bank upstream of XS-44. December 4, 1990 high water mark indicated by toe of right boot and trash line beyond.

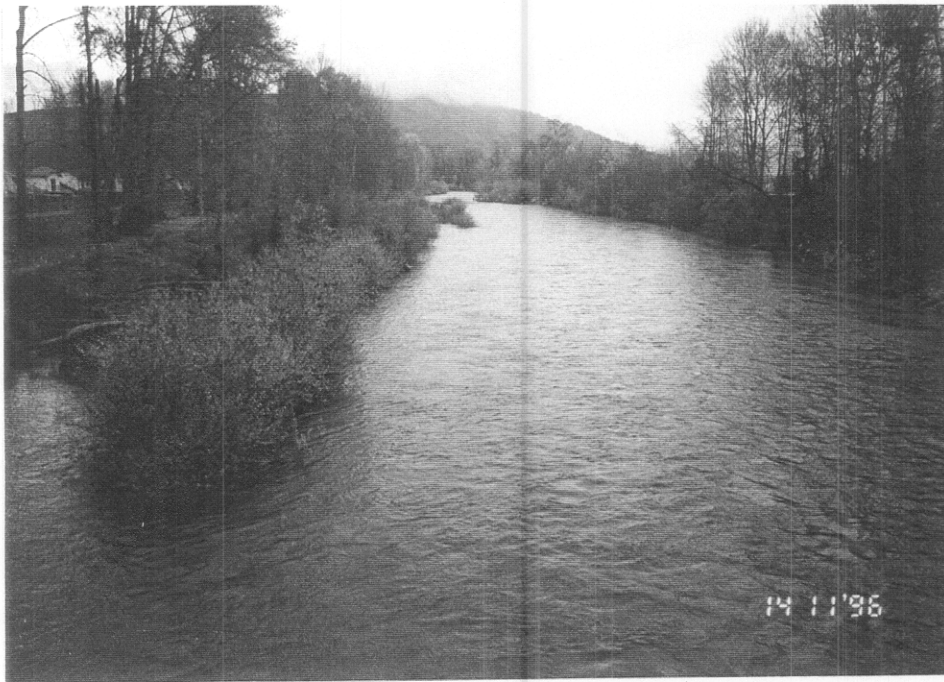
**Photo 15** Looking downstream from the Silver Bridge (XS-42). Crest of Duncan City Dyke is at base of gray wall in front of buildings to left side of photo. District of North Cowichan South Dyke is just behind vegetation on right.

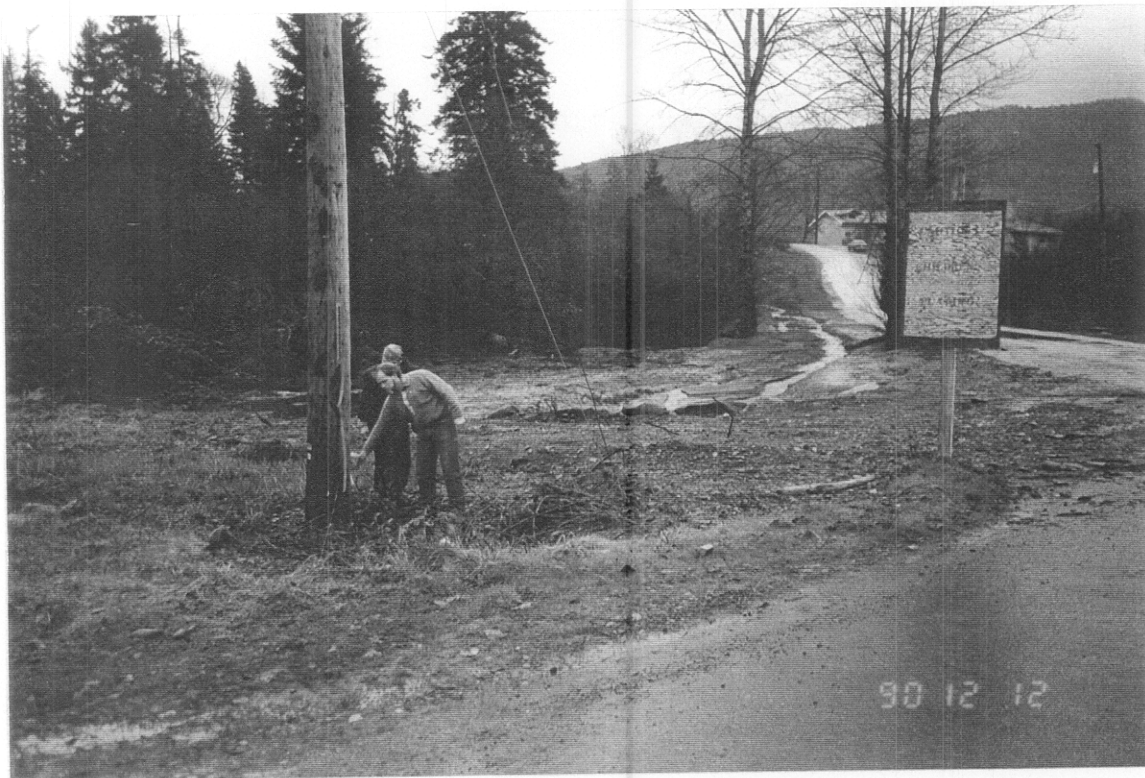
**Photo 18** High water mark (nail in power pole) from December 4, 1990 flooding. This is on the left bank just downstream of XS-26.

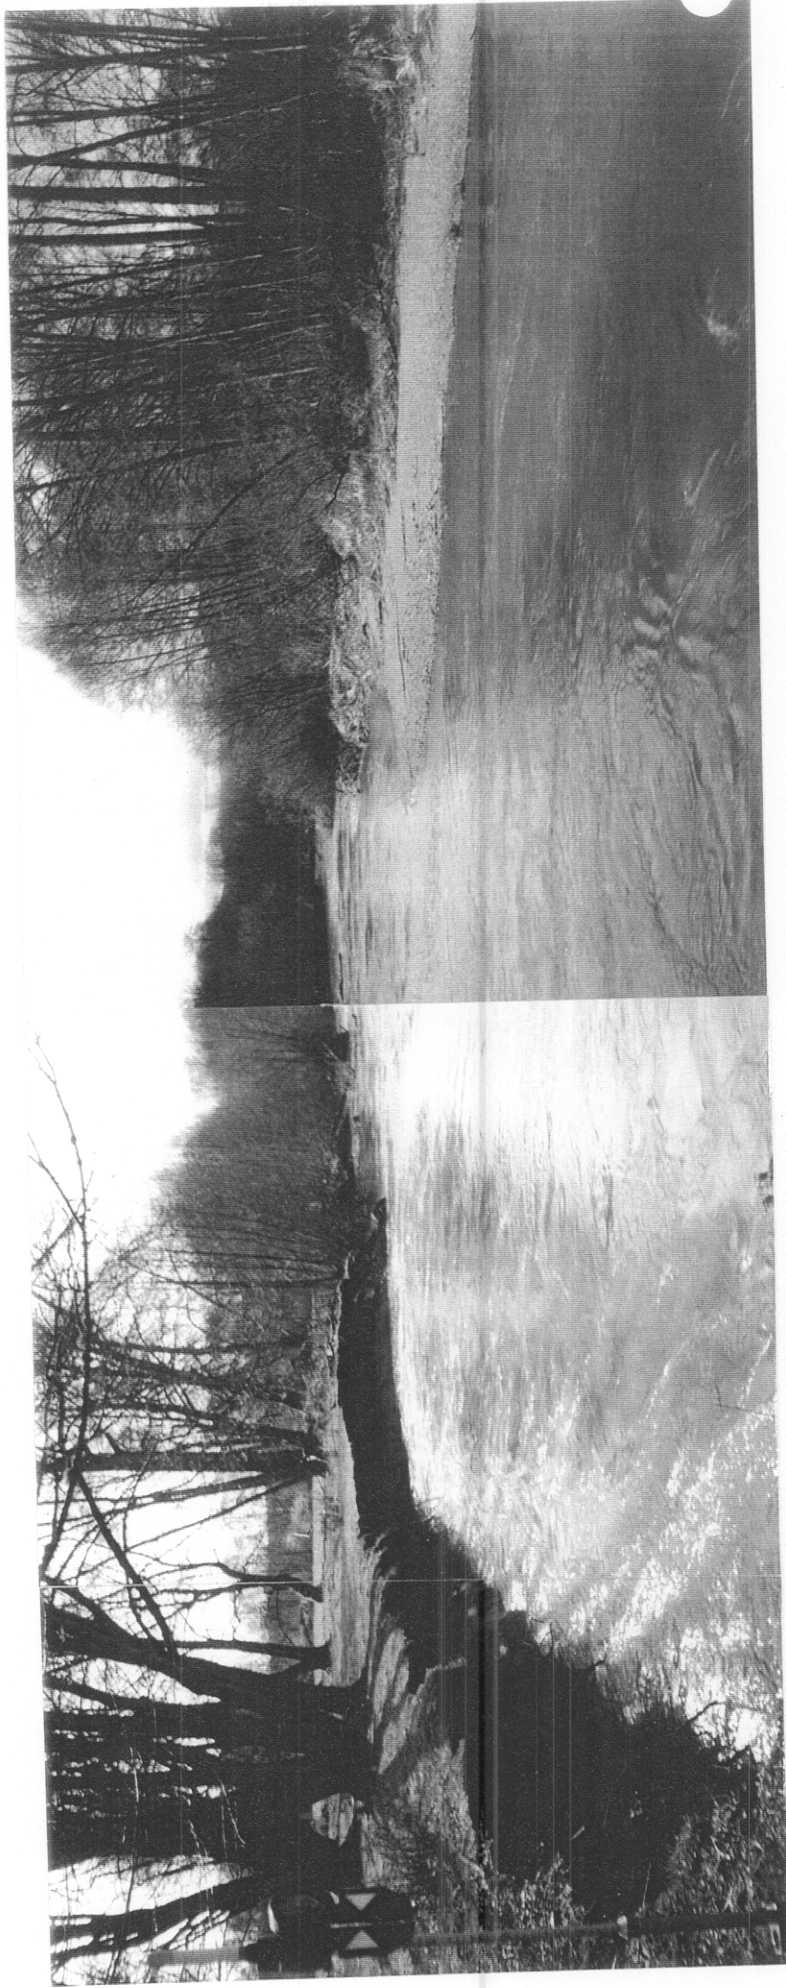
Photo 22 Looking downstream from XS-11. Note severe erosion on left bank, gravel deposition on left bank.

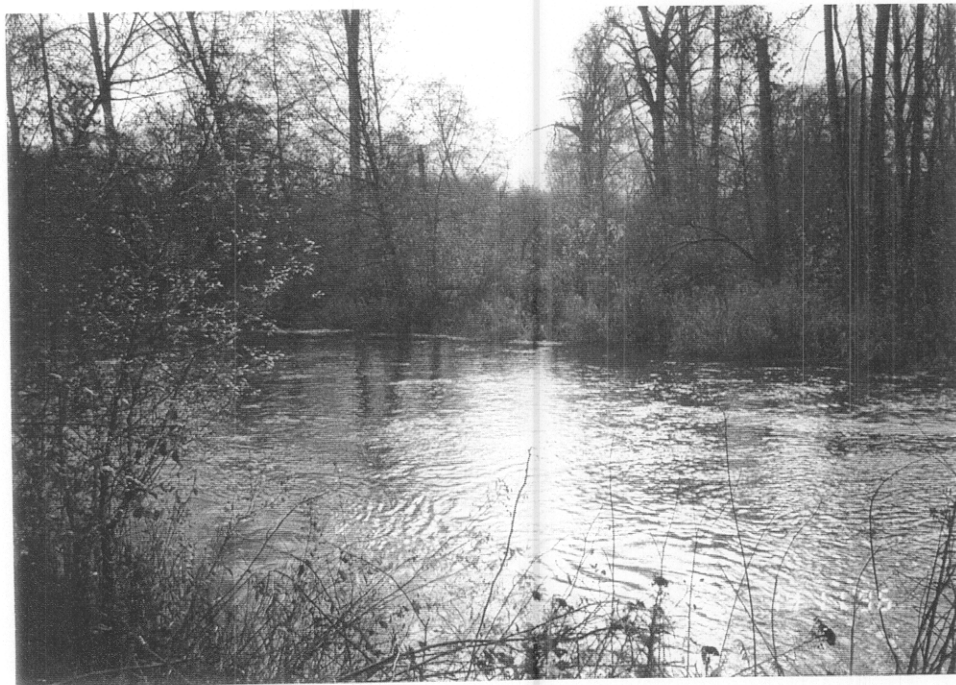
**Photo 26** Looking to the right bank from the end of the Quamichan Dyke downstream of XS-23. High water overtops the right bank and flows southwesterly to the south channel.

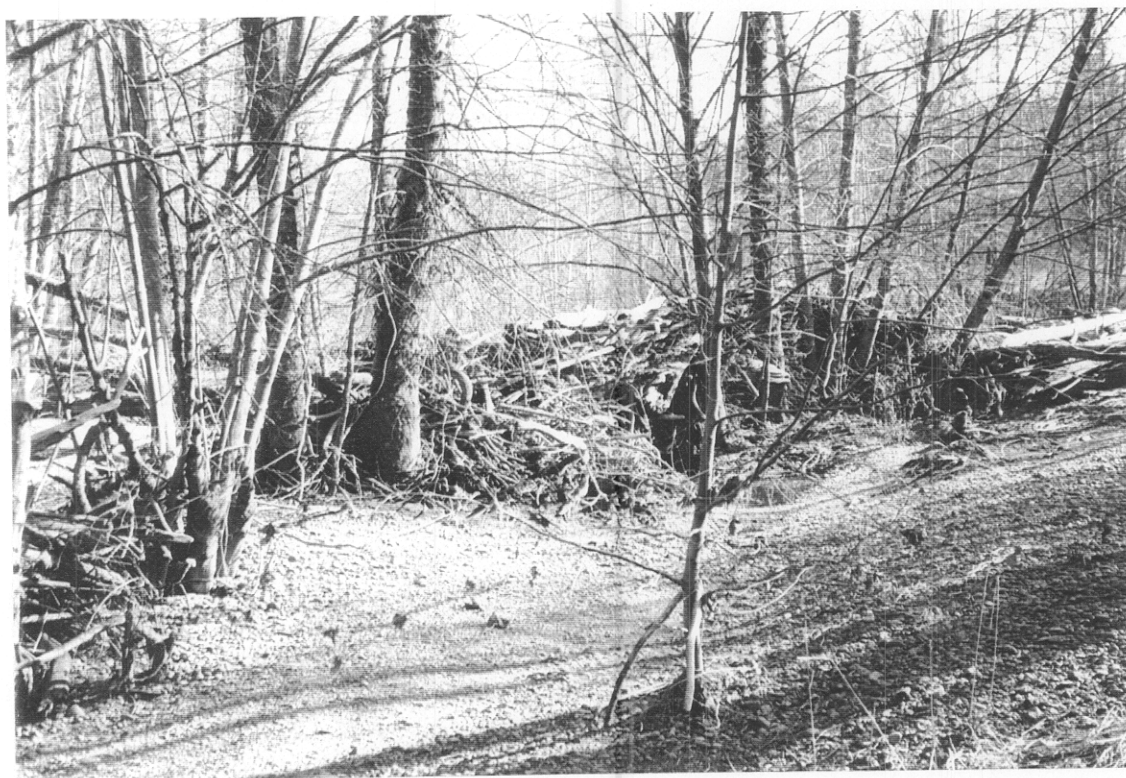
**Photo 31** Looking upstream at XS-6 backchannel. Note large log jam.

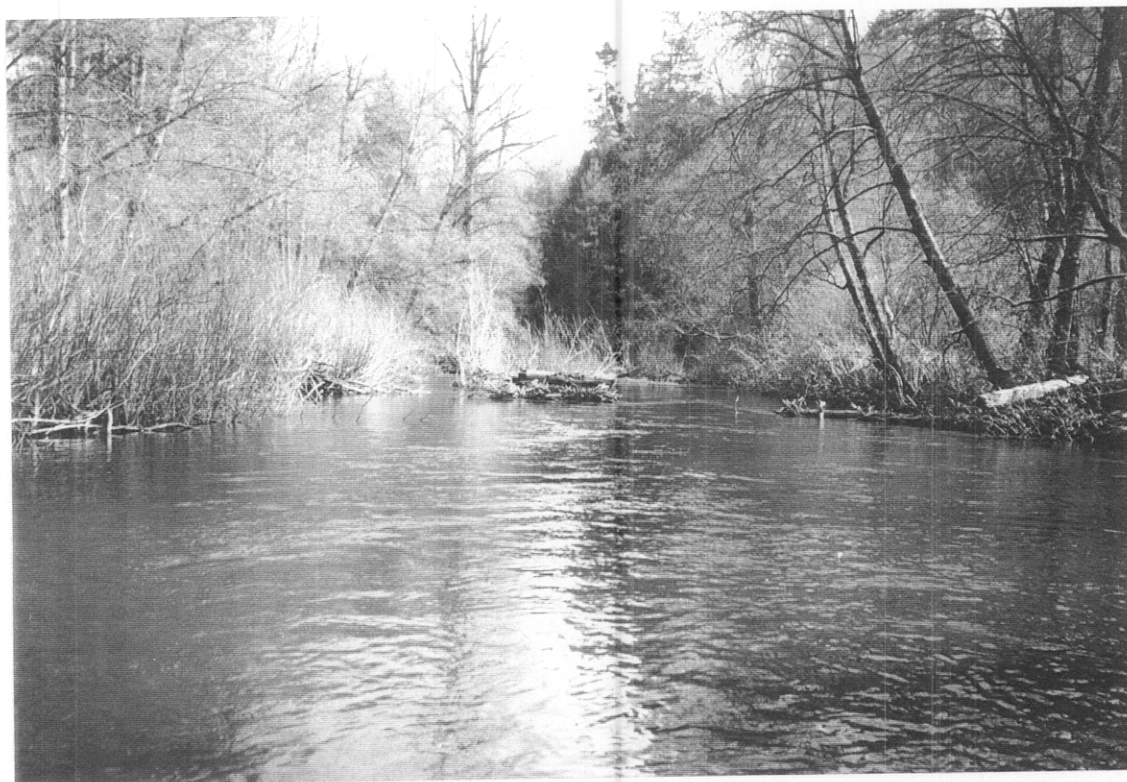
**Photo 34** Looking downstream from XS-14. Note debris on both banks and mid-channel.

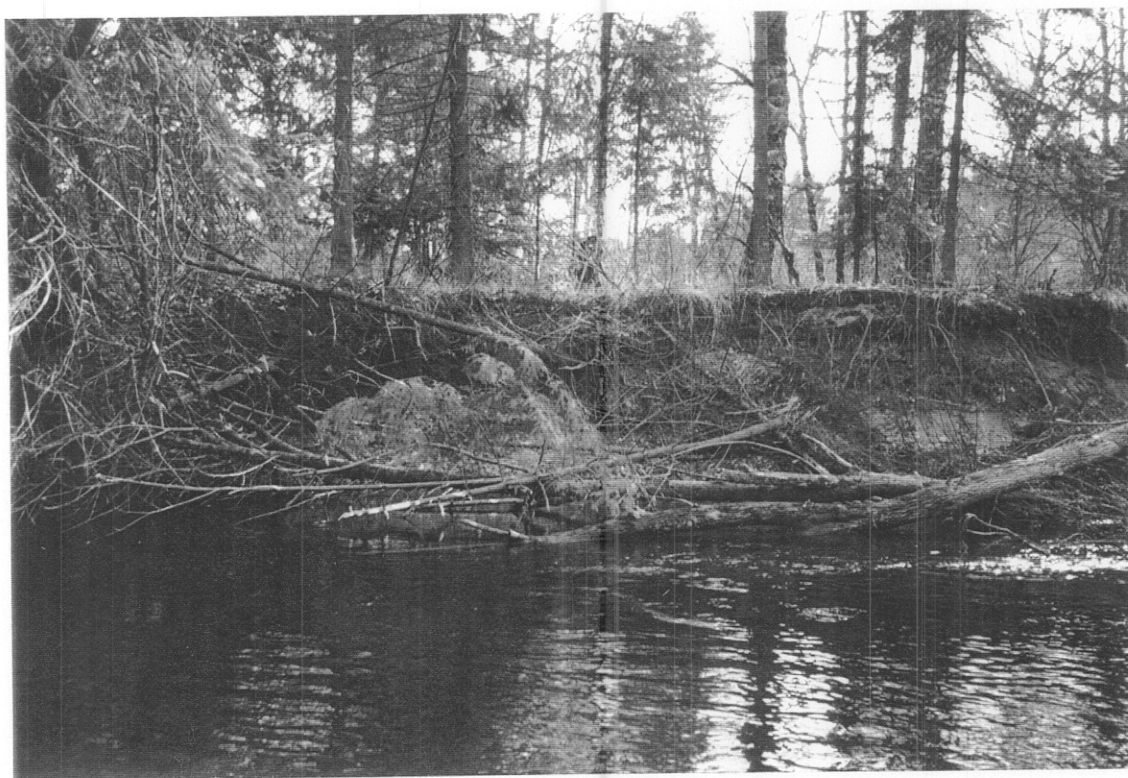
**Photo 35** Erosion and debris on the right bank at XS-22..

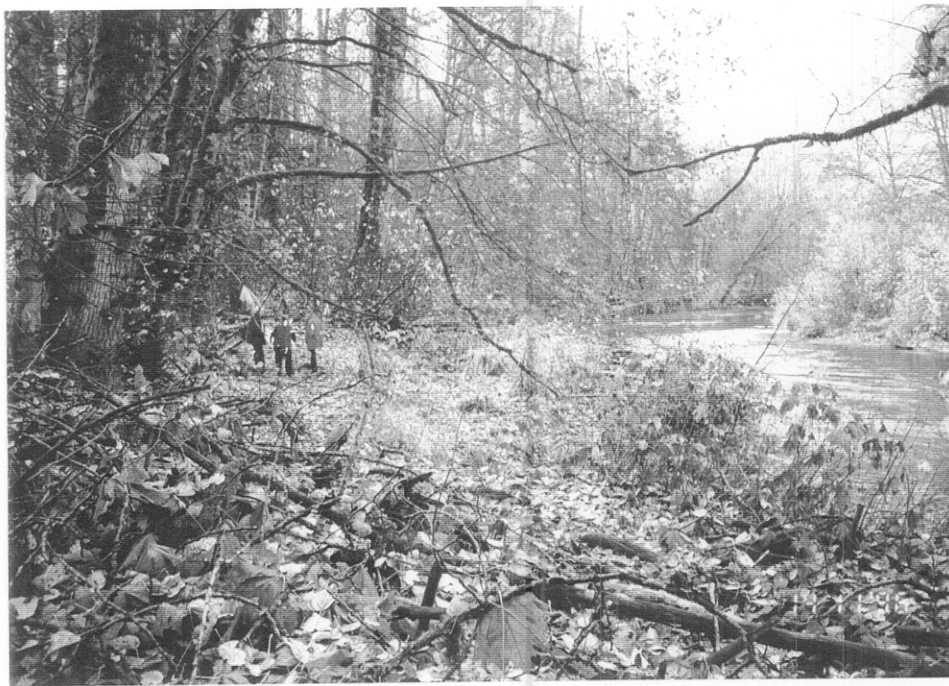
**Photo 40** Looking upstream near XS-25. During high flows, water overtops area where men are standing and flows to side channel noted in photo 39.

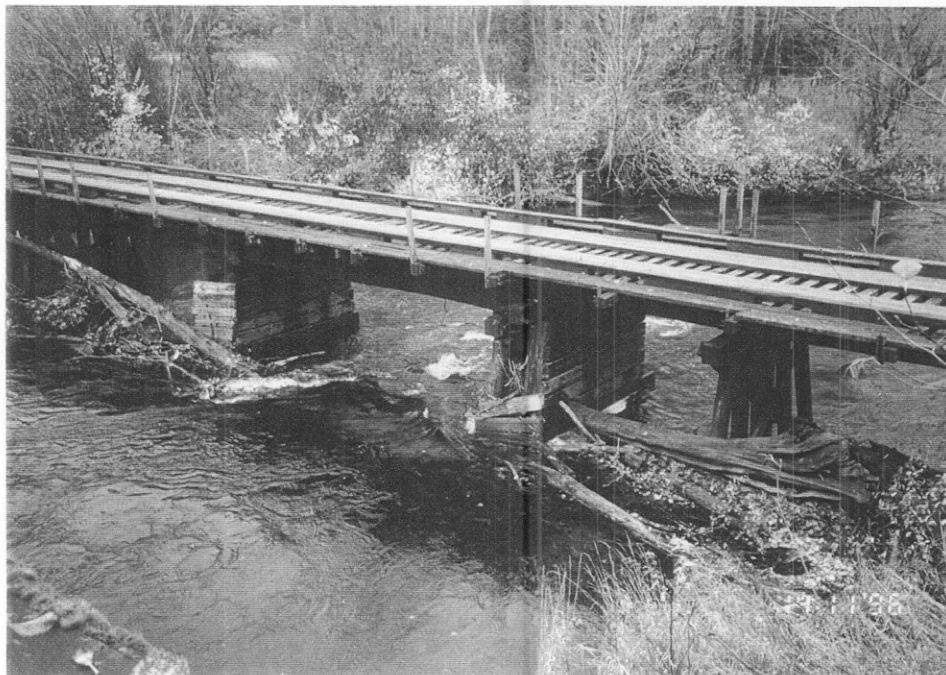
**Photo 41** Looking downstream from abandoned M&B haul bridge to XS-27 along upstream edge of former rail bridge. Note debris buildup.

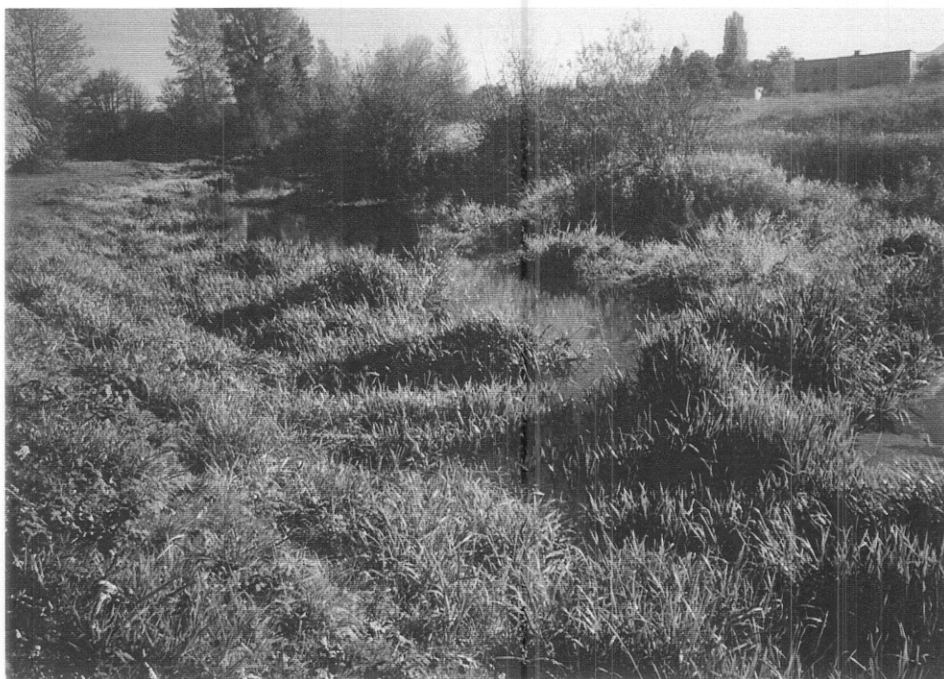
Photo 42 Typical weed growth in creek channel near XS-3.

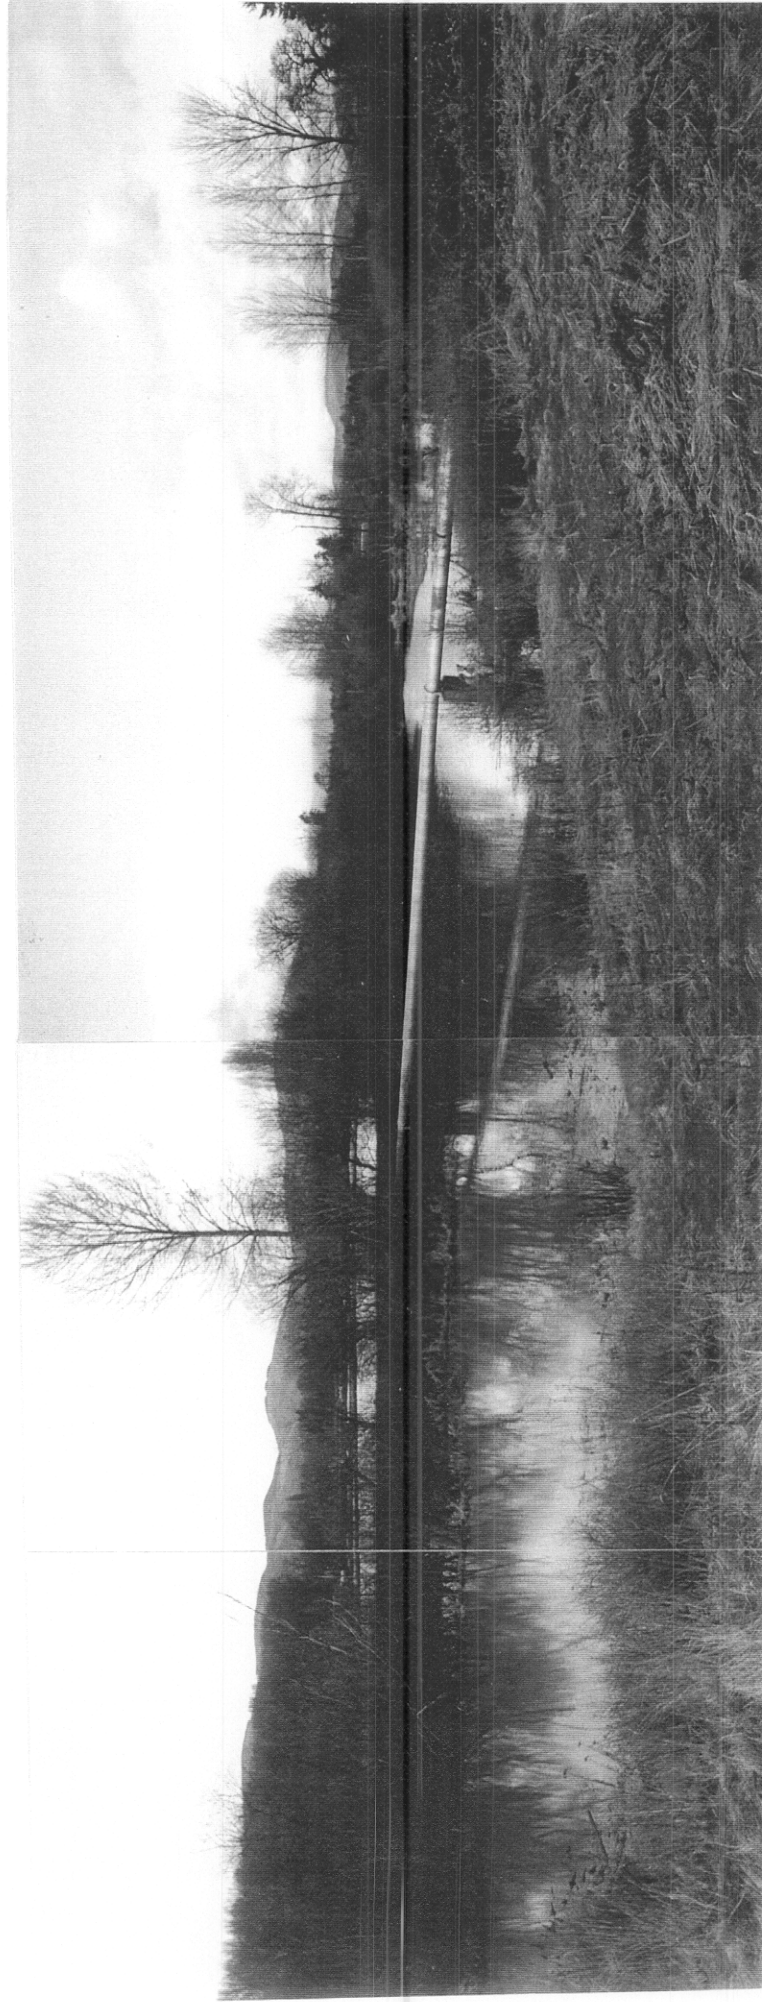
Photo 48 Looking to the right bank and upstream at XS-10. Note overflow extending to sewage lagoon dyke and overflow at the upstream left bank.

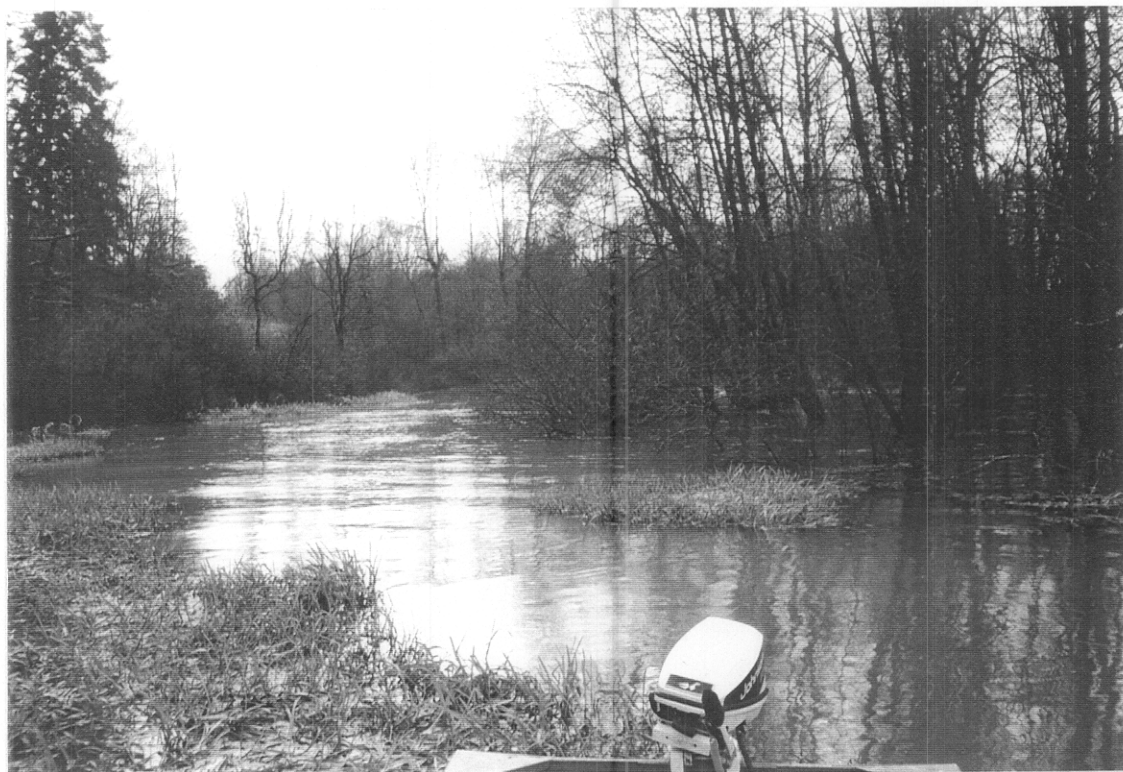
**Photo 49** Looking downstream from XS-11. Normal incised channel is between grassy top by boat and grassy clump opposite, flowing to brown bush at left of photo.

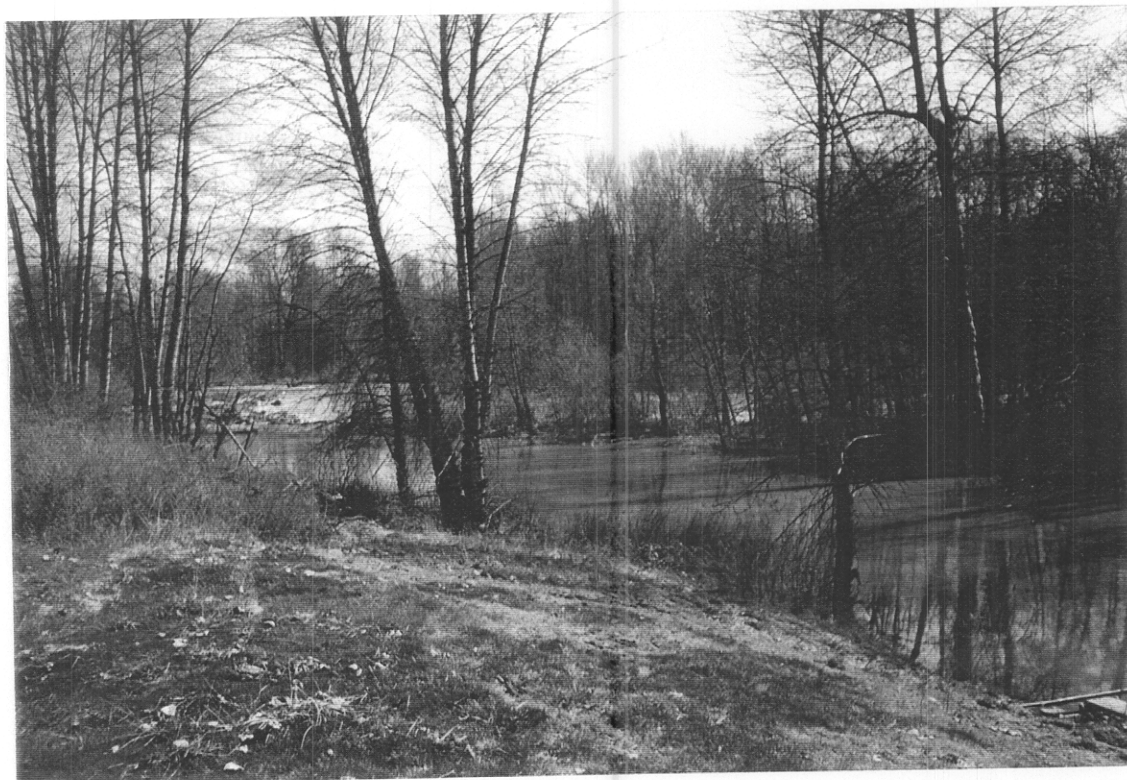
**Photo 50** Looking downstream to XS-12 (Somenos)/XS-28 (Cowichan). High Cowichan flow is preventing Somenos outflow causing upstream flooding depicted in photos 45, 48 and 49.
