Floodplain Mapping Study

Lakelse River and Lake

An Overview of the Study Undertaken to Produce Floodplain Mapping for Lakelse River and Lake

Victoria, British Columbia August, 1989

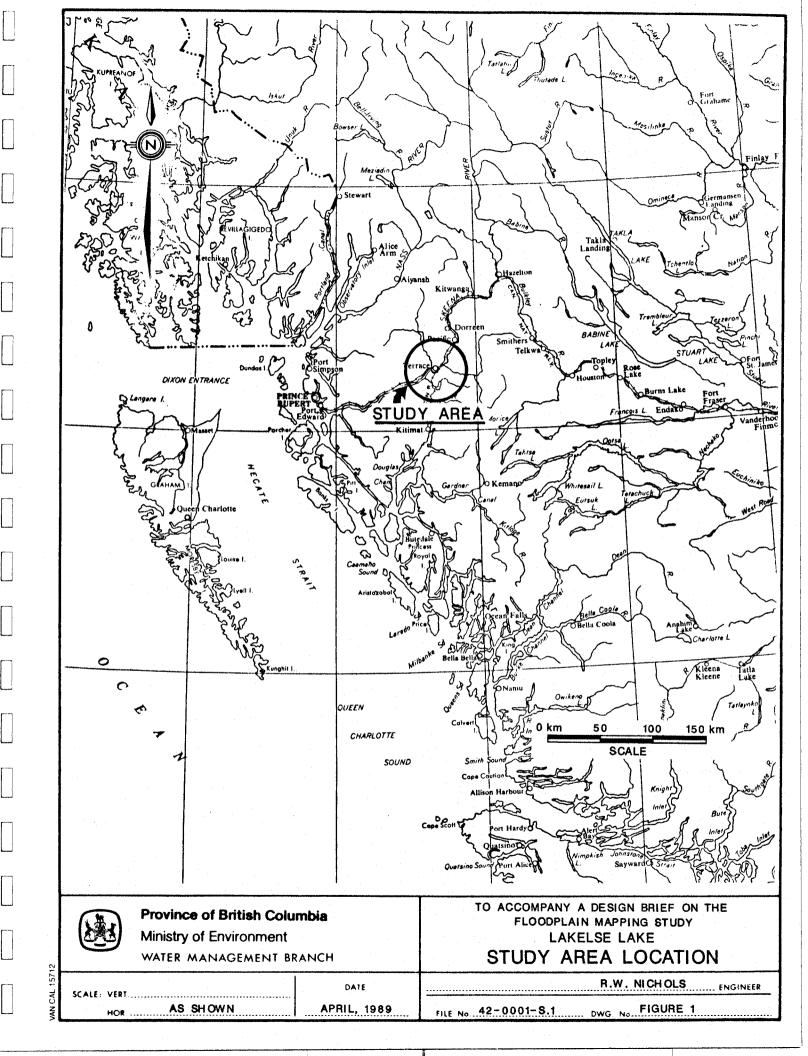
The study area is located (Figure 1) approximately 15 km south of Terrace, in the Coast Mountain System, one of the six main physiographic regions of the Province. Mean annual precipitation in the study area exceeds 250 cms (Appendix 1.1).

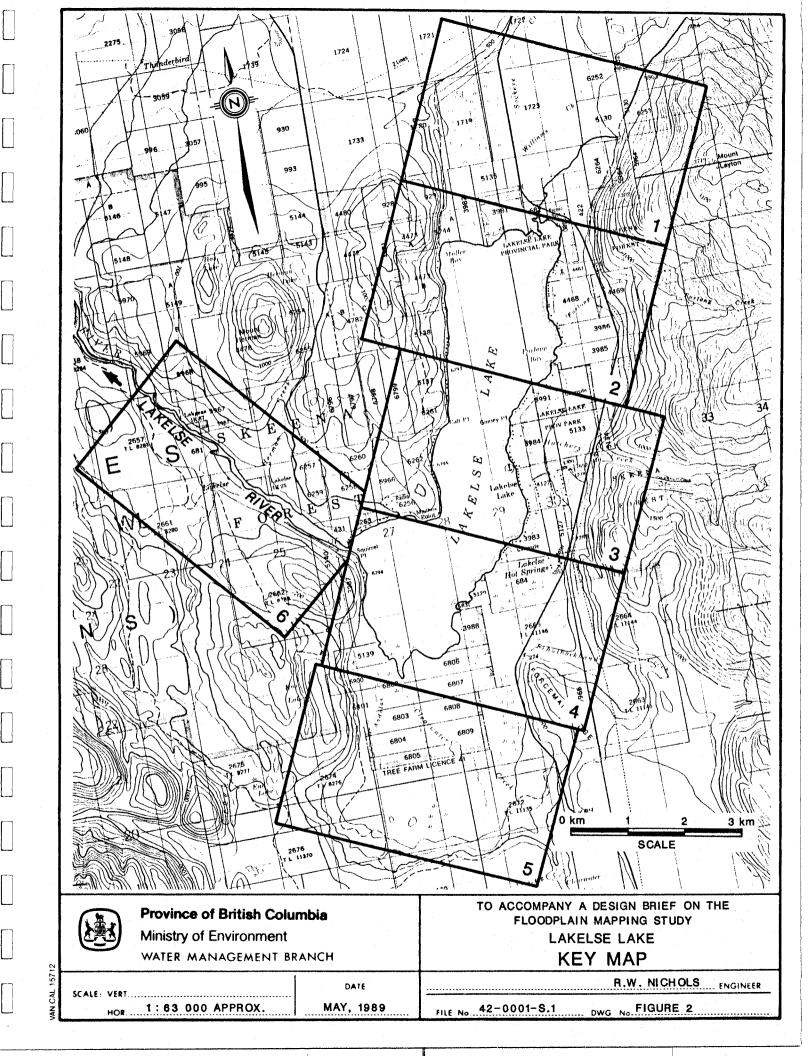
Lakelse Lake is located west of Highway 37 which connects Terrace and Kitimat in the Regional District of Kitimat-Stikine. Figure 2 is a key map which shows the location of the 6 floodplain mapping sheets produced for the study area.

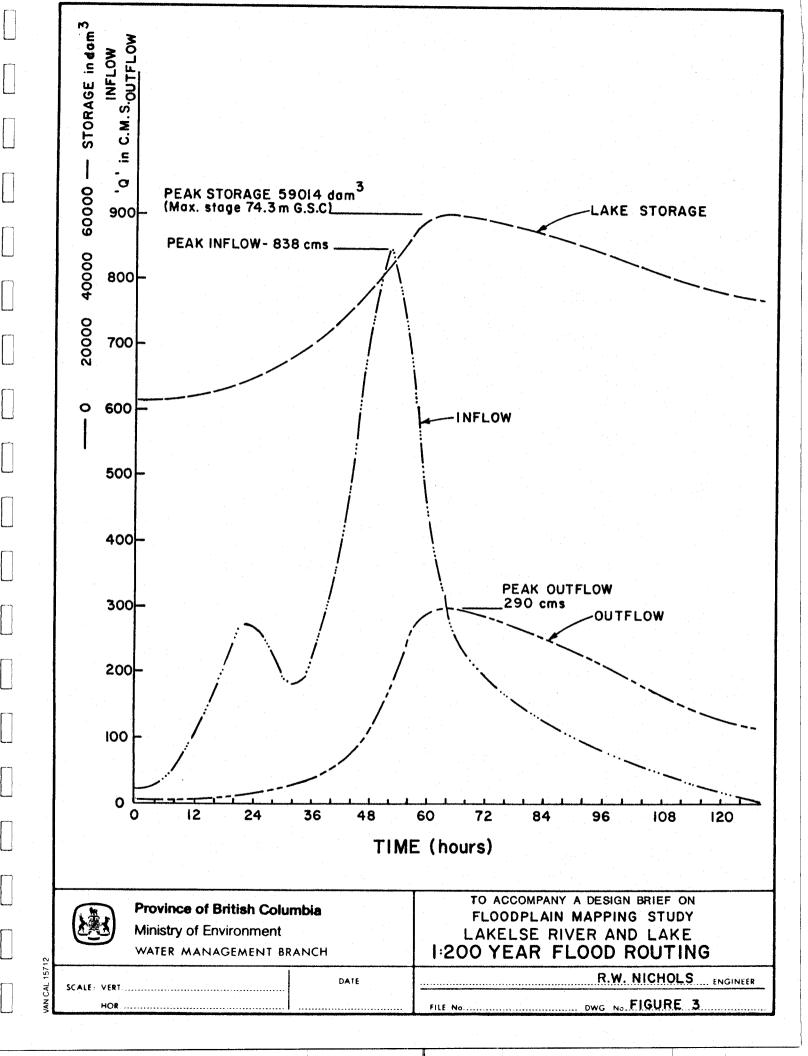
To produce the 200 year peak inflow hydrograph for Lakelse Lake with a peak of 838 cms, a factor of 1.40 was applied to the base inflow hydrograph resulting in a 1:200 year inflow as indicated in Figure 3.

Figure 3 indicates in graphical form the flood routing results for a 1:200 year inflow of 838 cms. As shown, the maximum outflow is 290 cms and the storage volume utilized is 60×10^6 dam³ corresponding to a lake elevation of 74.3 metres.

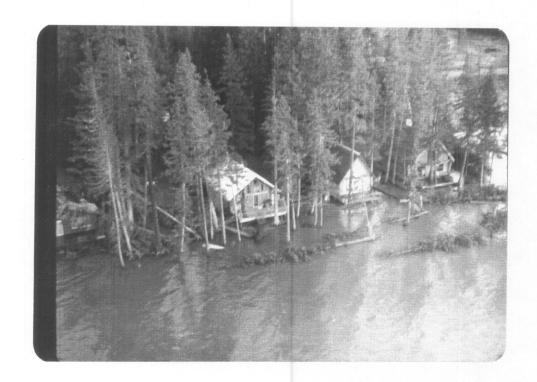
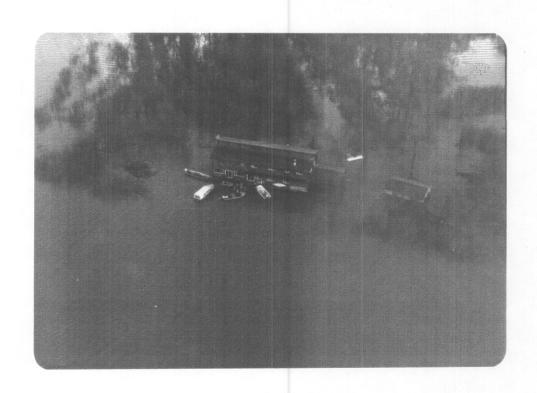
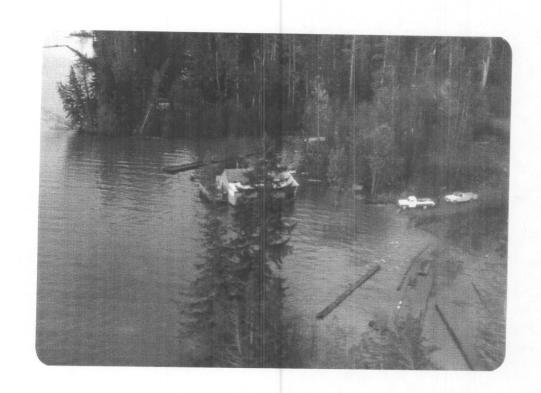
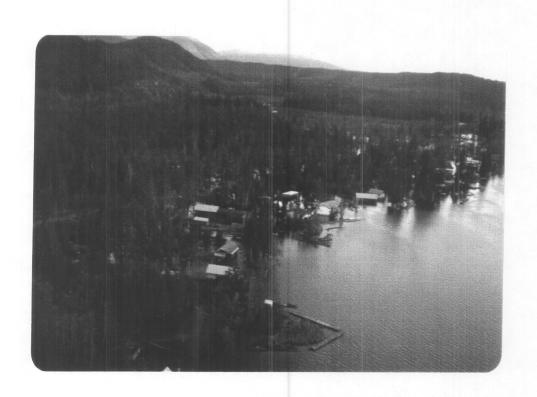
Photos of 1978 Flood

During the November 1978 flood, the lake level increased within 3 days from a normal elevation of approximately 71.5 metres to 74.2 metres by November 2. Approximately 60% of the homes and cottages around the lake were flooded. Appendix 2 provides photos of the 1978 flood event at Lakelse Lake.

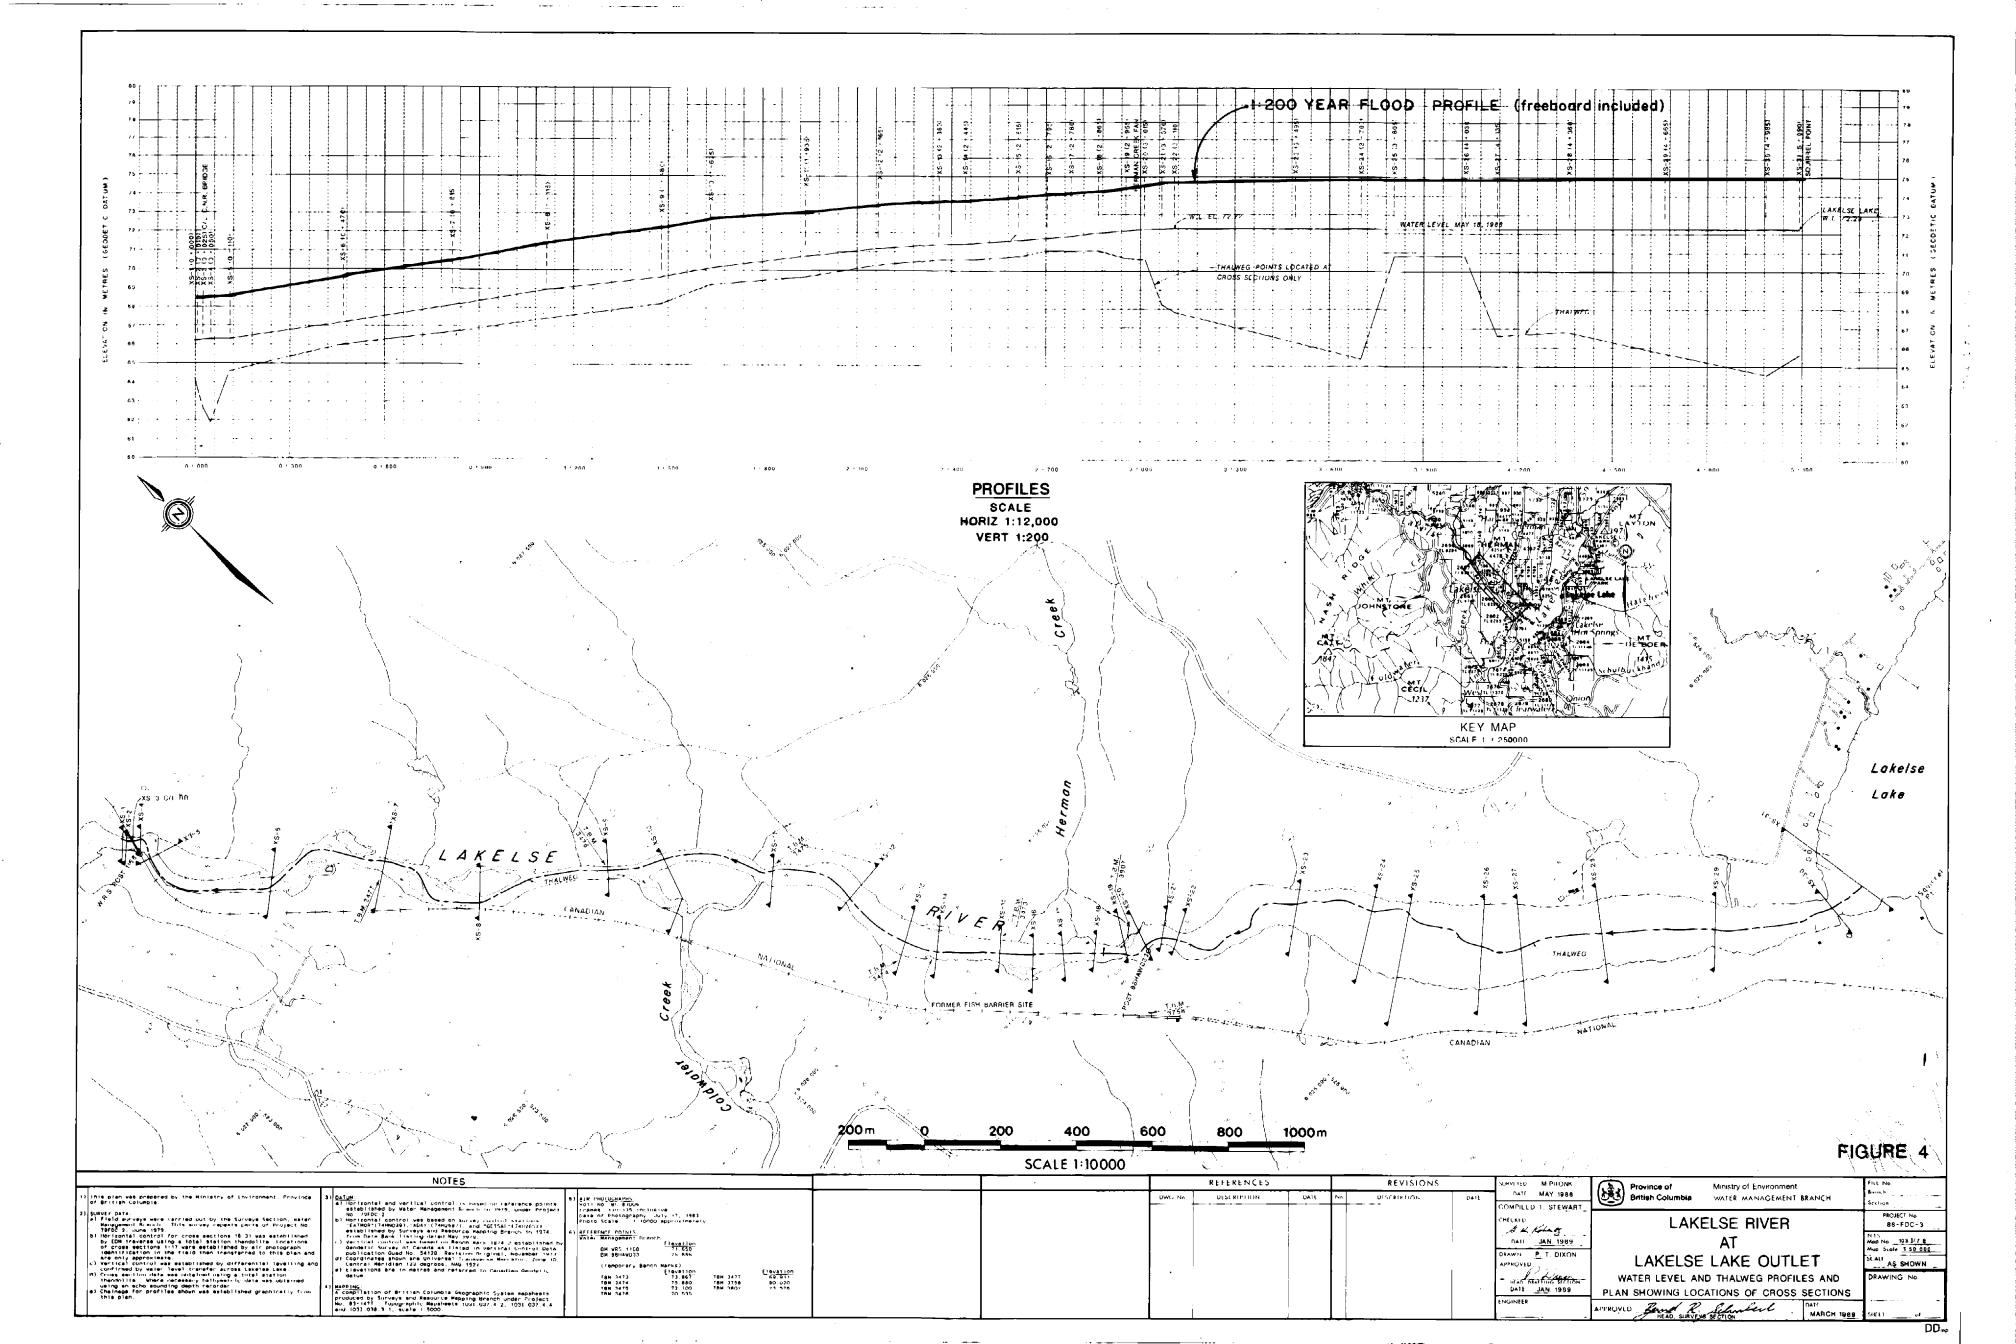
Figure 4 is a reduction of Drawing 89-2-1 showing the location of the 31 river cross sections obtained in 1988 along Lakelse River, a distance of 5.1 km downstream of the lake outlet. Also shown are water level and thalweg profiles of the area. The May 18, 1988 water level profile was metered and amounted to 28.3 cms.

The 1:200 year flood profile (freeboard included) is shown on Figure 4. In keeping with Ministry practice, a freeboard allowance of 0.6 m was used based on the daily (24 hour) outflow of 275 cms. The 1:20 year flood levels (freeboard included) for Lakelse River were also calculated and are shown on the Floodplain Mapping Sheet Number 6.
