**FLOODPLAIN MAPPING PROGRAM
SALMON RIVER
SPA CREEK TO FALKLAND**

DESIGN BRIEF

December 1991

**KPA Engineering Ltd.
300 - 2659 Douglas Street
Victoria, B. C.
V8T 4M3**

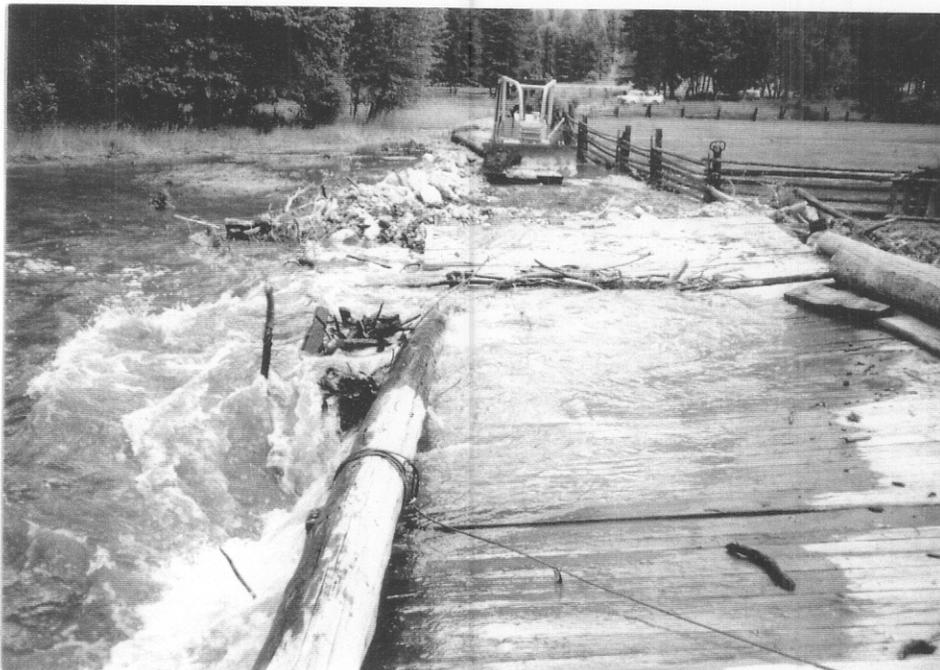
Photo 2 Attempts to save a driveway bridge during the June 1990 flood. Looking toward the left abutment along the upstream side of the bridge at cross section XS-260.

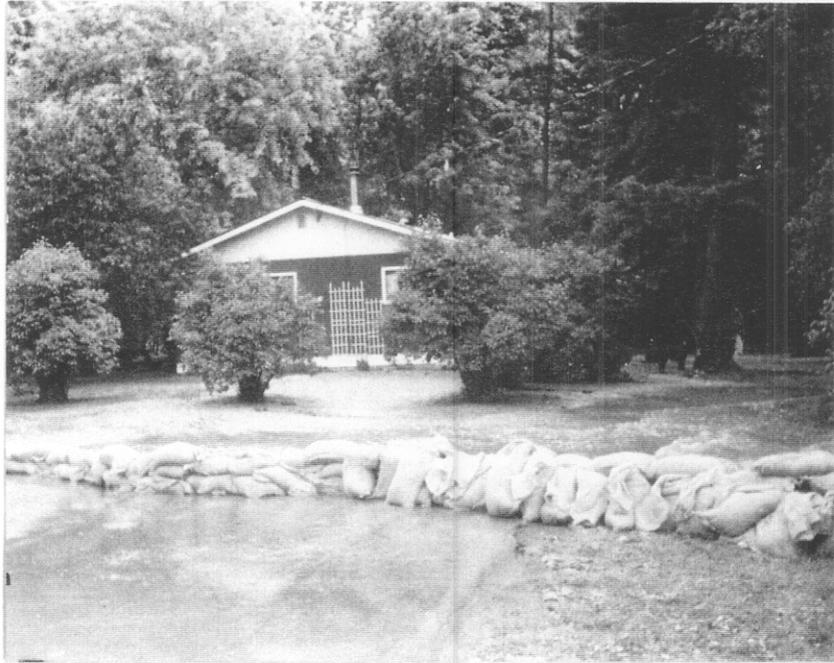
Photo 3 Bolean Creek floodwaters surrounding a house in the Falkland Trailer Park, June 1990.

In Falkland, Bolean Creek did not overflow its left bank, as it had in 1948. However, it did spill over the right bank and flowed through the Falkland Trailer Park adjacent to the Creek. Mobile homes were surrounded by water as a flood channel traversed a field next to the Park (Photos 3 and 4). Log jamming at a bend in Bolean Creek was reported as a cause of the overflow.

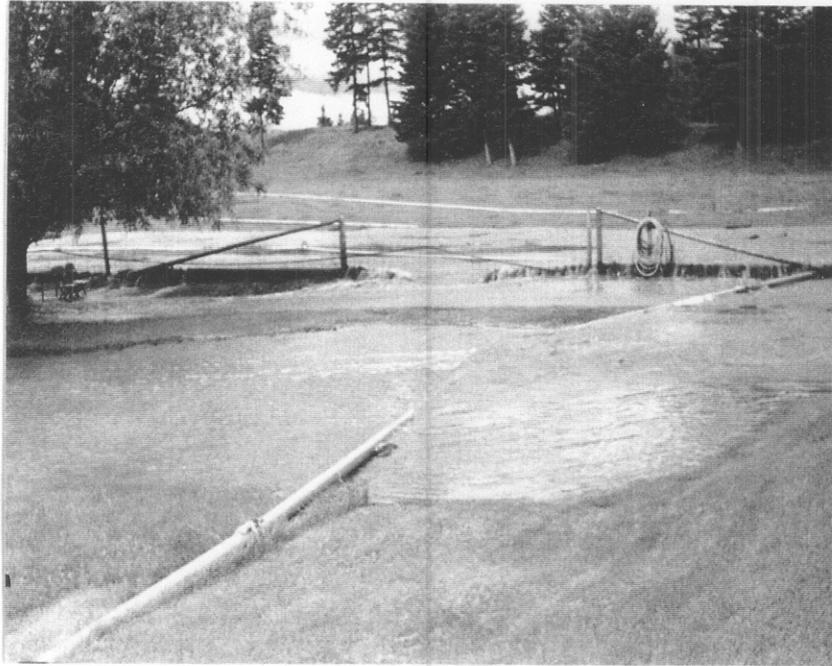
Photo 5 A flood channel of Bolean Creek in the fields to the West of the Falkland Trailer Park, June 1990.

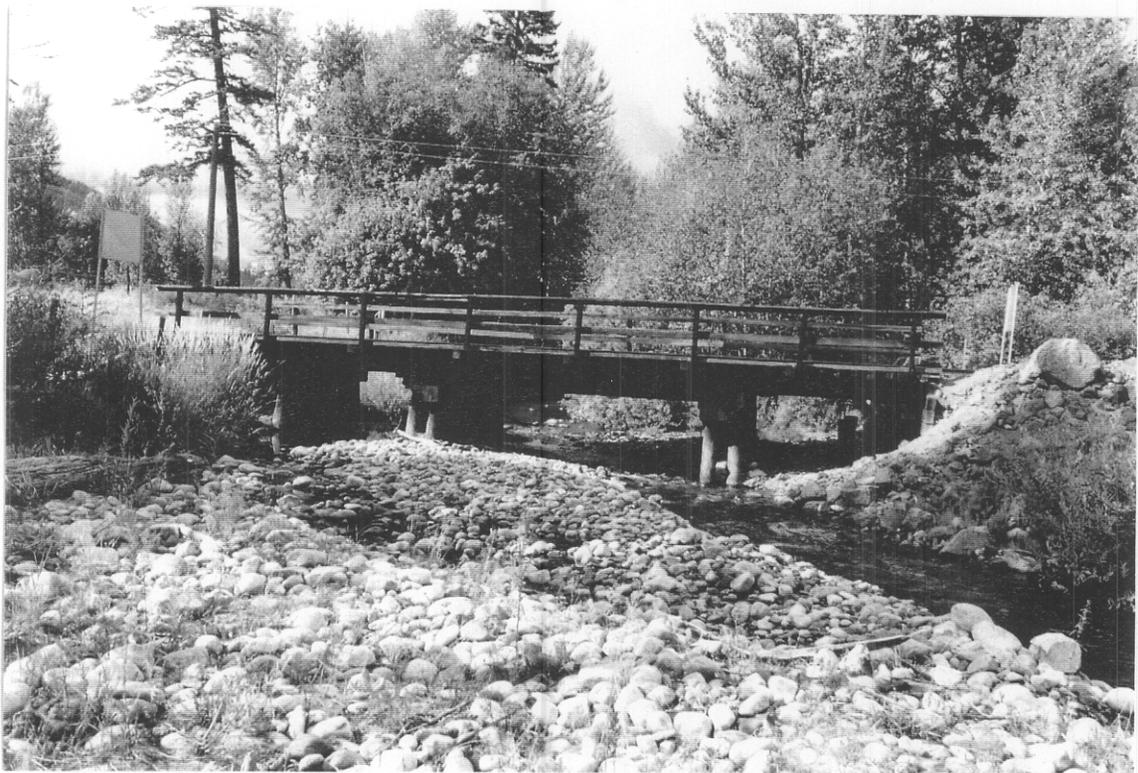
Photo 6 Deposition of gravel, cobbles and boulders which occurred during the June 1990 flood near the Railway Bridge over Bolean Creek.

Downstream of the highway bridge, a few properties suffered damage from flood waters. A large new gravel bar developed at the mouth of Bolean Creek (Photo 8), and new deposition was found just downstream of the Railway Bridge over Bolean Creek near XS-2 (Photo 6).

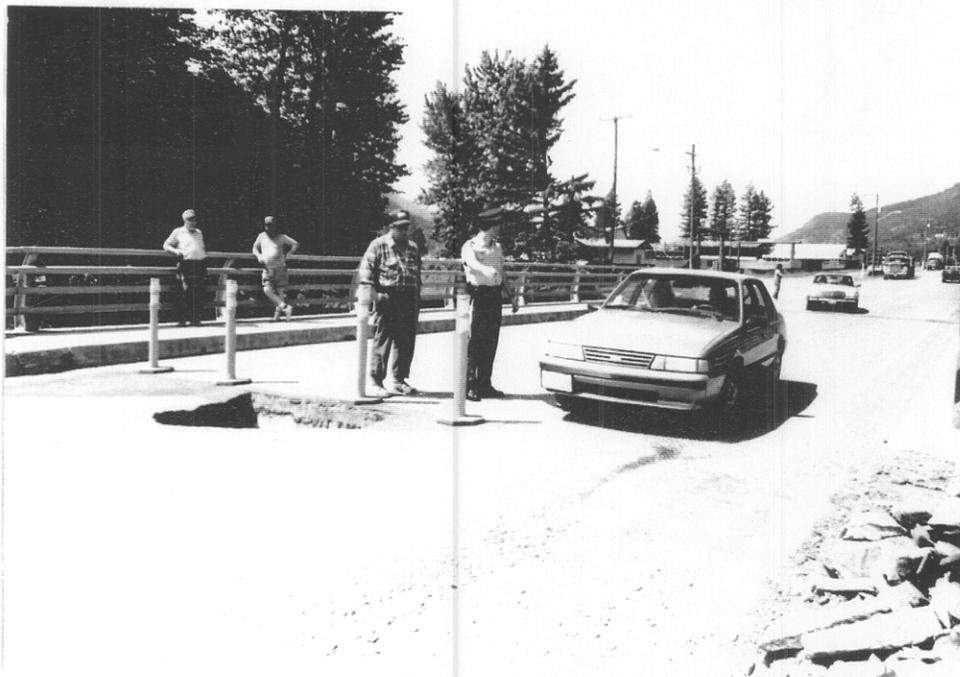
Photo 7 A hole in the pavement at the left abutment of the Highway 97 bridge over Bolean Creek caused by undermining by flood flows, June 1990.

Erosion occurred at the left abutment of the Highway 97 bridge over Bolean Creek, undermining the fill under the road. A hole in the roadway developed at the abutment as a result (Photo 7).

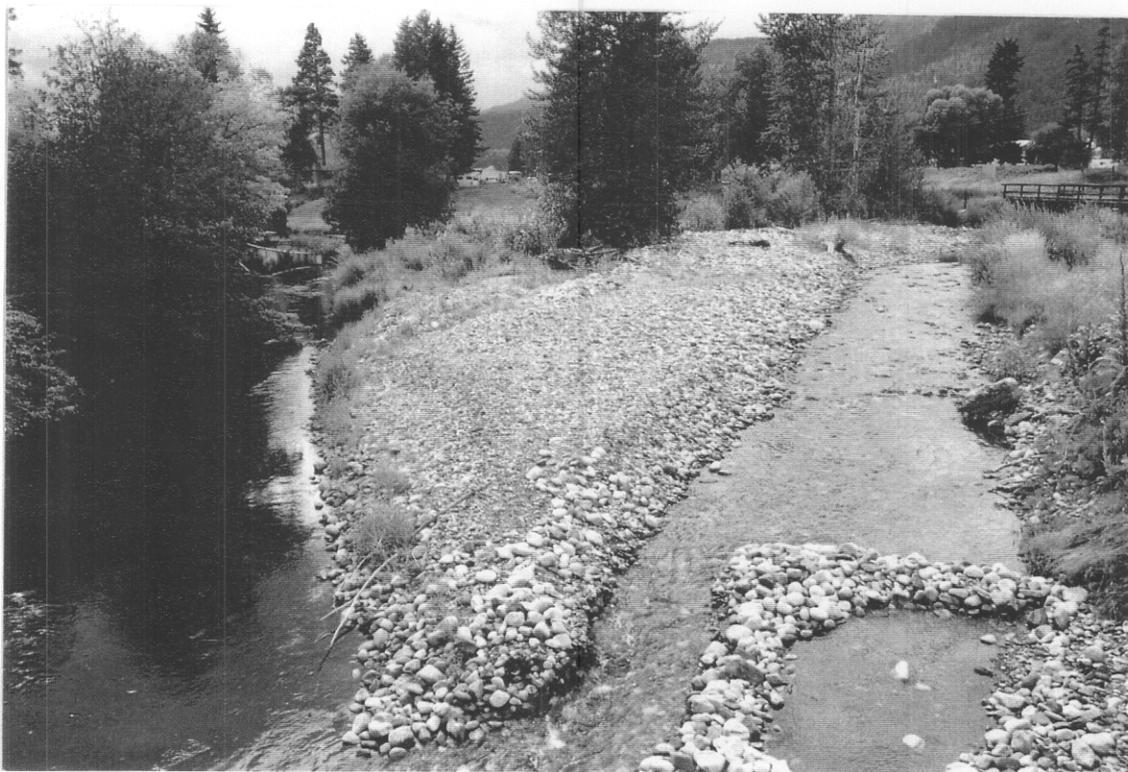
Photo 8 Looking upstream toward gravel deposited during the June 1990 flood at the Salmon-Bolean confluence. Note the placid surface of the Salmon River whose profile is controlled here by the continually aggrading mouth of Bolean Creek.

The transport and deposition of material by Bolean Creek has also determined the nature of the Salmon River near Falkland. Because of its steepness, Bolean Creek can carry larger bed material than the Salmon River can. Therefore, the Bolean fan has pushed the Salmon River to the far side of the valley and caused the Salmon River to aggrade at the confluence.
