A DESIGN BRIEF ON THE
Floodplain Mapping Study

Whistler Area

An Overview of the Study Undertaken
to Produce Floodplain Mapping in the
Resort Municipality of Whistler

R.W. Nichols, P. Eng.
Senior Hydraulic Engineer
Flood Hazard Identification Section
Victoria, British Columbia
June 1992
File: 35100-30/119-4671

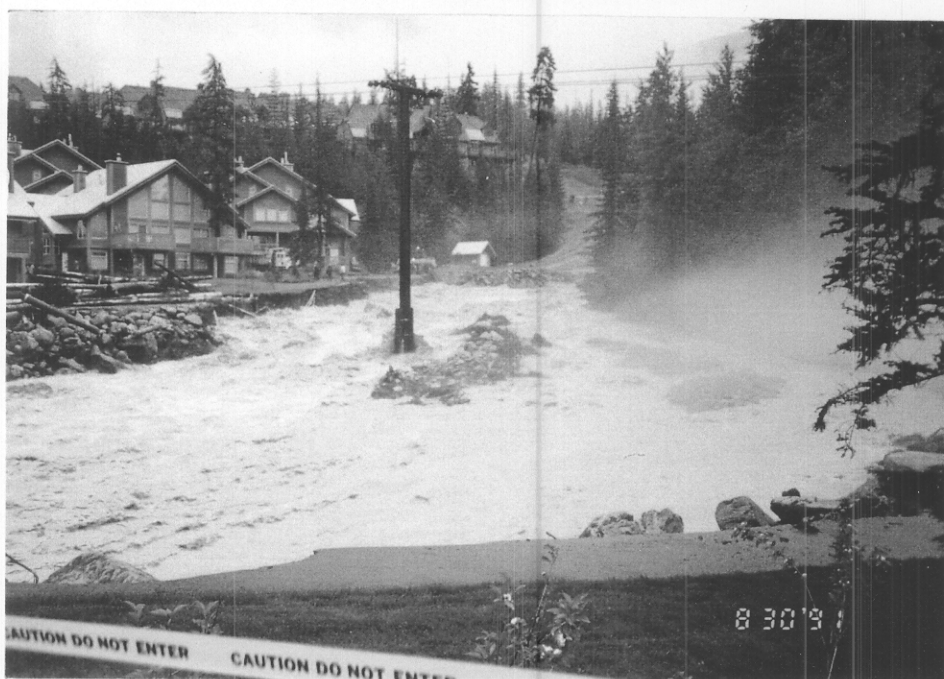
Fitzsimmons Creek Flood of 8/30/91

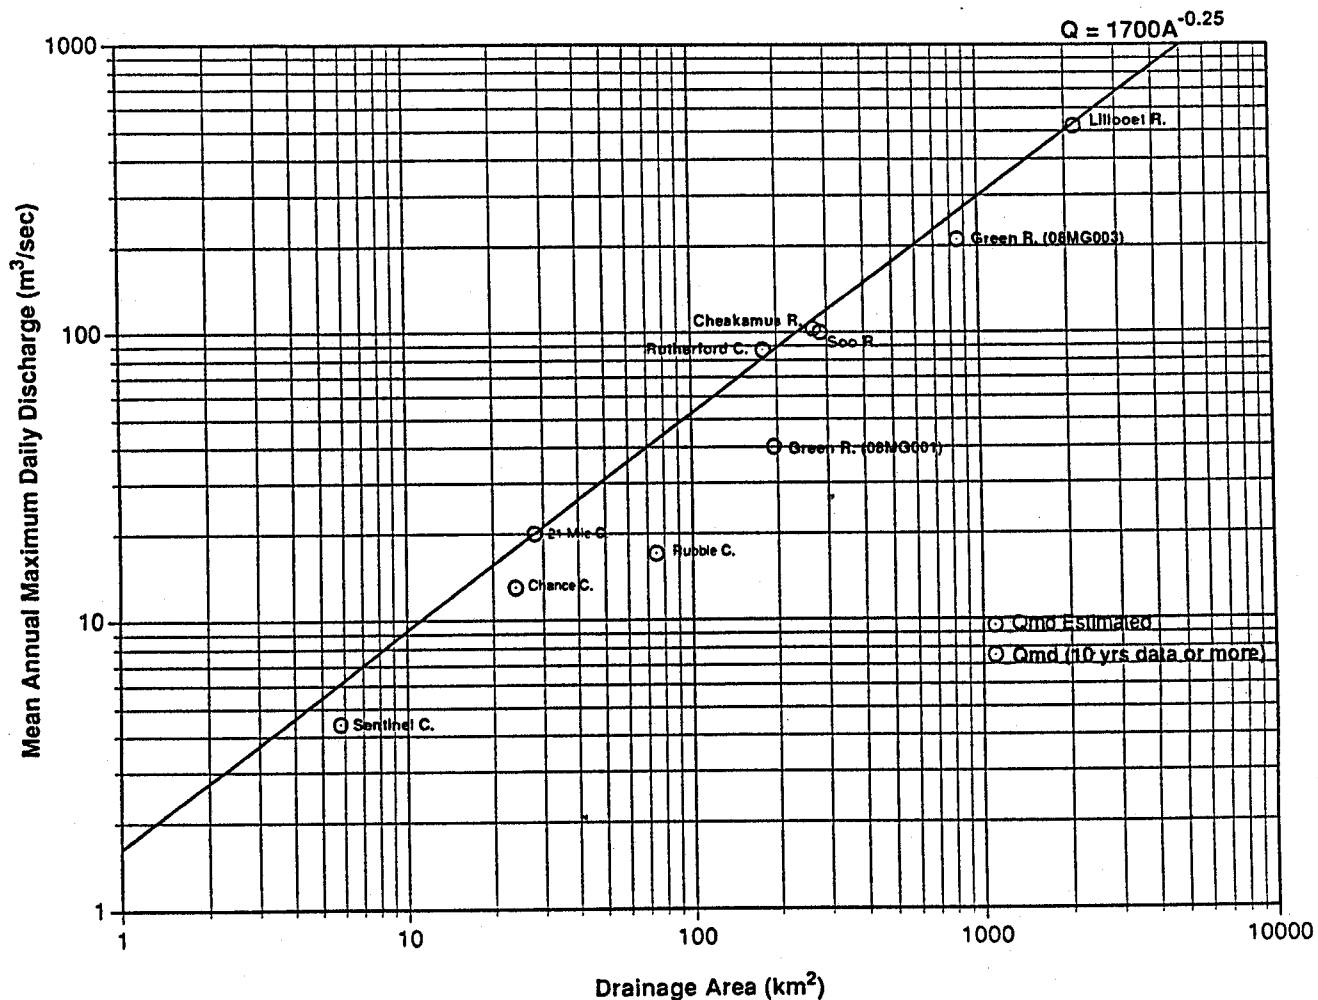
MEAN ANNUAL MAXIMUM DAILY DISCHARGE (MAMDD) VS. DRAINAGE AREA (1)

(1) Reference Appendix 1.6

A graphical relationship (Figure 3) was developed which related drainage area to MAMDD by passing the slope of the Water Survey of Canada Envelope Curve for B.C. through both Rutherford and Twentyone Mile Creeks to make estimates of MAMDD for the ungauged study basins.

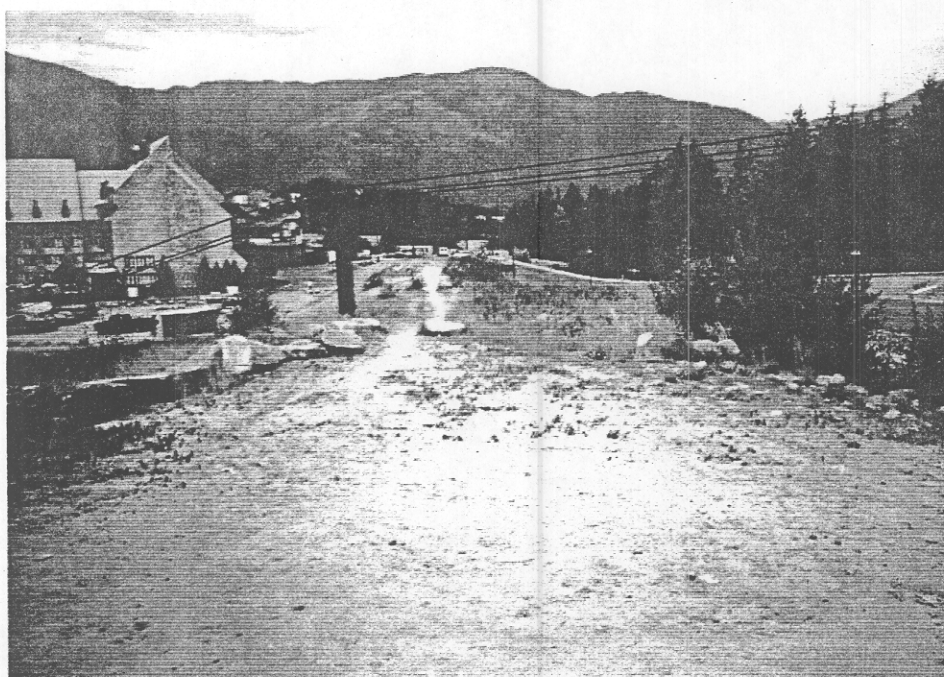
Photo 1

Fitzsimmons
Creek

View looking north along existing retaining wall just upstream of ski lift (See Dwg. 89-16-2)
"Village Centre" on left of photo. "Blackcomb Way" on right of photo.

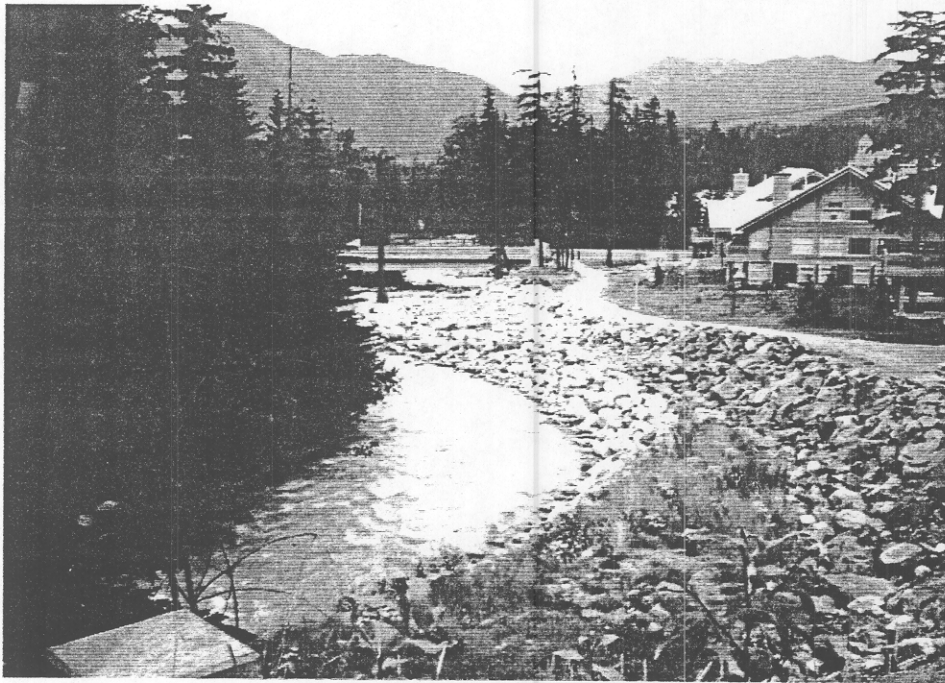
Photo 3

Fitzsimmons
Creek

View looking north (downstream) along Fitzsimmons Creek with "Blackcomb Way" bridge in background (Dwg. 89-16-2).

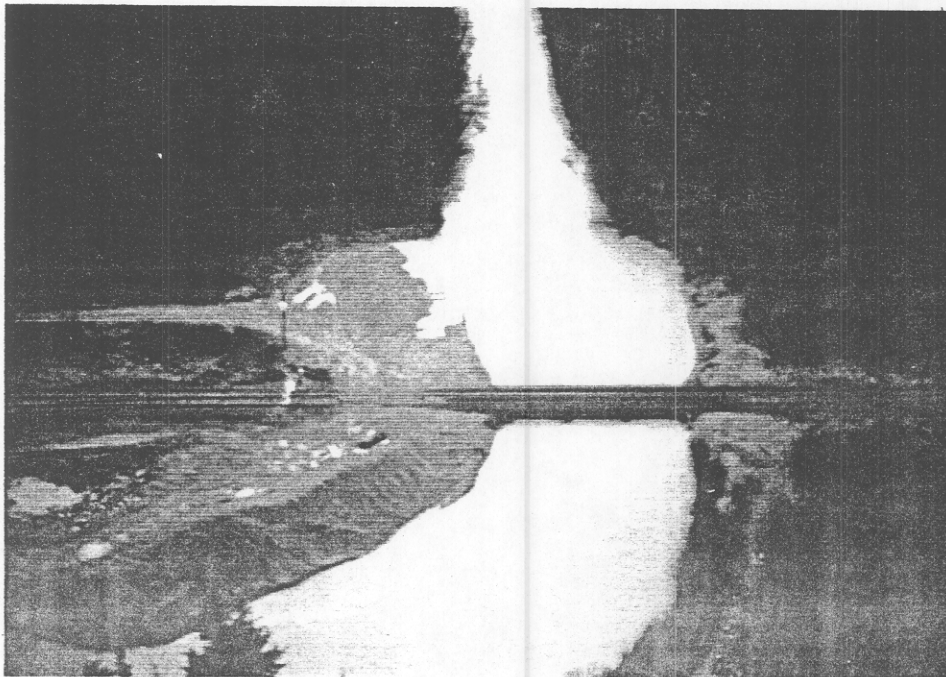
Photo 4

Fitzsimmons
Creek
(November
1989 flood)

View looking north at B.C.R. crossing just upstream of Green Lake (Dwg. 89-16-3).

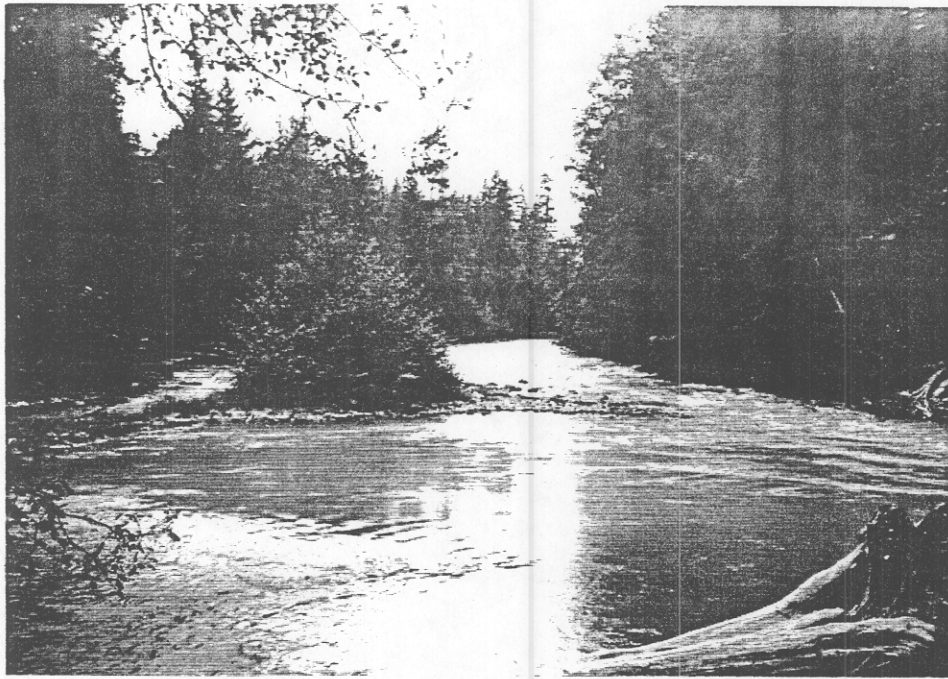
Photo 5

Green
River

View looking south (upstream) from near Highway 99 at first bend in river downstream of Green Lake (Dwg. 89-16-4).

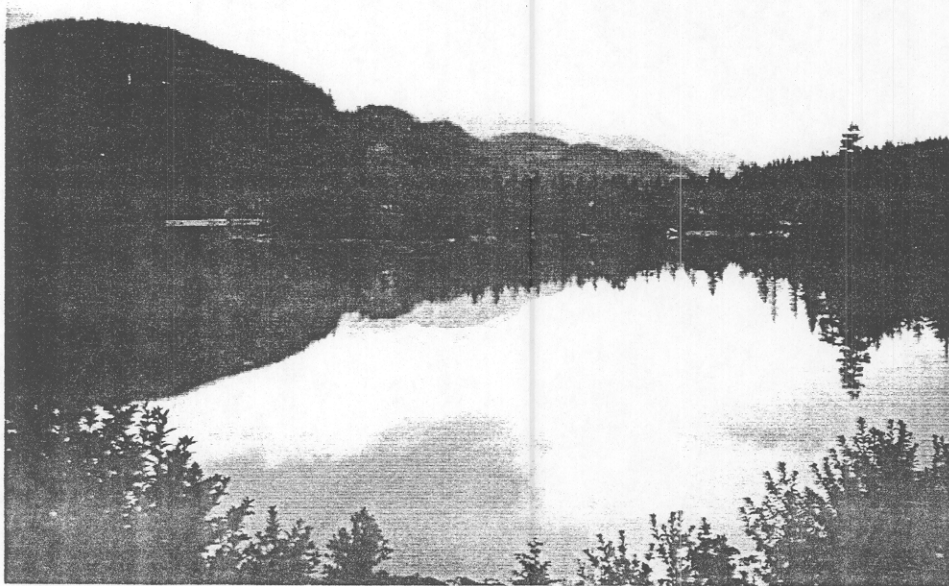
Photo 6

Green
Lake

View looking south from Highway 99 towards Lakeshore Drive near Emerald Park (Dwg. 89-16-4).

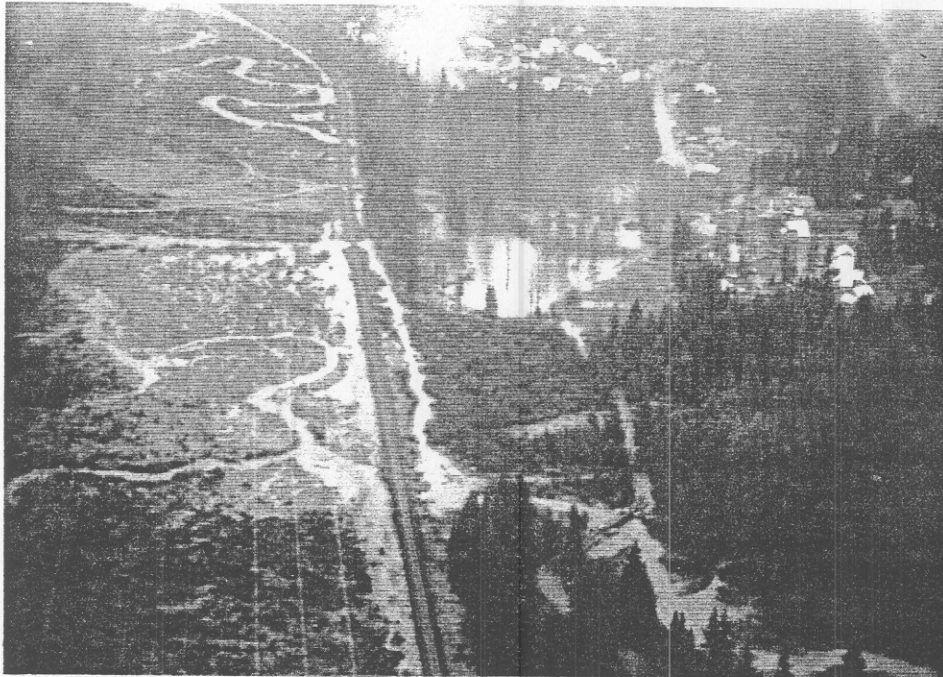
Photo 7

Alta and 21
Mile Creeks
(November
1989 flood)

Looking north along B.C.R. with 21 Mile Creek fan in lower left; confluence of creeks at B.C.R. crossing in centre of photo; and Alta Creek upstream of confluence in lower right of photo (Dwg. 89-16-2 and 3).

Photos 7 to 12 (Appendix 2) show the Alta Creek floodplain area. The photos of the flood of November 1989 indicate the conditions at the confluence of Alta Creek with Twentyone Mile Creek.

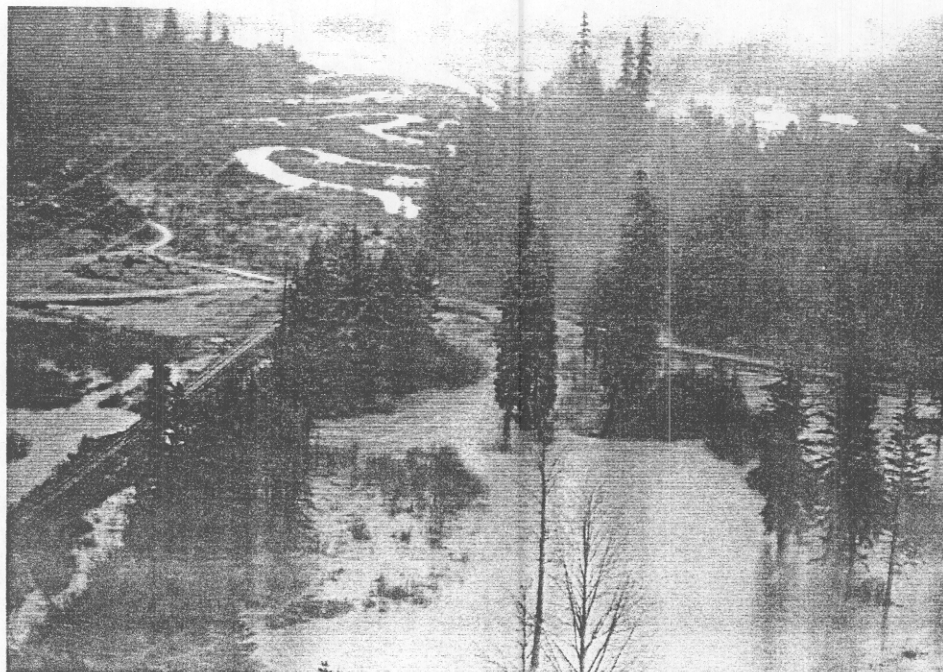
Photo 8

Alta and
21 Mile Creeks
(November
1989 flood)

Closeup view of confluence area. B.C.R. on left of photo; "Valley Trail" on centre right of photo (Dwg. 89-16-3).

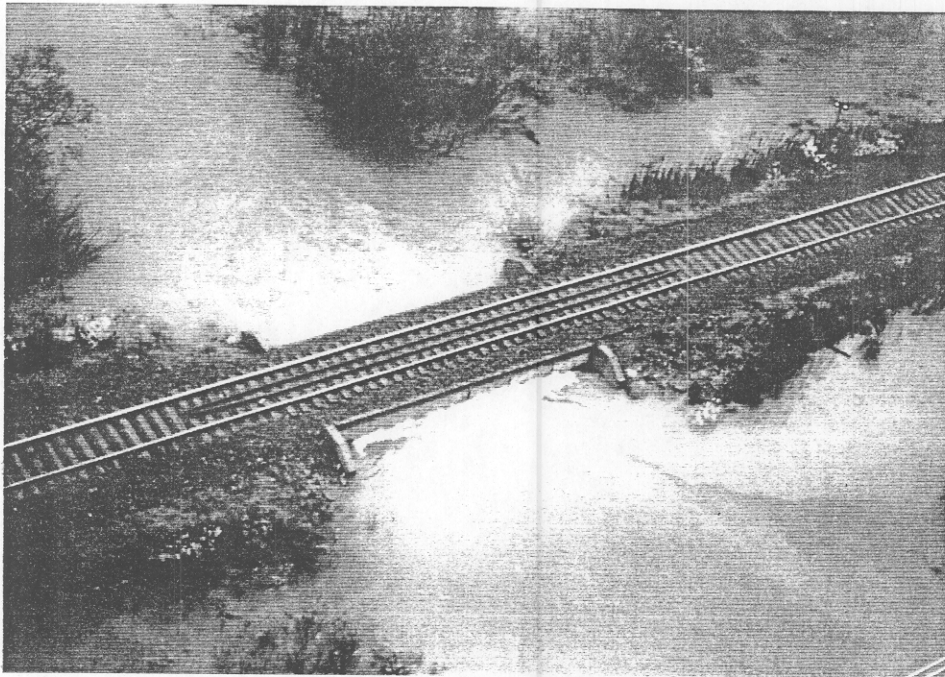
Photo 9

Alta and 21
Mile Creeks
(November
1989 flood)

Photo looking east at B.C.R. bridge at confluence area, which is in upper part of photo. 21 Mile Creek is in lower part of photo (Dwg. 89-16-3).

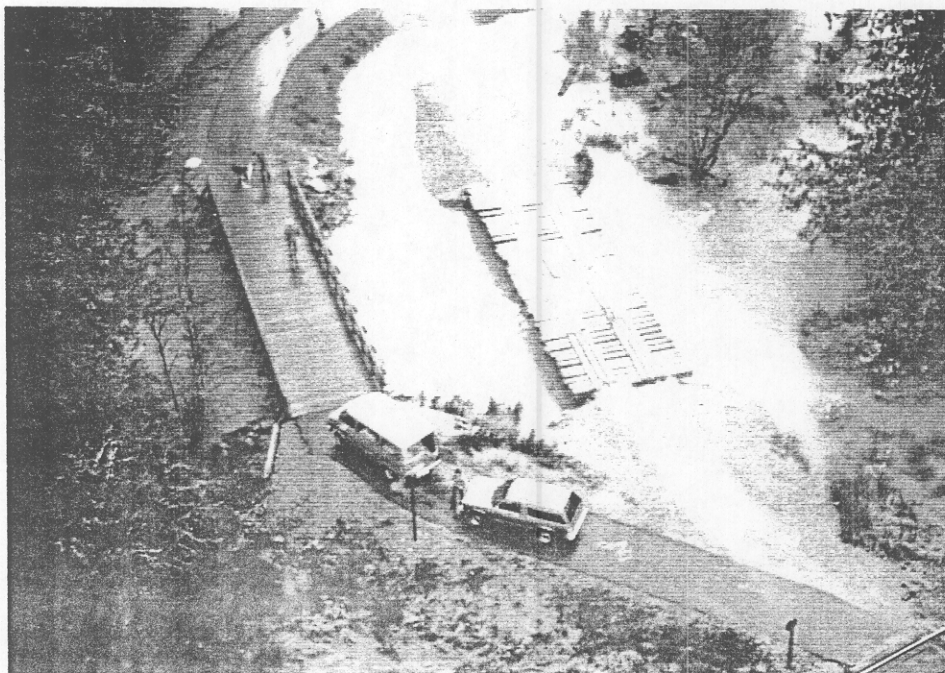
Photo 10

Alta Creek
(November
1989 flood)

Area just downstream of Photo 9 showing "Valley Trail" bridge and abandoned older bridge on right of photo (Dwg. 89-16-3).

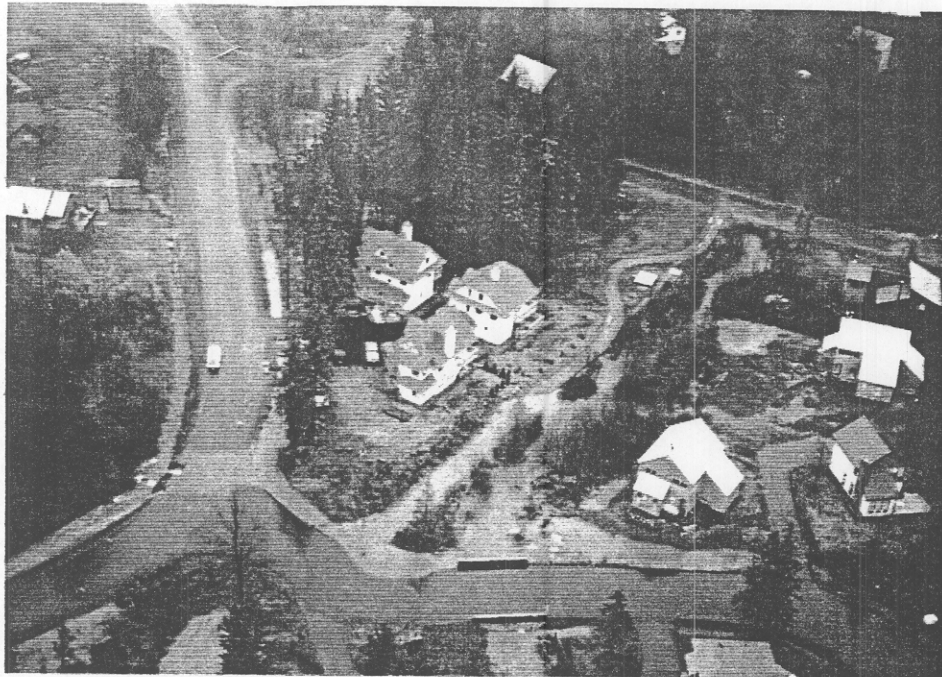
Photo 11

Alta Creek
Floodplain
(November
1989 flood)

Red roofed home can be seen in Photo 7. Small creek causing local flooding drains the adjacent golfcourse. Lower half of photo (approximately) is within the Alta Creek floodplain (Dwg. 89-16-3).

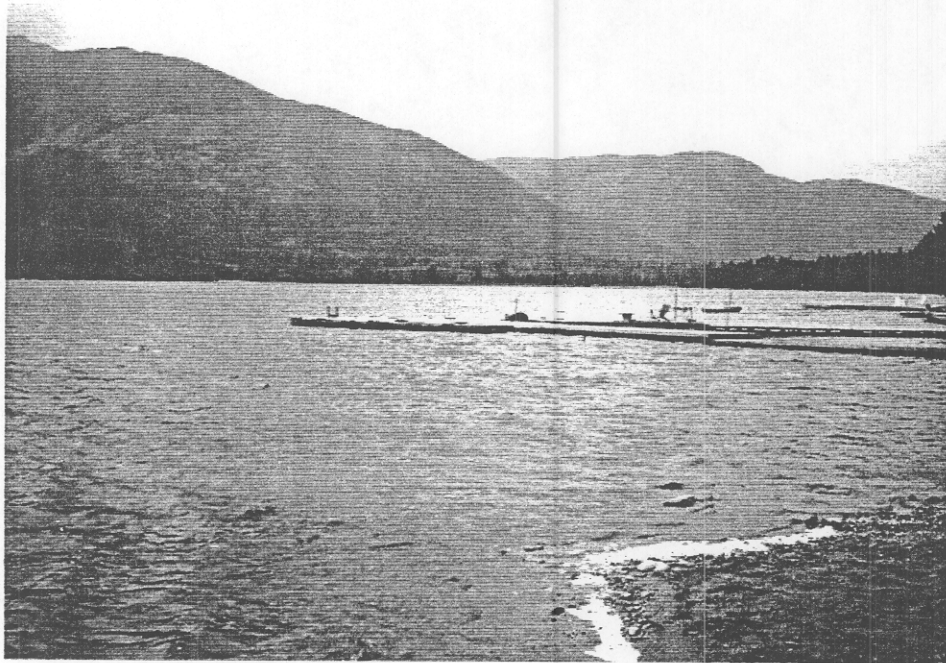
Photo 13

Alta Lake

From Lakeside Park looking north towards the lake outlet (Dwg. 89-16-2).

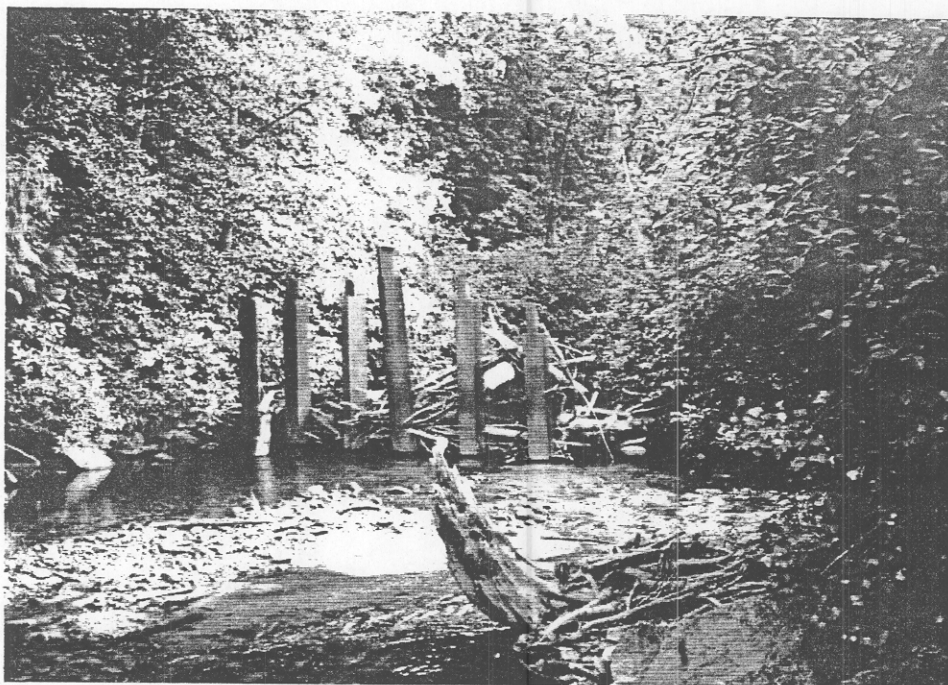
Photo 15

Millar Creek

Debris rack looking upstream of Highway 99 crossing, Industrial Park area (Dwg. 89-16-1).

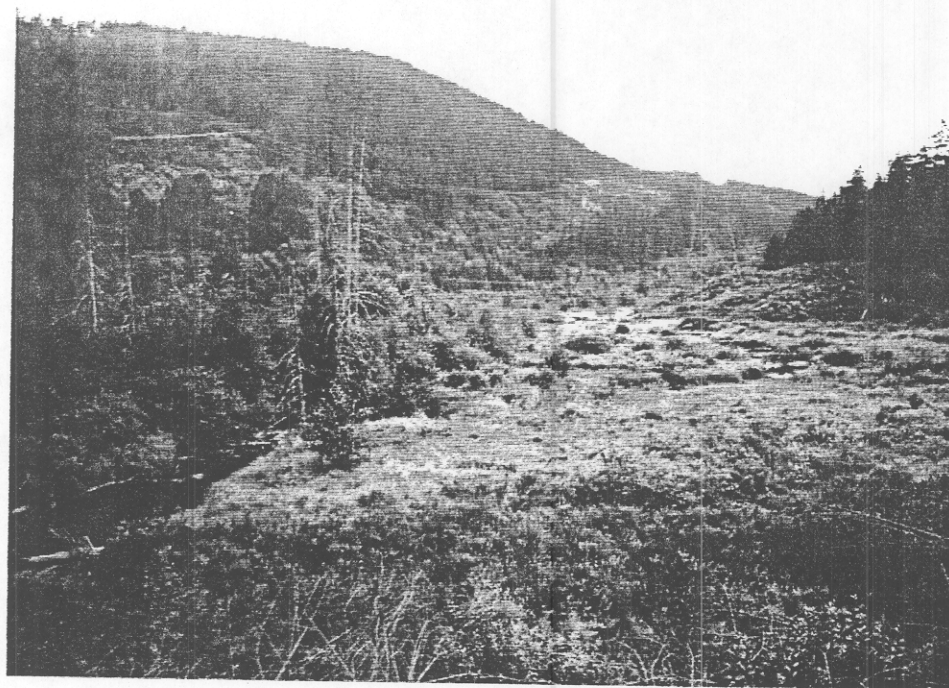
Millar Creek

Floodplain between Industrial Park and Alpha Lake.

Photo 17 (Appendix 2) indicates the Millar Creek floodplain which is undeveloped in the area between the Industrial Park and Alpha Lake. There is a relatively large number of residential developments around Alpha Lake and future expansion of this floodplain area is anticipated. Flooding problems associated with bridge and culvert blockages in the Whistler area have been documented (Appendix 4). This experience suggests that the suitability of the existing culvert under Alta Lake Road near the outlet of Alpha Lake should be reviewed taking into account the residential development noted above.

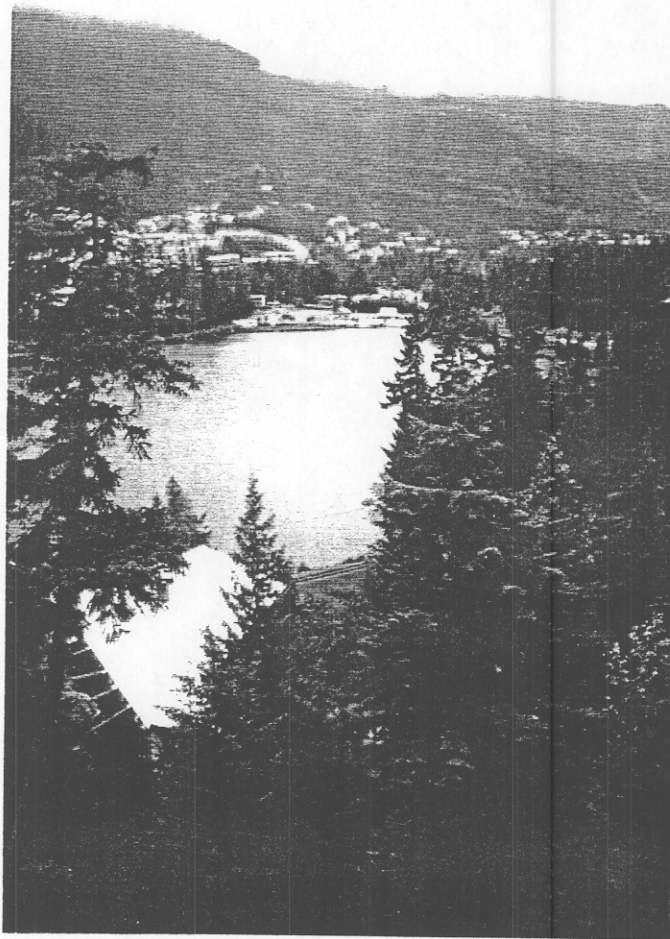
Photo 19

Nita Lake

View looking south from Alta
Lake Road towards lake
outlet, "Whistler Centre" area
(Dwg. 86-16-1).

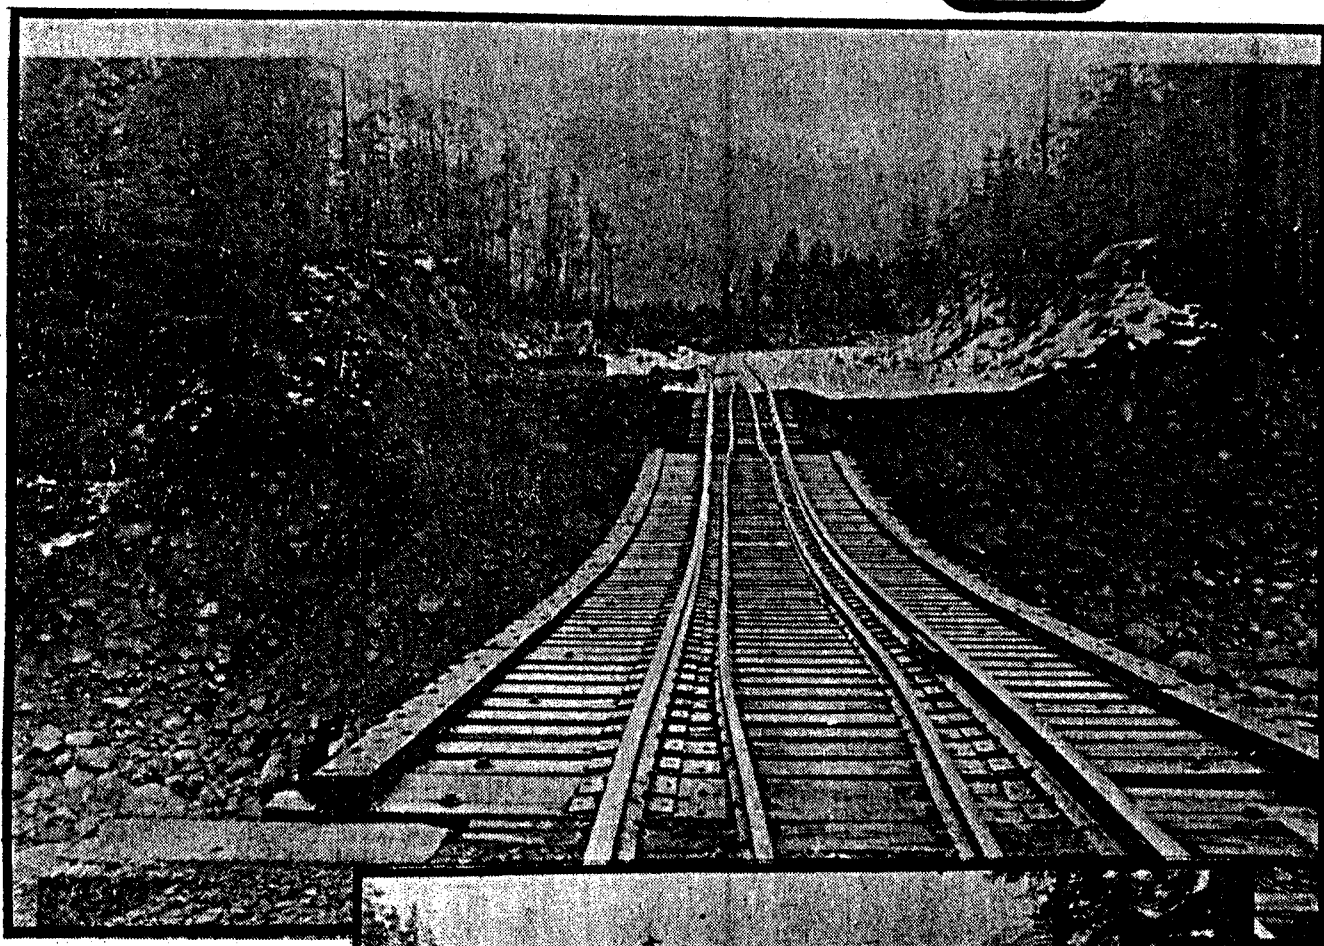
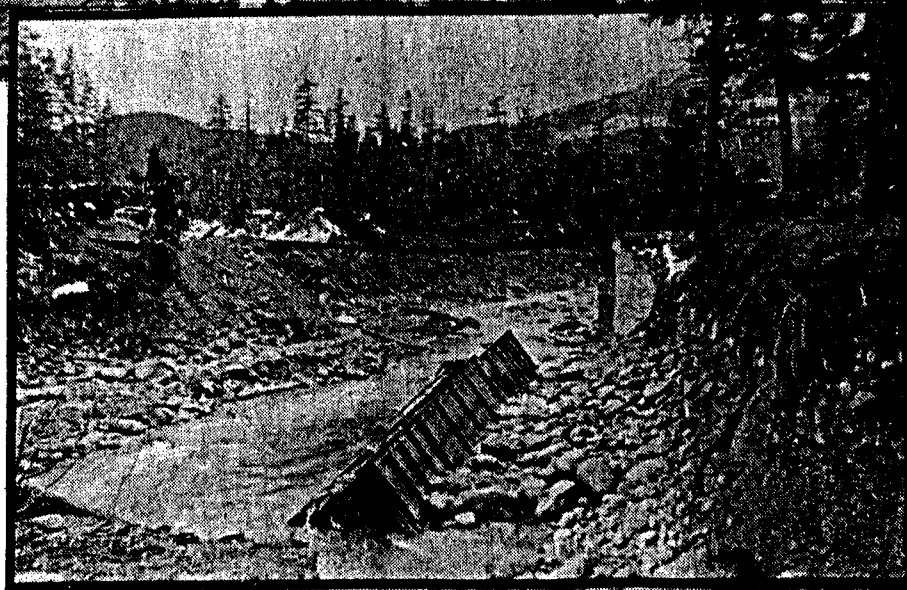
BCR Rutherford Creek crossing hangs by its rails after December 26 flood washed away all supports and girders (see inset) downstream.

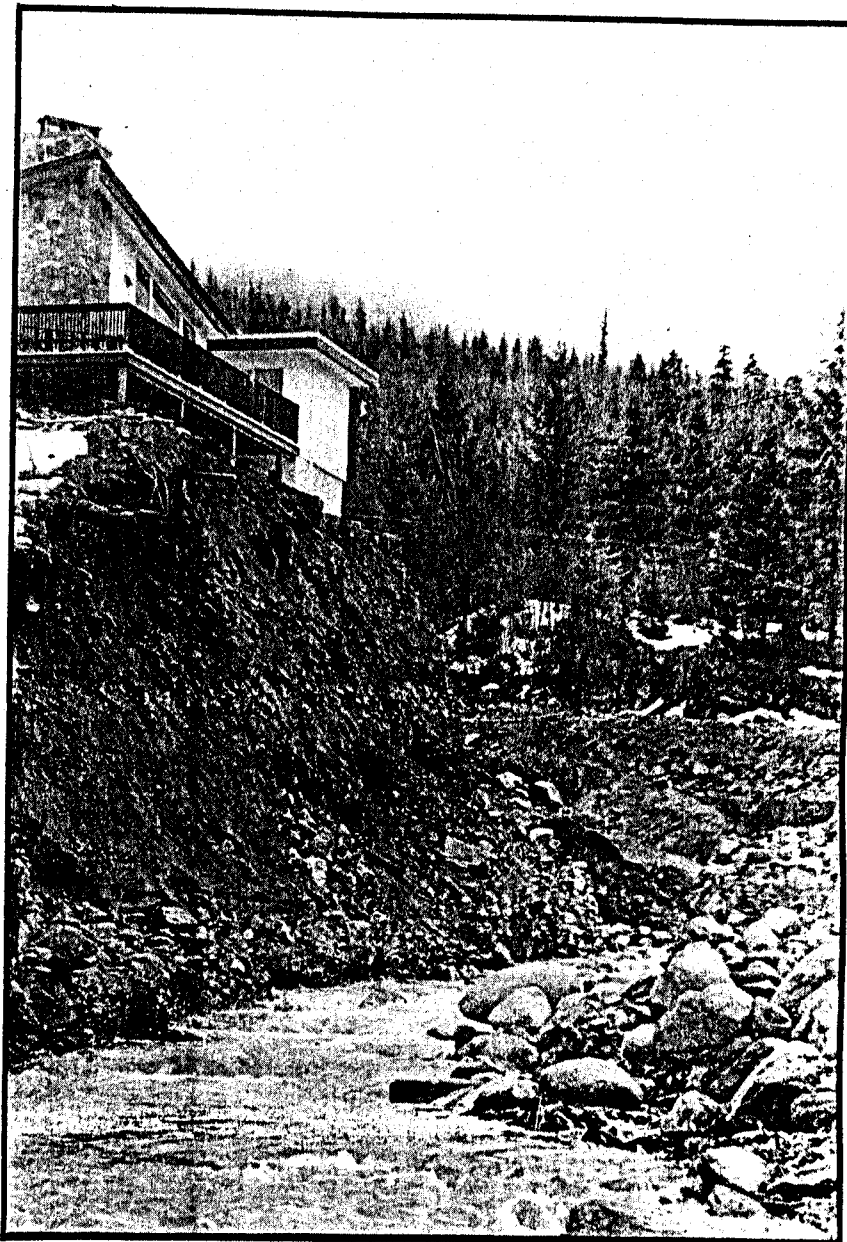
That's the way the cliff crumbles when raging 19 Mile Creek jumped its bank December 26 and threatened to topple a Valley Drive duplex into the Alpine Meadows abyss.

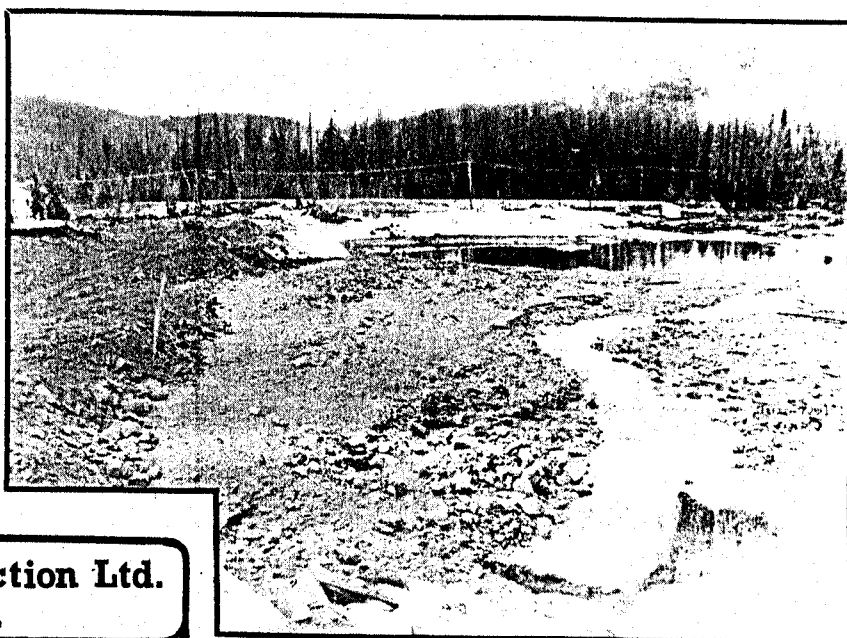
Gravel pit, then lake, then back to gravel pit. At left is the newly rerouted 19 Mile Creek bed as crews repaired flood damage and prepared to return the creek back to its original path.

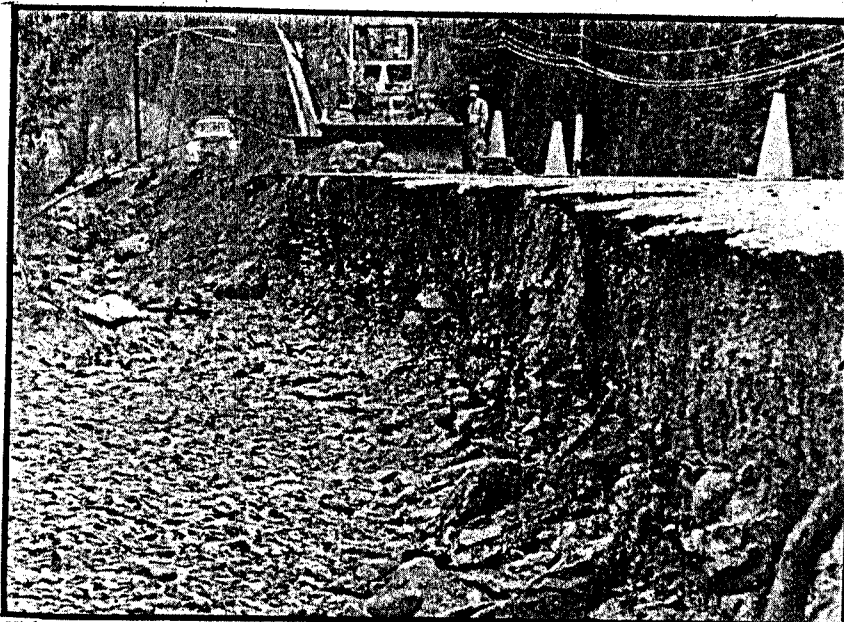
Highway 99 parallel to Alpine Meadows shows effects of rampant 19 Mile Creek. Turbulent waters carved a new creek bed for hundreds of yards.
