Homathko River & Mosley Creek Watersheds

Level 2 Fish Habitat & Riparian Assessment Procedure & Restoration Prescriptions

Final Report

October 1999

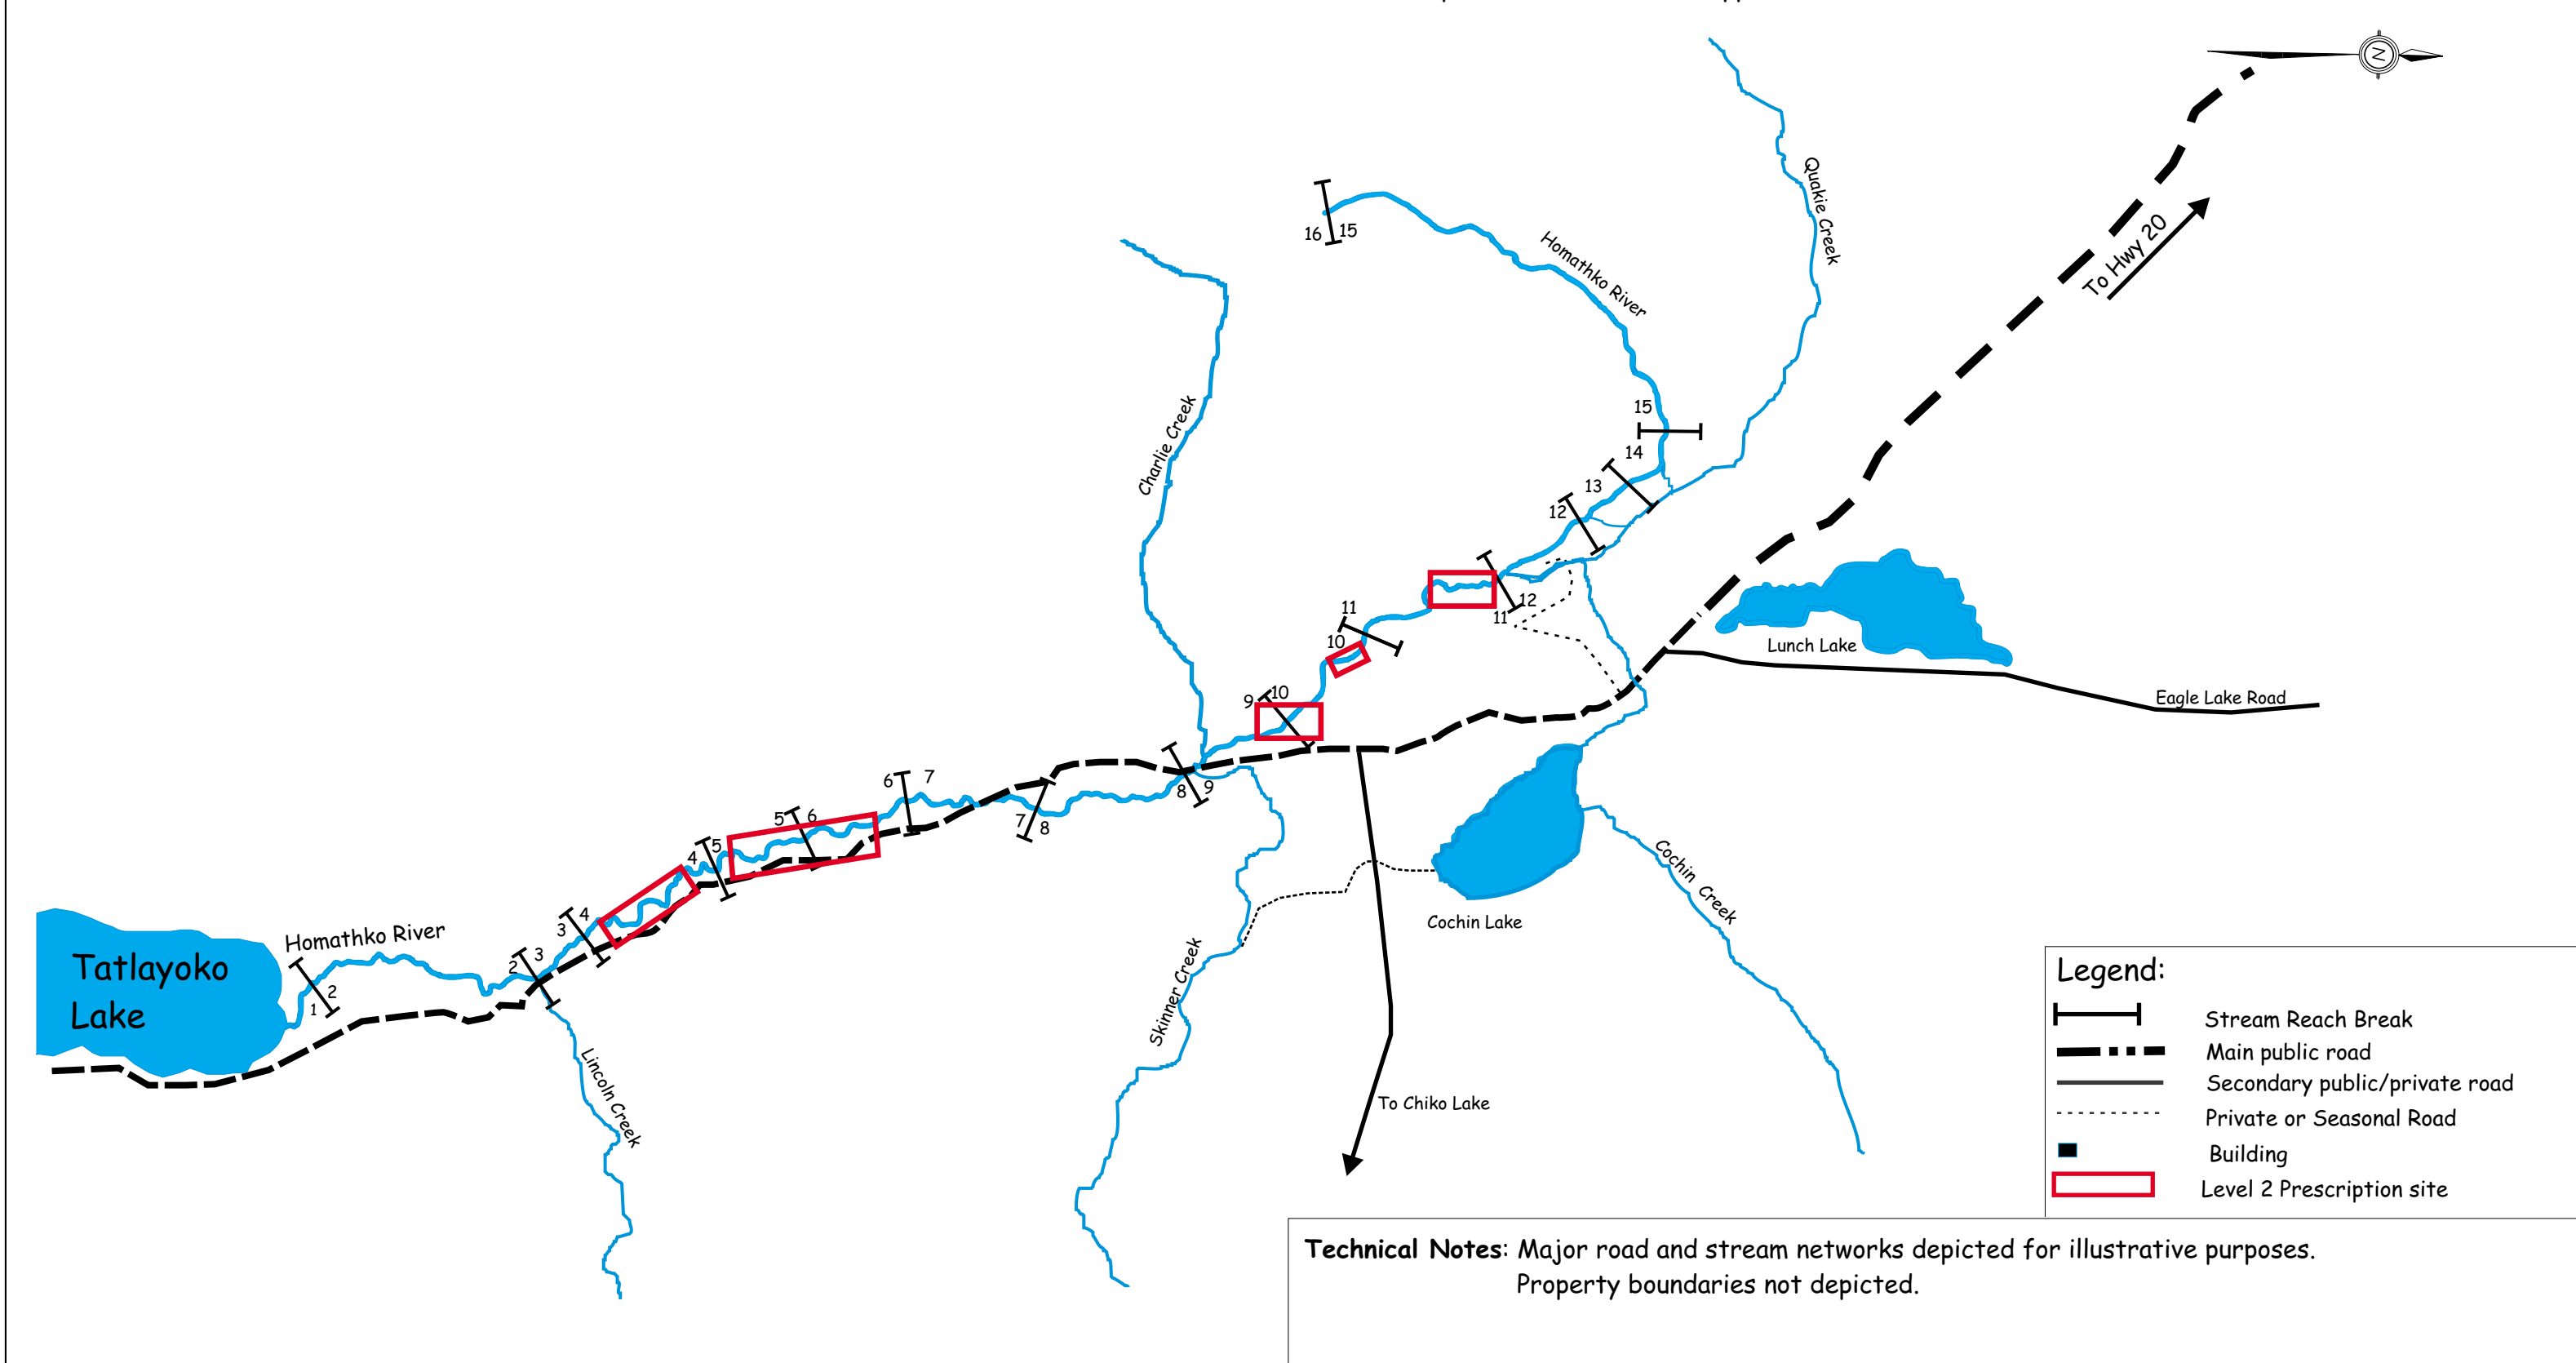
Figure 2: Homathko River Study Area Map

Date:	September 20, 1999	Stream Name:	Homathko River	Watershed:	Homathko	Reach:	1 to 15
Project:	9H	Survey Crew:	NA	Comments:	Created from air photo and TRIM data. Approximate scale 1:70,000

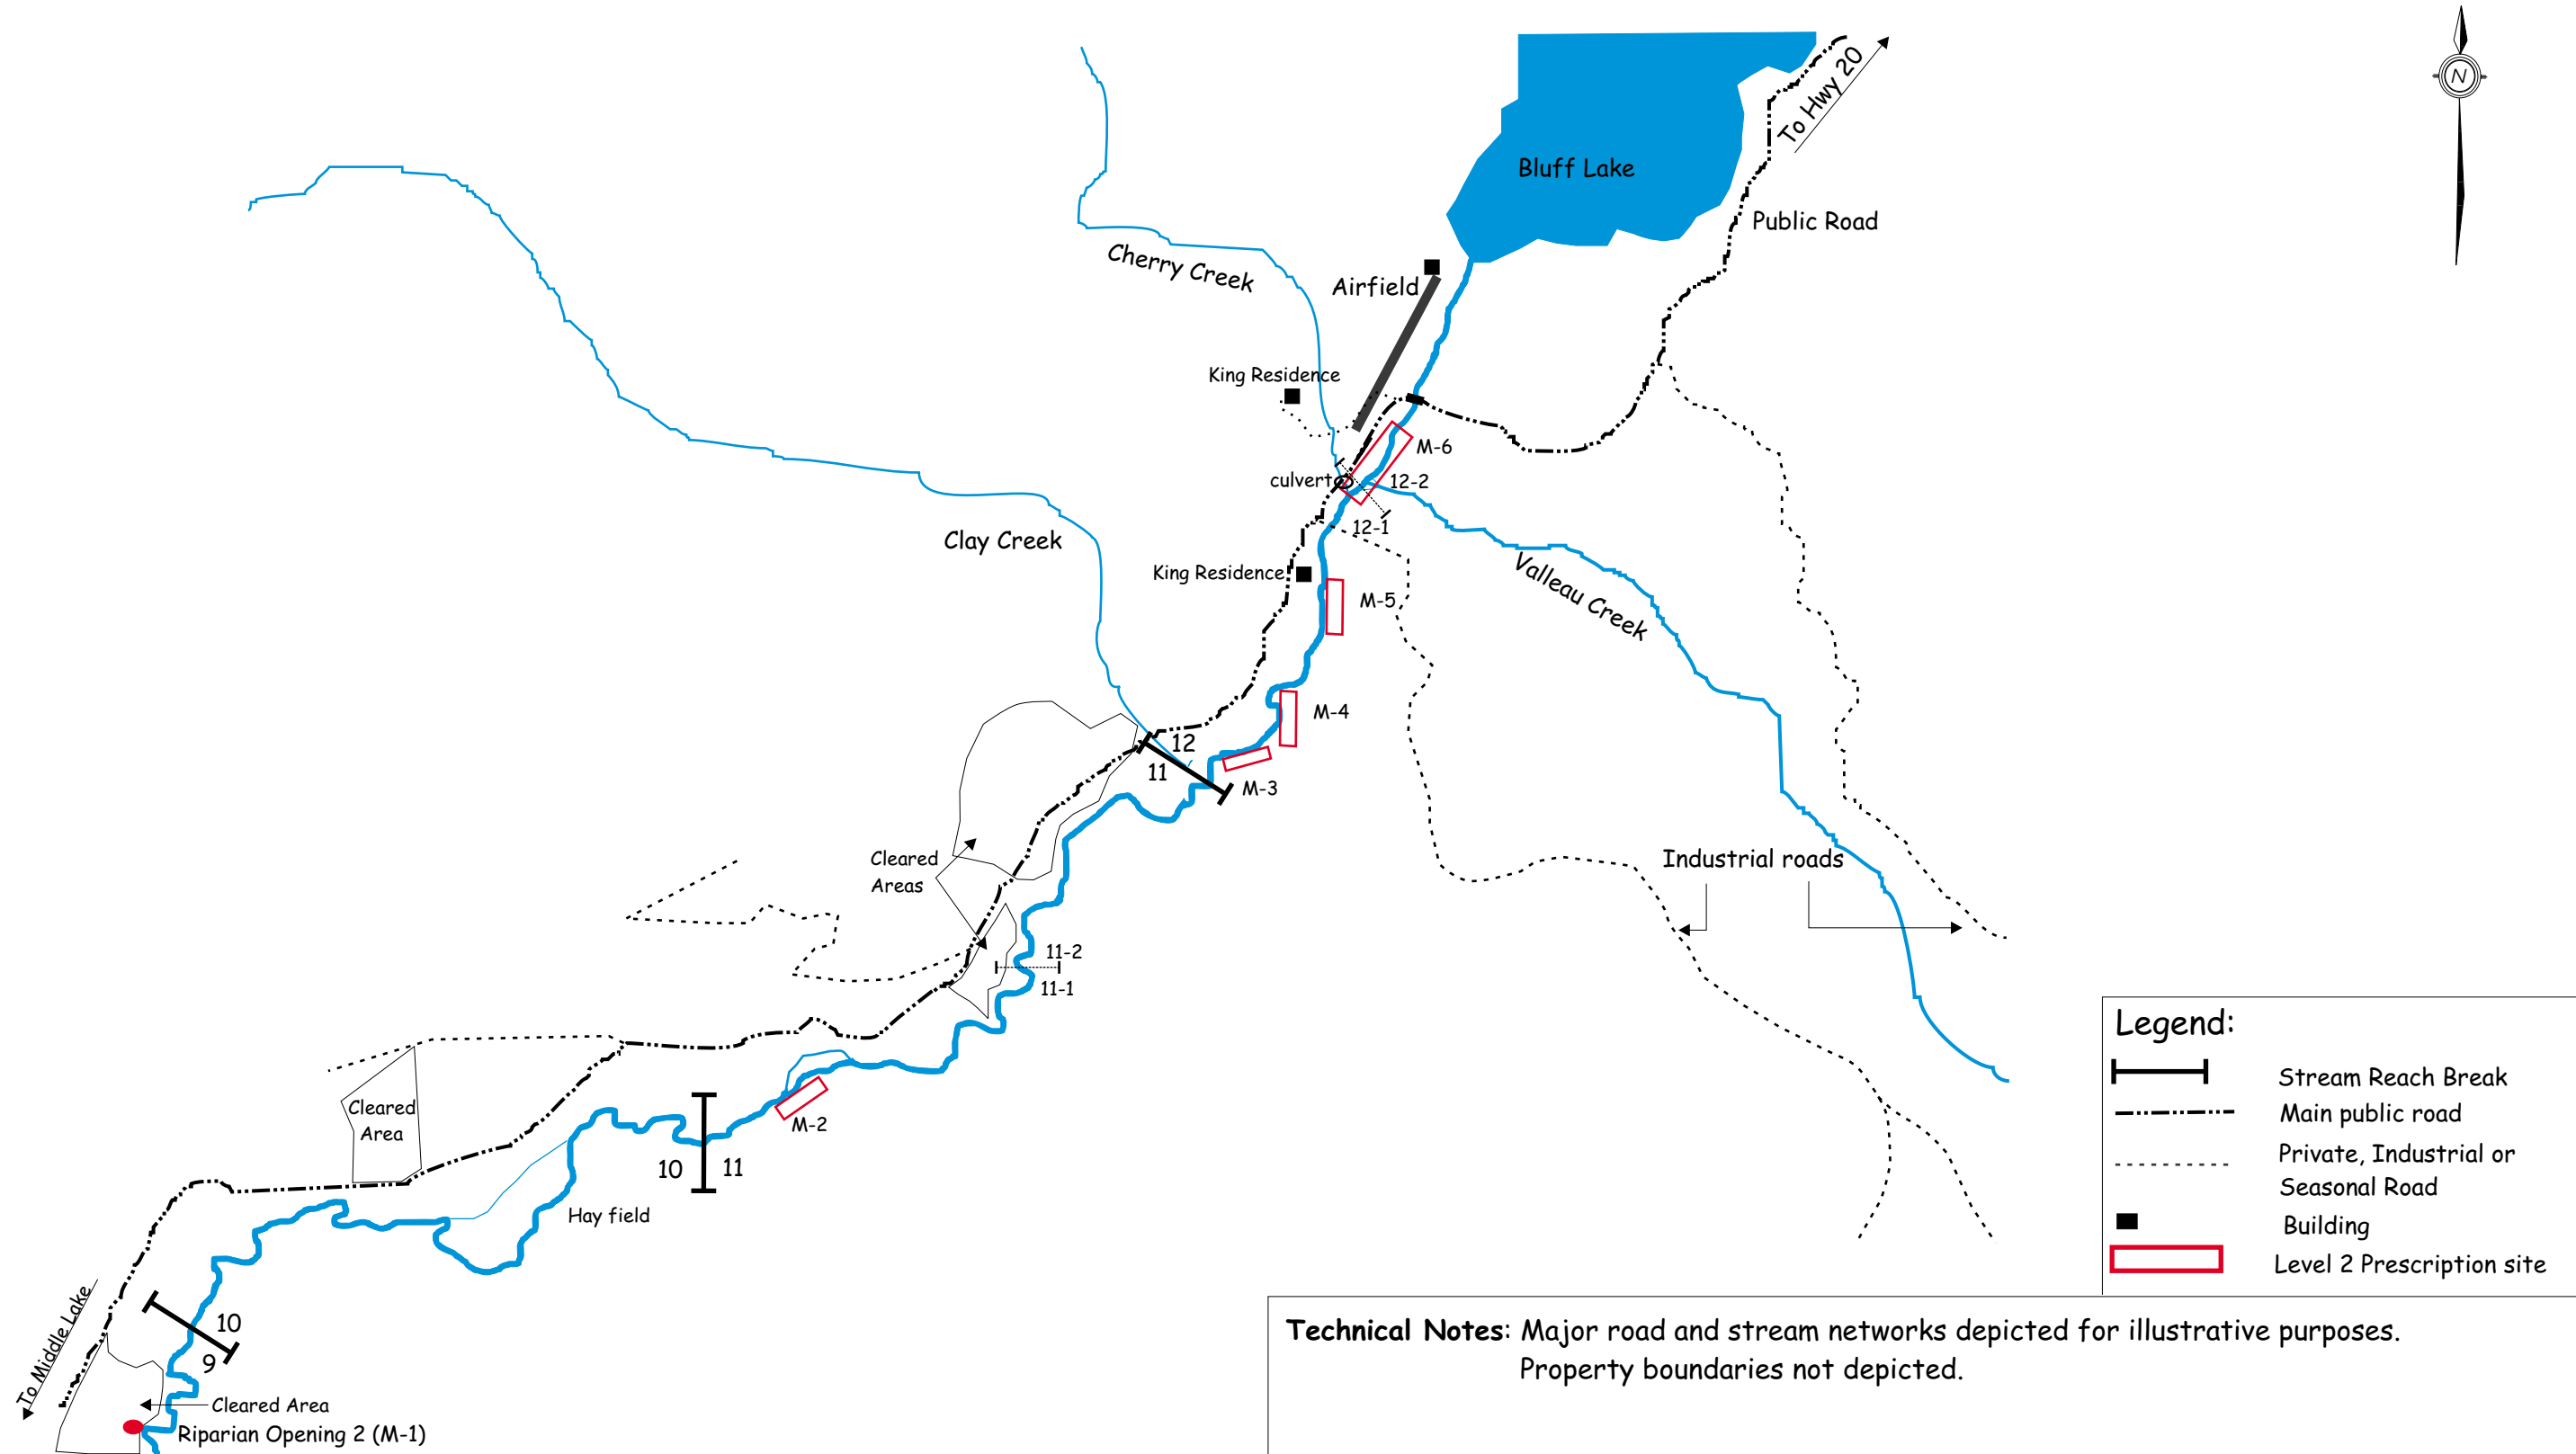
Figure 3: Mosley Creek Study Area Map

Date:	September 20, 1999	Stream Name:	Mosley Creek	Watershed:	Homathko River	Reach:	10 to 12
Project:	9H	Survey Crew:	NA	Comments:	Created from air photo and TRIM data. Approximate scale 1:20,000

One area of bank instability (Site M-6) which would benefit from stabilization was identified in upstream sections of Reach 12 (upstream of the confluence with Valleau Creek; Figure 3; Photo 11). During Level 2 FHAP surveys (July 7 to 17, 1999) the right bank of Subreach 12-2 exhibited signs of increased erosion since Level 1 FHAP surveys (September, 1998). Approximately 45 m of bank was eroding and sloughing into the stream channel. The area immediately downstream provided suitable spawning and rearing habitat for resident fish, and was situated upstream of the relatively silt-laden confluence of Valleau Creek. The site was located adjacent to a public road and accessible for machine placed LWD and rootwad revetments to stabilize the stream bank and increase localized stream cover. Bioengineering and riparian planting of this section subsequent to in-stream bank stabilization was also recommended.

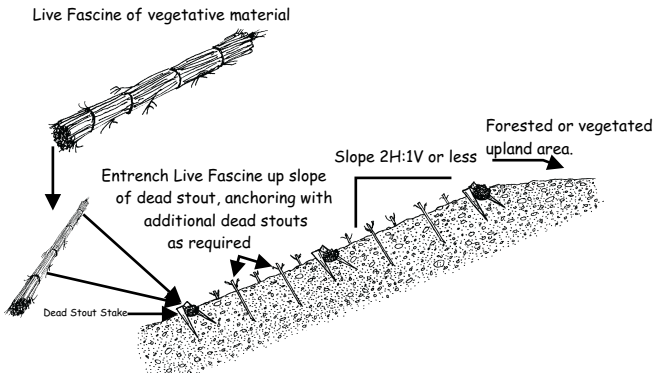
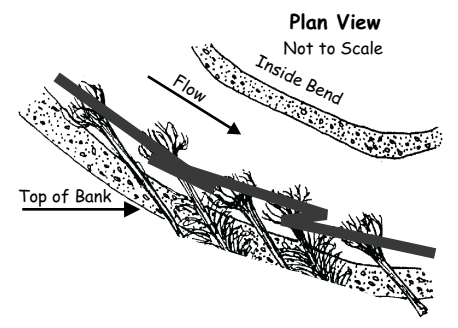
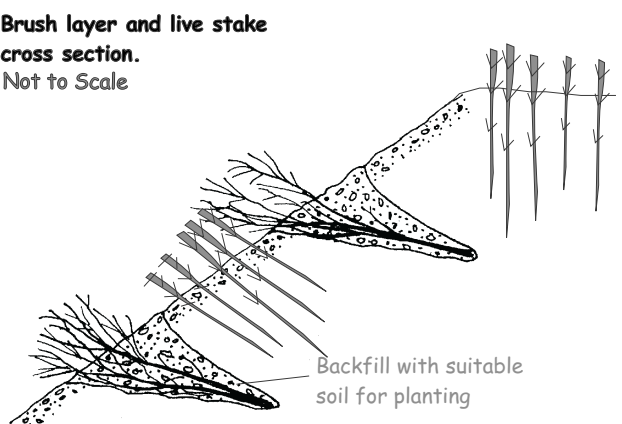
REACHES 5 & 6 : Bank Stabilization & Fish Habitat Restoration Prescriptions

Site	Length	Opportunity	Prescription
5-A-1	35 m	bank stabilization, increased pool cover	live-tree revetment, live staking
5-A-2	45 m	bank stabilization, increased pool cover	live-tree revetment, live staking
5-B	35 m	bank stabilization, increased pool cover	live-tree revetment, live fascine and staking
5-C	25 m	bank stabilization, increased pool cover	LWD/Live-tree revetment, rootwad
5-D-1	35 m	bank stabilization	LWD/Live-tree revetment, live staking, riparian planting
5-D-2	10 m	bank stabilization	LWD/Live-tree revetment, live staking, riparian planting
5-E	30 m	bank stabilization,	live-tree revetment, live staking, live fascine
6-A	55 m	bank stabilization, increased pool cover	live-tree revetment, live fascine, rootwad placement
6-B	35 m	bank stabilization)	live staking, live fascine, increased riparian planting
6-C	30 m	bank stabilization, increased fish habitat cover (pool and glide)	live-tree revetment, rootwad placement, live staking

6-D	35 m	bank stabilization, increased pool/glide cover	LWD revetment rootwad placement
6-E	25 m	bank stabilization	live-tree revetment, live fascine

- Bank Slope Details**
1. Place dead stout stakes between 1.0 m and 1.5 m of elevational gain.
 2. Dig trenches up slope of dead stouts to a depth of between 1/2 and 1/3 of fascine diameter.
 3. Place fascine in trench and dead stake to anchor.
 4. Lightly pack fascines with damp soil, leaving ~1/3 of fascine above grade level.
 5. Place erosion control geotextile between fascines as required.
 6. Live stake remaining slope between fascines.

Use willow, cottonwood or aspen whips. Ensure whips contain buds, plant at least 2/3 of whip in soil.

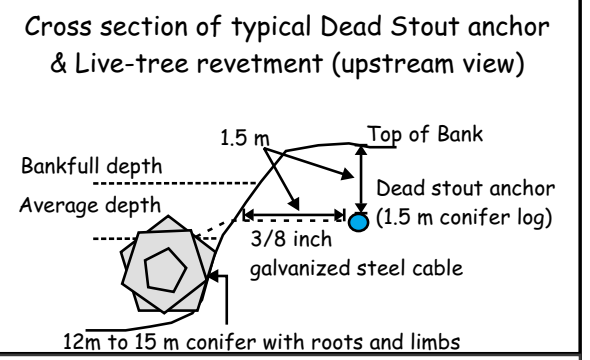
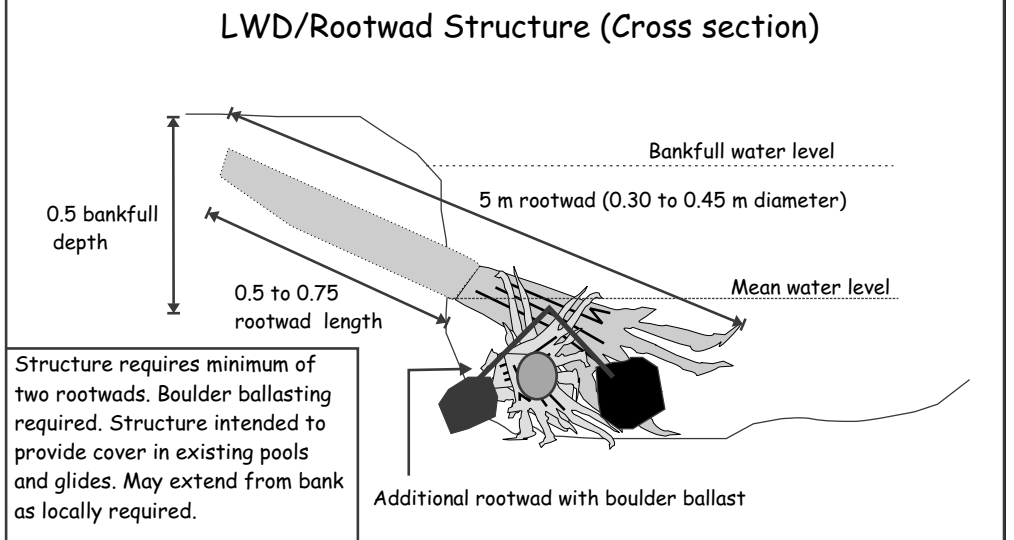
Reach 10: Fish Habitat Restoration Prescription

Technical Notes: Well developed glides and pools observed throughout surveyed section. In-stream cover was limited in areas of reduced riparian vegetation. Downstream sections exhibited moderate coniferous riparian vegetation and increased in-stream complexing (LWD). Opportunity to increase in-stream cover with clustered LWD placement. Limited bioengineering required. Riparian prescriptions developed for lower stream sections. Property boundaries not depicted.

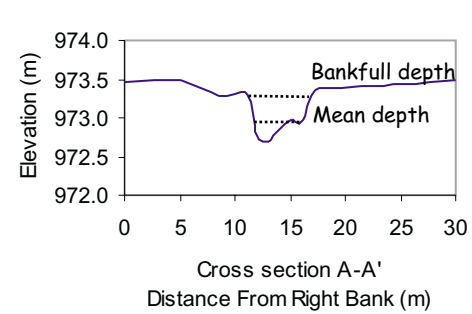
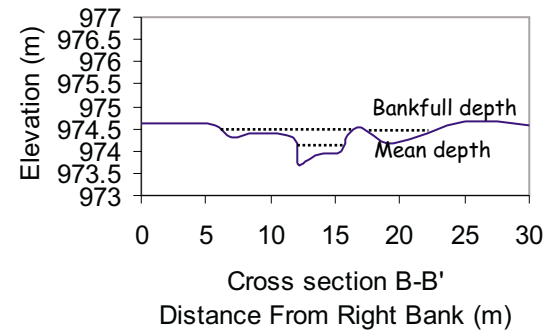
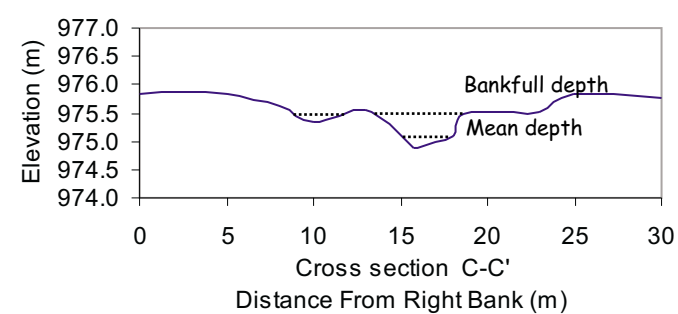
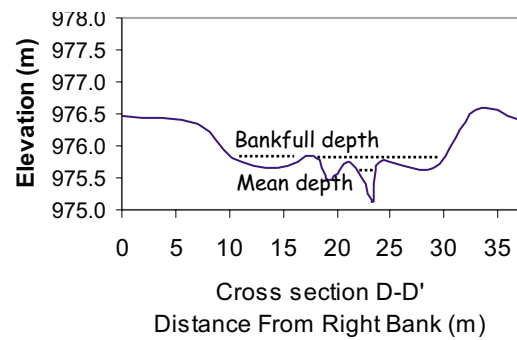
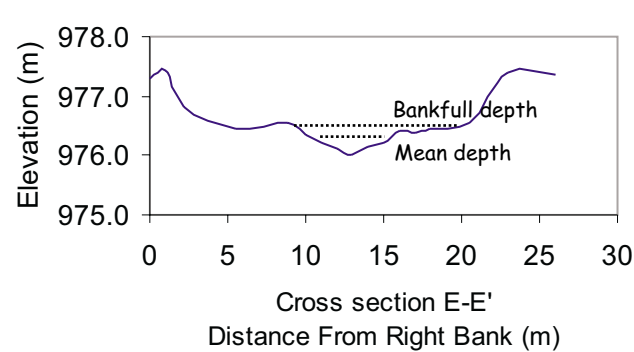
Reach 11, Fish Habitat Restoration Prescription

Date:	July 11-12, 1999	Stream Name:	Homathko River	Watershed:	Homathko	Reach:	11-2	Chainage:	0+200-1+000
Project:	9H	Survey Crew:	FK/DB	Comments:	Created from air photo and Level 2 FHAP surveys

Chainage	Bankfull Width (m)	Bankfull Depth (m)
0+200	2.8	0.80
0+300	4.4	0.70
0+400	4.6	0.75
0+500	3.7	0.65
0+600	5.7	0.50
0+700	7.5	0.80
0+800	6.5	1.00
0+900	8.1	0.55
1+000	8.5	0.50
AVERAGE	5.75	0.69
