Title: RICHMOND DYKES-REMEDIAL TREATMENT

Location: CORPORATION OF THE TOWNSHIP OF
RICHMOND, BRITISH COLUMBIA

Client: FRASER RIVER JOINT
PROGRAM COMMITTEE
THE PROVINCE OF BRITISH COLUMBIA
MINISTER OF LANDS, FORESTS &
WATER RESOURCES

Our File: VA1346 OCTOBER 17, 1969

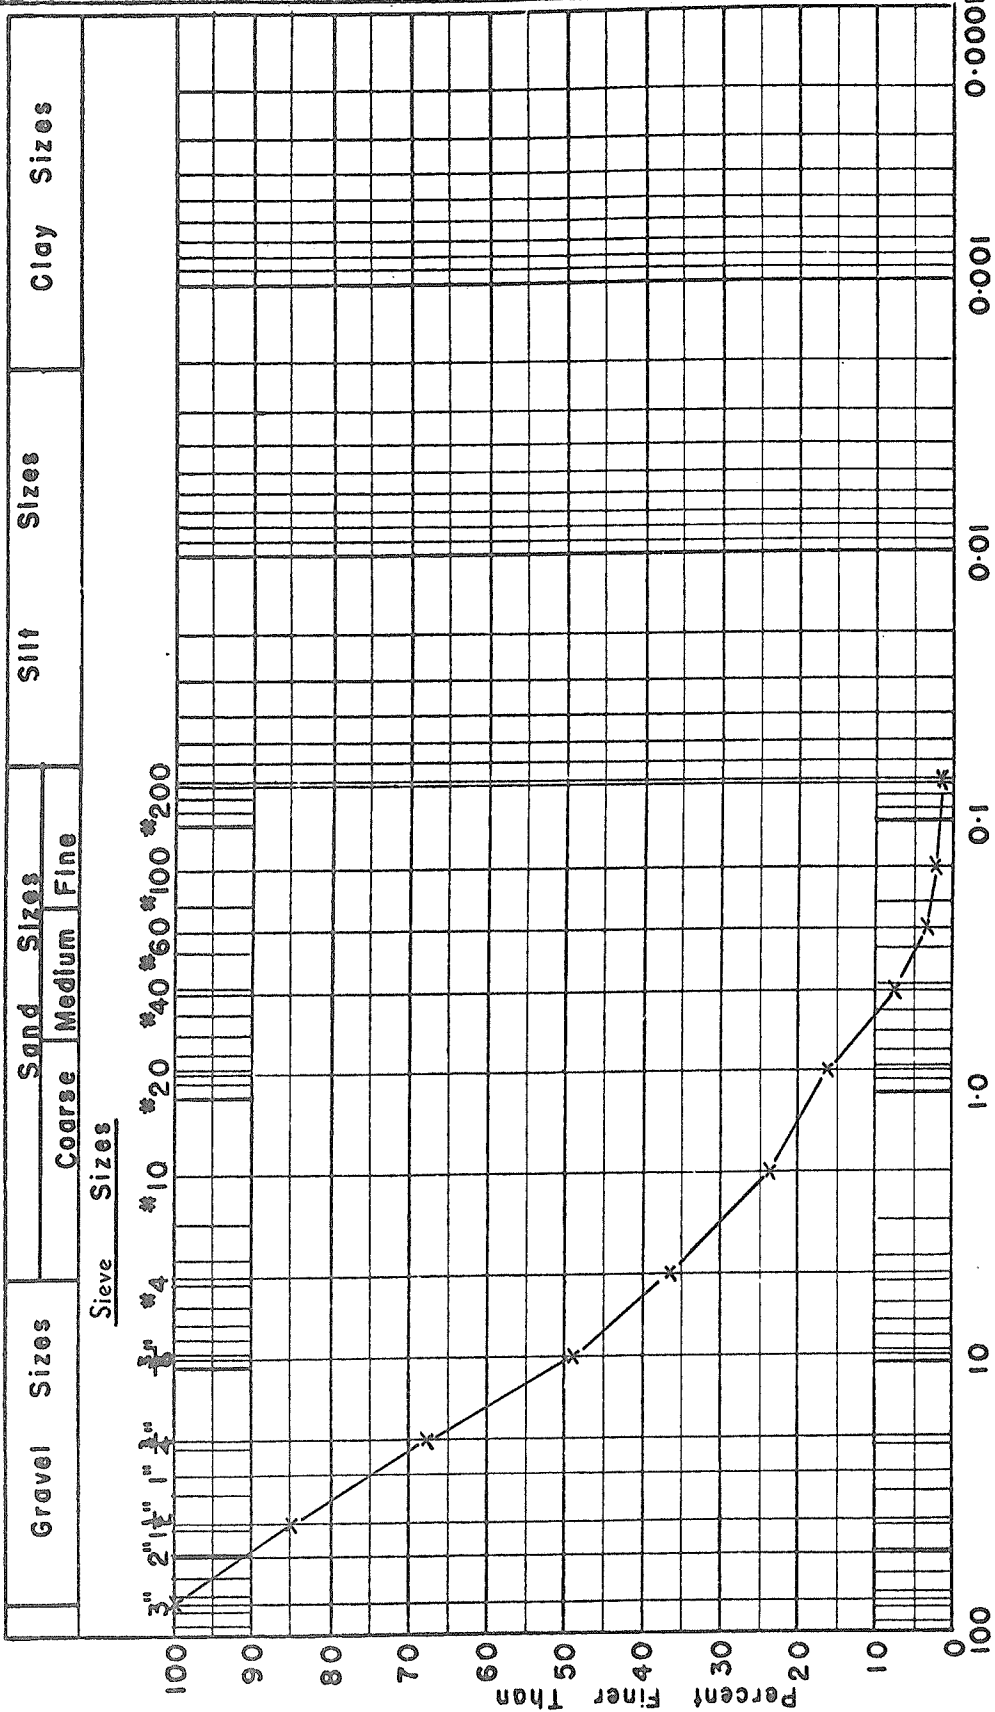
LAB. ORDER: _____
PROJECT VA 1346- RICHMOND DYKES
SAMPLE BULK _____
LOCATION DUCK ISLAND STOCKPILE
HOLE _____ DEPTH _____
TECHNICIAN B.C. DATE OCT 3, 1969

Remarks: SAMPLES TAKEN FROM ROUTLEDGE GRAVEL LTD. PIT-RUN STOCK PILE ON DUCK ISLAND.
SAMPLE WASHED ON #200 SIEVE.

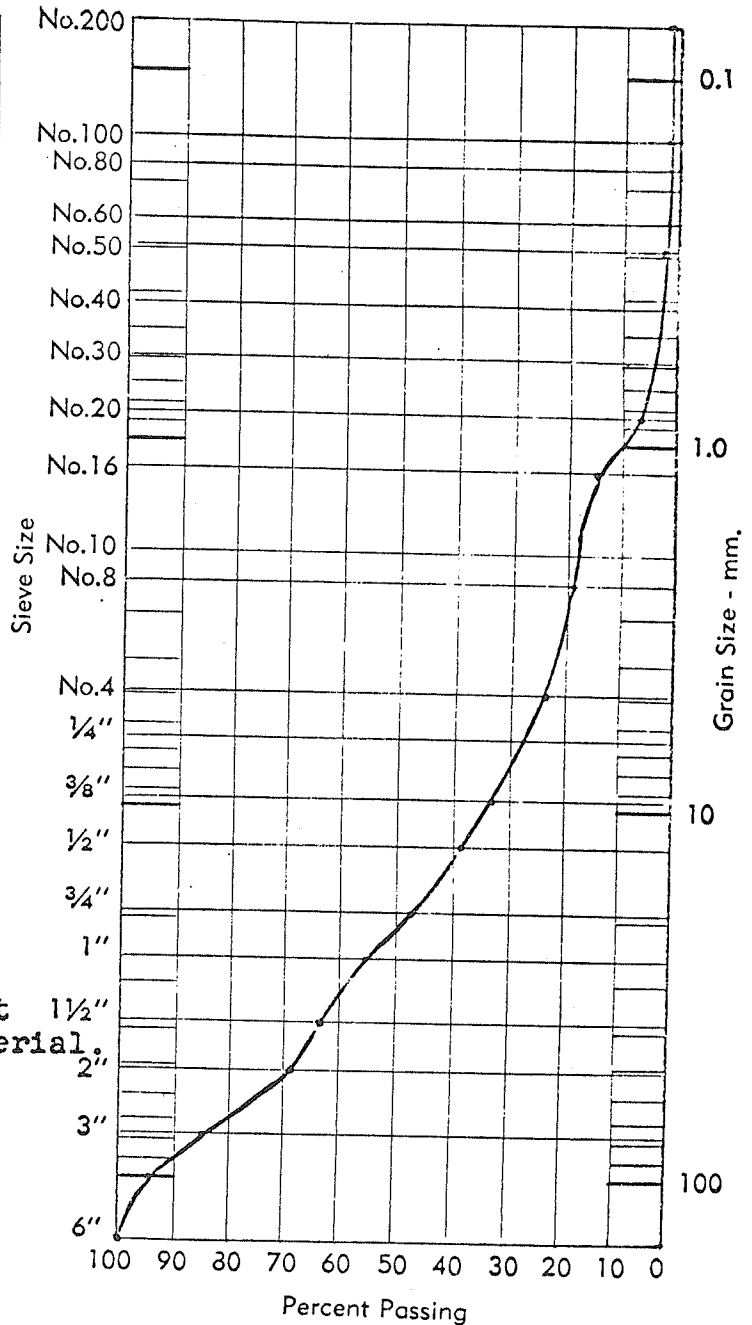
Some unsound mica-quartz present in 2". Also some organic material. Shape - mostly rounded. Hard silt particles in passing ¼ material.

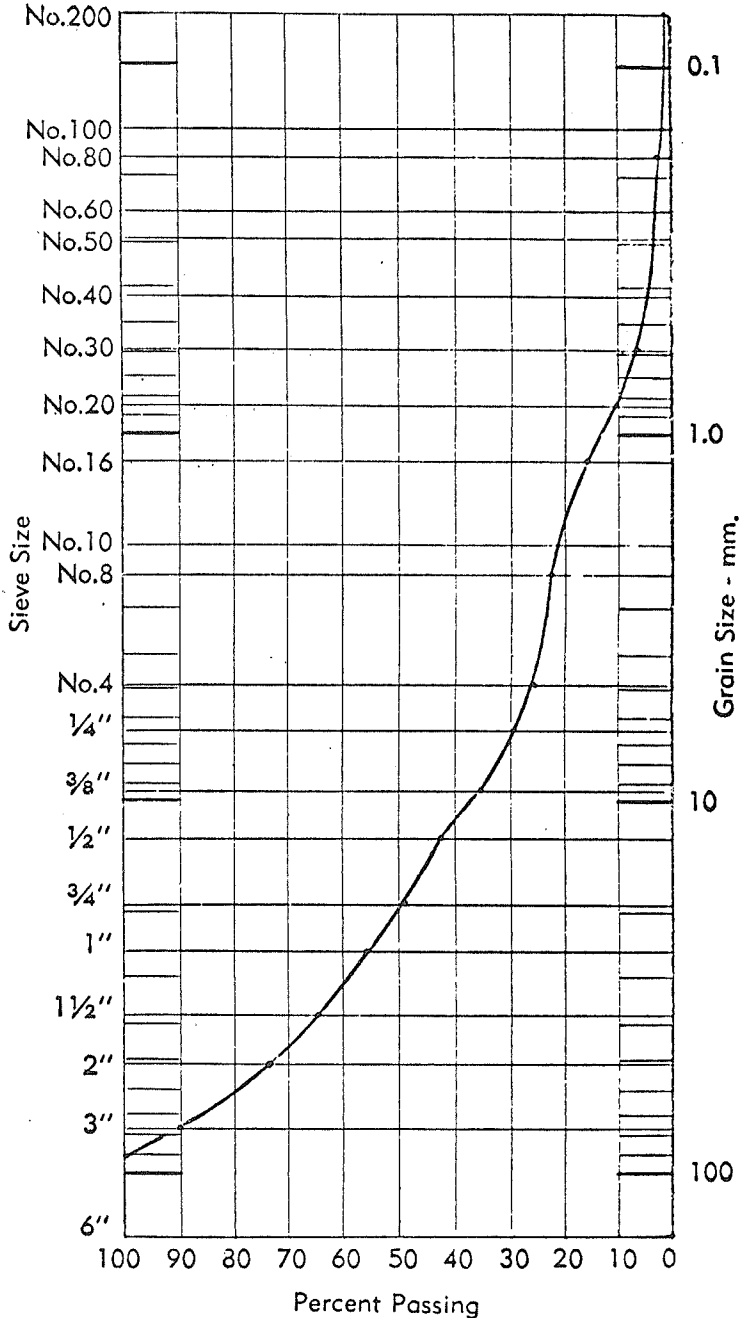
Some unsound mica-quartz and organic material.
Shape - mostly rounded.
Hard silt particles in passing #4 material.

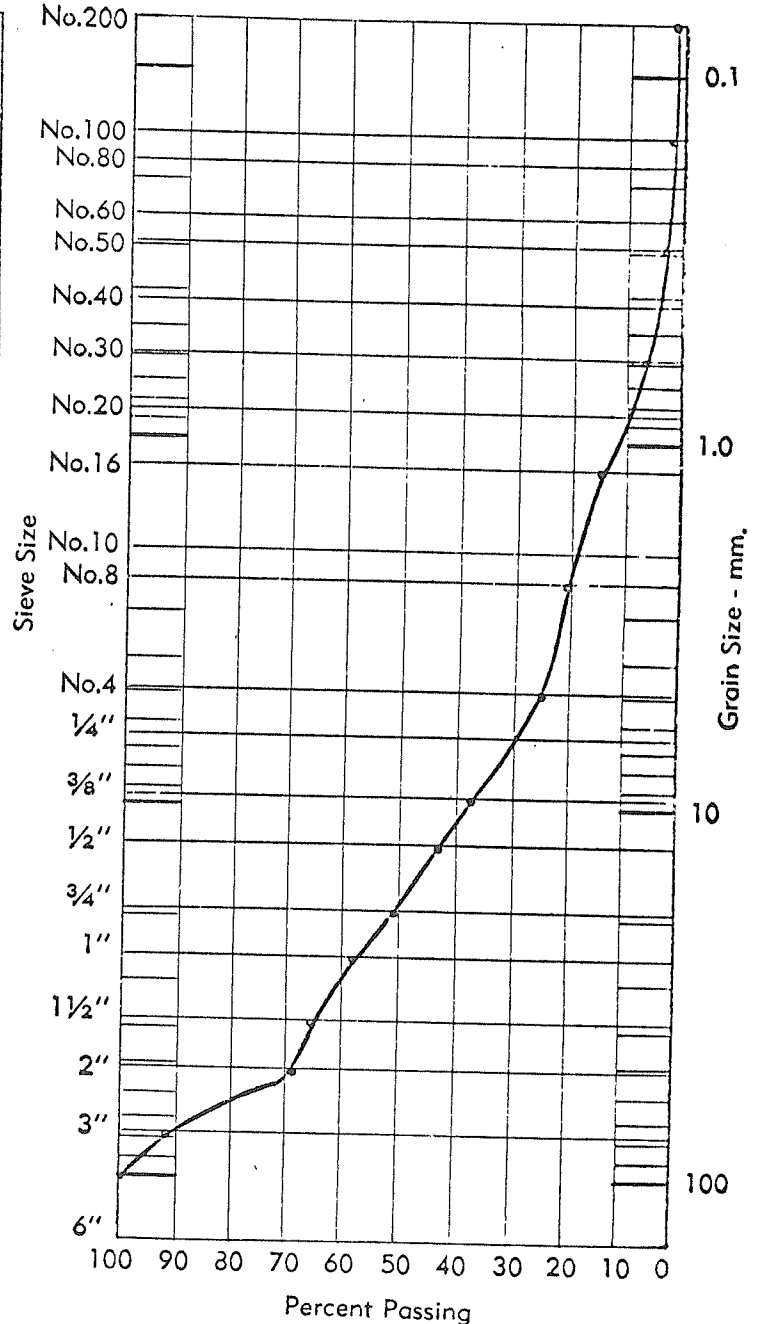
Mostly rounded aggregate.
Some organic material present.
Hard silt particles in passing #4 material.

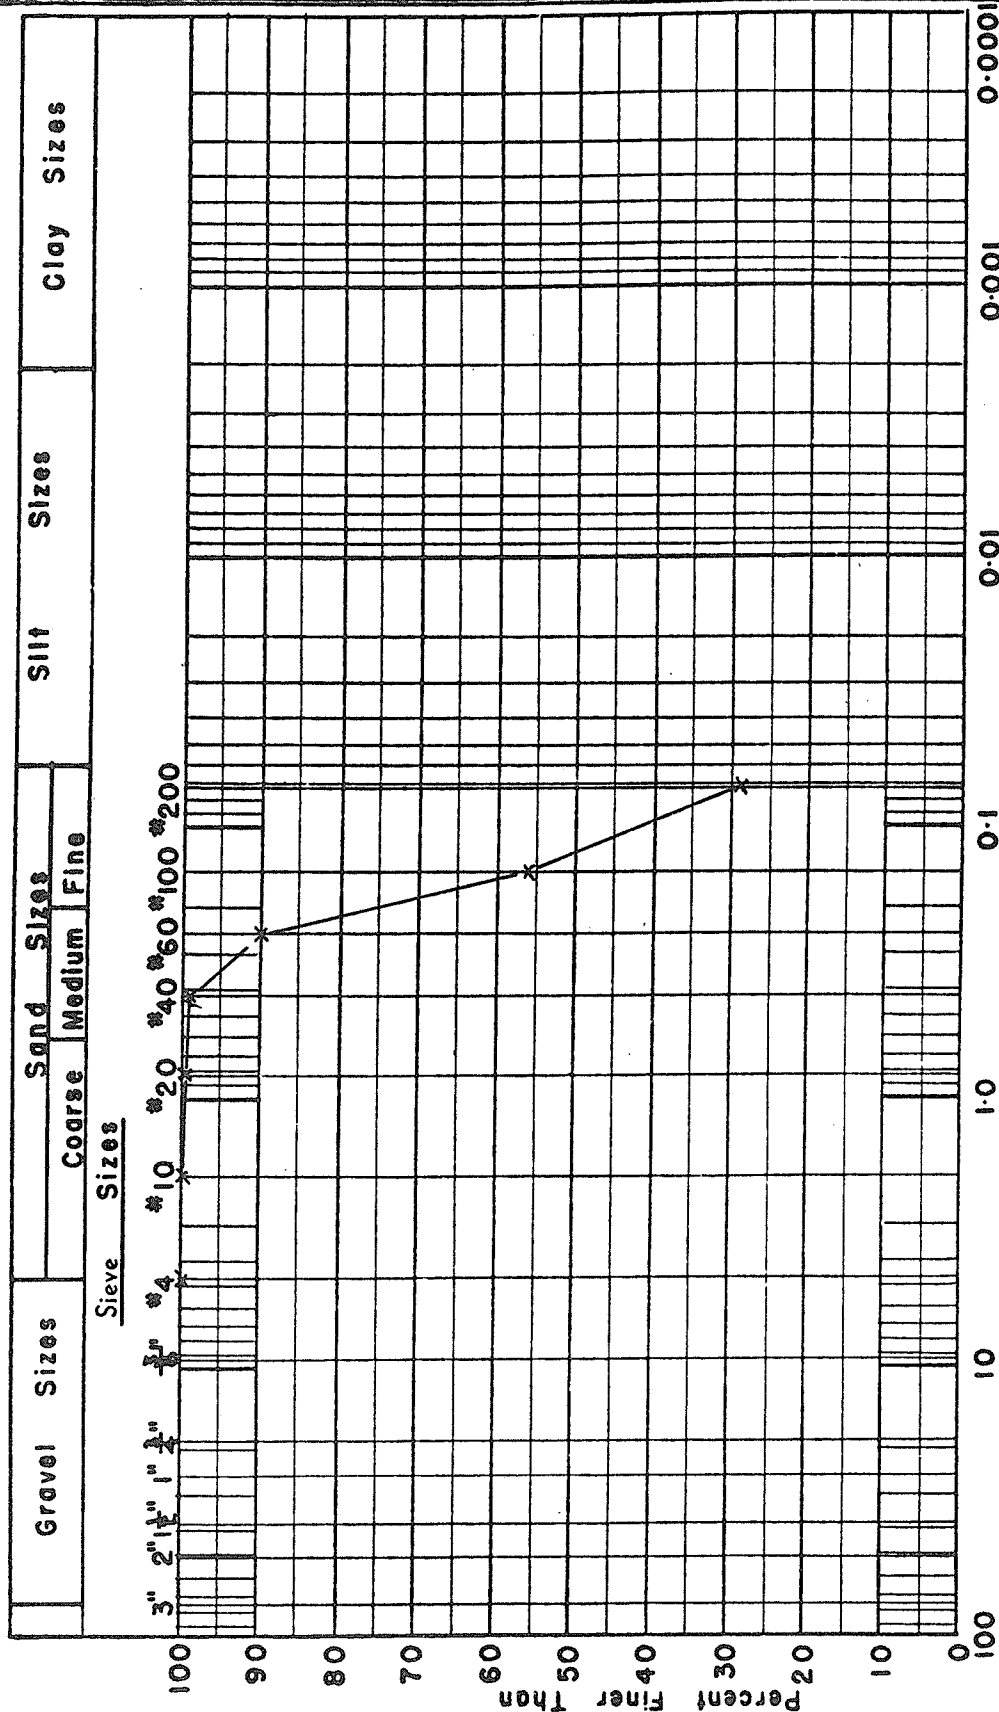
Remarks: SAMPLE WASHED THROUGH #200 SIEVE.
 PORTION RETAINED ON SIEVE #10 AND #20 WAS SEA SHELLS.

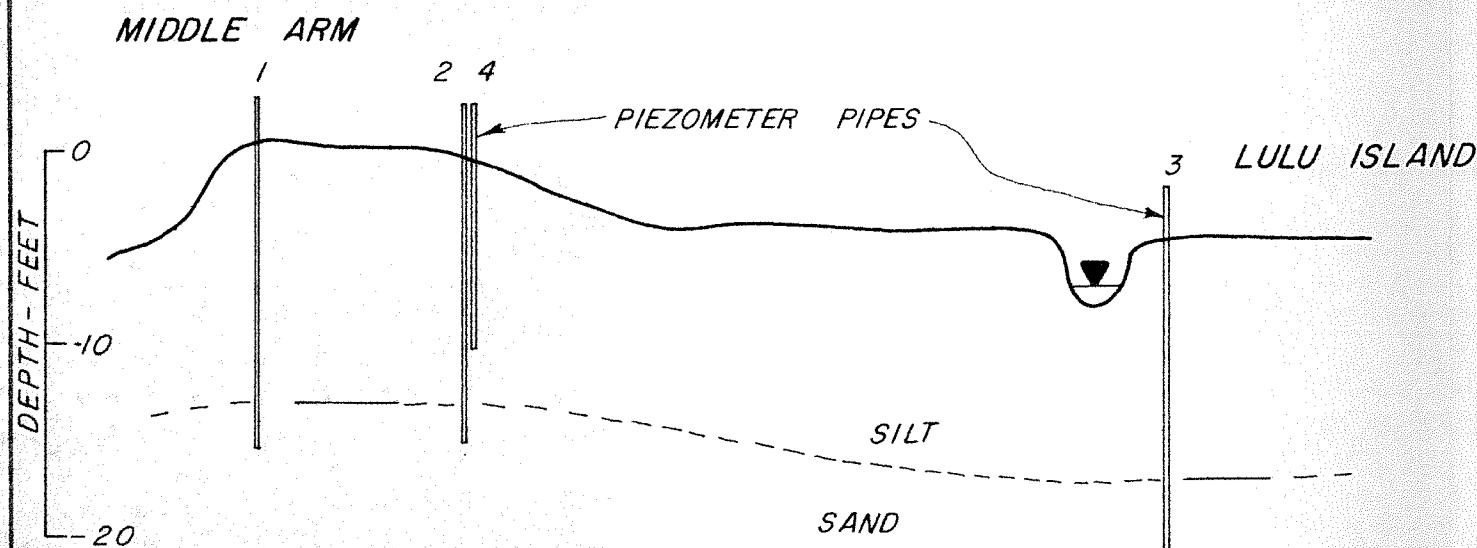
SECTION 1009

Piezometers 2 and 3 at Section 1009 showed very active response to changes in river level but Piezometer 1 showed a response that was much less than that in the other two piezometers. Reaction in the piezometers to changes in river level was almost instantaneous indicating that transfer of seepage pressure through the underlying sand takes place quite rapidly. No change in ditch water level was observed.

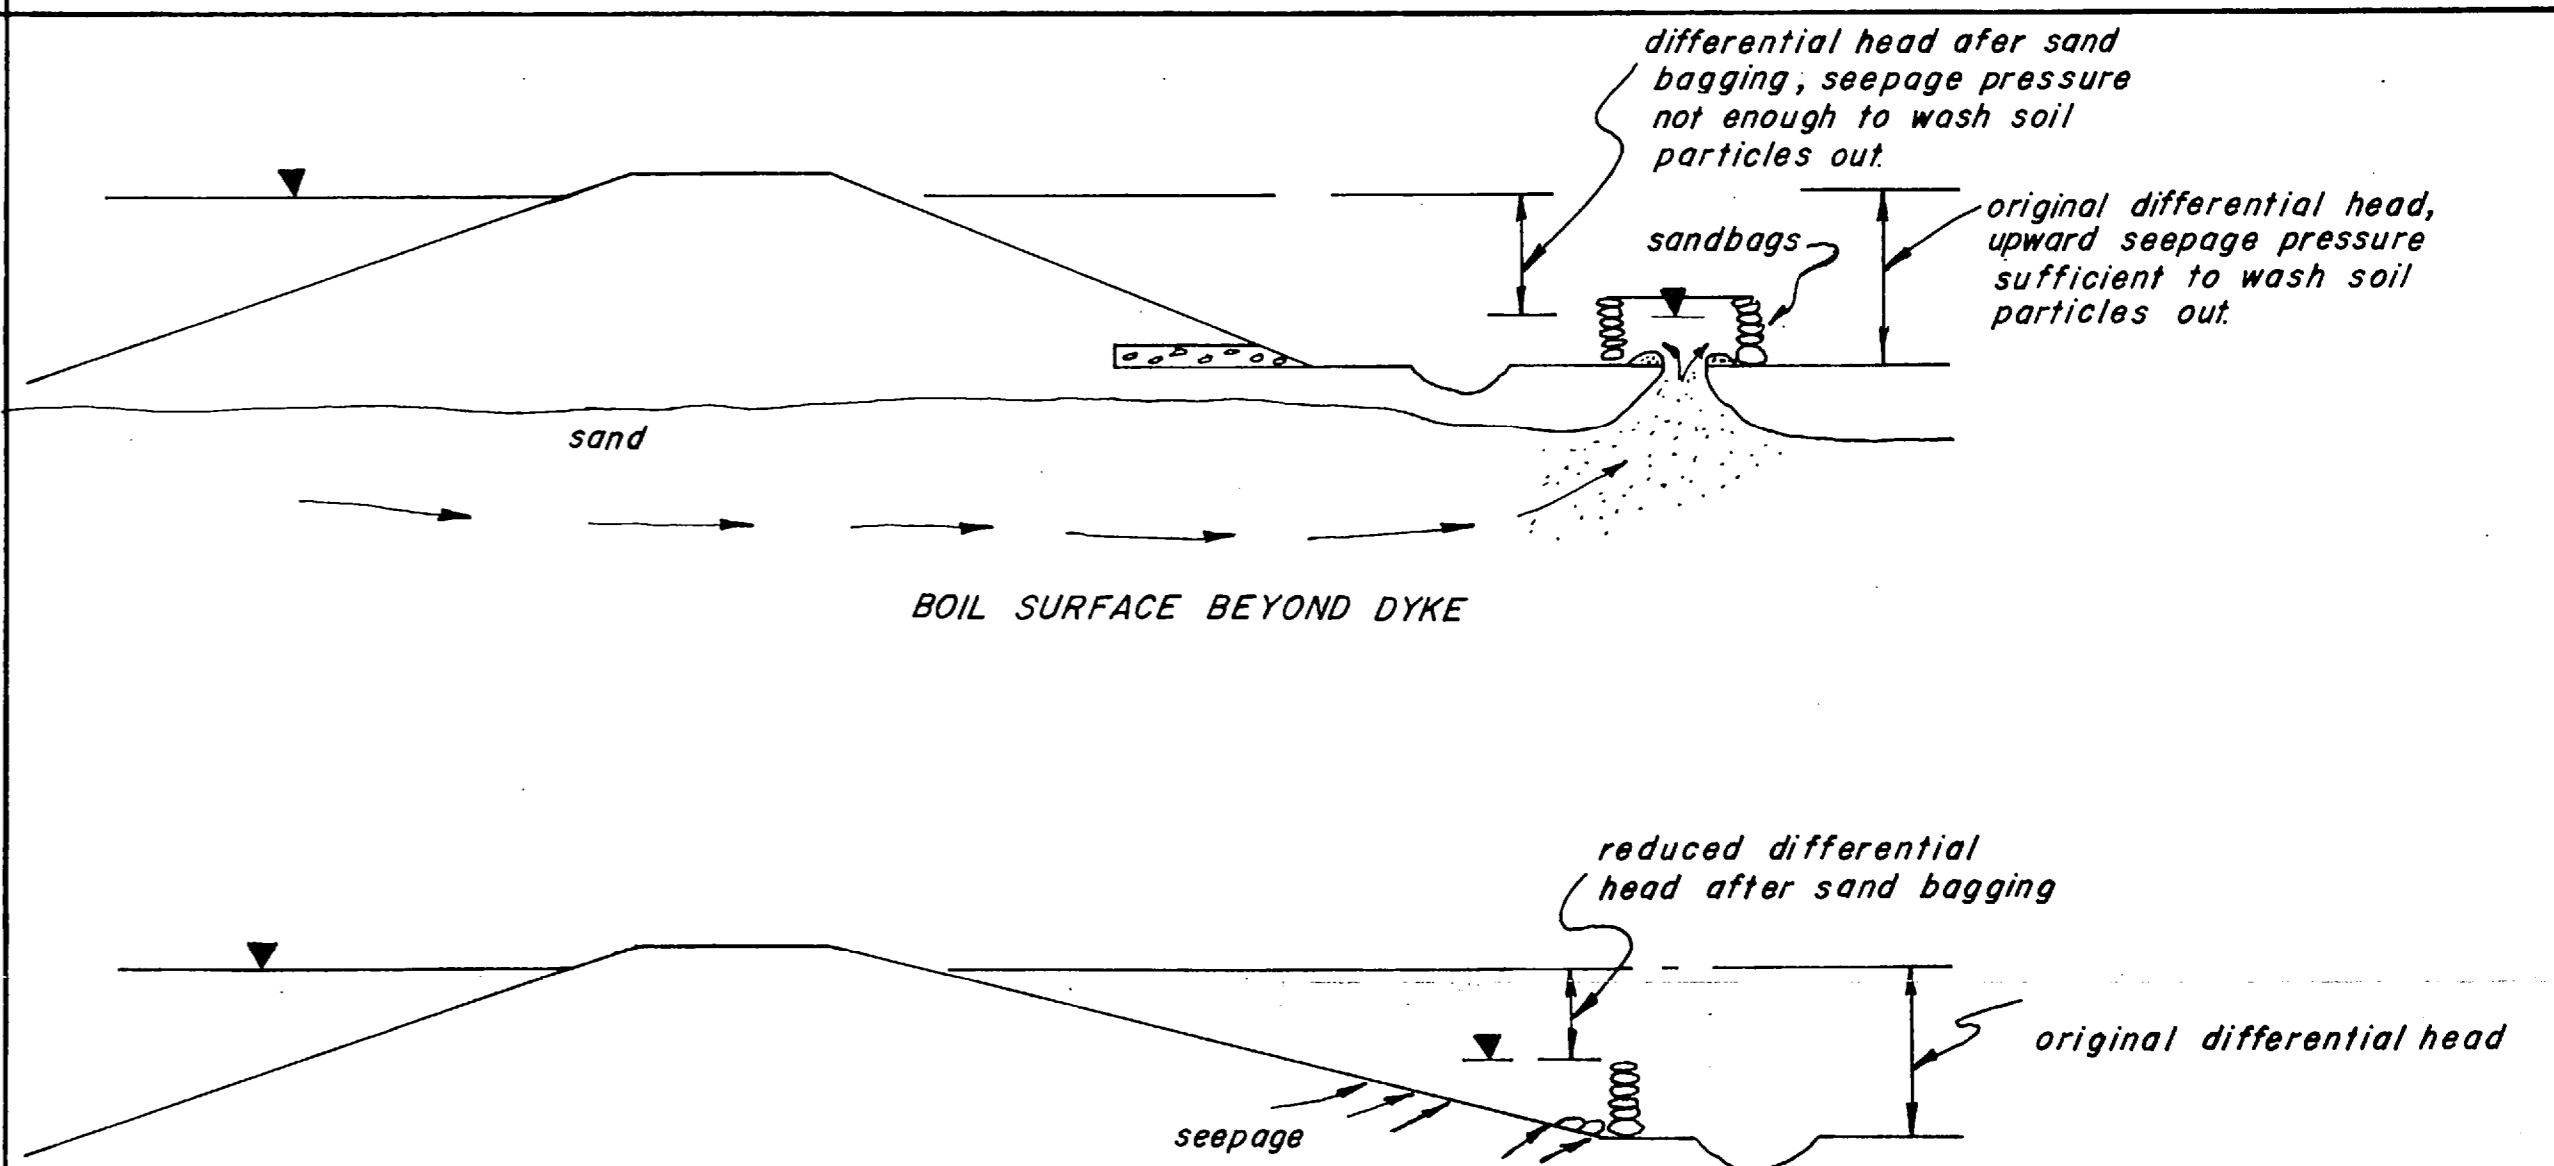
METHODS OF TEMPORARY SEEPAGE CONTROL

Although boils and piping have not been the cause of a dyke failure in the Richmond area, it will nevertheless be prudent to take steps to prevent such a catastrophe in future.

1. Impervious blanketing on the riverward side to increase the length of seepage path. This can involve a complete blanket or simply repairing of scars cut by drainage channels and old borrow pits.
2. Application of a weighting zone on the landward side to increase the load on the semipervious surface layer and to reduce the effective head.
3. Drainage wells along the landside toe.
4. Drainage trenches along the landside toe.
