**COLEBROOK DYKING DISTRICT
SERPENTINE RIVER
FLOOD CONTROL WORKS
OPERATION AND MAINTENANCE MANUAL**

**Victoria, British Columbia
September, 1987
File Nos. P83-6 and P84-3**

SERPENTINE RIVER FLOOD CONTROL WORKS

OPERATION AND MAINTENANCE MANUAL

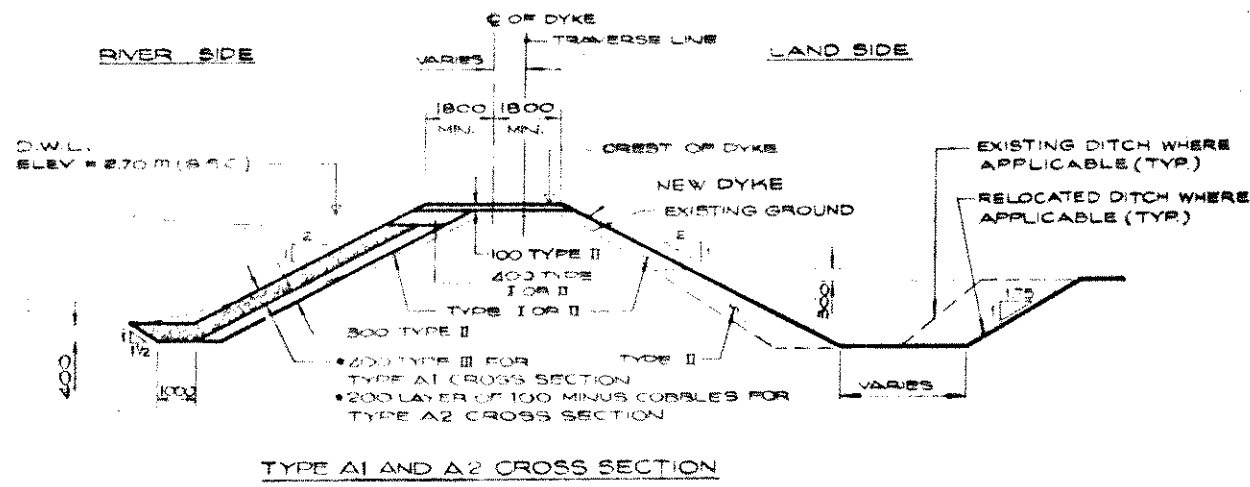
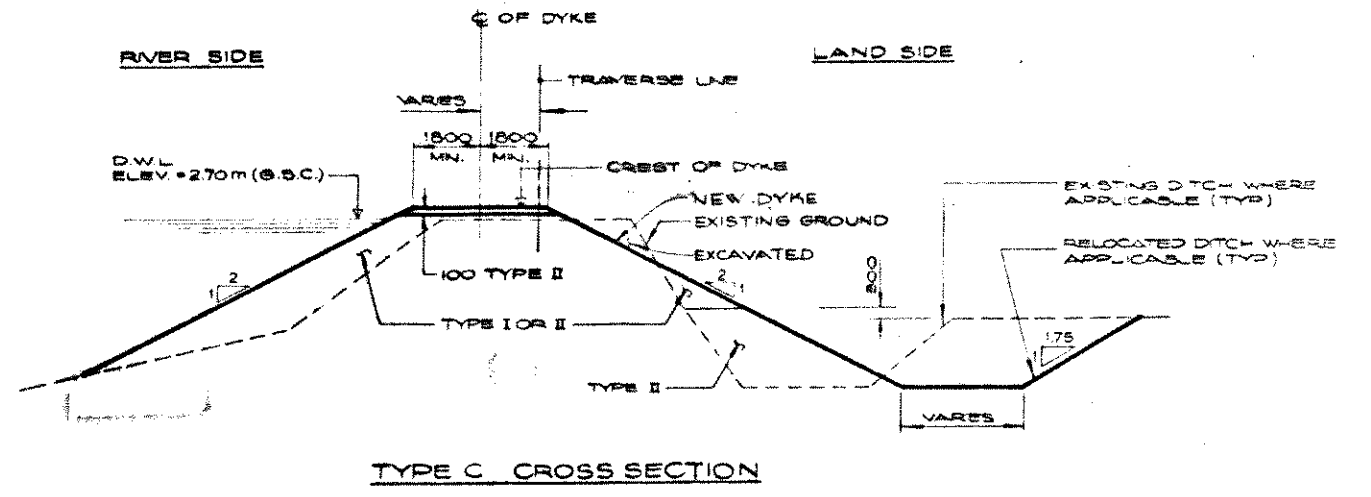
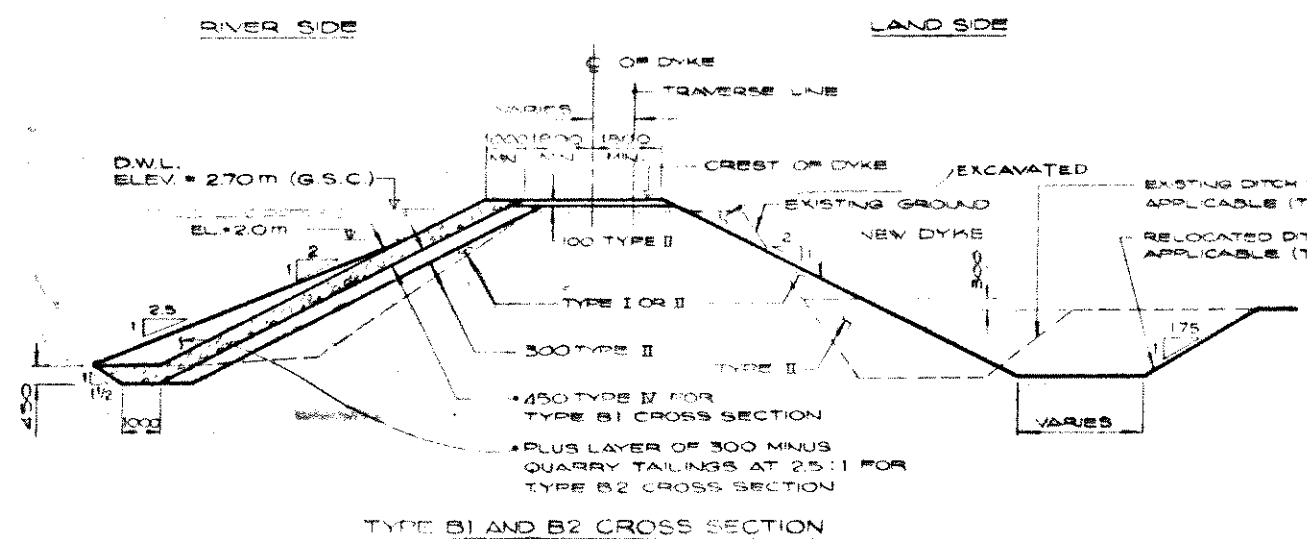
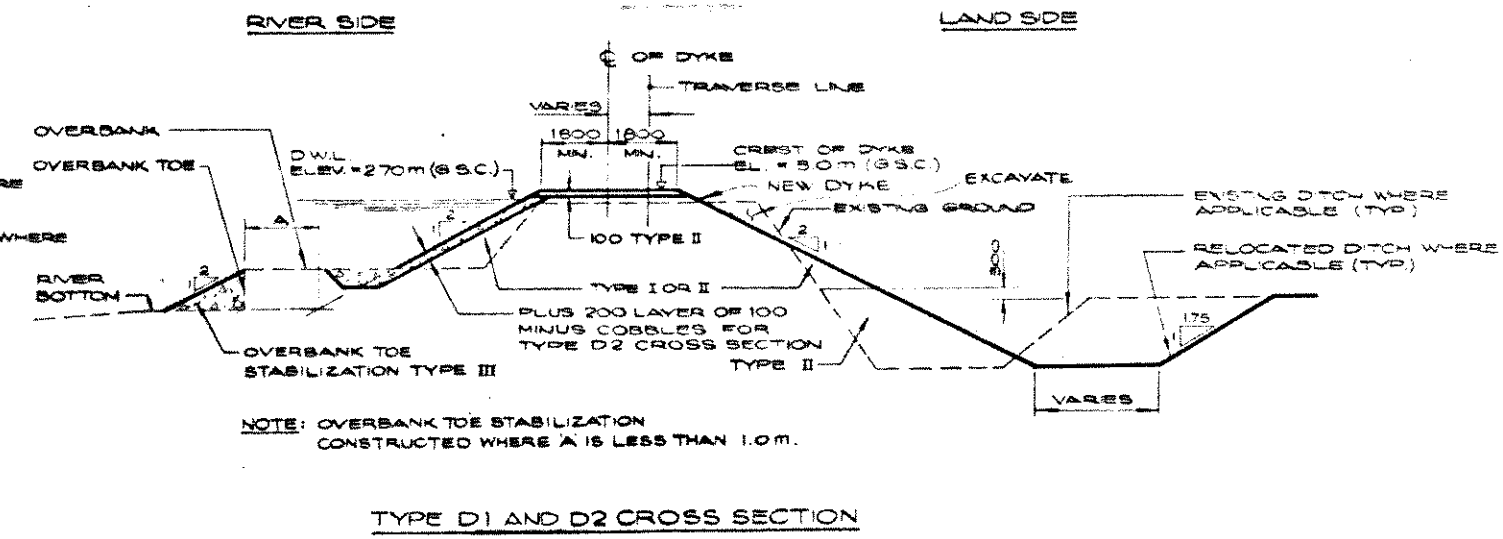
NOTE: WHERE THE EXISTING DYKE CREST ELEVATION IS 3.0m G.S.C. OR MORE AND THE WIDTH AND THE LOCATION OF THE CREST CONFORMS TO THE NEW DYKE CROSS SECTION, A 100mm LAYER OF TYPE II MATERIAL PLACED ON THE TOP OF THE EXISTING DYKE CREST

TYPE III - COBBLESTONE	
PARTICLE SIZE	PERCENTAGE BY WEIGHT FINER THAN
200.00 mm	100
150.00 mm	65-100
75.00 mm	15-30
50.00 mm	not exceeding 10

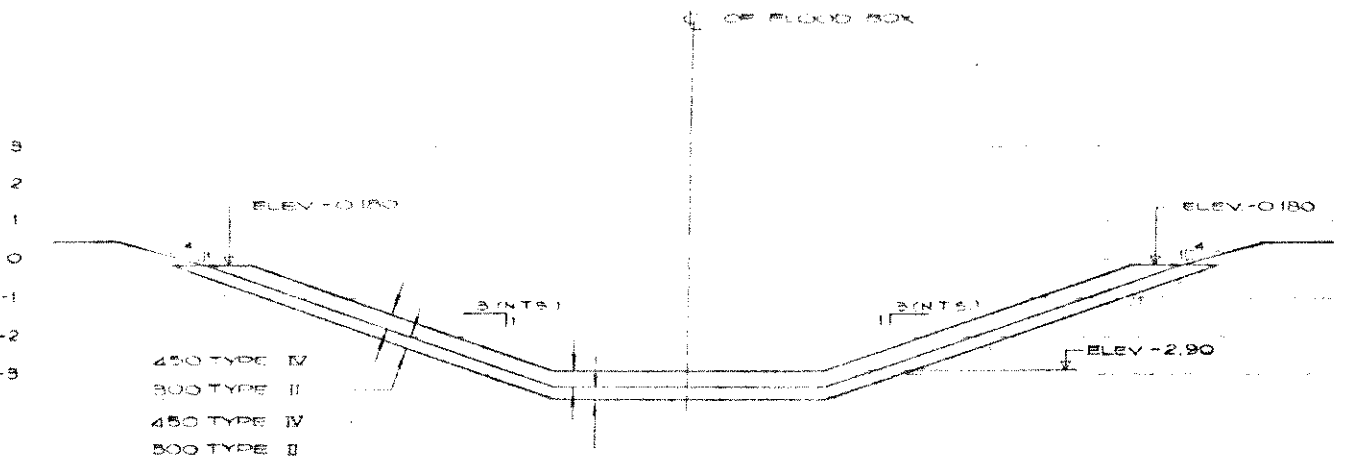
SECTION 8/15

LOCATION, NUMBER AND DIAMETER OF BOLTS AS PER SUPPLIER'S RECOMMENDATION

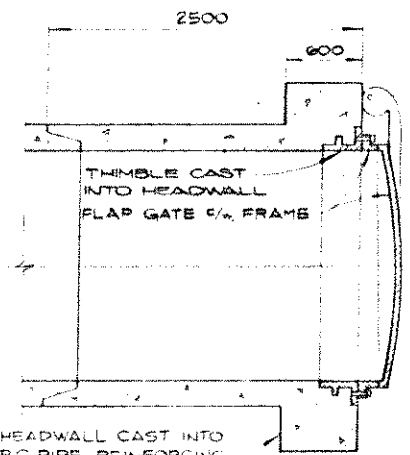
SECTION 9/15
FLAP GATE ASSEMBLY
DETAIL 9/15

HEADWALL CAST INTO RC PIPE REINFORCING AS PER PIPE SUPPLIER'S RECOMMENDATION

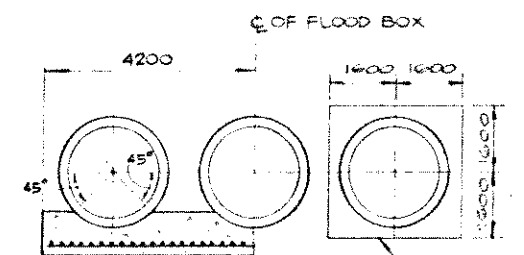
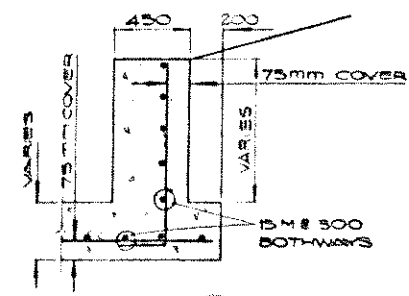
SECTION 10/15
N.T.S.

CAST CUT OFF COLAR INTO RC PIPE. REINFORCING AS PER PIPE SUPPLIER'S RECOMMENDATION

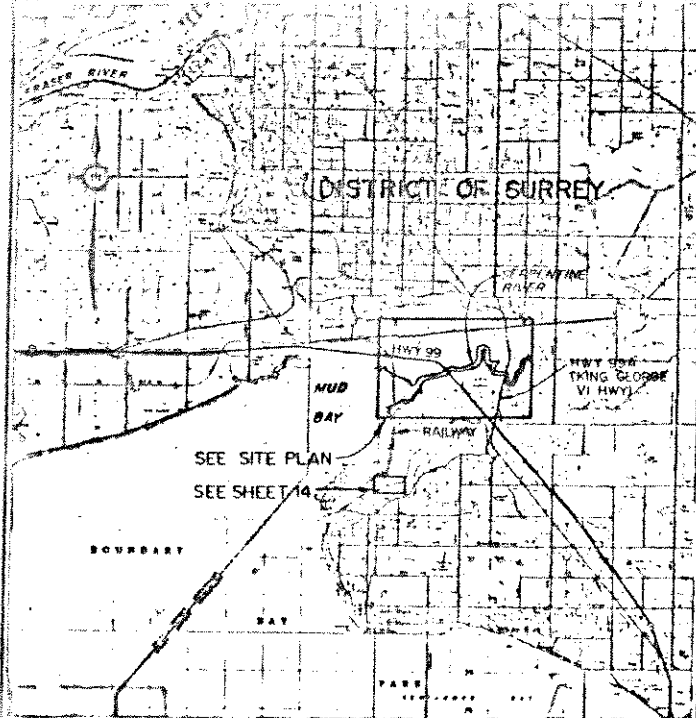
STATION	TOP OF DYKE ELEV	DESCRIPTION
0+304		King George Hwy.
0+100	2.89	
0+200	2.99	
0+300	2.91	
0+400	2.96	
0+500	2.97	
0+600	2.93	
0+665	3.14	
0+700	2.93	
0+800	2.90	
0+900	3.16	
1+000	3.05	
1+100	2.99	
1+200	2.88	
1+300	2.94	
1+400	2.98	
1+500	2.85	
1+600	3.09	
1+700	3.07	
1+800	2.95	
1+900	2.93	
2+000	2.98	
2+100	2.94	
2+200	2.91	
2+300	2.92	
2+400	2.95	
2+500	2.93	
2+600	2.92	
2+700	2.87	
2+800	2.96	
2+839	2.97	Fenceline

NOTE: SURVEYED MARCH 5, 1987

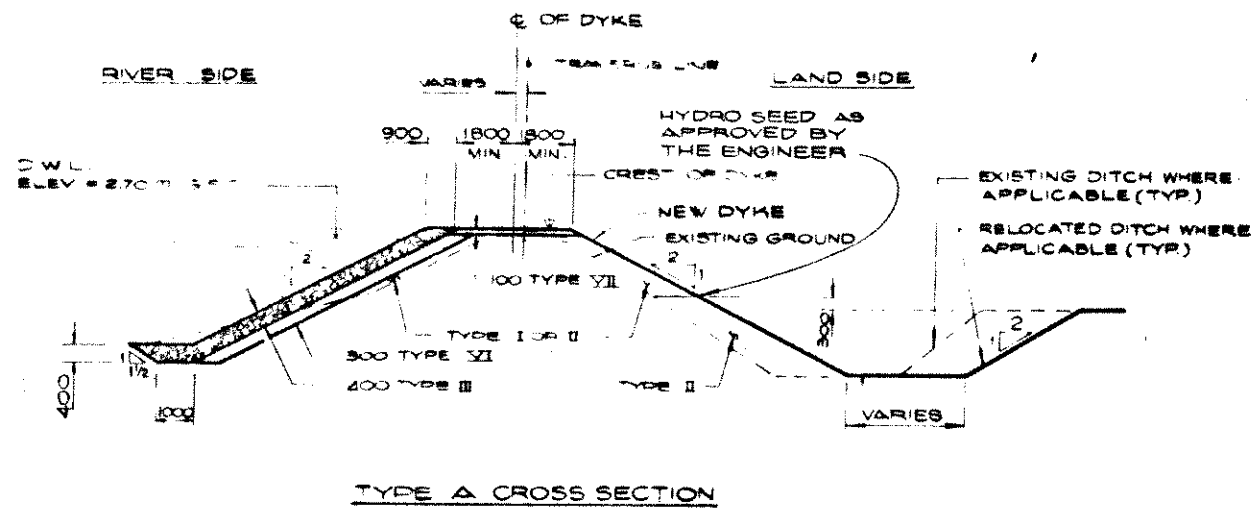
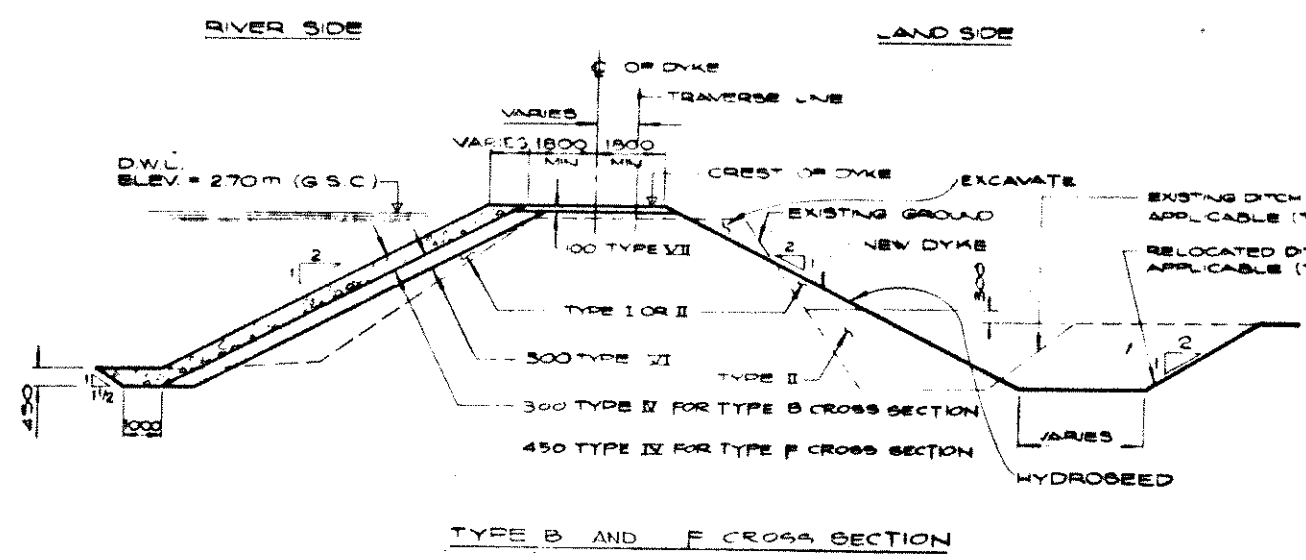
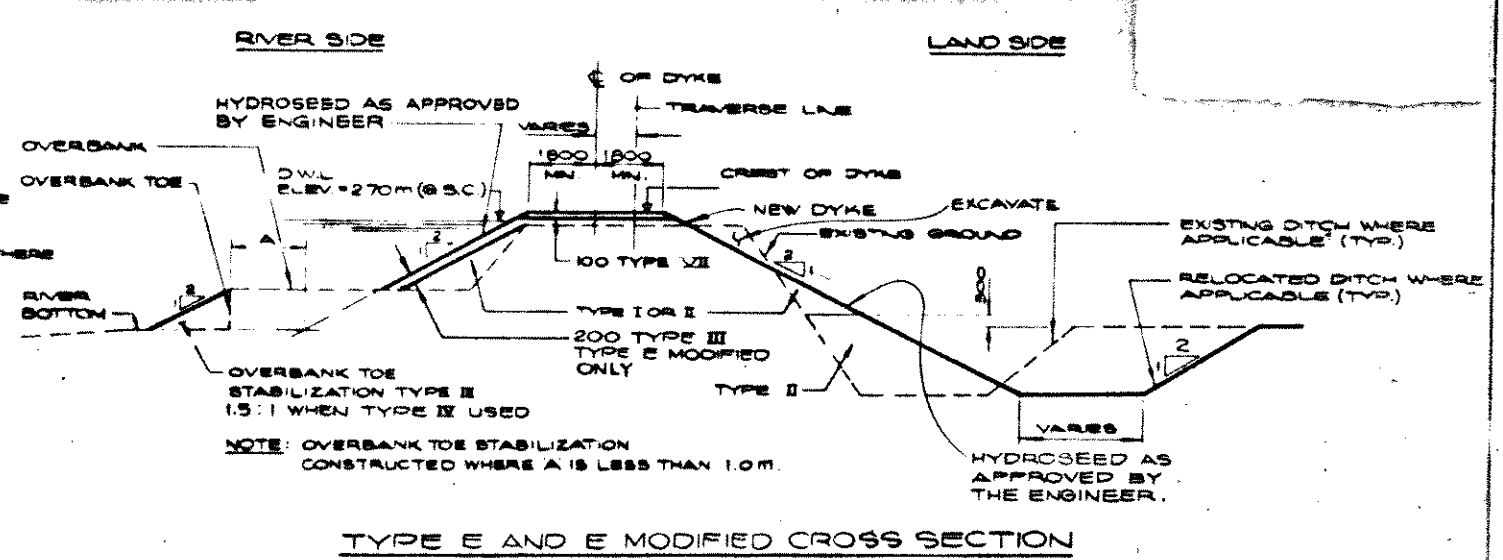
TYPE IV - QUARRY TAILINGS	
PARTICLE SIZE	PERCENTAGE BY WEIGHT FINER THAN
220.0 mm	100
150.0 mm	65-85
125.0 mm	40-60
75.0 mm	15-35
25.0 mm	not exceeding 10

TYPE III - COBBLESTONE	
PARTICLE SIZE	PERCENTAGE BY WEIGHT FINER THAN
200.00 mm	100
150.00 mm	65-100
75.00 mm	15-30
50.00 mm	not exceeding 10
