**DISTRICT OF SURREY  
SERPENTINE RIVER AND CRESCENT BEACH  
FLOOD CONTROL WORKS  
OPERATION AND MAINTENANCE MANUAL**

**Victoria, British Columbia  
September, 1987  
File Nos. P83-9, P84-3 and P85-9**

**As-Constructed Drawings**

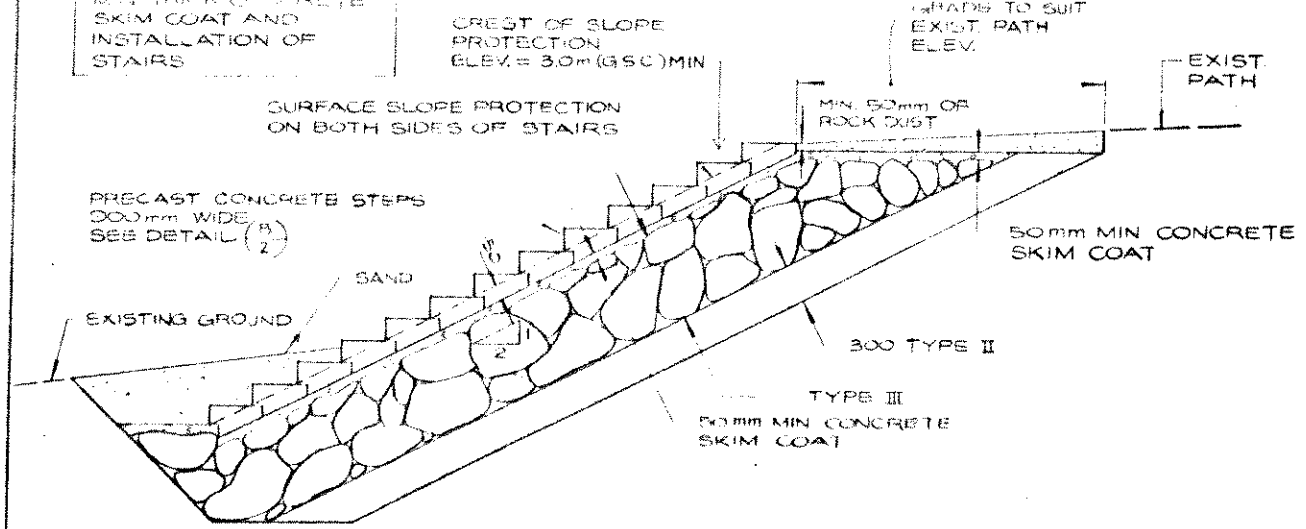
STAIRS DETAIL A/2  
 N.T.S.

NOTE:  
 SURFACE OF RIP-RAP  
 GRADED  
 TO SUIT EXIST. PATH  
 ELEV. TO SUIT  
 EXIST. PATH  
 MIN. THICKNESS OF  
 SKIM COAT AND  
 INSTALLATION OF  
 STAIRS

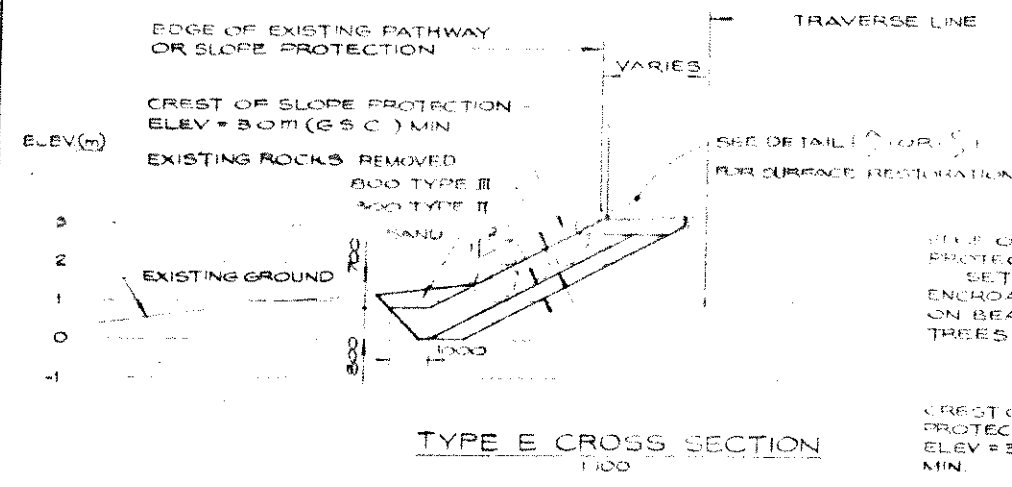
TYPE E CROSS SECTION  
 1:100

DESCRIPTION OF FILL MATERIALS	
TYPE I	NATIVE BEACH MATERIAL
TYPE II	GRADED 50mm MINUS MATERIAL
TYPE III	GRADED 600mm (300 Kg) MINUS ROCK RIP-RAP

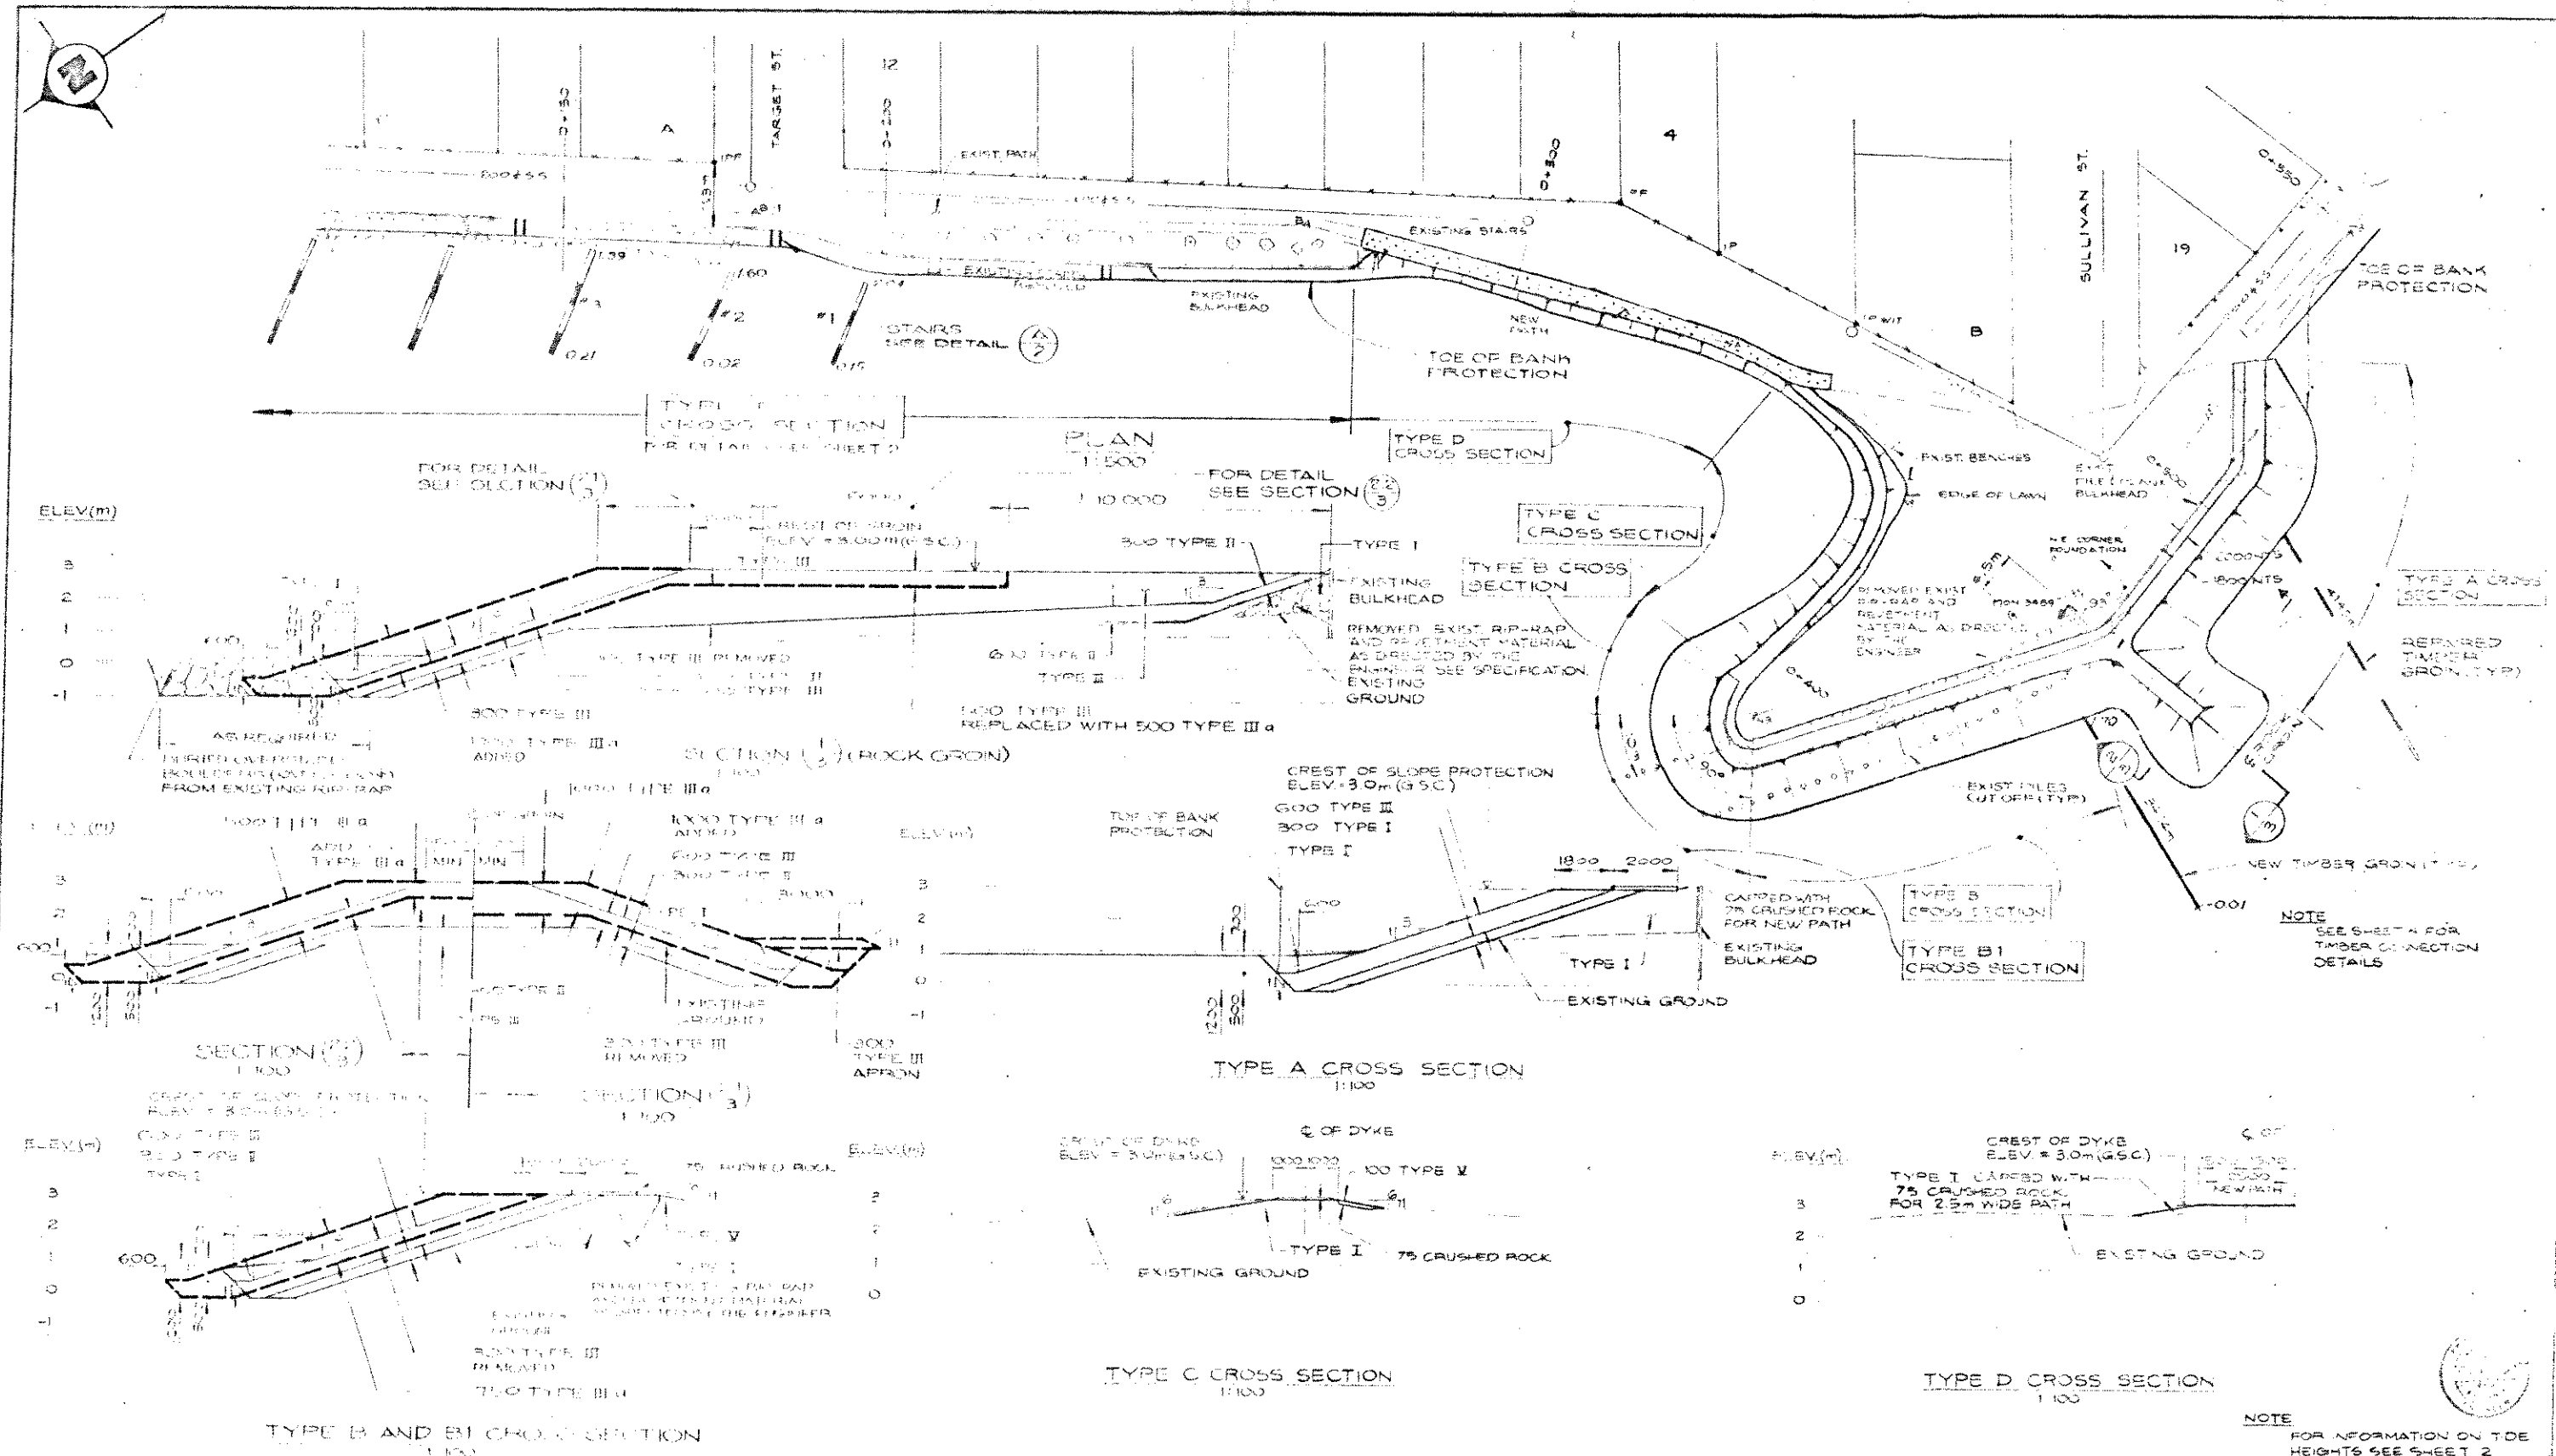
TYPE IIIa RIP-RAP ROCK PARTICLE SIZE	PERCENTAGE OF TOTAL WEIGHT EXCEEDING GIVEN PARTICLE SIZE
600 Kg	100
300 Kg	85-90
150 Kg	40-55
39 Kg	15-25
12 Kg	NOT EXCEEDING 10

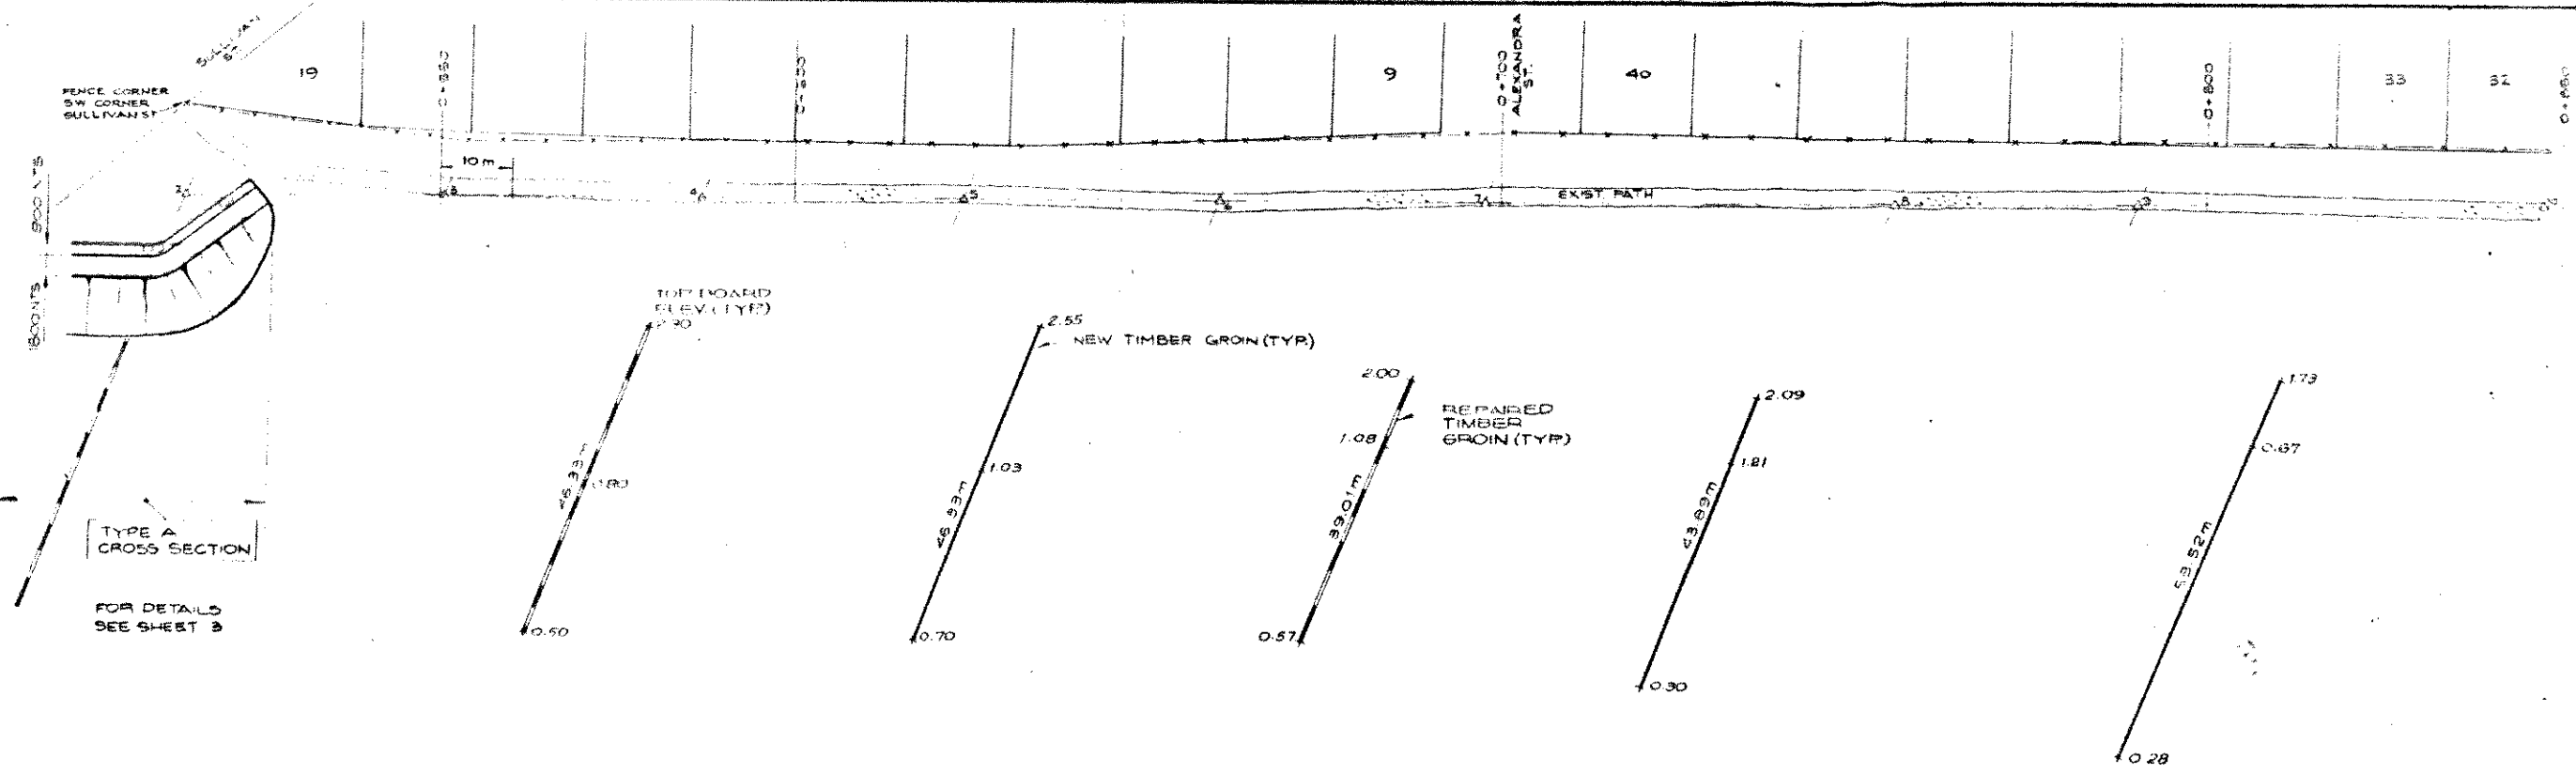
**PLAN**  
1:500

NOTE:  
FOR INFORMATION ON  
TIDE HEIGHTS  
SEE SHEET 2.

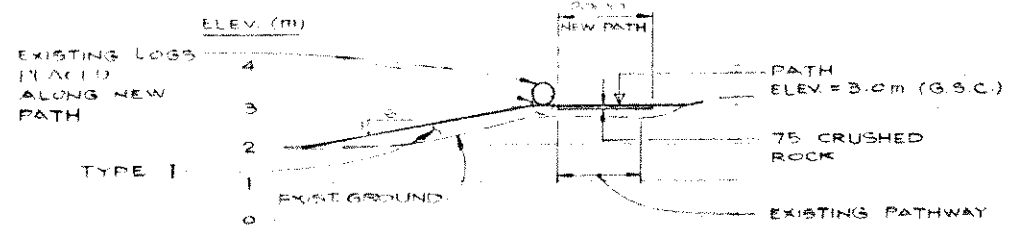
**TYPE L CROSS SECTION**  
1:100

PATH VARIES  
FROM 1.5m TO  
3.0 m (G.S.C.)  
(SEE PLAN)

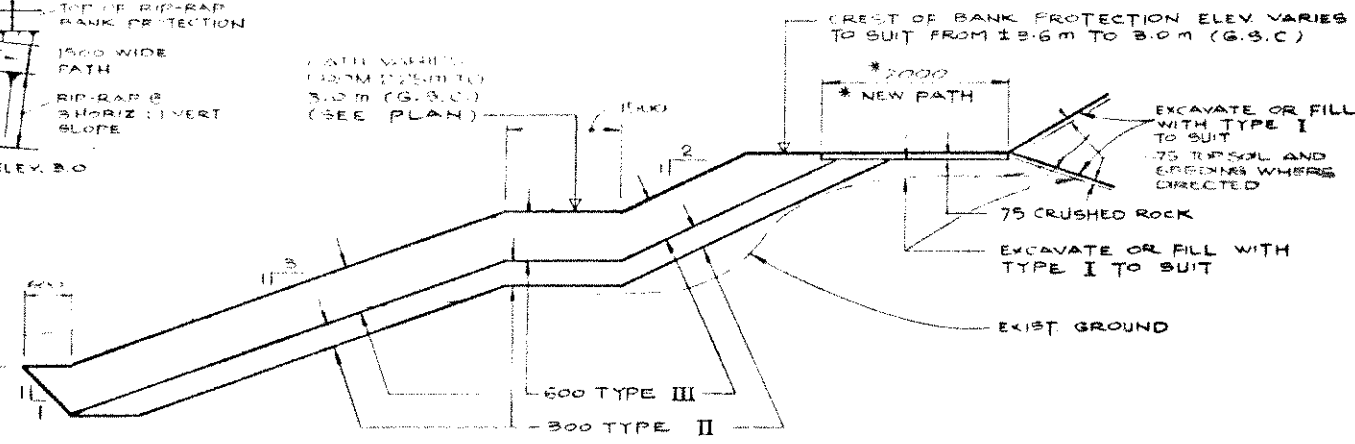
**TYPE M CROSS SECTION**  
1:50

- NOTES:**
- THE MINIMUM 28 DAY STRENGTH OF CONCRETE USED FOR SKIM COAT SHALL BE 27.5 MPa. THE CONCRETE MIX SHALL BE SUITABLE FOR SEA WATER EXPOSURE AND SHALL BE SUBMITTED TO THE INSPECTION FOR APPROVAL.
  - EXPANSION JOINTS IN SKIM COATS SHALL BE FORMED AT MAXIMUM SPACING OF 12 M.
  - CONTRACTING JOINTS SHALL BE CONSTRUCTED AT MAX. 2 M INTERVALS BY FORMING A GROOVE THROUGH SURFACE OF CONCRETE TO A DEPTH OF 12 MM.
  - REINFORCEMENT TO CONTINUE THROUGH EXPANSION AND CONTRACTING JOINTS.
  - THE SURFACE OF CONCRETE SKIM COAT SHALL BE FINISHED PRIOR TO FINAL SET BY BUSHING TO PROVIDE A UNIFORM, NON-SKID FINISH.

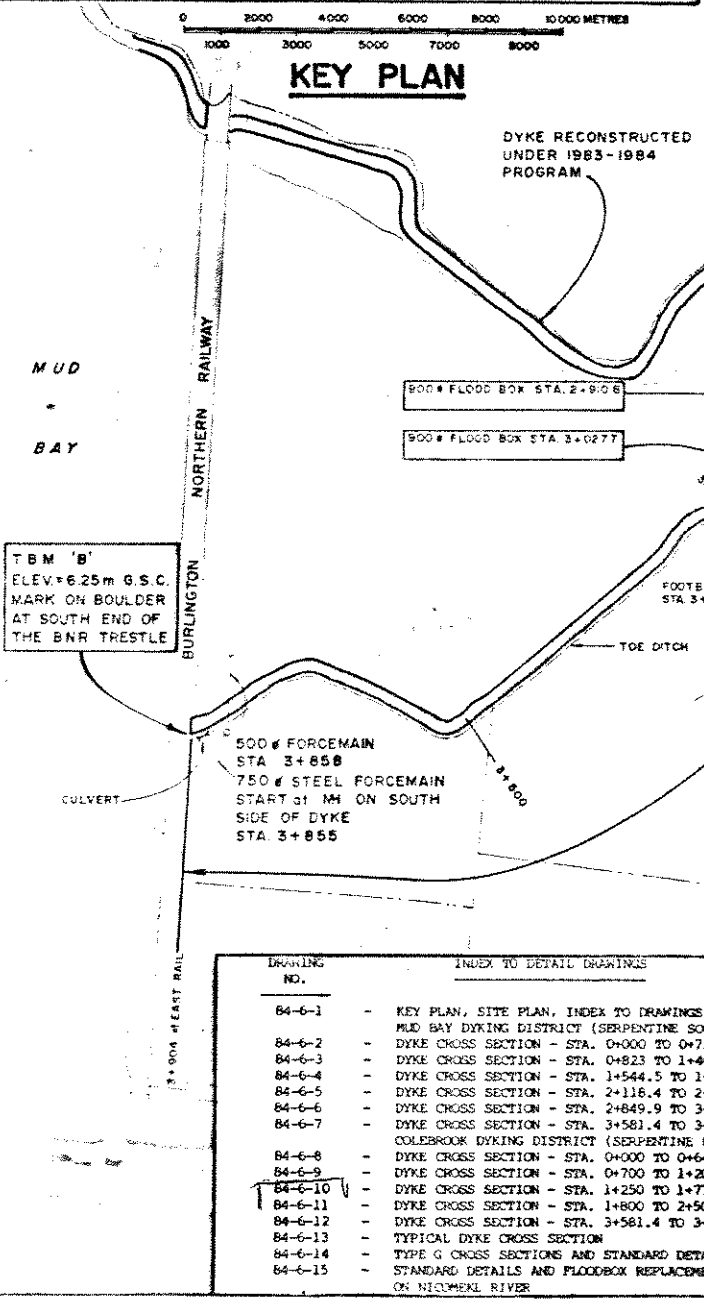
TRASH RACK ON 3+1800 FLOOD BOX

FLAP GATE ON EXISTING 1050 FLOOD BOX

FOOTBRIDGE STA 3+070

TOE DITCH

5.2.3 The flapgates should be periodically cleaned and lubricated ensuring that they swing freely and close properly with a good seal. The gates should be painted as required with a high quality rust resistant primer and paint.

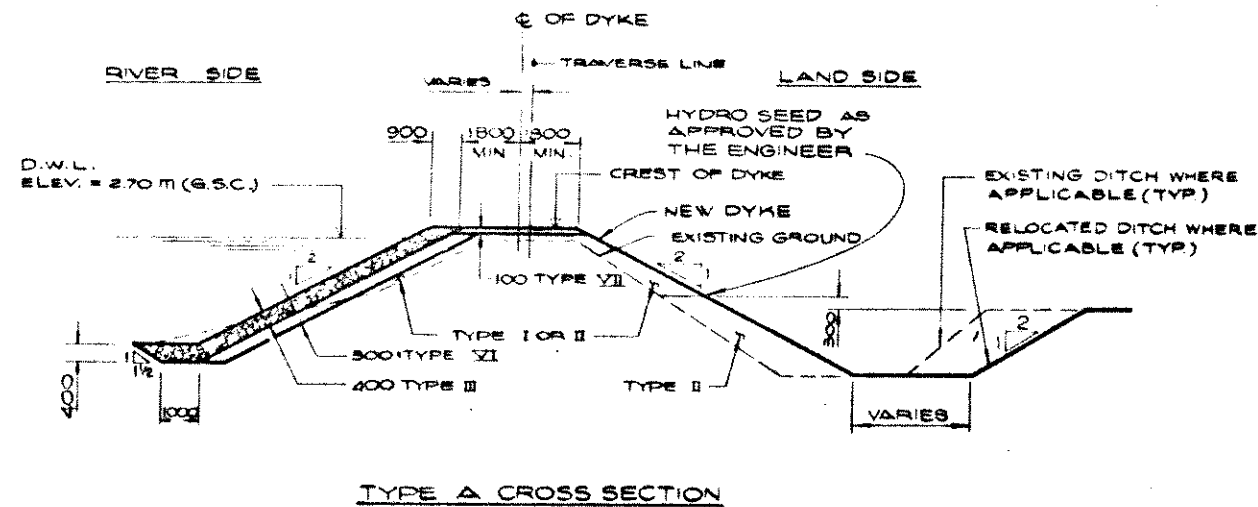
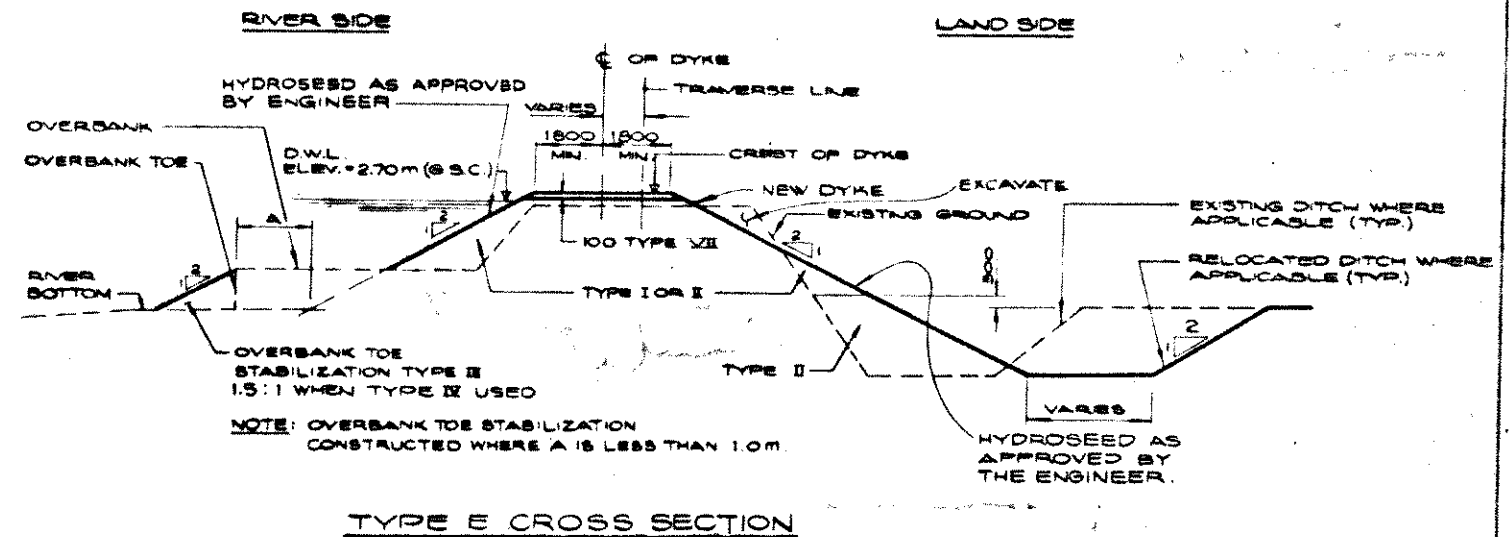
TYPE III - COBBLESTONE	
PARTICLE SIZE	PERCENTAGE BY WEIGHT FINER THAN
200.00 mm	100
150.00 mm	65-100
75.00 mm	15-30
50.00 mm	not exceeding 10

TYPE IV - QUARRY TAILING	
PARTICLE SIZE	PERCENTAGE BY WEIGHT FINER THAN
220.0 mm	100
150.0 mm	65-85
125.0 mm	40-60
75.0 mm	15-35
25.0 mm	not exceeding 10

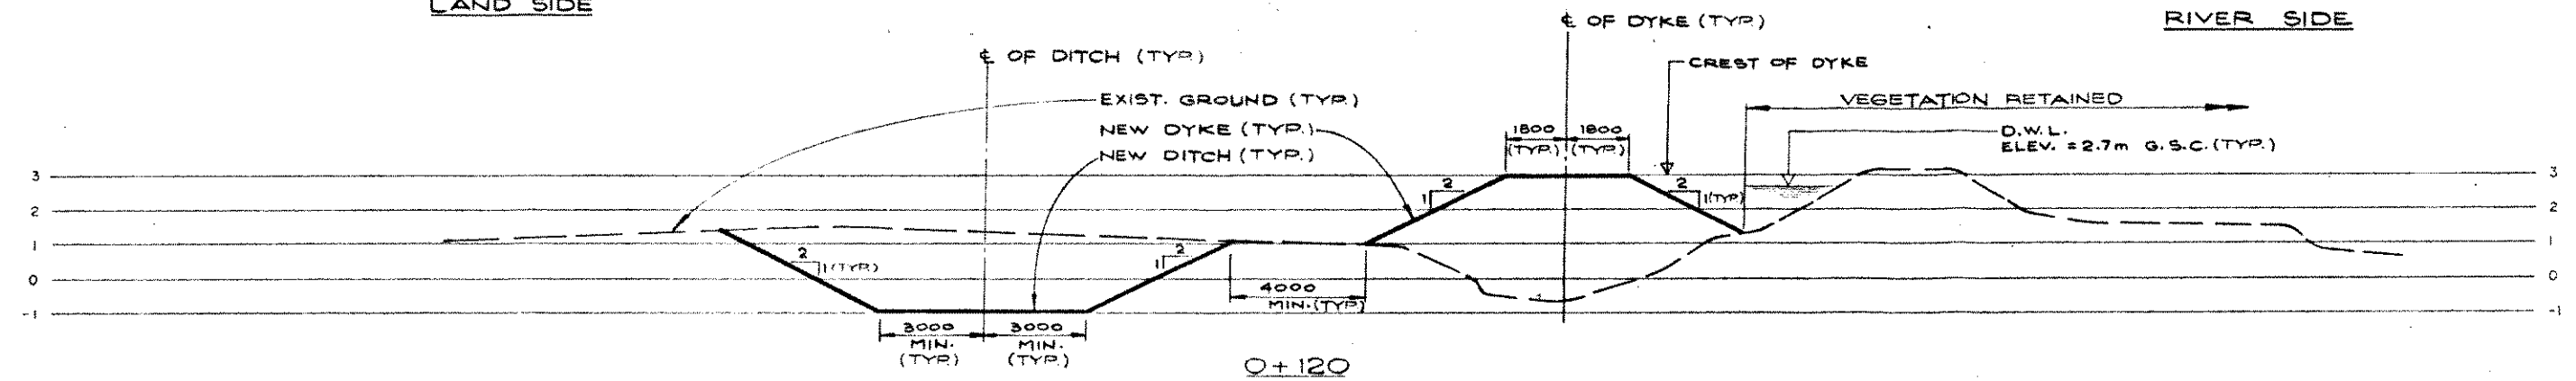
O+120

LAND SIDE

RIVER SIDE

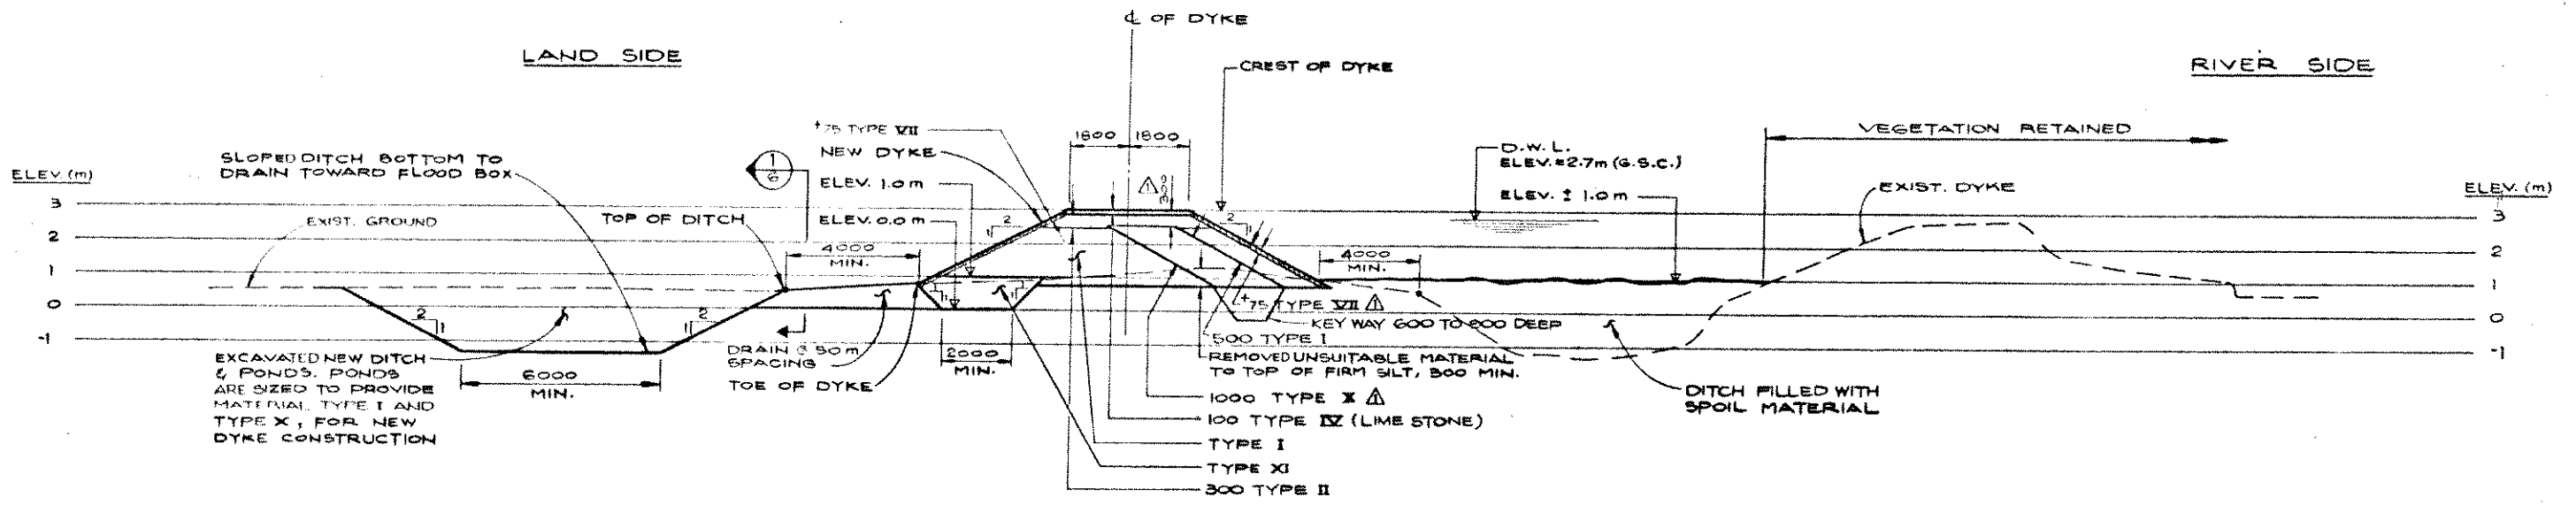
TYPE B CROSS SECTION

NOTE:  
\* ONLY IF TYPE II MATERIAL USED FOR DYKE CONSTRUCTION

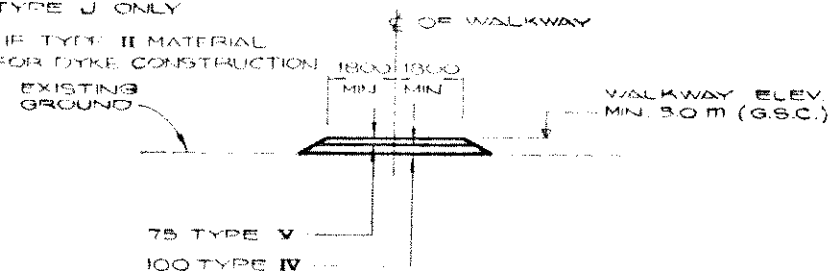
TYPE F CROSS SECTION THIS DRAWING REDUCED TO HALF SIZE (FOR LOCATION SEE SHEET 2)

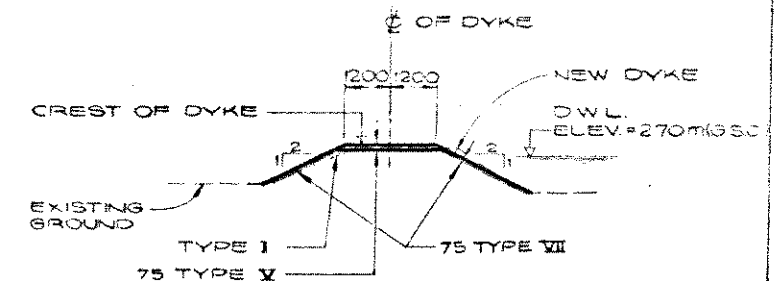
- DYKE FILL MATERIALS**
- TYPE I - GENERAL FILL
  - TYPE II - IMPORTED FILL
  - TYPE III - QUARRY TAILINGS
  - TYPE IV - ROAD GRAVEL
  - TYPE V - LIME STONE
  - TYPE VI - FILTER MATERIAL
  - TYPE VII - TOP SOIL
  - TYPE VIII - BEACH GRAVEL
  - TYPE IX - NOT APPLICABLE
  - TYPE X - SILT CORE
  - TYPE XI - TOE FILTER

TYPE K CROSS SECTION (FOR LOCATION SEE SHEET 2)

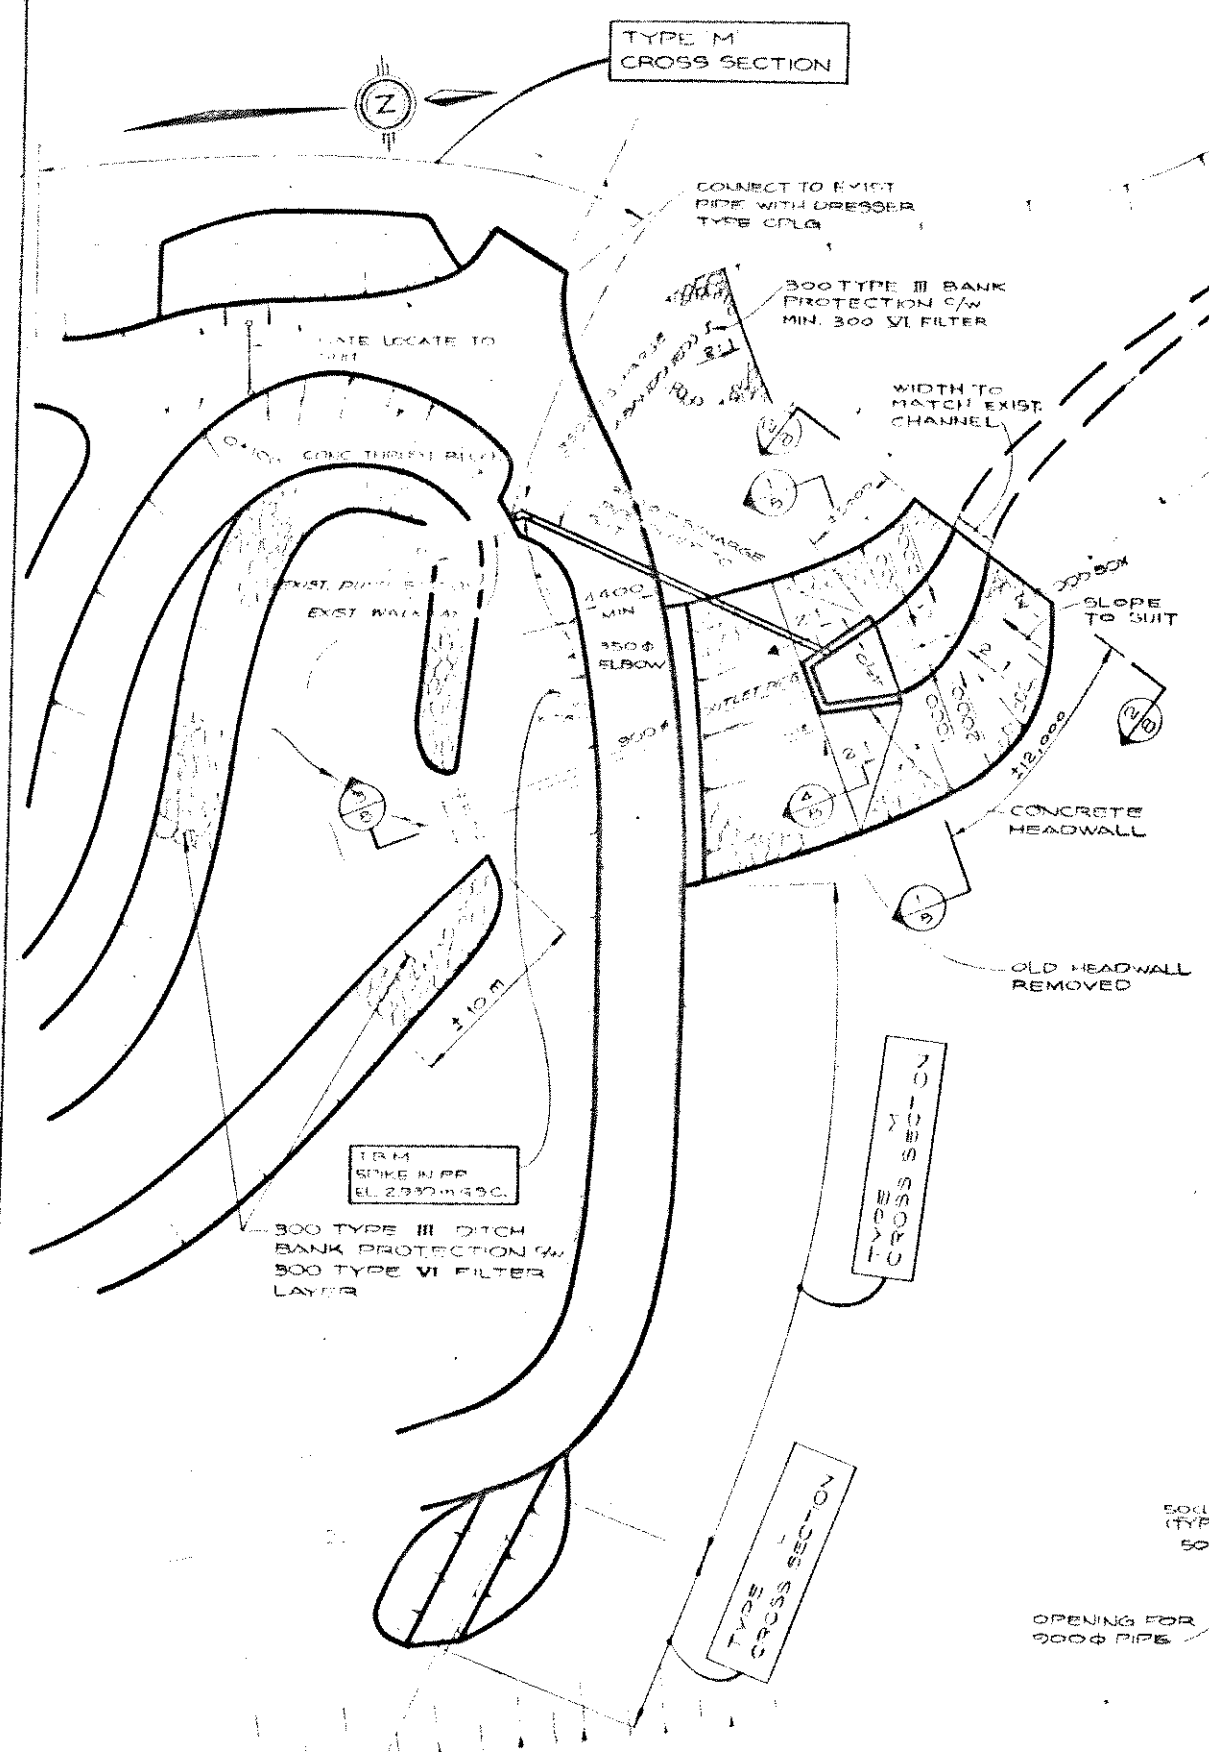
PLAN  
1:200
