Golder Associates Ltd.

**GEOTECHNICAL ASSESSMENT
FRESHET 2007
URGENT MITIGATIVE FLOOD WORKS
IR#2 AND COLONY FARMS DIKE
PITT RIVER ROAD, PORT COQUITLAM, BC**

July 26, 2007

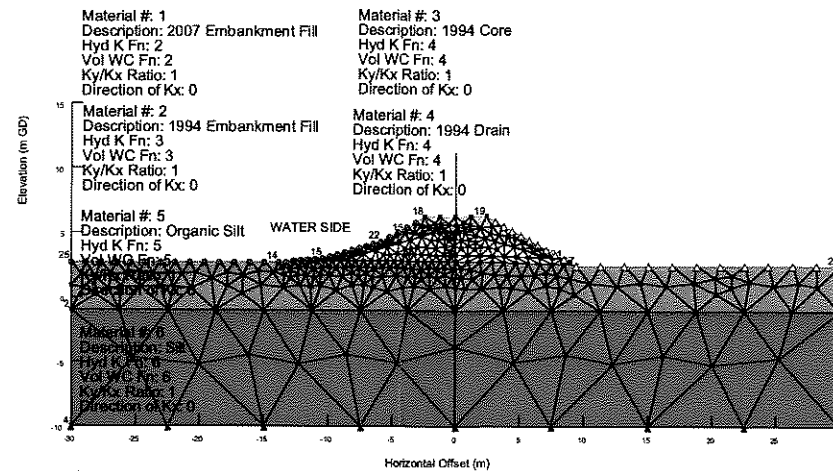
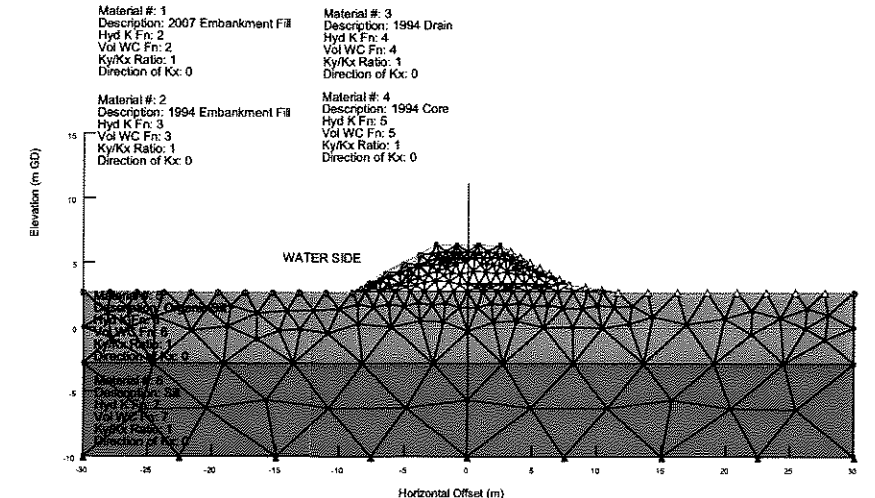
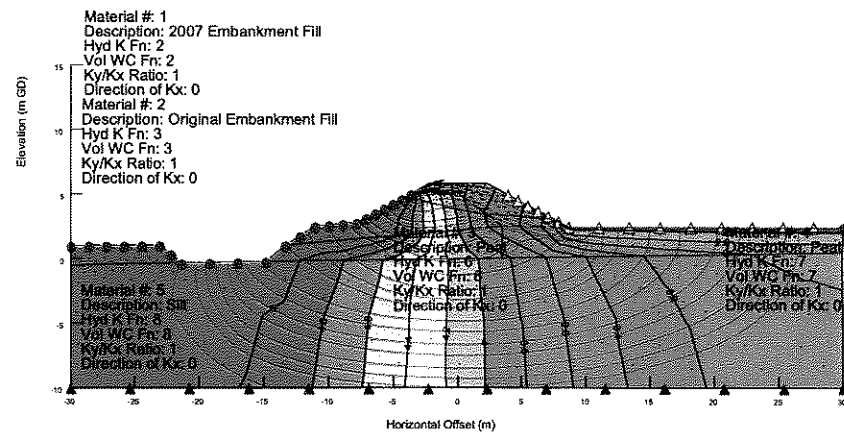
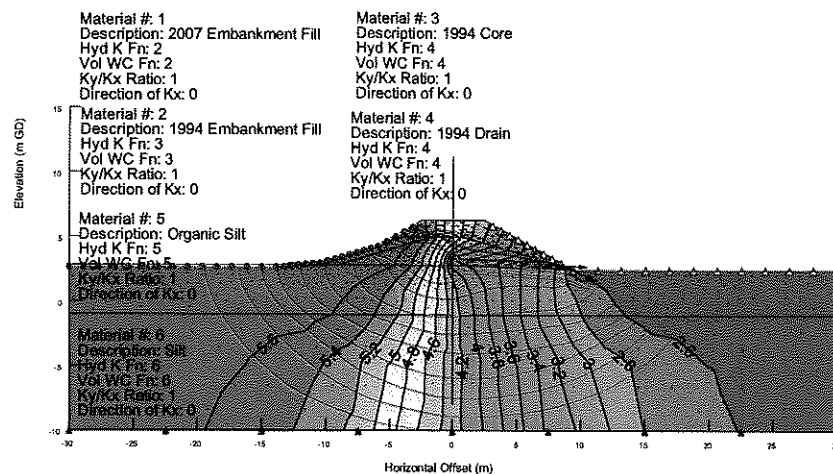
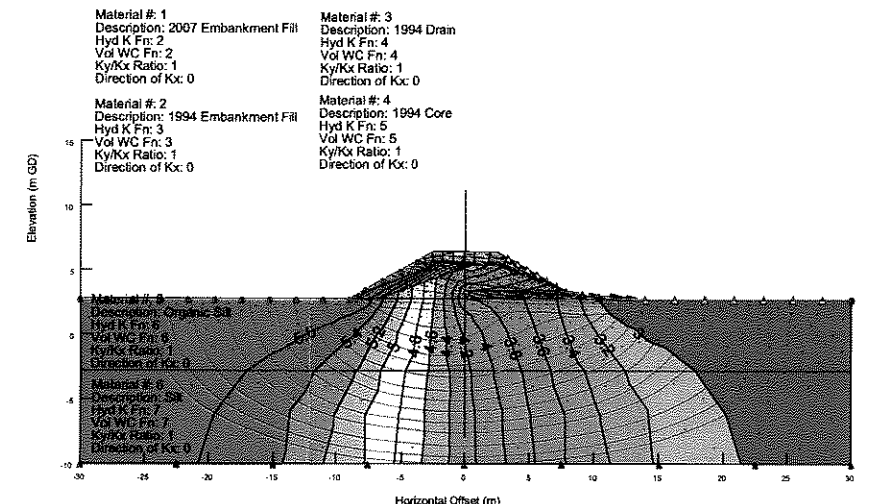
PROJECT		ASSOCIATED ENGINEERING	
		URGENT MITIGATIVE FLOOD WORKS	
		PITT RIVER ROAD, PORT COQUITLAM, B.C.	
TITLE		COQUITLAM RIVER DIKE	
		RESULTS OF SEEPAGE ANALYSIS	
PROJECT No. 07-1411-0098		FILE No.	
DESIGN	JP	14MAY07	SCALE AS SHOWN
CADD	SRR	14MAY07	REV.
CHECK			
REVIEW			
		FIGURE 3

STA 0+300 DOWNSTREAM MODEL

STA 1+400 DOWNSTREAM MODEL

STA 1+800 DOWNSTREAM MODEL

STA 0+300 DOWNSTREAM CONTOUR PLAN OF TOTAL HEAD

STA 1+400 DOWNSTREAM CONTOUR PLAN OF TOTAL HEAD

STA 1+800 DOWNSTREAM CONTOUR PLAN OF TOTAL HEAD

The results of the analyses indicate that exit gradients at the toe of the dike are acceptable and in the order of 0.1 to 0.4. The results are presented on Figure 3.

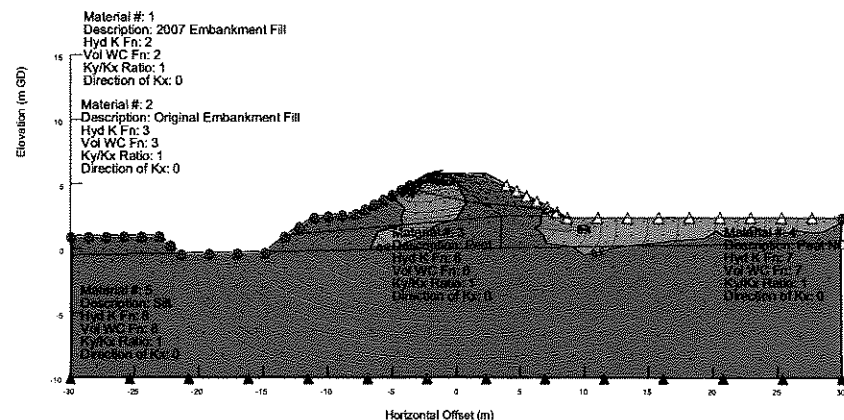
STA 0+300 DOWNSTREAM CONTOUR PLAN OF XY GRADIENT

STA 1+400 DOWNSTREAM CONTOUR PLAN OF XY GRADIENT

STA 1+800 DOWNSTREAM CONTOUR PLAN OF XY GRADIENT

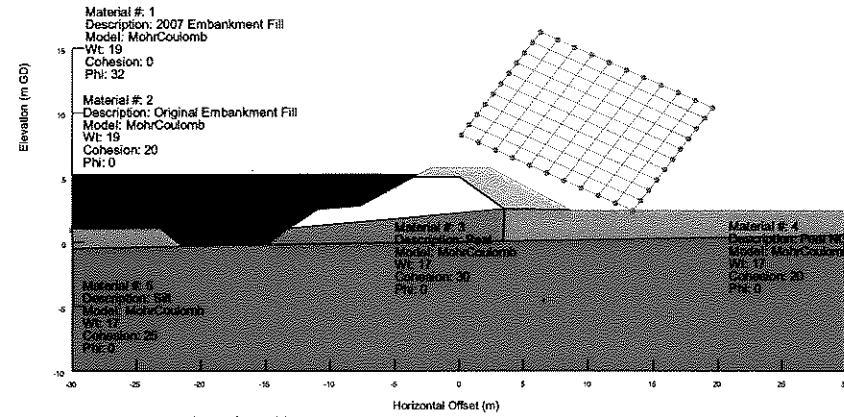
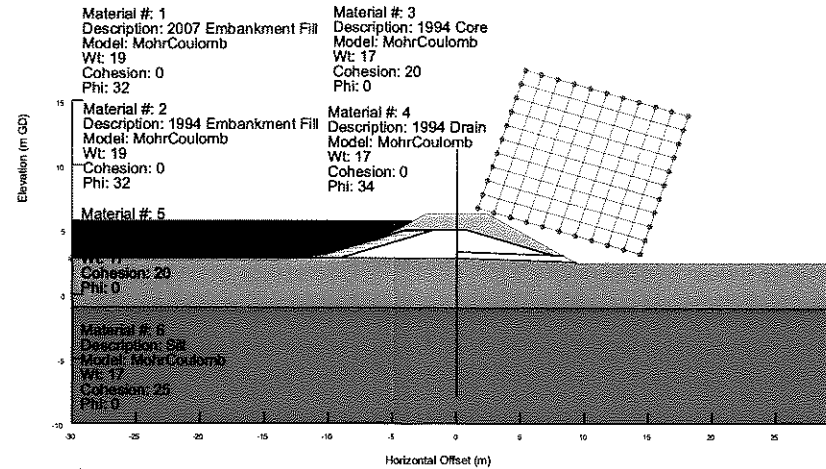
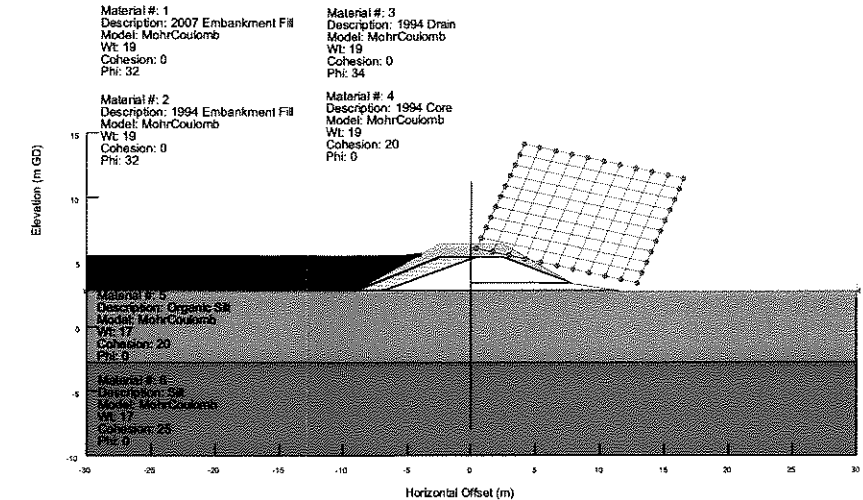
PROJECT		ASSOCIATED ENGINEERING URGENT MITIGATIVE FLOOD WORKS PITT RIVER ROAD, PORT COQUITLAM, B.C.			
TITLE		COQUITLAM RIVER DIKE RESULTS OF STABILITY ANALYSIS			
	DESIGN	JP	14MAY07	SCALE	AS SHOWN
	CADD	SRR	14MAY07	REV.	
	CHECK			FIGURE 4A	
	REVIEW				
PROJECT No. 07-1411-0098		FILE No.

STA 0+ 300 DOWNSTREAM

STA 1+ 400 DOWNSTREAM

STA 1+ 800 DOWNSTREAM

The results of the stability analyses are presented on Figures 4A and 4B and are summarized in Table 3.

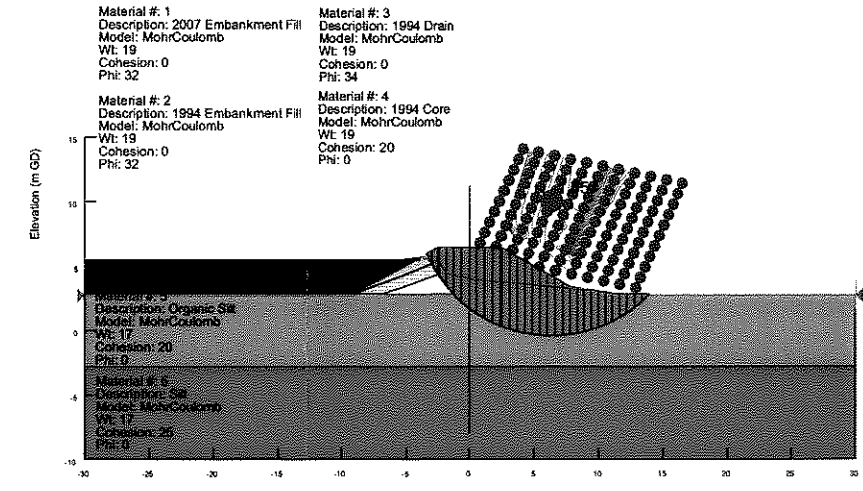
STA 0+ 300 DOWNSTREAM

STA 1+ 400 DOWNSTREAM

STA 1+ 800 DOWNSTREAM

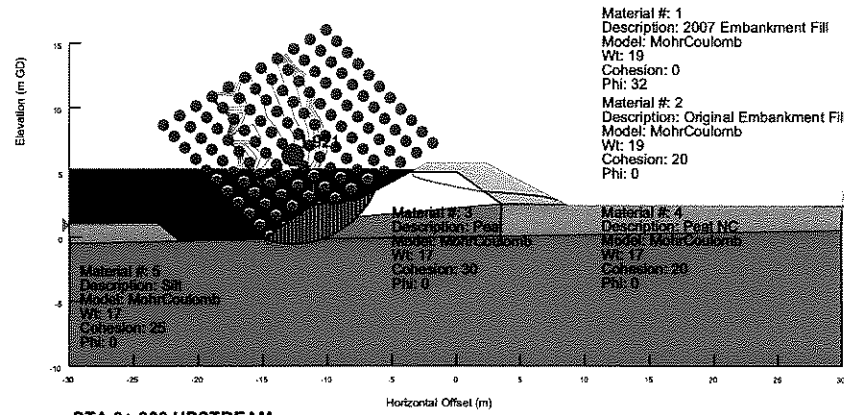
PROJECT No. 07-1411-0098	FILE No.		
	DESIGN JP 14MAY07	SCALE AS SHOWN	REV.	
	CADD SRR 14MAY07			
	CHECK			
REVIEW				FIGURE 4B

STA 0+ 300 UPSTREAM

STA 1+ 400 UPSTREAM

STA 1+ 800 UPSTREAM

STA 0+ 300 UPSTREAM WITH RAPID DRAWDOWN

STA 1+ 400 UPSTREAM WITH RAPID DRAWDOWN

STA 1+ 800 UPSTREAM WITH RAPID DRAWDOWN

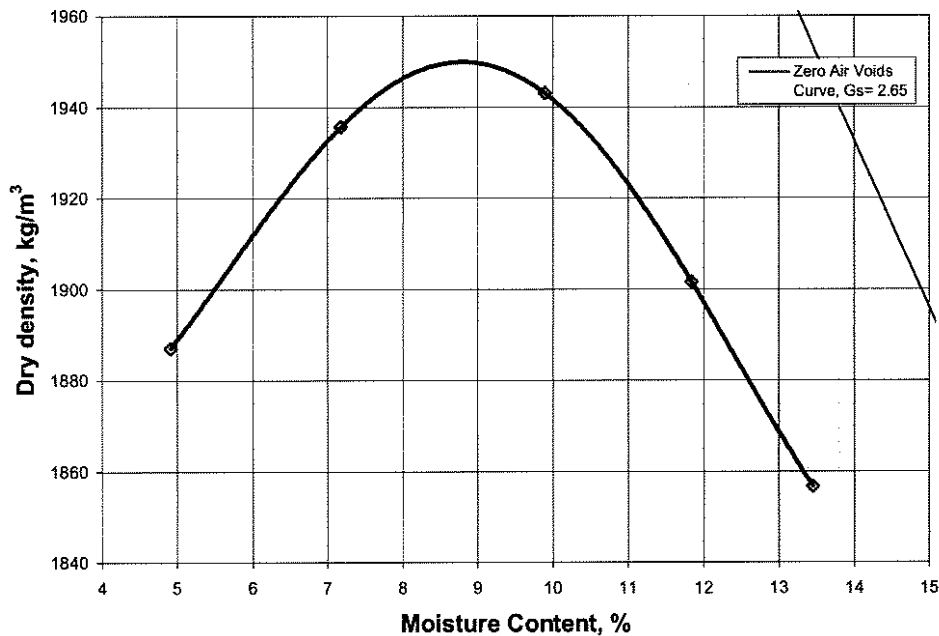
Moisture - Density Relationship

Trial No.	1	2	3	4	5
Dry Density, kg/m ³	1887	1936	1943	1857	1902
Moisture Content, %	4.9	7.2	9.9	13.5	11.8

Maximum Dry Density	1950.0 kg/m ³	Gs (assumed)	2.65
Optimum Moisture	8.8 %	Oversize	18.3 %
Rock Corrected Dry Density	2049 kg/m ³		
Rock Corrected Moisture	7.7 %

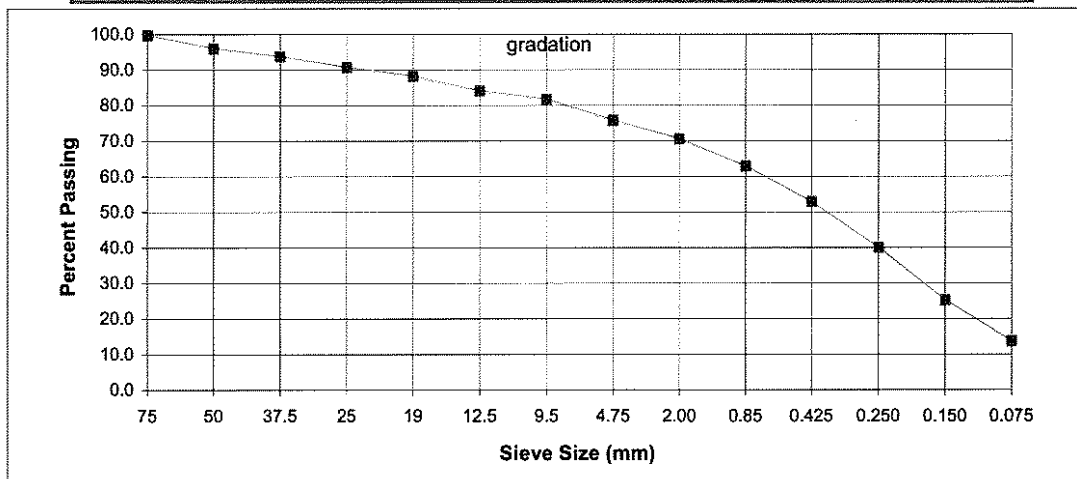
SIEVE ANALYSIS				
Sieve Size (mm)	% Retained	% Passing	Individual % Retained (Split values)	
			+ 4.75	- 4.75
75	0.0	100.0	0.0	
50	3.7	96.3	15.3	
37.5	2.3	94.0	9.5	
25	3.1	91.0	12.8	
19	2.6	88.4	10.6	
12.5	4.1	84.4	17.0	
9.5	2.3	82.0	9.7	
4.75	6.0	76.0	25.0	
2.00	5.1	70.9		6.8
0.85	7.7	63.2		10.1
0.425	10.0	53.2		13.2
0.250	12.9	40.3		17.0
0.150	14.7	25.5		19.4
0.075	11.5	14.0		15.2
PAN	13.9			18.3
Total	100.0
