# Flood Protection Works Inspection Guide

Public Safety Section

Water Management Branch

March 2000

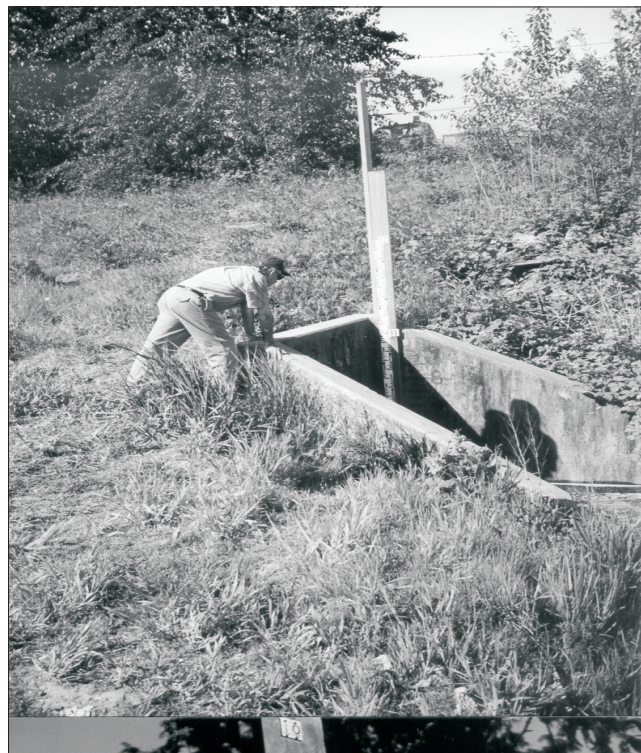
*Inspecting a Floodbox*

Since many appurtenant works are mechanical in nature, they usually require hands-on inspection. Checking that locks work, pumps run properly, floodbox gates open fully and easily are a few examples of this aspect of inspection. Structures such as pumpstation chambers and floodbox conduits should be viewed internally for defects and deterioration.

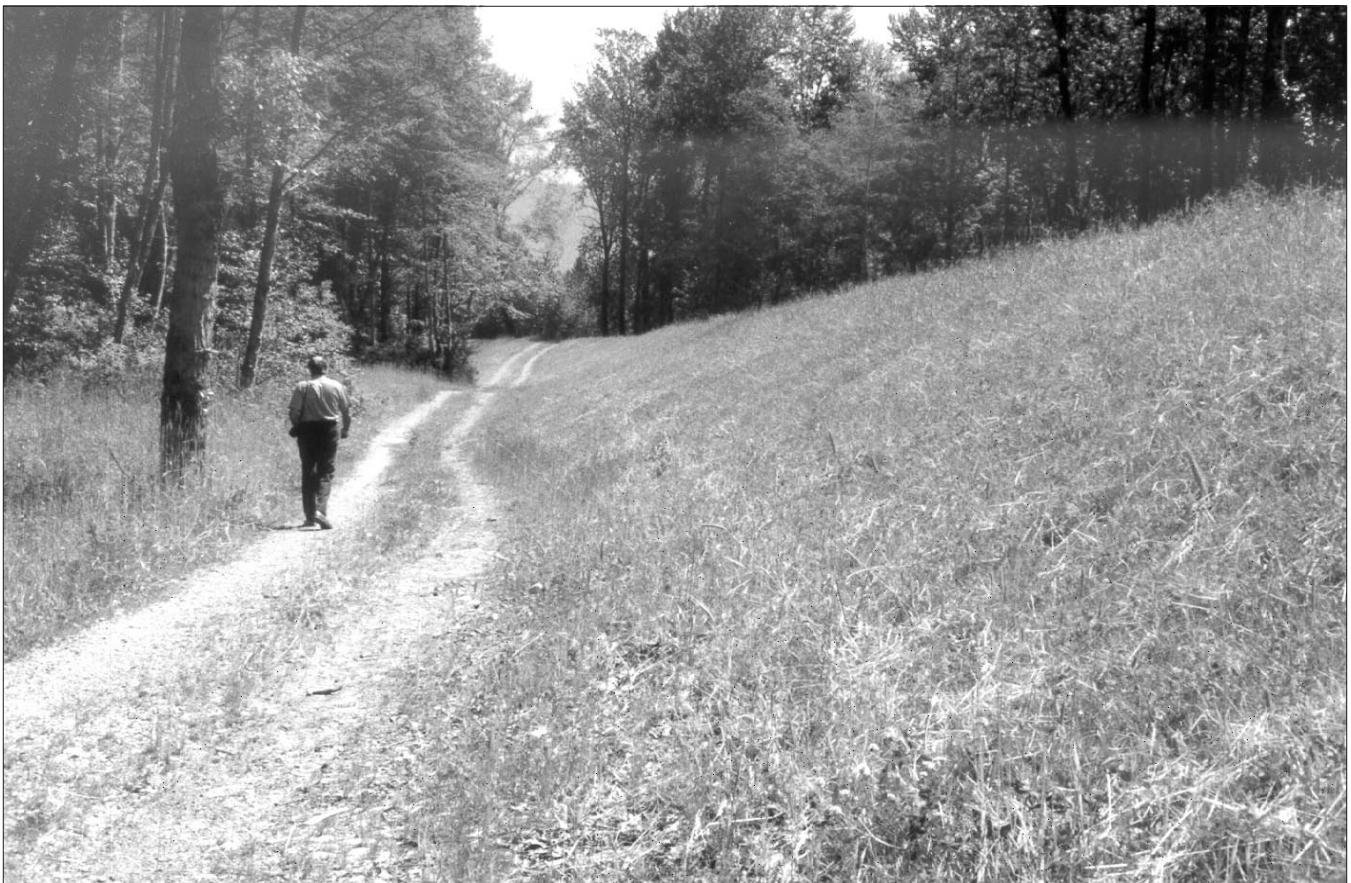
*Inspecting the Landside Toe*

The usual method of inspecting the dike fill is to walk along both crest edges (shoulders) and the landside toe, in order to see the entire surface area clearly. Details can usually be seen for a distance of 3 to 10 metres depending on the roughness of the surface, vegetation, or other surface conditions. The riverside toe is inspected in the same manner as the landside toe for set-back dikes, however for riverside dikes without erosion protection, walking along the slope just above the current water level can prove challenging and may be more efficiently done from a boat.

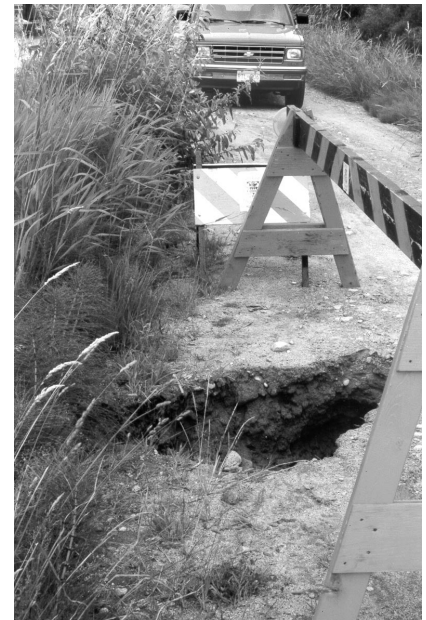
## Sinkholes

Sinkholes usually have steep, bucket-like sides and are a more serious type of depression. Depressions and sinkholes weaken the dike by decreasing the length of the normal path of water seepage through the dike. Sinkholes also provide an entrance point for surface water into the

embankment and, depending on the size and depth of the sinkhole, may lead to dike failure. In addition sinkholes can pose a danger to vehicular and pedestrian traffic. Animal burrows and decaying vegetation, e.g. rotting stumps, embedded within or under the dike fill are common causes of

sinkholes. During inspection look for settlement in the both the crest and slopes of the embankment.

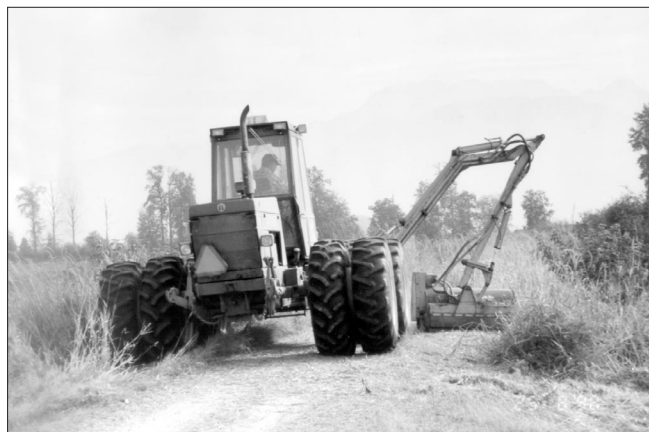
*Mowing dike slopes.*

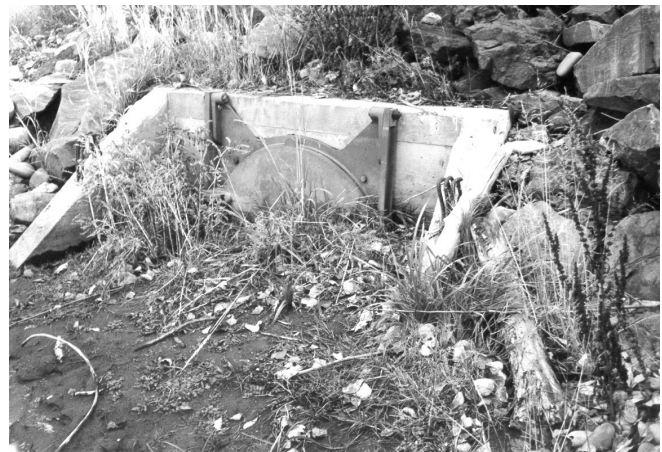
Floating debris from the internal drainage system can also become lodged in the culvert. Trash racks or floating debris catchers are often placed at or near the culvert intake. They too can become clogged.

*Blocked floodbox outlet.*

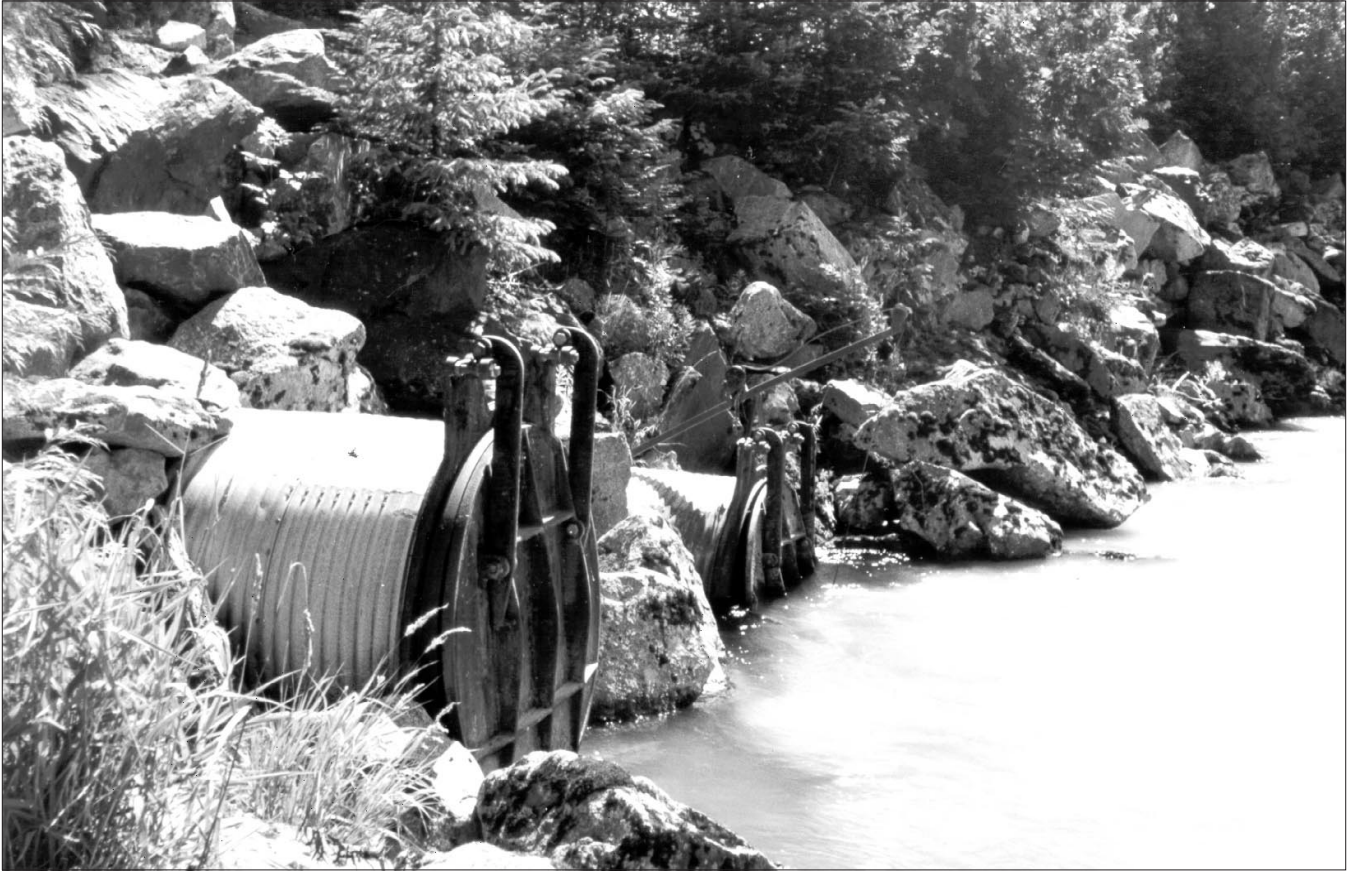
*Uncontrolled Vegetation Growth on Erosion Protection Works.*
