CHECKED		BULKLEY RIVER			
	RIVER SURVEY MP		· · · -	QUICK		JSTON
	DESIGNED BB	10	00m 0	100 SC/	200 ALE 1:5000	300
Pedice .	ENGINEER R.W.IV.	J.L.	RECOMMENDED		,	APPROVED

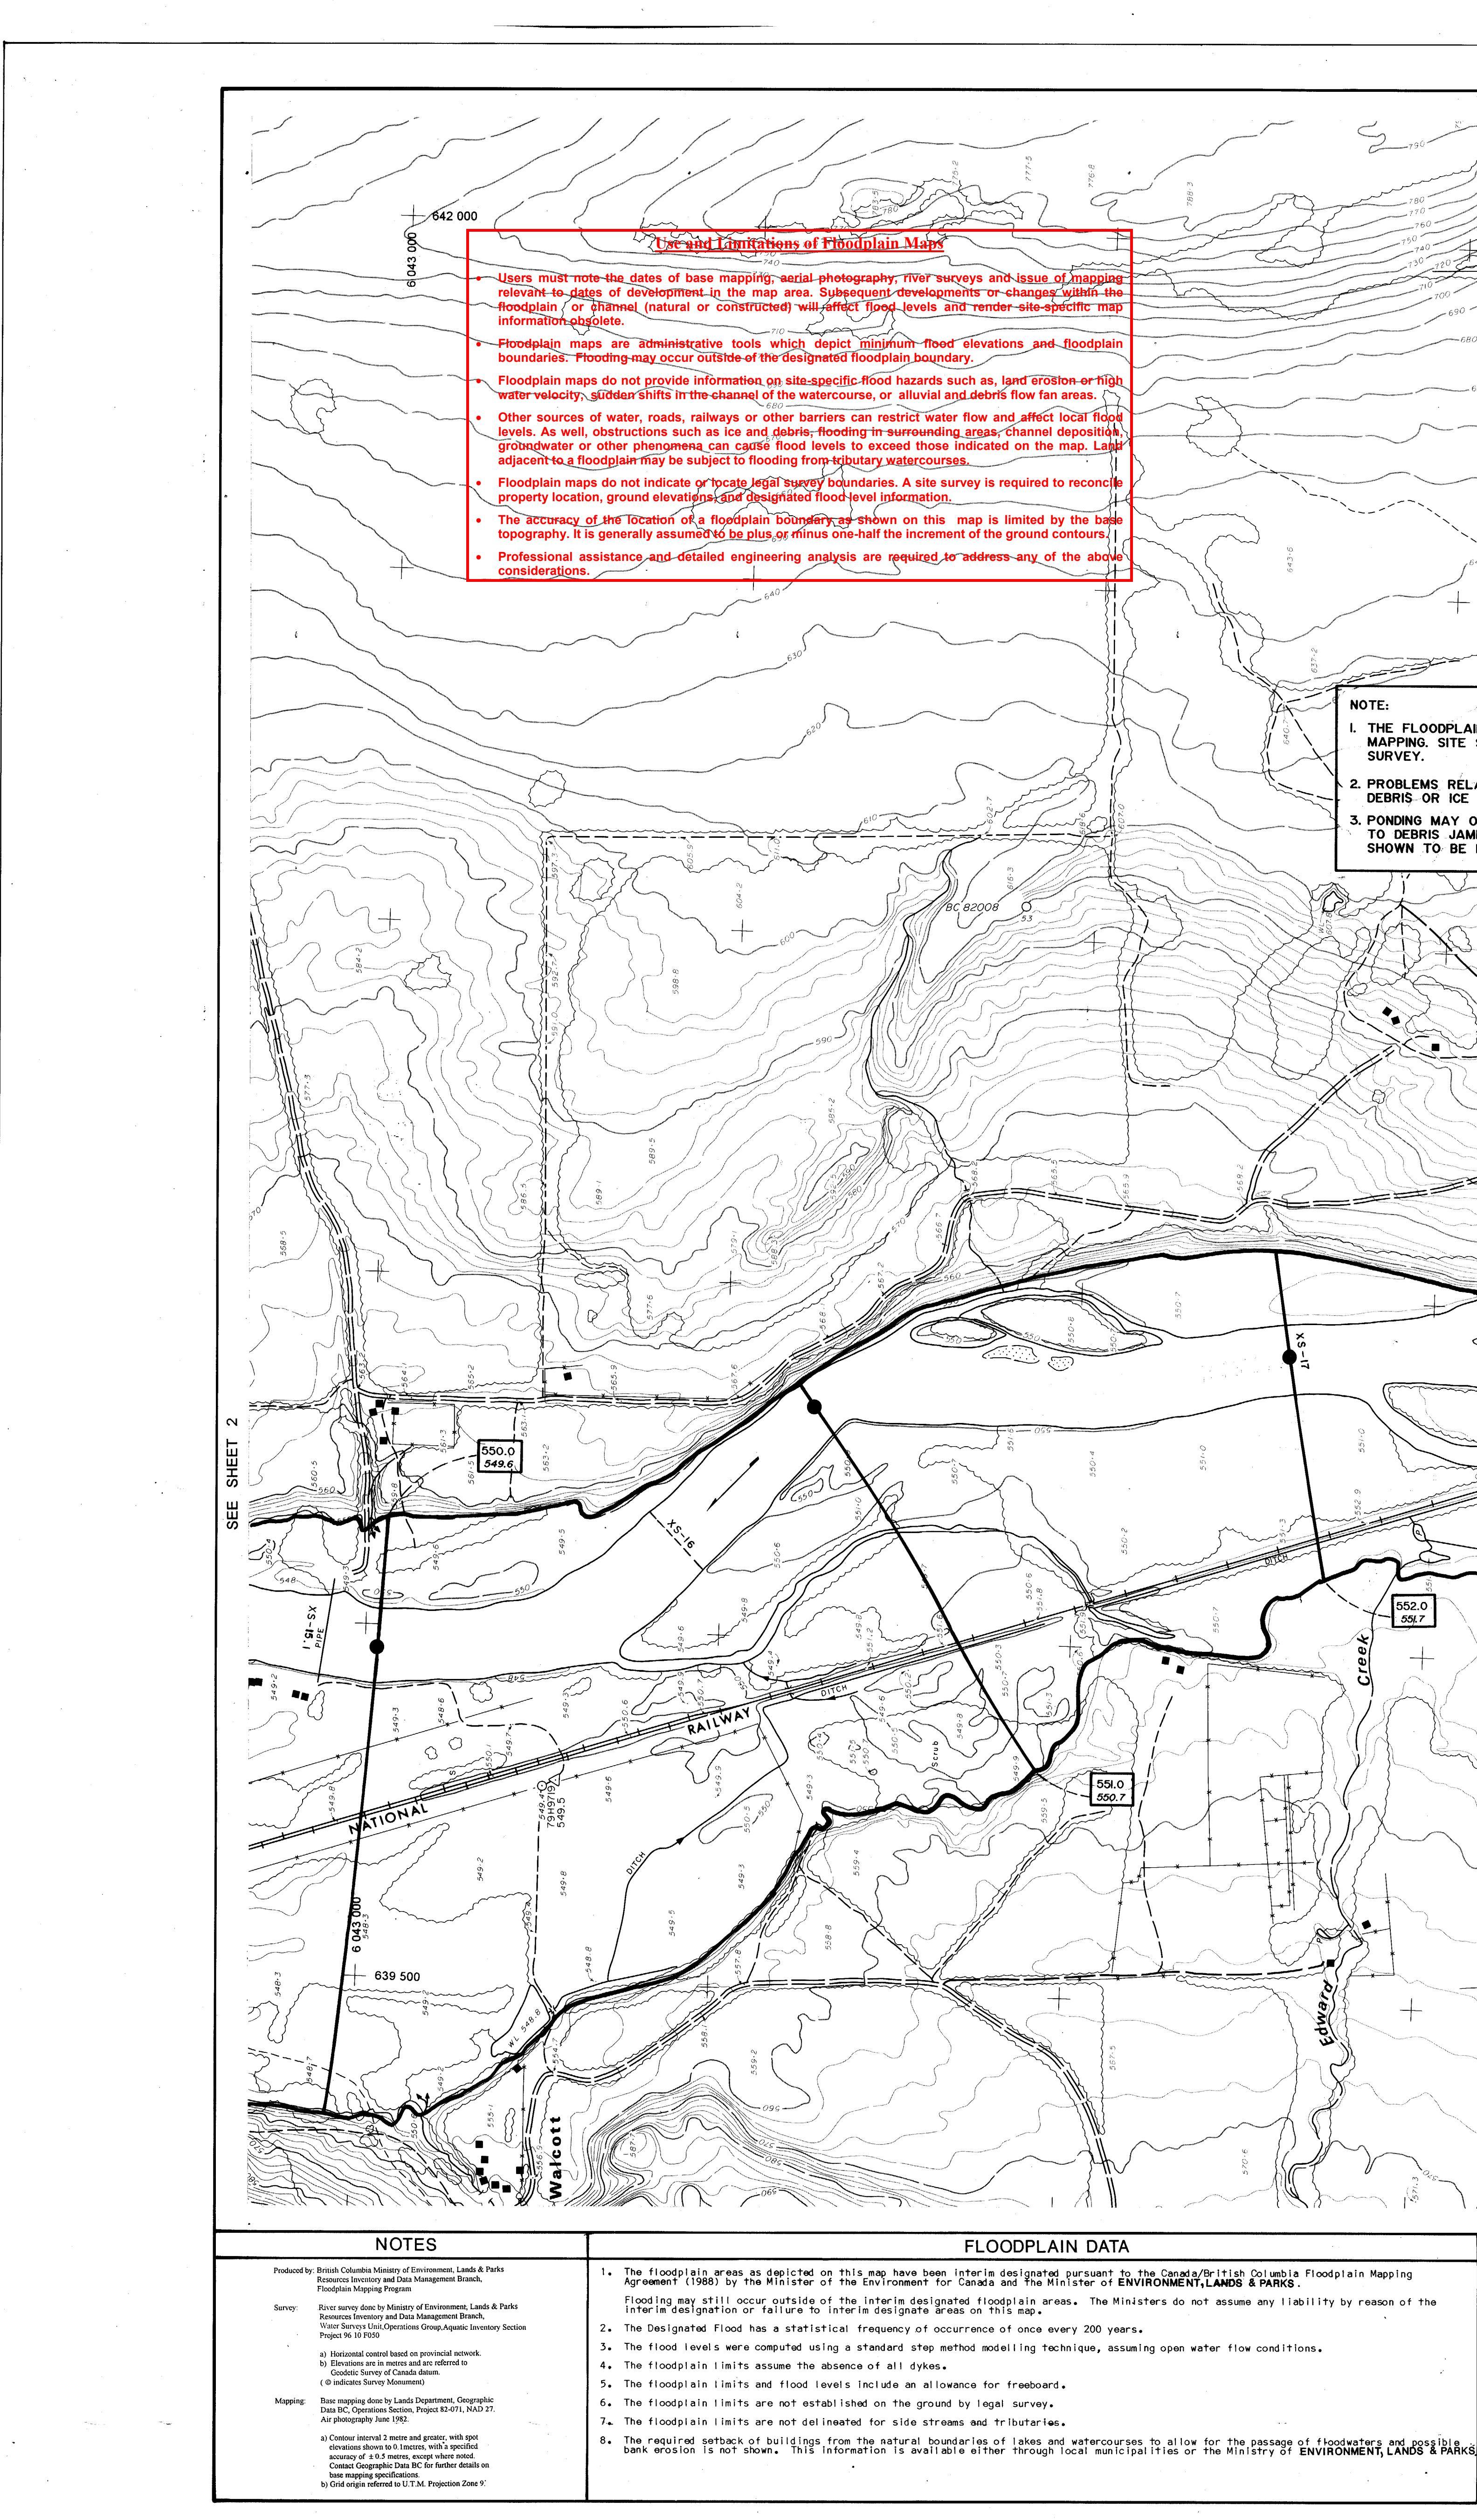
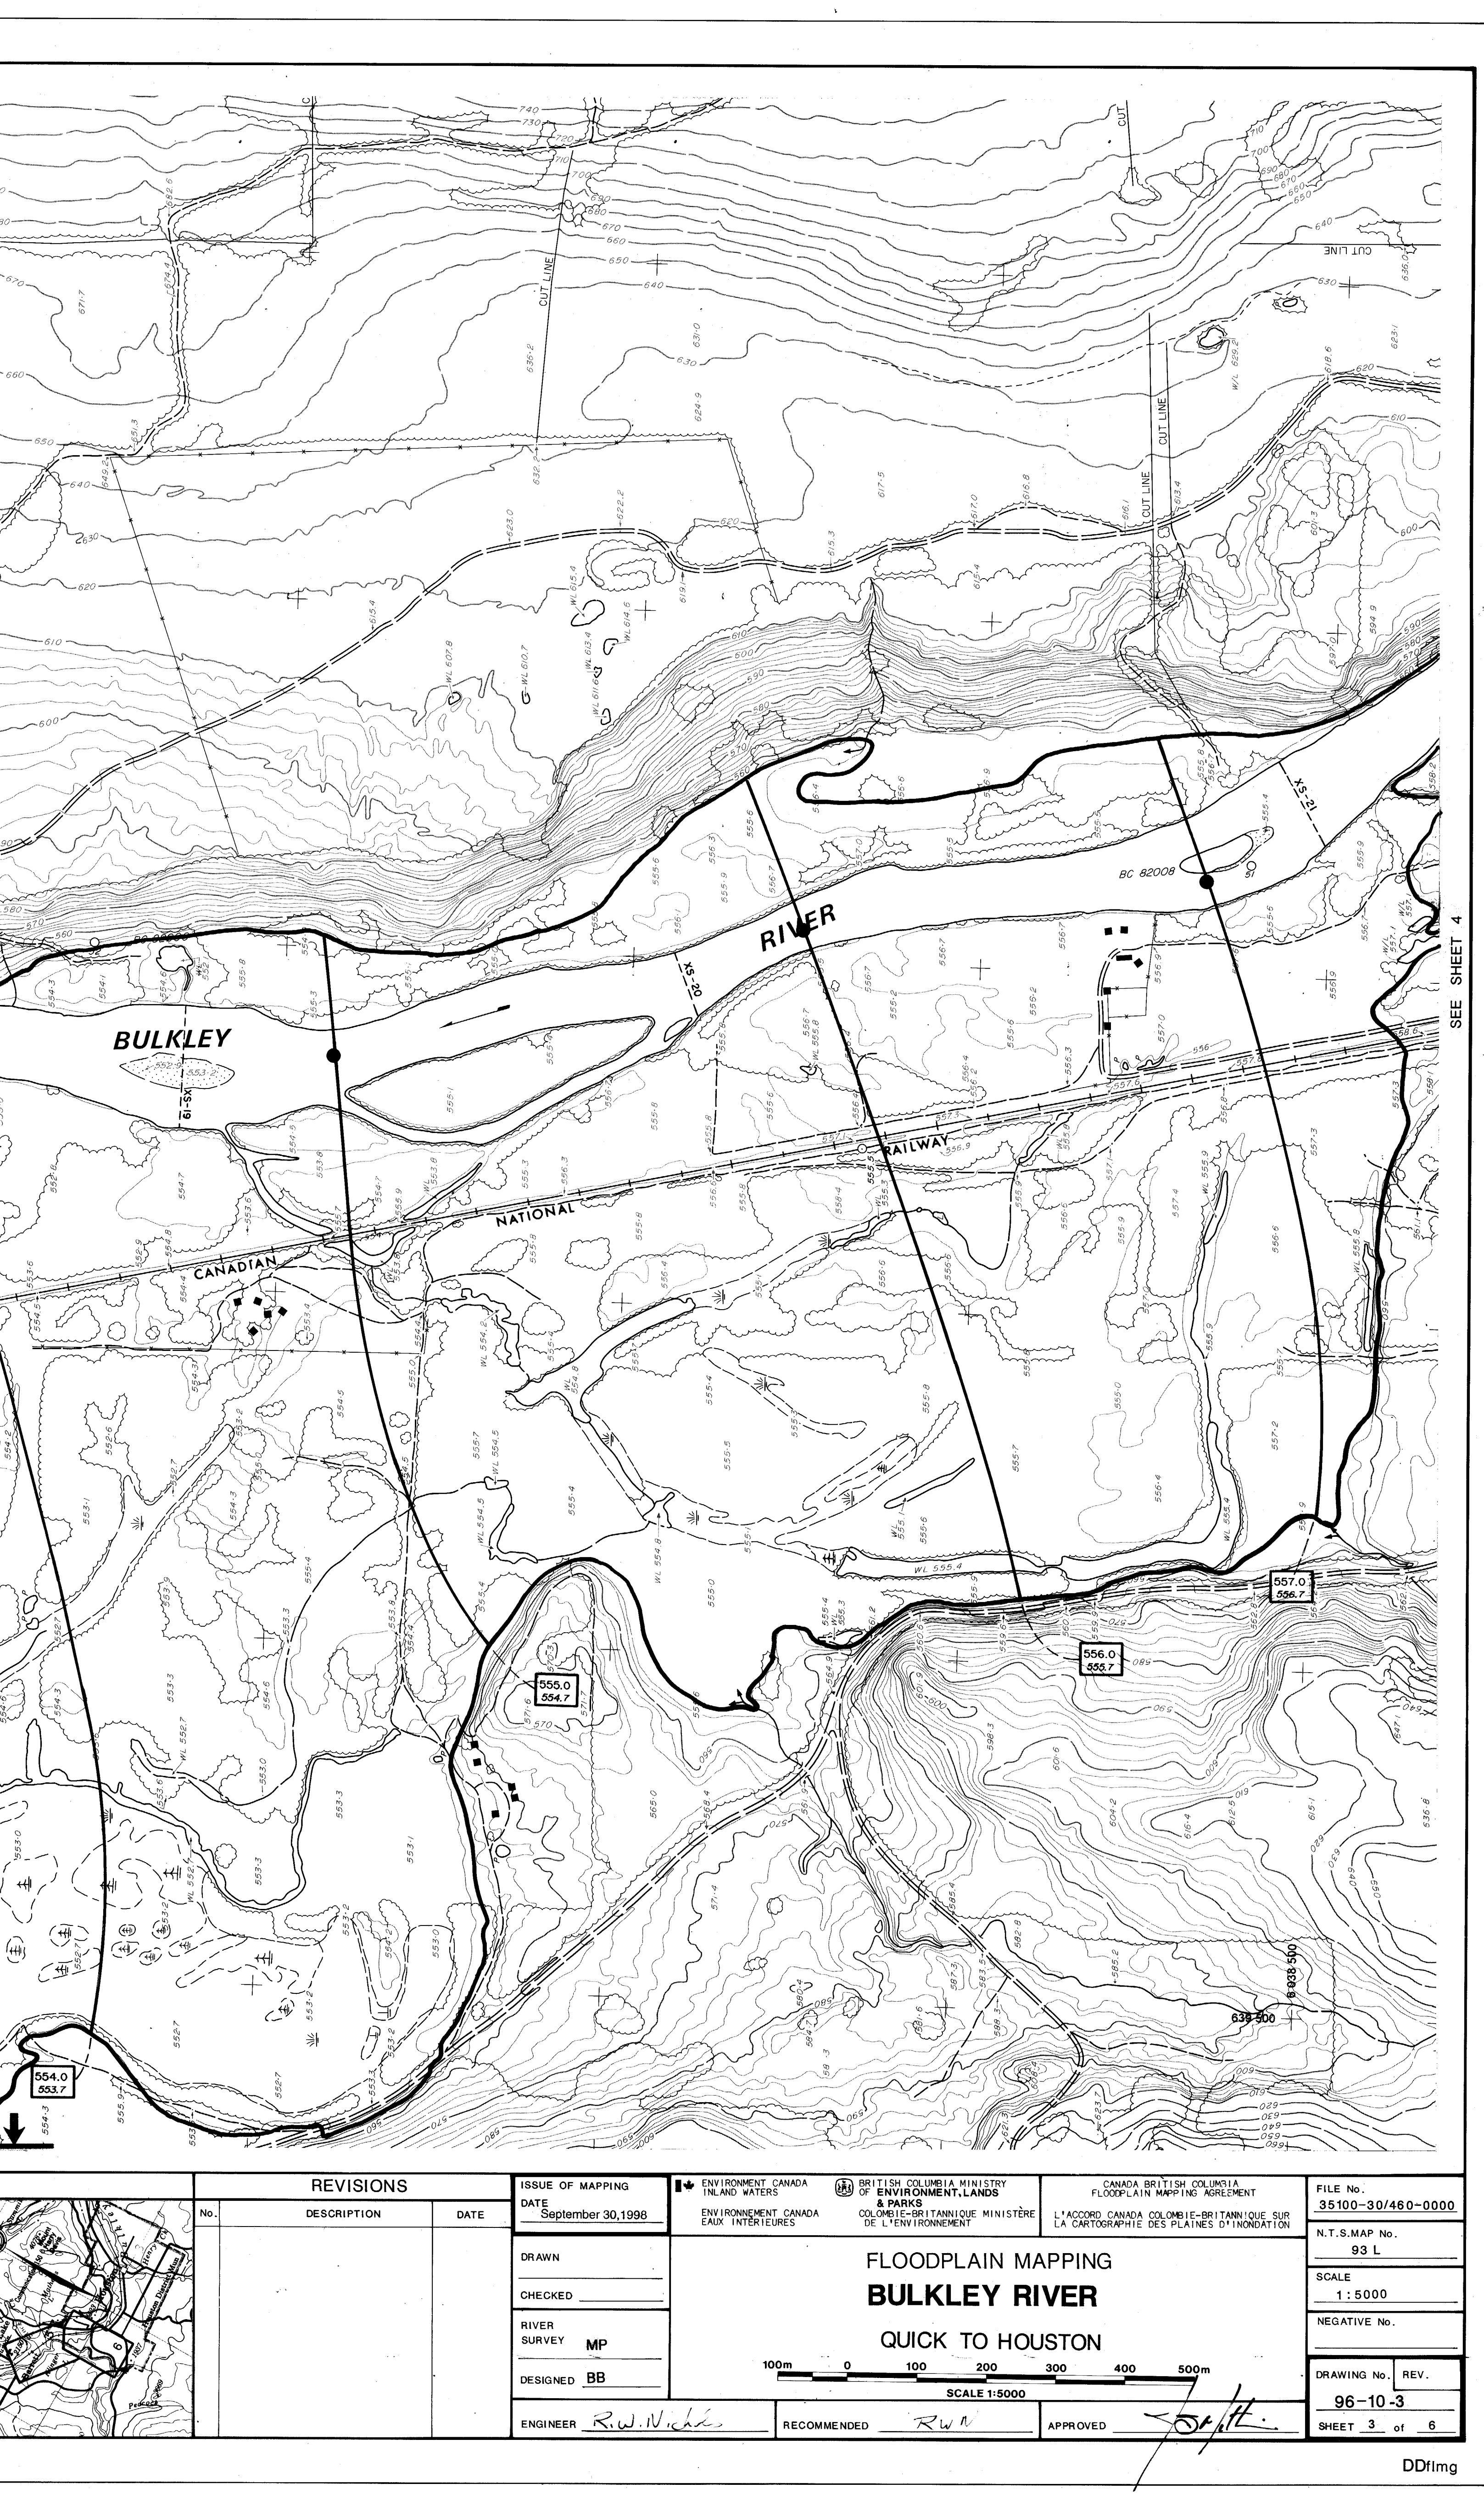
NOTE: THE FLOODPLAIN LIMITS AS SHOWN ARE WITHIN THE ACCURACY OF THE BASE MAPPING. SITE SPECIFIC GROUND ELEVATIONS SHOULD BE CONFIRMED BY FIELD SURVEY. 2. PROBLEMS RELATED TO MAJOR CHANNEL DISLOCATION, PROPERTY DAMAGE AND DEBRIS OR ICE JAMMING HAVE BEEN OBSERVED IN THE BULKLEY RIVER FLOODPLAIN. 3. PONDING MAY OCCUR UPSTREAM OF TRANSPORTATION ROUTE EMBANKMENTS DUE TO DEBRIS JAMMING AT BRIDGES OR CULVERTS RESULTING IN THE FLOOD LEVELS SHOWN TO BE EXCEEDED. Image: 1 . <del>بلہ سے ب</del>ے ر 552.0 551.7 553.0 552.7 551.0 550.7 LIMIT OF STUDY LEGEND ΚΕΥ ΜΑΡ DESIGNATED FLOODPLAIN LIMIT
