Bella Coola Valley Fish Habitat Restoration

Objectives

The objective of this project is to diversify the in stream hydraulics in selected reaches of tributaries of the Bella Cola River by increasing the amount of stable riffle/pool habitat and the amount of cover as well as improving access.

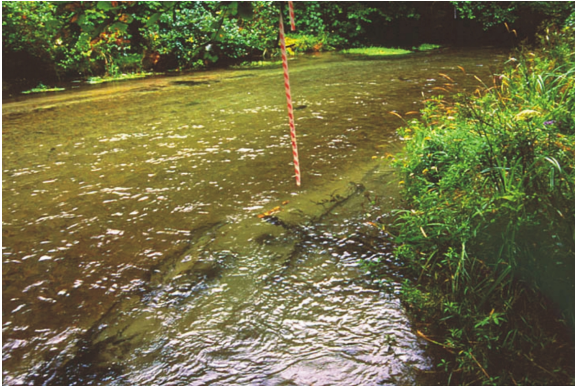
Figure 1. Pre-construction view of Snootli Creek site.

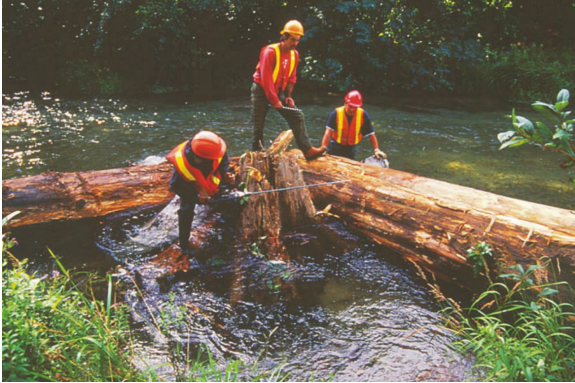
Reconfiguring stream channels into a stepped pattern or more sinuous morphology has created more diverse hydraulic and habitat conditions (Fig. 2). It also provides more water depth during low flow periods. The constructed riffles will enhance pools, recruit gravel, re-aerate flows, and assist fish passage. The pools will provide holding cover for spawners and rearing habitat for juvenile and resident salmonids.

Figure 2. Post-construction view of Snootli Creek site.

Riffles were constructed at a frequency of approximately 6 times the average bankfull width. The riffle structures consisted of logs that span the bank full width of the stream and are placed 30 degrees from perpendicular to the flow in an alternating sequence from the left bank to the right bank. Large wood in the form of logs and rootwads as well as cobble and boulder were the primary materials employed to add complexity and provide cover. The completed project has created approximately 50 new or improved riffle/pool /cover habitat sites.
