AQUATIC VEGETATION SURVEY OF THE MAJOR PARKS, GARDENS  
AND OTHER TOURIST ATTRACTIONS OF SOUTHERN VANCOUVER ISLAND  
AND THE LOWER FRASER VALLEY, 1982

P. D. WARRINGTON, Ph.D.  
Water Management Branch,  
Ministry of Environment.

February, 1983

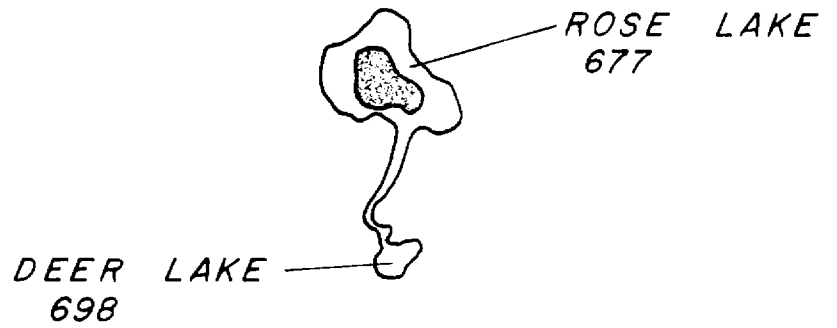
BEACON HILL PARK

Beacon Hill Park is a well established public park in Victoria with 6 small, shallow ponds which are connected by a stream system. All the ponds are continuously and heavily grazed by waterfowl. Fountain Lake (504), contains cultivated water lilies (Nymphaea sp.) but the other ponds (Arbor Lake (499), Goodacre Lake (498), Rose Lake (677), Deer Lake (678), Queen's Lake (679), and a decorative fountain pond at the service building) have no plants.

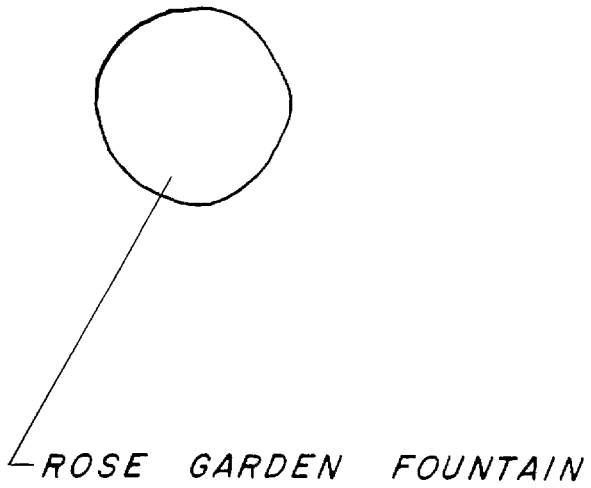
PARK AND TILFORD GARDENS

The fountain pool is very shallow and tiled; it has no plants. The flower garden pool and creek has some Menyanthes trifoliata growing in pots beneath the Gunnera but is not otherwise planted. The Japanese garden pond (597) is the main aquatic garden. It is concrete, has walkways around most of the margin and a bridge over the middle. In addition to the species recorded in the table below, there are a number of introduced non-native aquatic plants in this pond which were not identified. No waterfowl have ever been seen here in several years of regular observations. The garden is in a heavy industry zone and suffers badly from deposition of a blackish material on the plants.

The presence of Myriophyllum brasiliense in this outdoor pond is of special interest. This species is a major pest in tropical and subtropical areas yet has been able to survive several winters with sub-freezing weather in North Vancouver. M. brasiliense often grows marginally as well as in the water and was seen one winter covered with ice as it sprawled alongside the waterfall. Thus M. brasiliense has shown that it can grow in temperate climates but we do not yet have any data on its ability to compete with native species outside cultivation.

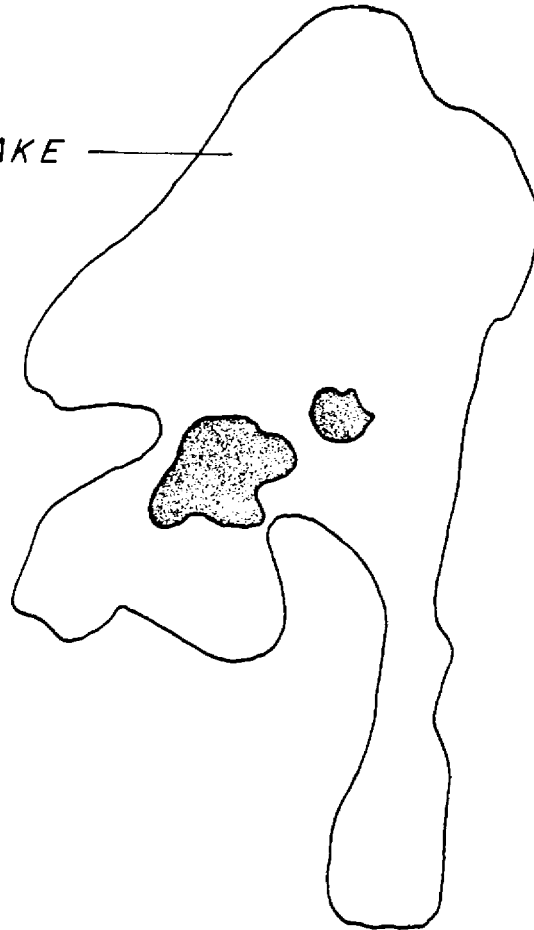
U.B.C. BOTANICAL GARDENS

The Japanese Nitobe Memorial Garden was opened in 1960 and contains an artificial, concrete-lined pond (682). Nymphaea sp., Callitriche heterophylla and Iris pseudacorus were found here. This pond has many large herbivorous carp. A small pond in the Alpine portion of the main garden contains Liriope minor, Typha minima and Fauria crista-galli. There is a shallow boggy pond called J.K. Henry Lake (680) which has quite an extensive list of native species including one rare occurrence in B.C. of Azolla filiculoides, an aquatic fern.
